STATE COMMISSION ON RAILWAY ACCIDENT INVESTIGATION

ANNUAL REPORT 2023

ON THE ACTIVITIES
OF THE STATE COMMISSION
ON RAILWAY ACCIDENT INVESTIGATION

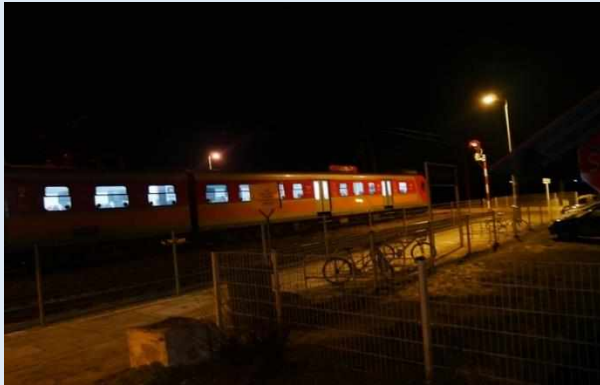
Photograph 1 – A view of the occurrence site at night from the passenger stop Krzcięcice (own material of PKBWK)

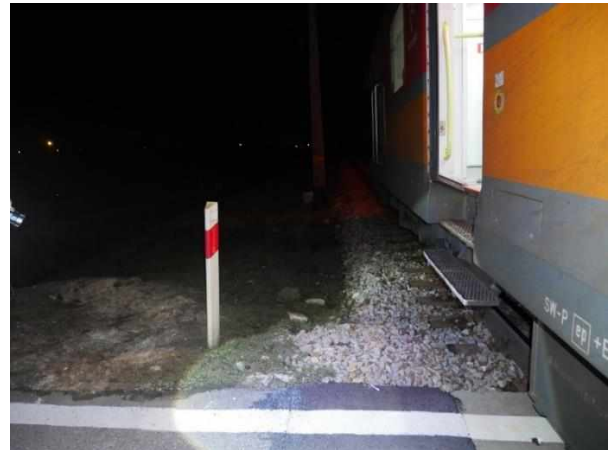
Photograph 2 – A view of the occurrence site at night from the passenger stop Krzcięcice (own material of PKBWK)

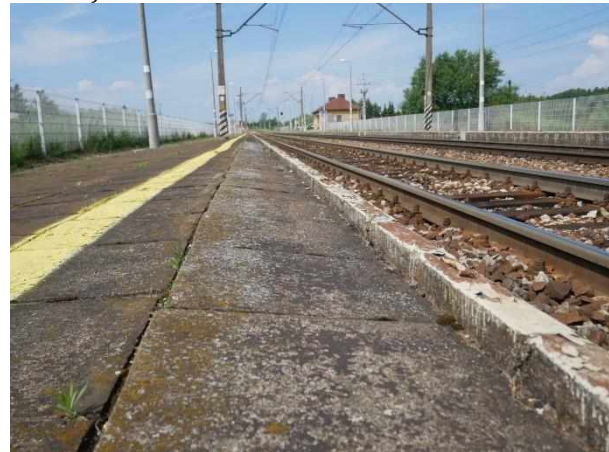
Photograph 3 – A view of Platform 2 with uneven pavement (own material of PKBWK)

6. PKP PLK S.A. Railway Line Plant in Kielce shall rectify the irregularities mentioned in Section V.3 of Report No. PKBWK 03/2023, i.e.
 - a) At the Cat. A level crossing, which is 33 m long and crosses two railway lines: no. 8 (double-track) at km 244.630 and no. 65 (single-track) at km 311.347, there are two light points installed, which is in conflict with §88 of the Regulation of the Minister of Infrastructure and Development of 20 October 2015 on the technical conditions to be met by crossings of railway lines and sidings with roads, and on their positioning (Journal of Laws, item 1744), which provides: "The number of light points shall be determined according to the length and width of the level crossing or passage, taking into account the illuminance and light evenness values in accordance with Standard PN-EN 12464-2 Light and lighting."

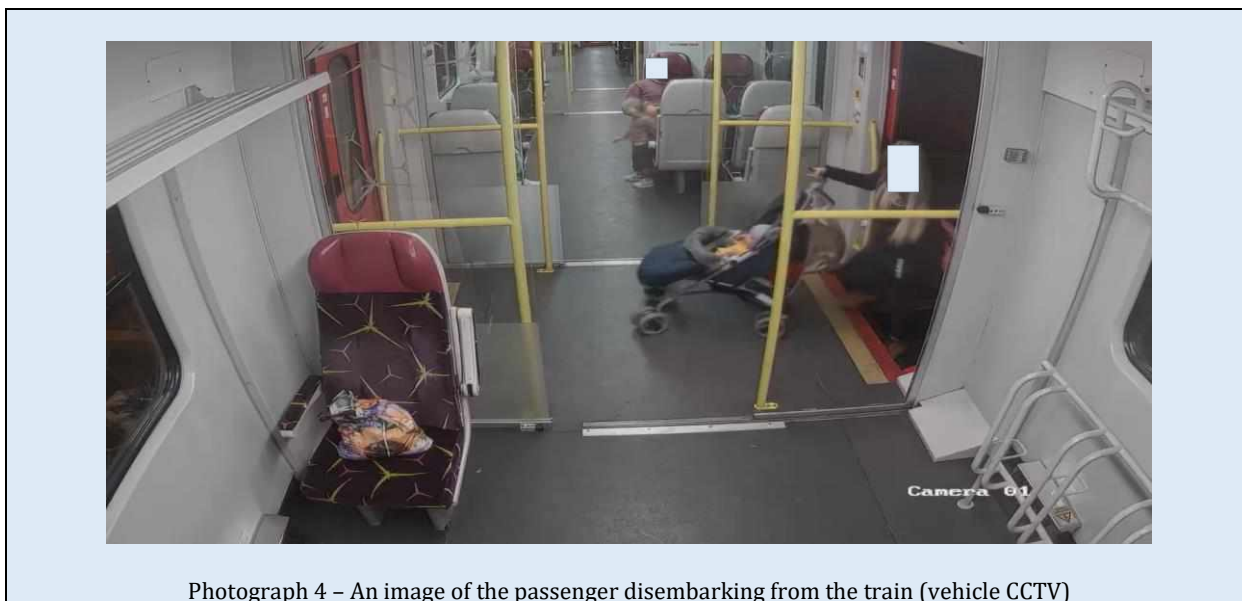
Photograph 4 – An image of the passenger disembarking from the train (vehicle CCTV)

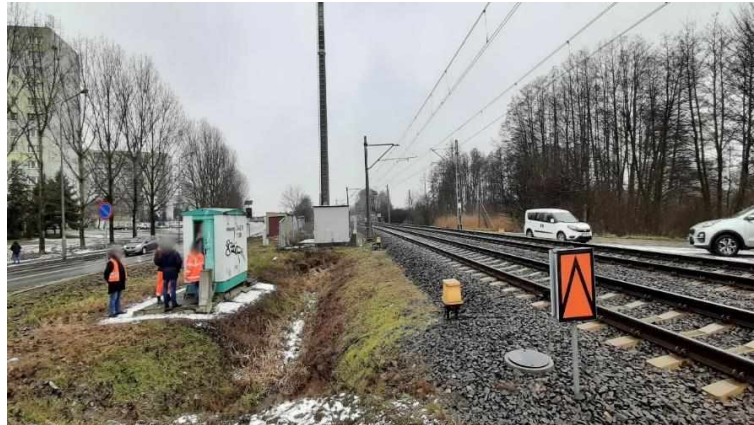
Photograph 5 – A view of track no. 2 from the road from the distance of 5 metres from the outermost rail (own material of PKBWK)

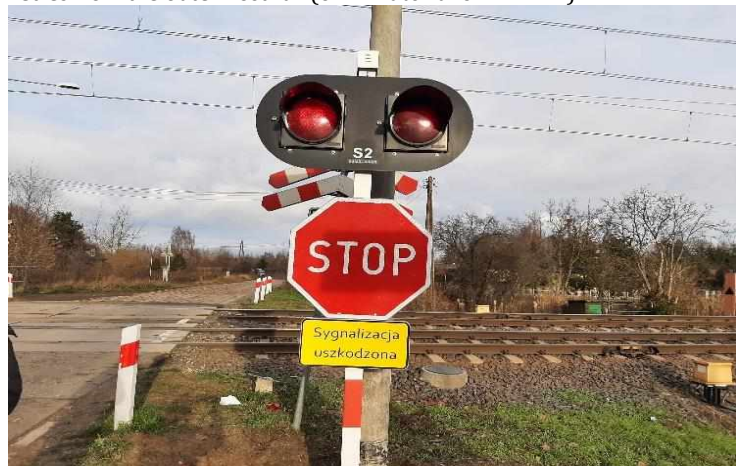
Photograph 6 - Marking of the crossing after the arrival of representatives of PKBWK (own material of PKBWK)

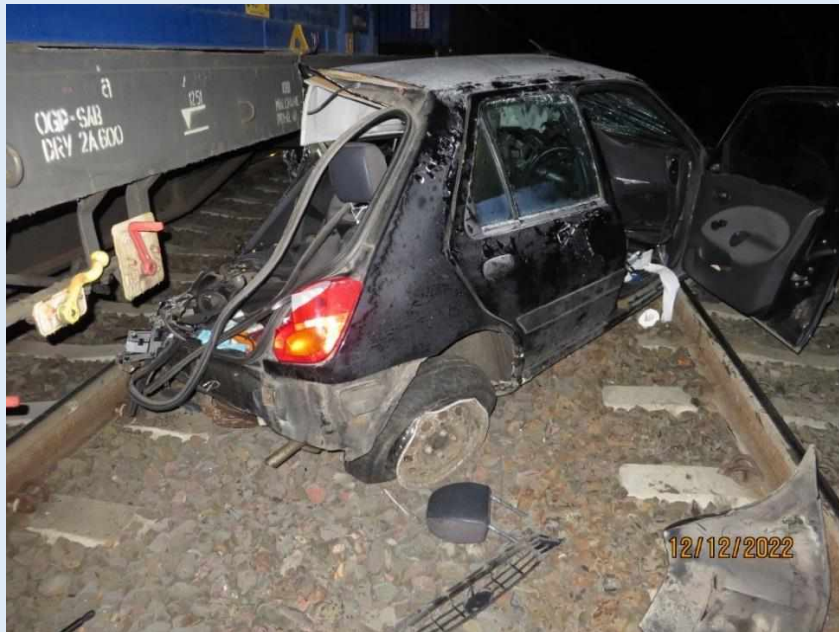
- the passenger car driver sustained injuries and was taken to hospital
- the Ford passenger car was damaged
- electric locomotive ET22-1082 was damaged
- the train did not derail

Photograph 7- Consequences of the occurrence (source: material provided by the railway commission)

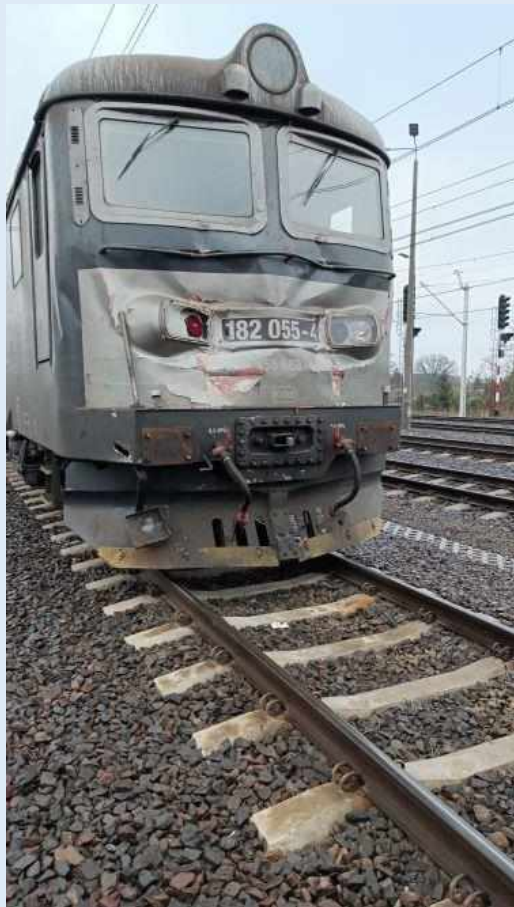
- locomotive E182-055-4 leading train LTE 785009 of the carrier CTL Logistics Sp. z o.o. was damaged
- the last wagon no. 84 51 594 4675 - 4 (loaded with stone) in train TME 684013 of the carrier POL-MIEDŹ TRANS Sp. z o.o. was damaged

Photograph 8- Consequences of the occurrence (source: material provided by the railway commission)

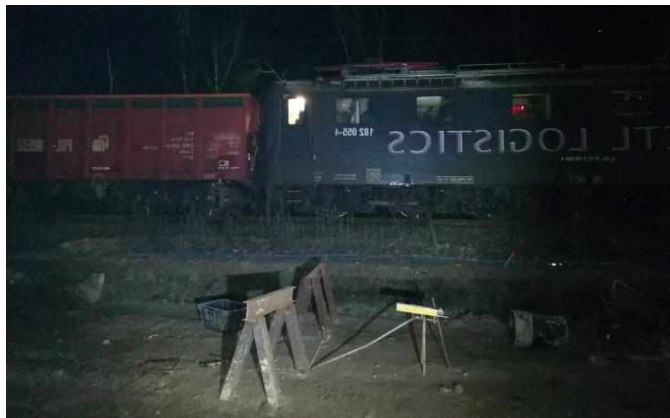
Photograph 9 - A view of the occurrence site (source: materials provided by the railway commission)

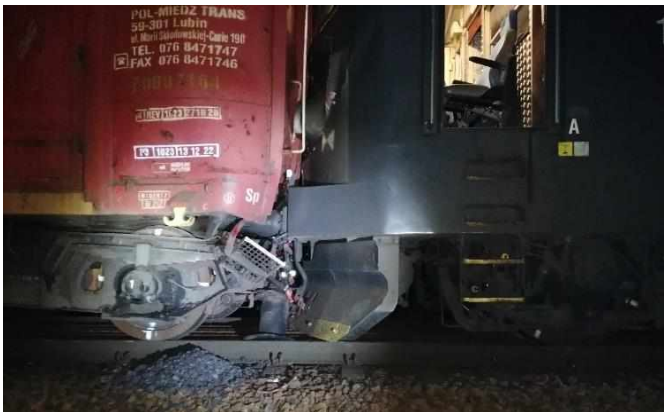
Photograph 10 - A view of the occurrence site (source: materials provided by the railway commission)

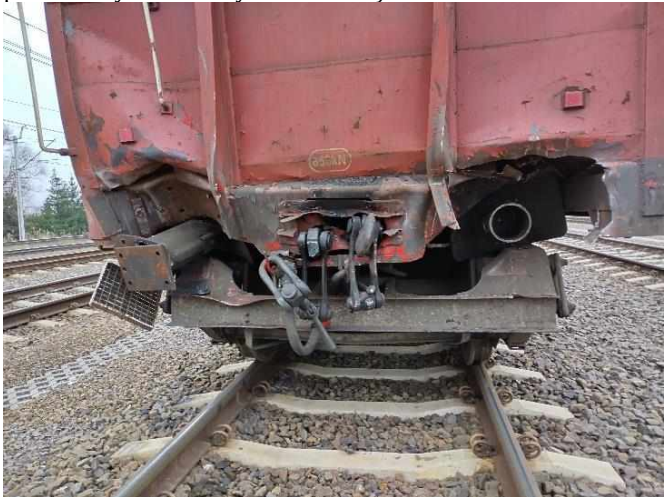
Photograph 11- Consequences of the occurrence (source: material provided by the railway commission)

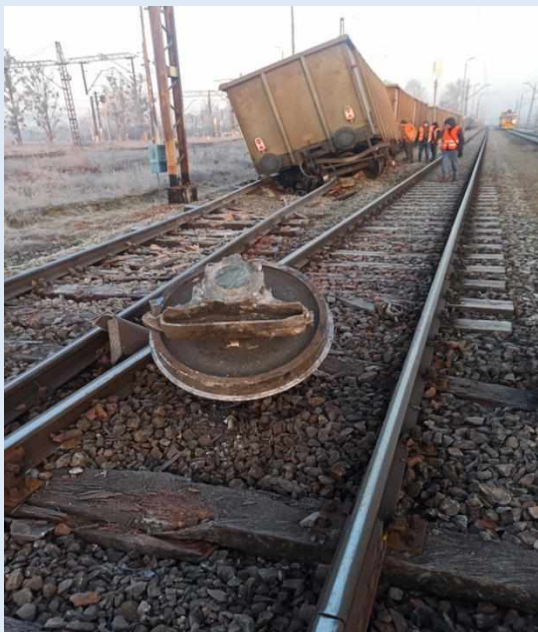
Photograph 12 – A view of the occurrence site (source: materials provided by the railway commission)

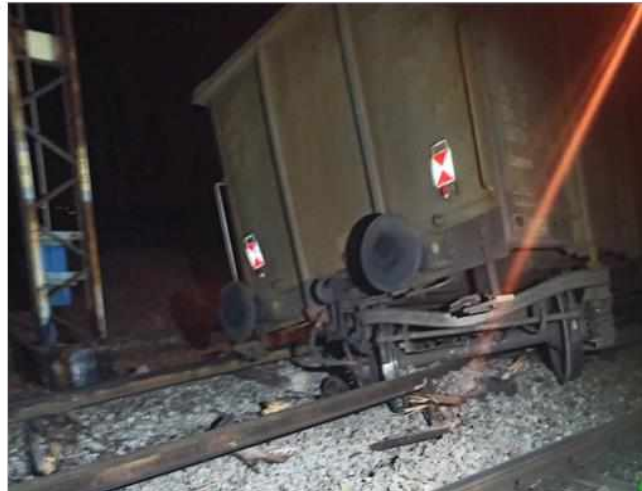
- train break-up between the 34th and 35th wagons and between 42nd and 43rd wagons in the train set
- wagon derailment (breakage of the first axle in the first bogie - Eamnos wagon no. 33 51 5839 055-9)
- damaged turnouts no. 501, 502, 503, and 506 of tracks no. 1N and 3N, and inserts between the turnouts

Photograph 13 – A view of the derailed wagon (source: materials provided by the railway commission)

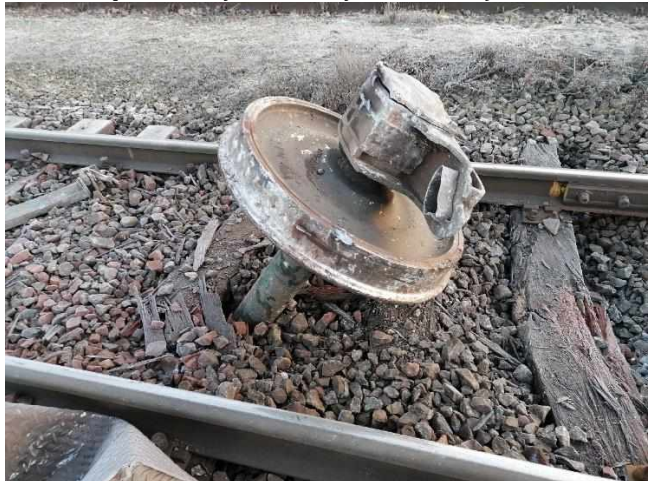
Photograph 14 – Consequences of the occurrence (source: material provided by the railway commission)

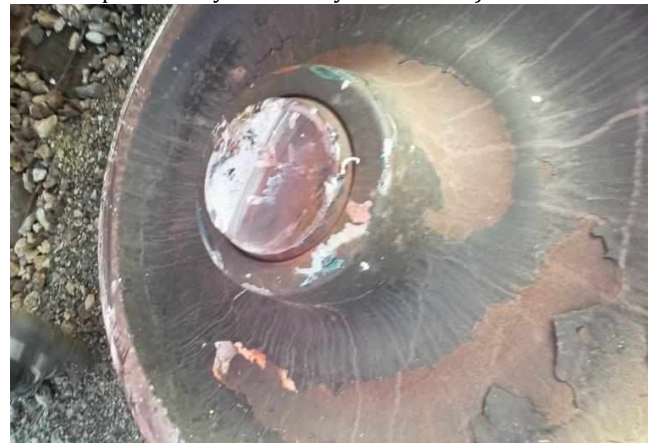
Photograph 15 – Consequences of the occurrence (source: material provided by the railway commission)

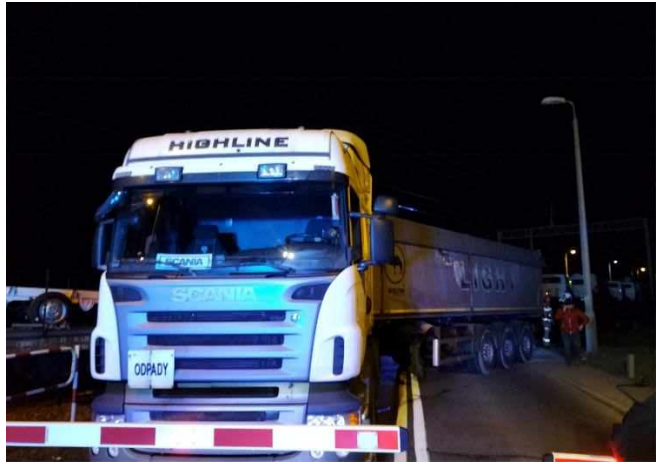
Photograph 17 – Consequences of the occurrence – the place where the head of the road tractor stopped after the collision (source: material provided by the railway commission)

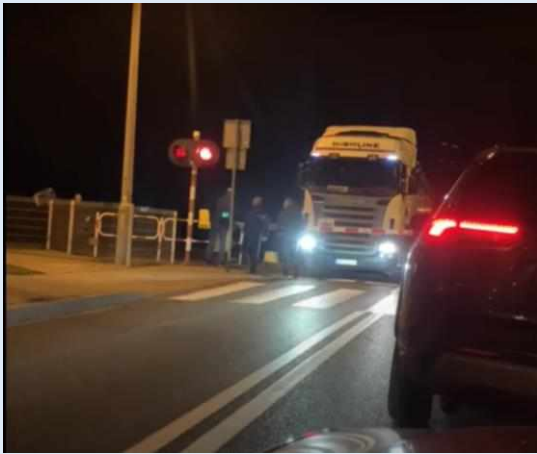
Photograph 16 – Attempts to lift the barrier bar undertaken by the witnesses (source: YouTube)

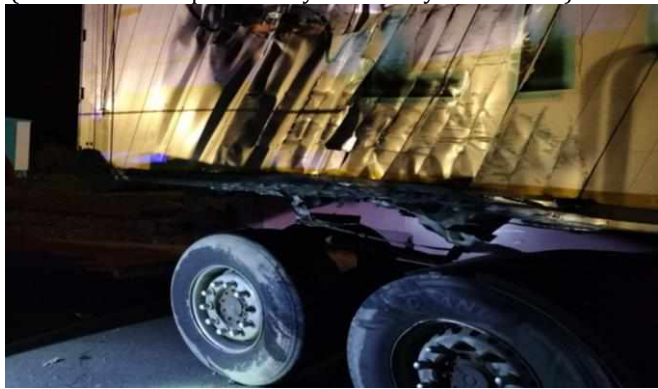
Photograph 18 – Consequences of the occurrence – damage sustained by the road tractor's semi-trailer (source: materials provided by the railway commission)

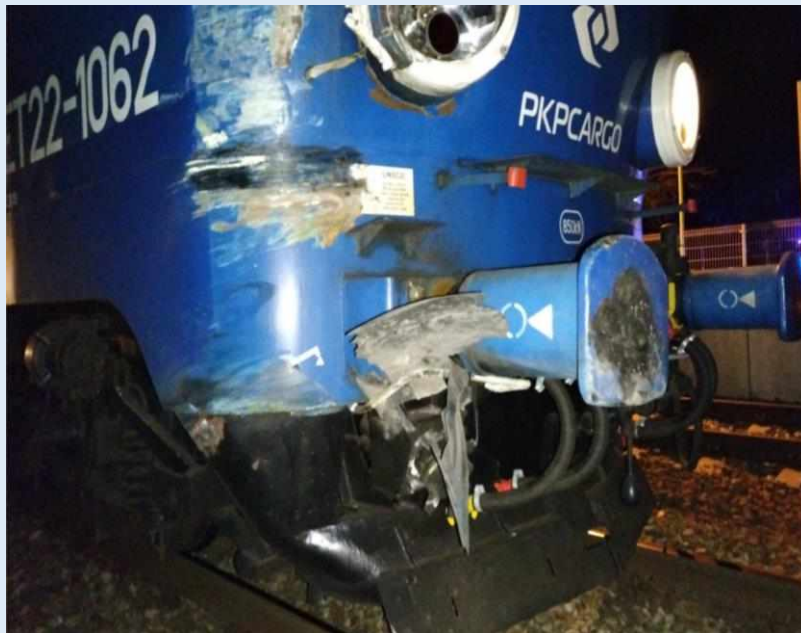
- damaged locomotive ET22-1062
- damaged Scania road tractor with Wielton semi-trailer

Photograph 19 – Consequences of the occurrence – damaged locomotive ET22-1062 (source: materials provided by the railway commission)

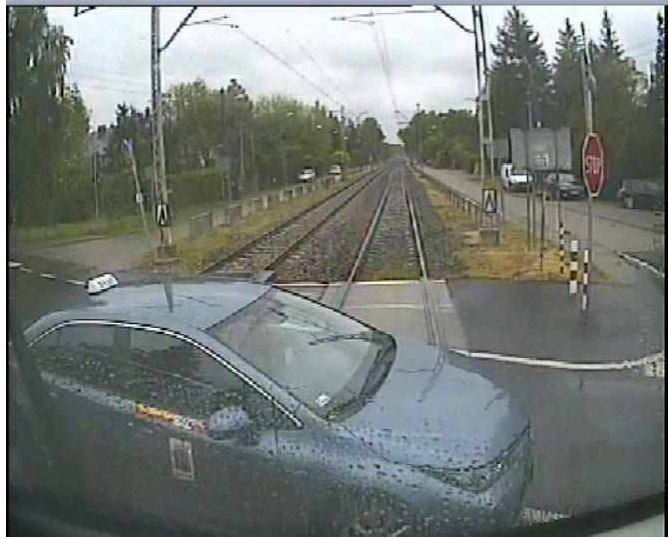
Photograph - A view of the foreground at the moment of the accident recorded by the rail vehicle's camera (source: materials provided by the railway commission)

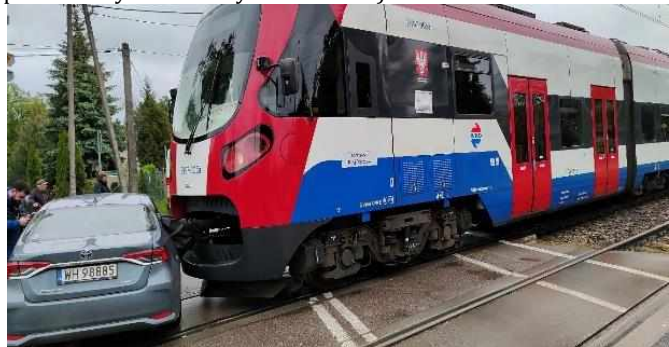
Photograph 21 - A view of the collision site (source: materials provided by the railway commission)

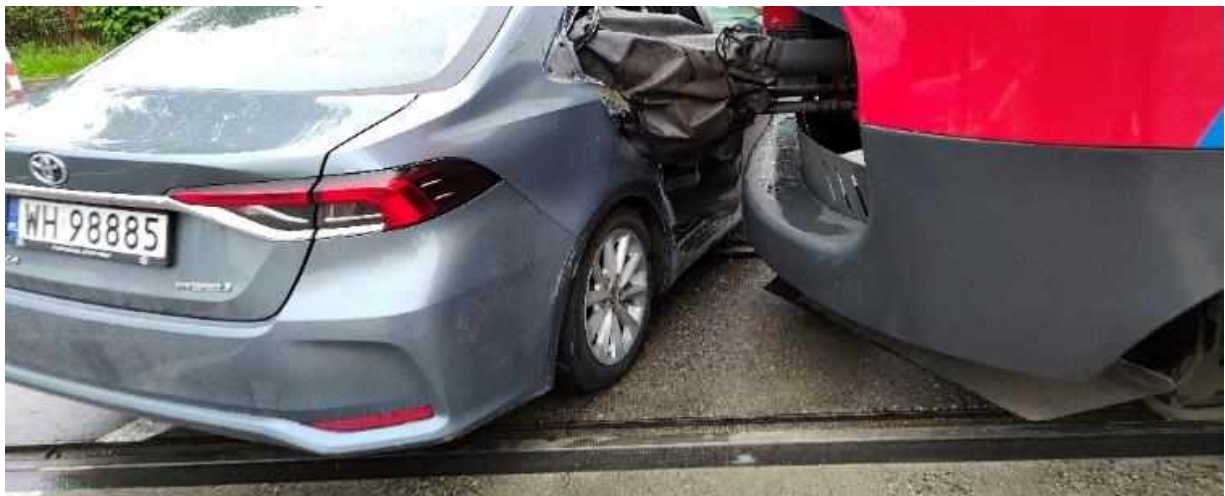
- damage to a Toyota Corolla passenger car
- damage to electric multiple unit EN97-005
- no injuries

Photograph 22 - Consequences of the occurrence (source: materials provided by the railway commission)

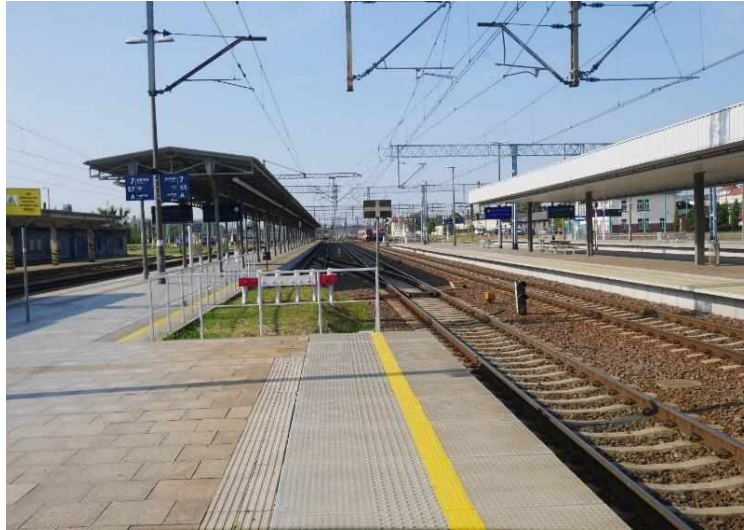
Photograph 25 – A general view of the occurrence site (source: own material of PKBWK)

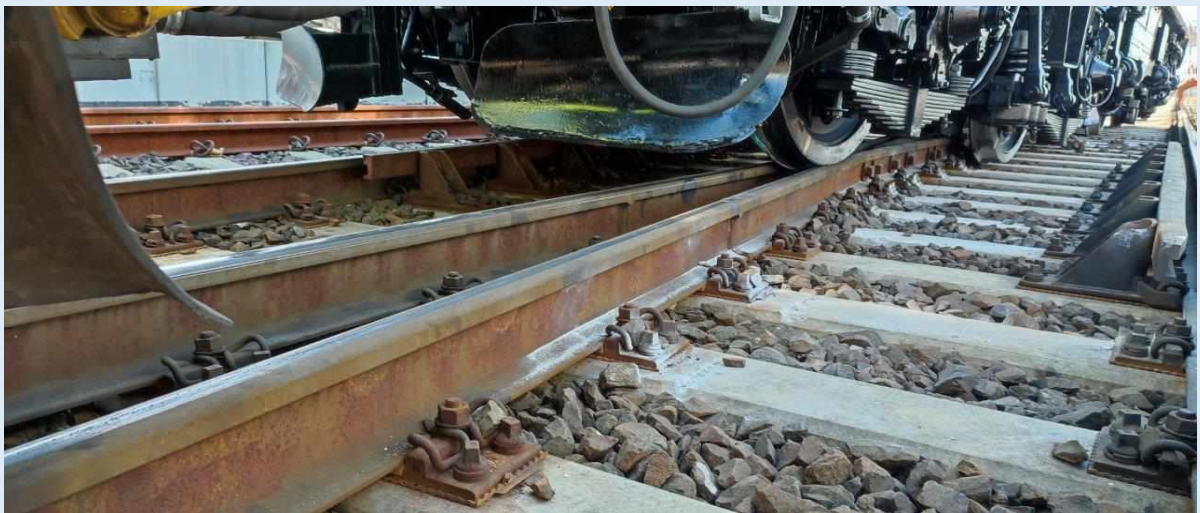
- damaged turnout No. 140 and station track no. 51 from the shunting disc Tm60 to the fouling point of turnout no. 140
- derailed and damaged locomotive EU07-1529

Photograph 26 – Consequences of the occurrence – derailment of locomotive EU07-1529 (source: own material of PKBWK)

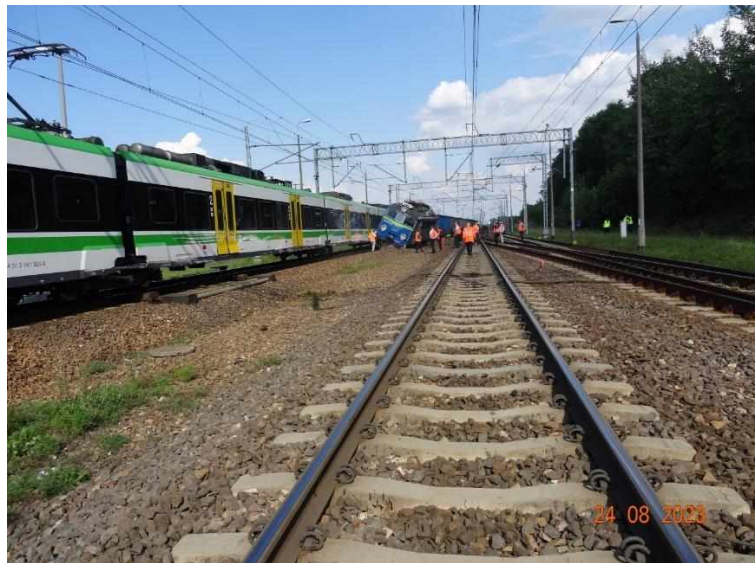
Photograph 27 – A general view of the occurrence site (source: materials provided by the railway commission)

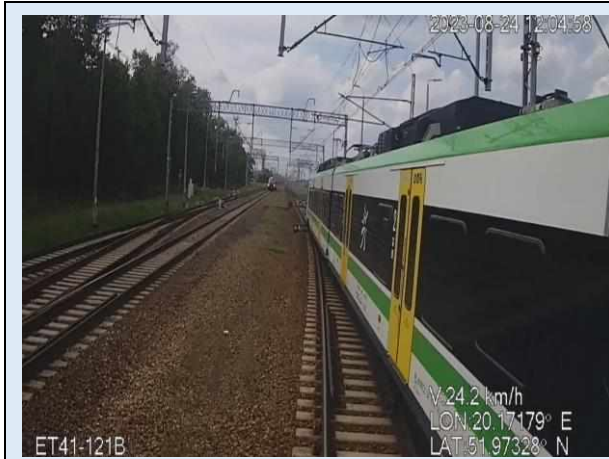
Photograph 28 – A view from the front view camera of train no. 524009 at the time of the collision (source: materials provided by the railway commission)

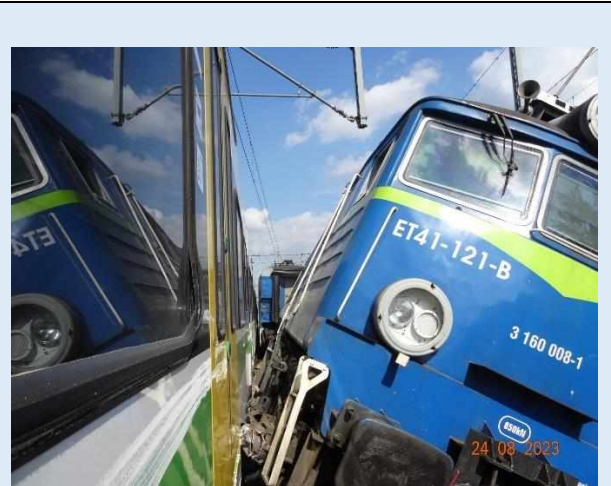
- all bogies of the first section and one bogie of the second section of the ET41-121 derailed, and section B and the gangway between the locomotive sections were damaged
- elements of the structure and body skin of electric multiple unit ER160-22 were damaged
- the drive of turnout no. 13 and turnout sleepers were damaged

Photograph 29 – Consequences of the occurrence (materials provided by the railway commission)

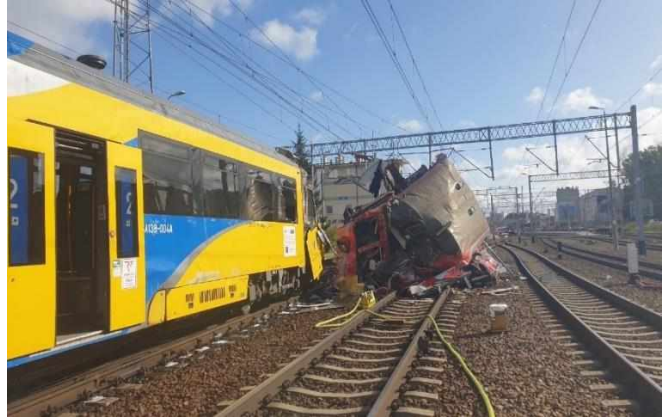
Photograph 31 – A general view of the occurrence site (source: materials provided by the railway commission)

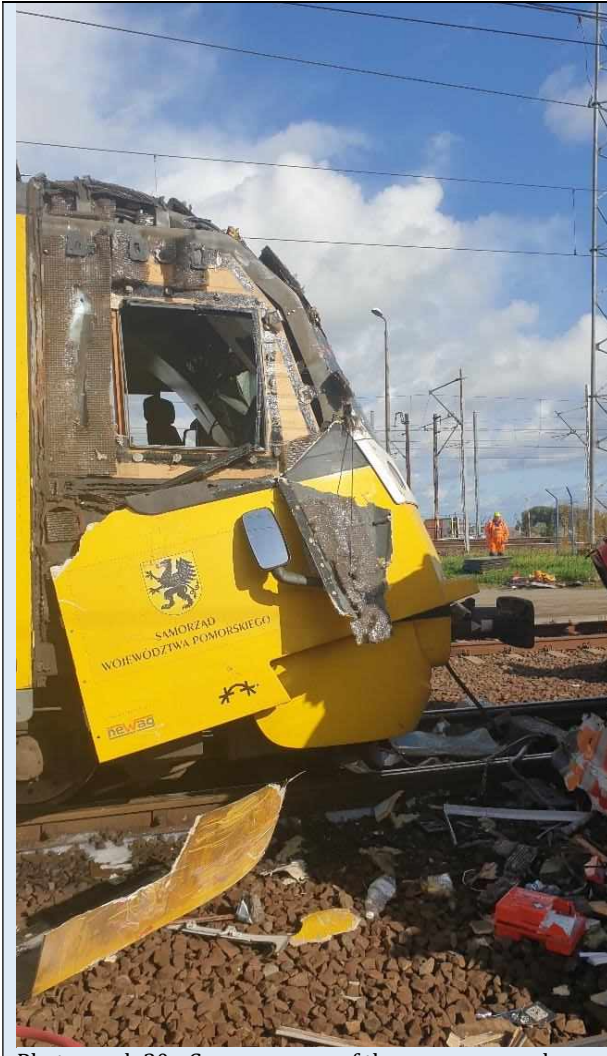
Photograph 30 - Consequences of the occurrence - damage to SA138-004 (source: own material of PKBWK)

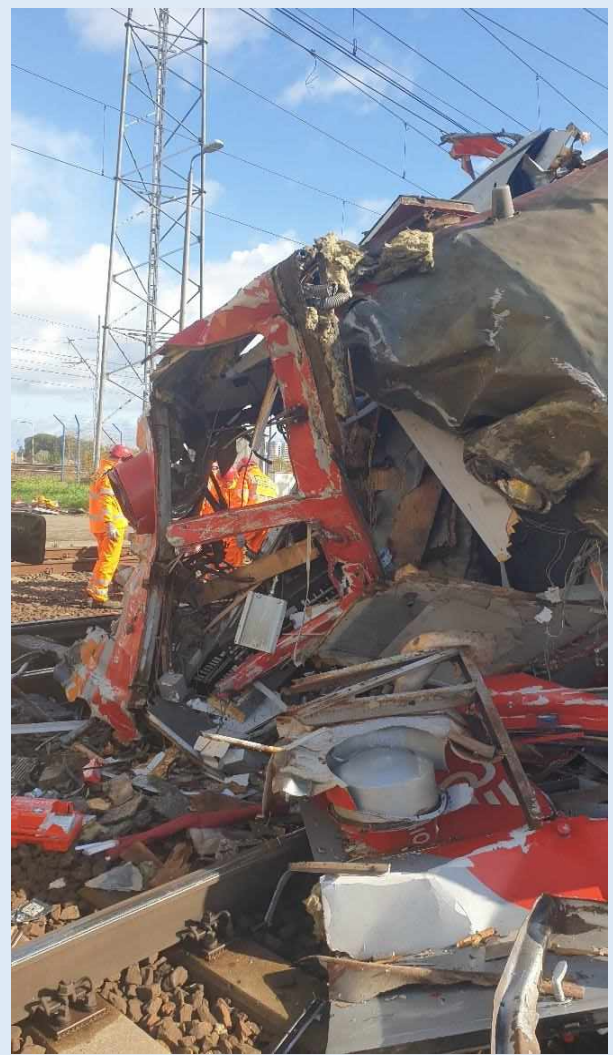
Photograph 32- Consequences of the occurrence - damage to EMU EN57-1248 (source: own material of PKBWK)
