STATE COMMISSION ON RAILWAY ACCIDENT INVESTIGATION
Ministry of the Interior and Administration

REPORT No. PKBWK 03/2022

**from the investigation of a railway accident which occurred on 30.04.2020 at 11:50 on the
route: Swidnica Kraszowice – Jedlina Zdrój at km track no. 1 of railway line no. 285
Wrocław Główny – Swidnica Przedmieście**

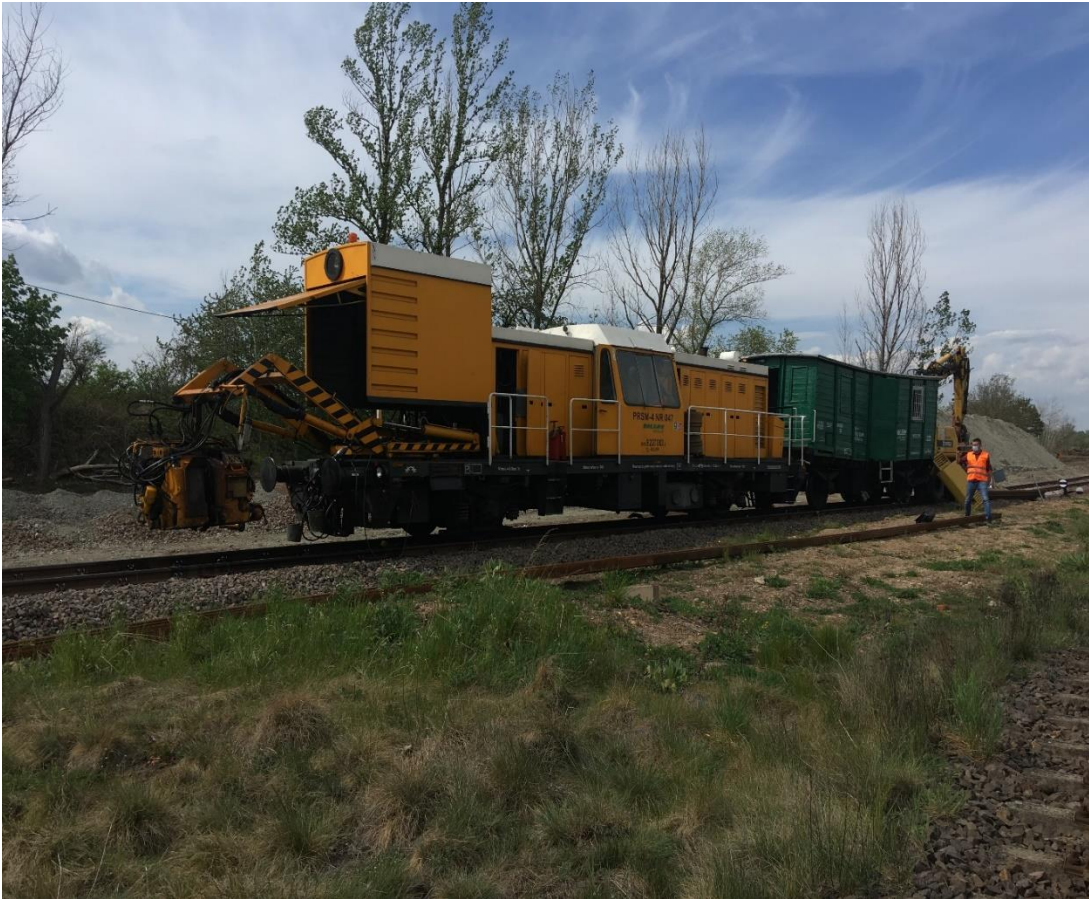
Photograph 1 – View of the area of the incident (Police footage)

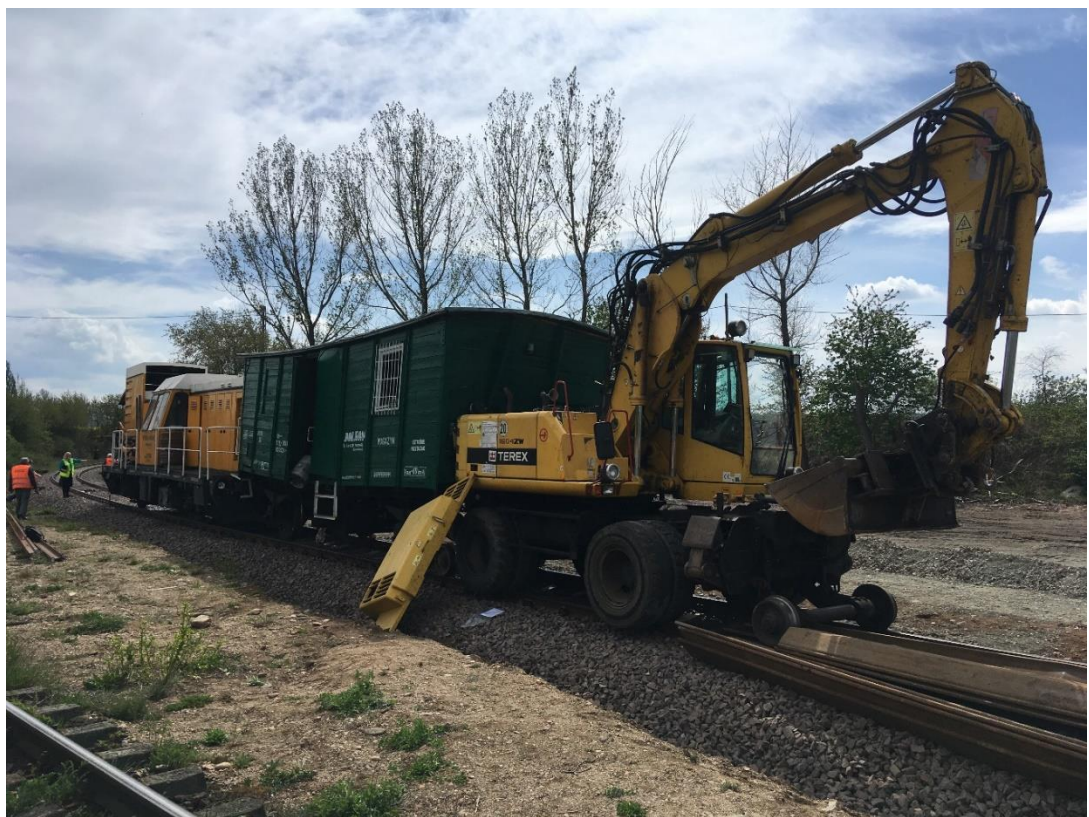
Photograph 2 – View of the area and consequences of the incident (Police footage)

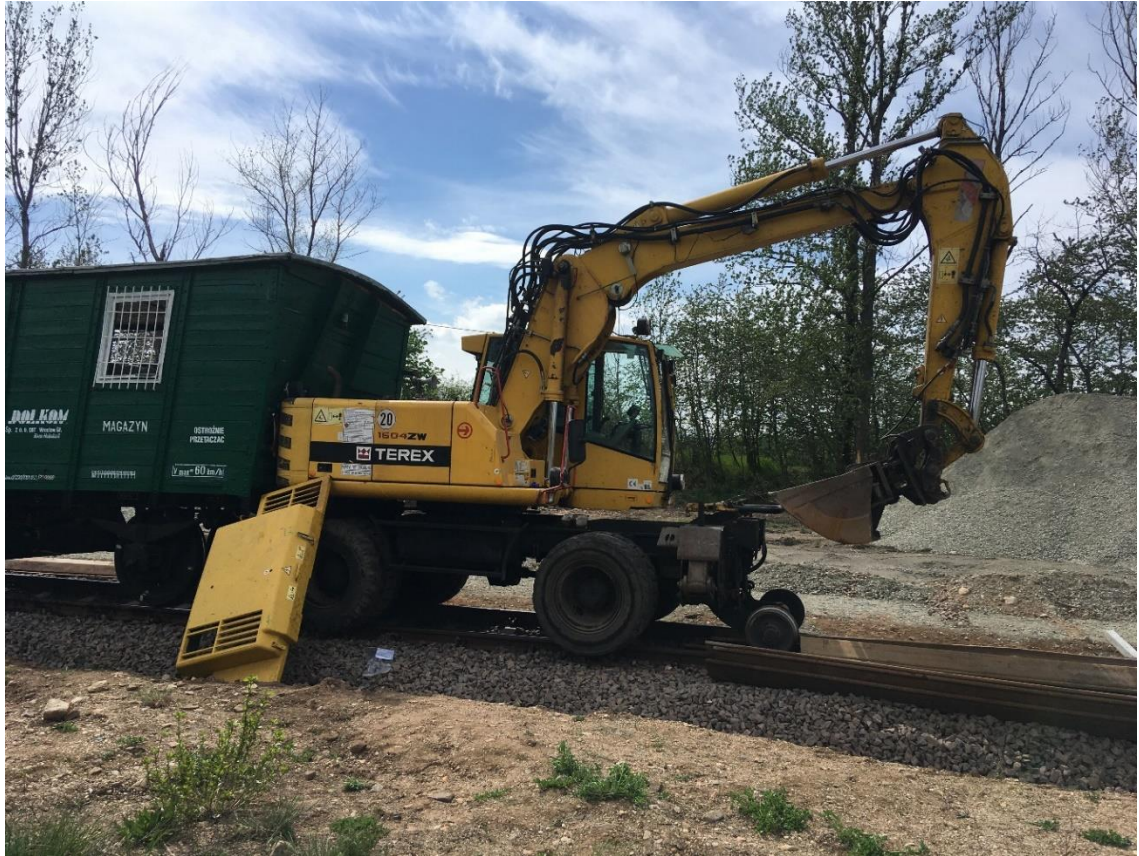
Photograph 3 – View of the area and consequences of the incident (Police footage)

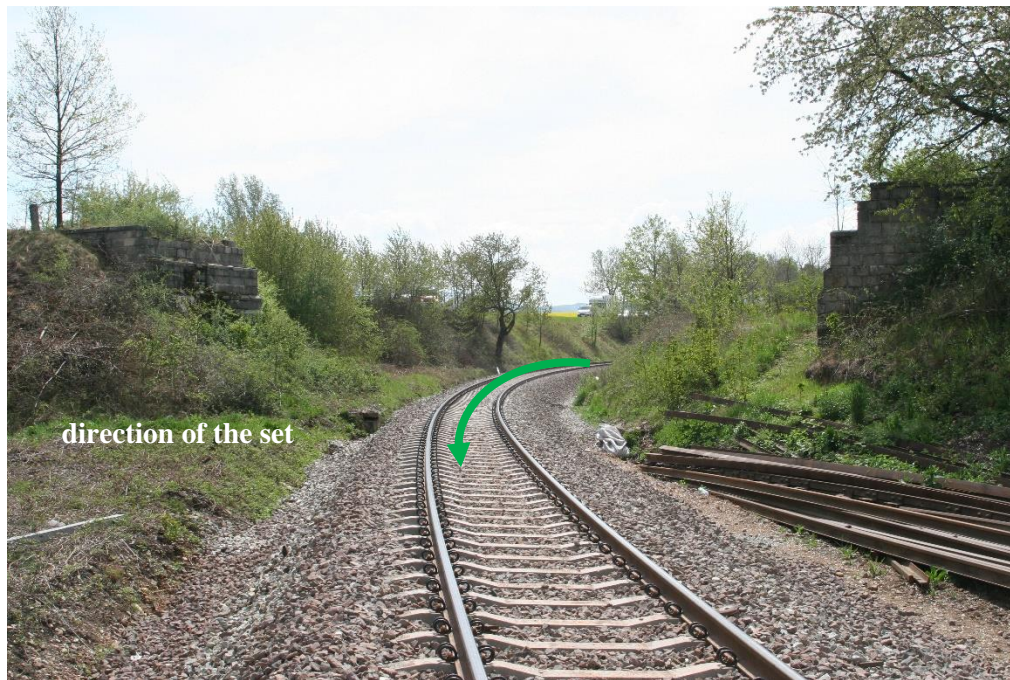
Photograph 4 – General view of the scene (source: phot. SCRAI)

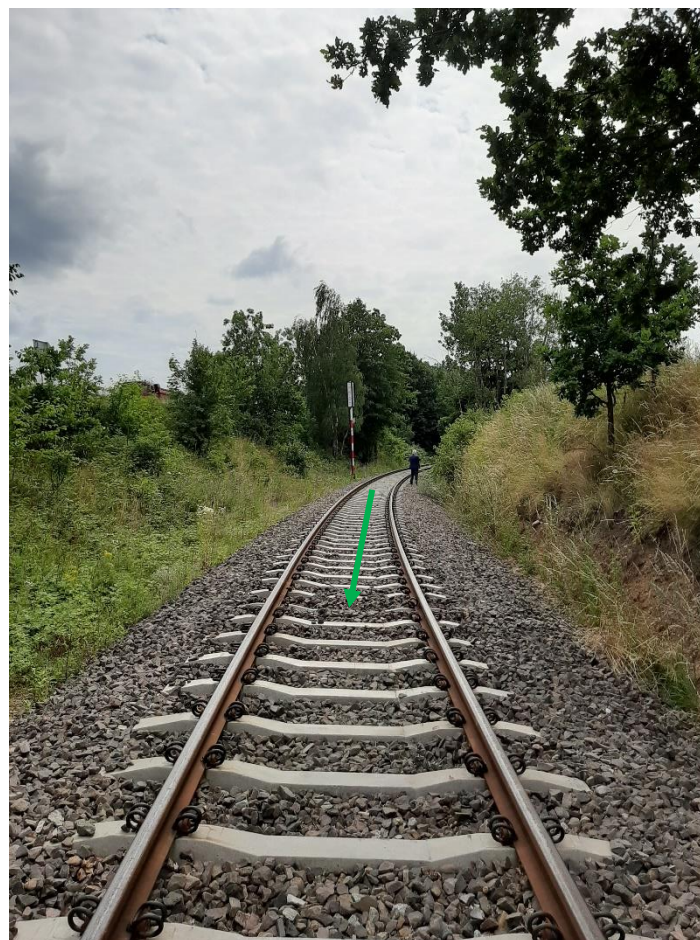
Photograph 5 - View towards the entrance semaphore (Source: phot. SCRAI)

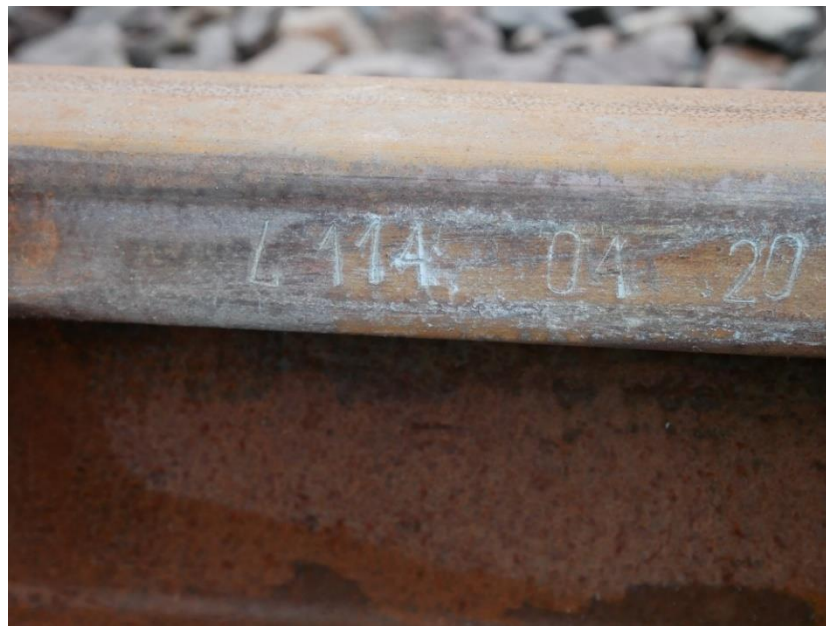
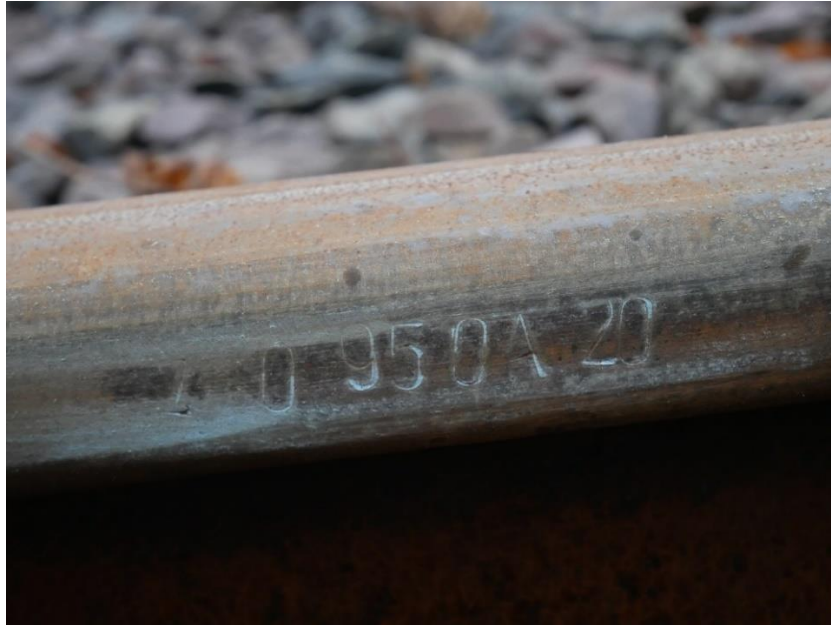
Photograph 6 – Welder operator identification number

Photograph 7 – Welder operator identification number

1. The use of welding machine operator identification numbers at the site of the welds made by an employee who, according to the record sheet, was not at work on the day of the incident.
2. Unauthorised removal of a worker from the scene of an accident and the workplace after the accident has occurred and failure to provide assistance to the injured person.
3. Discrepancies in the testimonies and explanations of the workers regarding: the course of work and the circumstances of the accident on 30.04.2020.
4. The Investigation Team, based on the analysis of the evidence, discovered that an employee (the welding machine operator) was drinking alcohol during working hours. The above was considered as another irregularity unrelated to the causal factors of the incident.

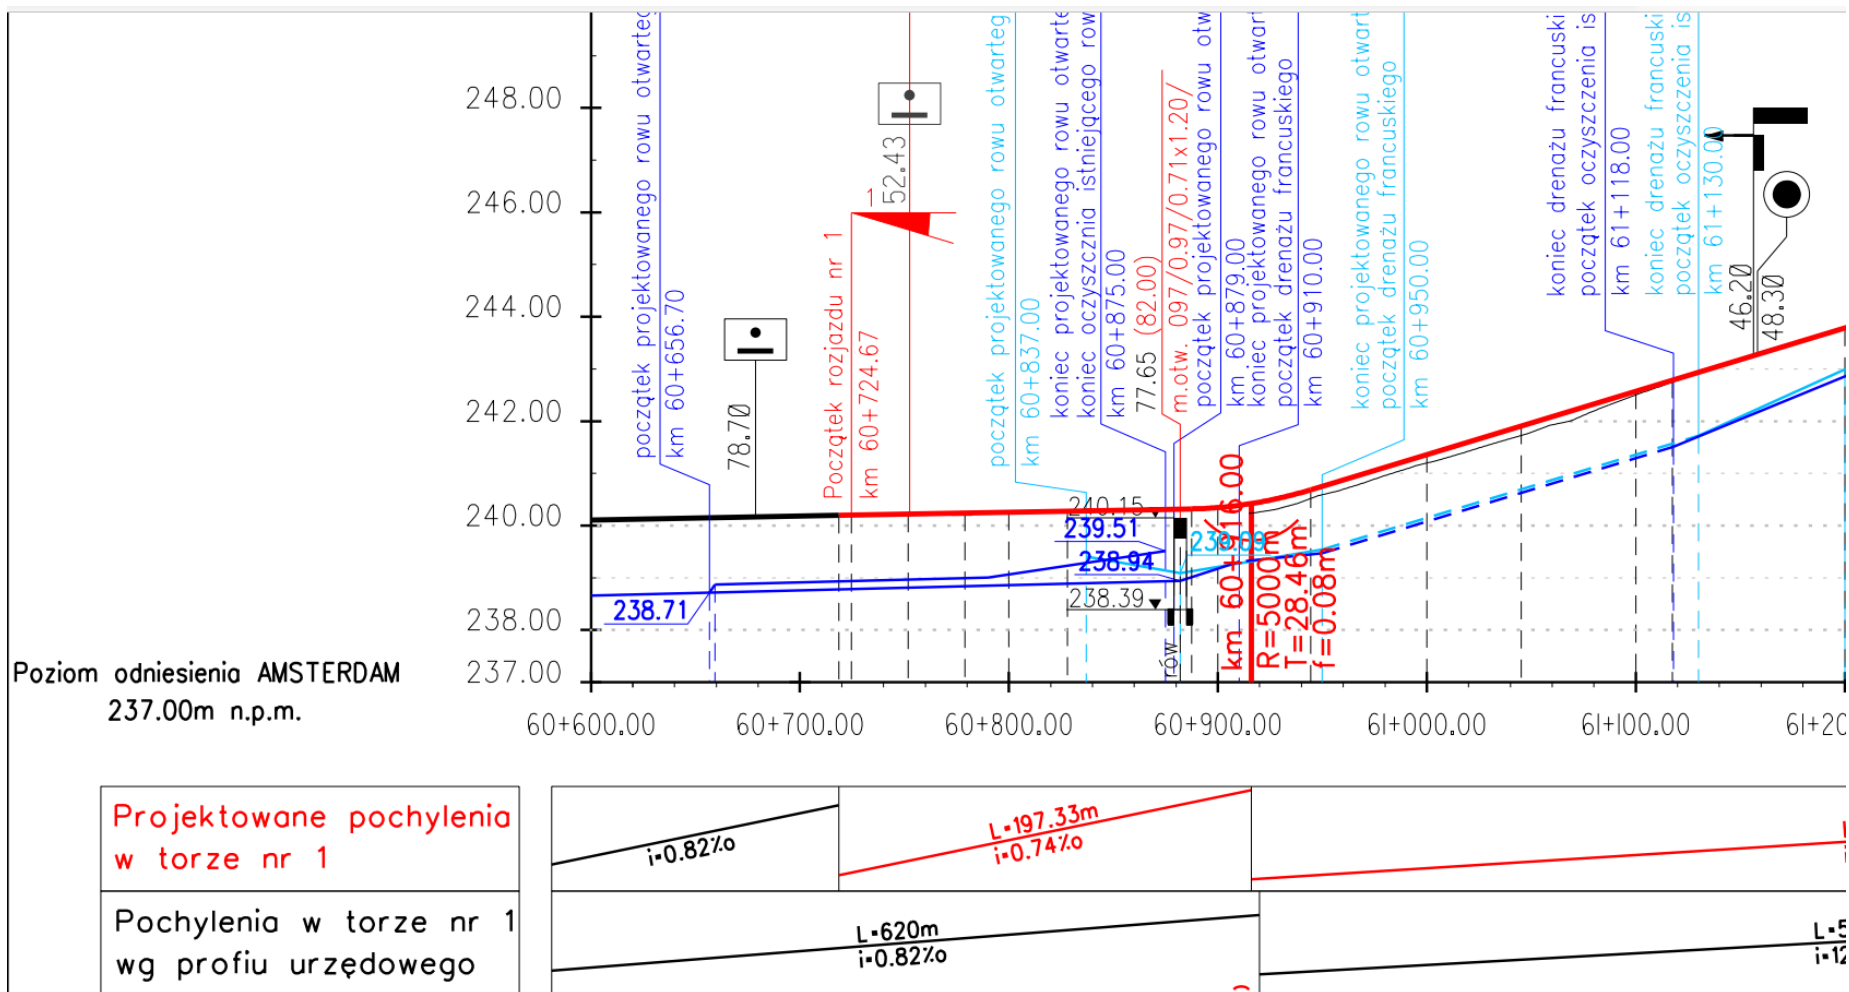
Figure 3 - Diagram of the track gradient at standstill km 60.885 (developed by SCRAI)

On the day of the incident, two vehicles were working simultaneously on the same track, i.e., a rail welder type PRSM-4 with a two-axle wagon and a rail-roader type ATLAS 1604 ZW. The vehicles were located approximately 3.5 km apart. Track on a slope of 11 ‰, with a curve of radius R250 m at the incident site.

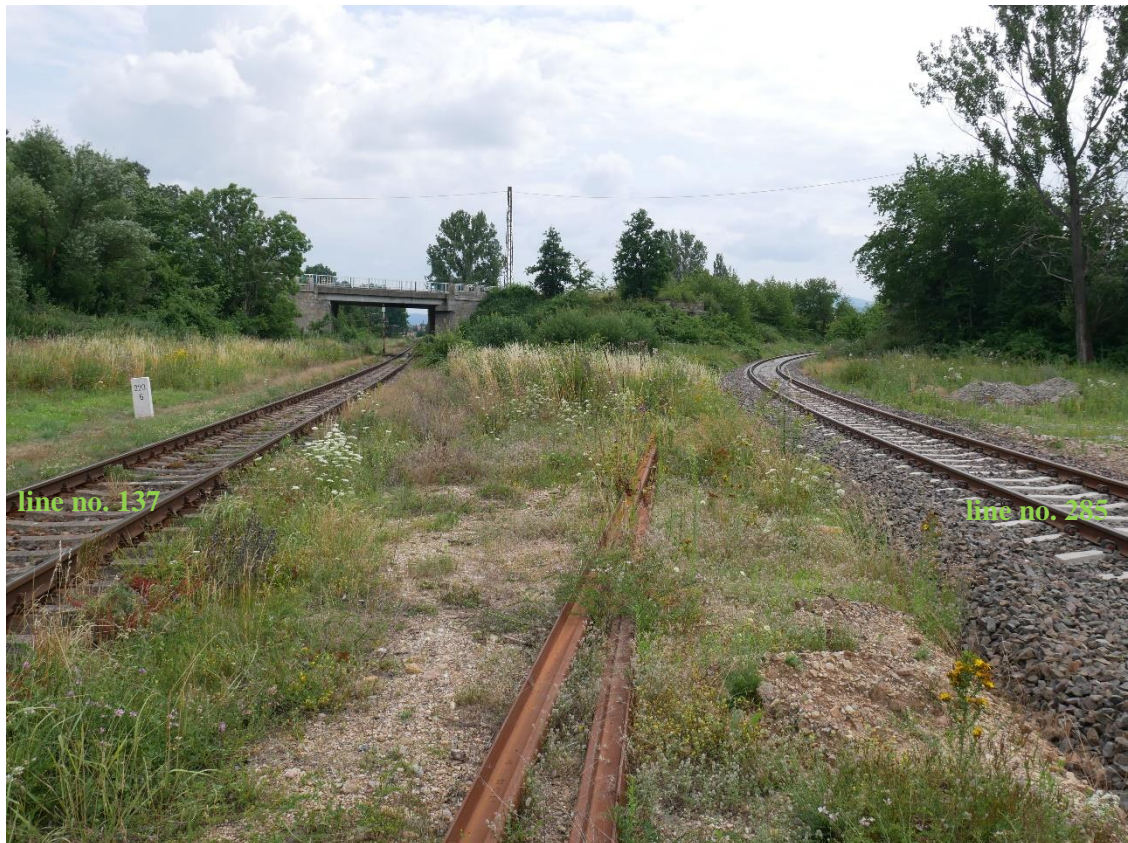
The incident took place at noon in good air clarity, the track on a gradient of 11‰, the track in a curve with a radius of 250 m, the track laid partly in a trench. Adjacent to line 137, active, increased passenger and goods train traffic. The above conditions prevented the victim from properly identifying the sound of the moving rolling stock that was endangering his life.

Photograph 8 – View of the collision site on line 285 (right) adjacent to active line 137 (left)
