STATE COMMISSION ON RAILWAY ACCIDENT INVESTIGATION
Ministry of the Interior and Administration

REPORT No. PKBWK 03/2024

**on the investigation of a railway accident
that occurred on 19 May 2023 at 09:51 hrs
on the Komorów – Podkowa Leśna Główna route,
track no. 1, Category D level crossing, at km 18.805
of railway line no. 47 Warszawa Śródmieście WKD – Grodzisk Mazowiecki Radońska
the area of the infrastructure manager Warszawska Kolej Dojazdowa sp. z o. o.**

Warsaw, 1 February 2024

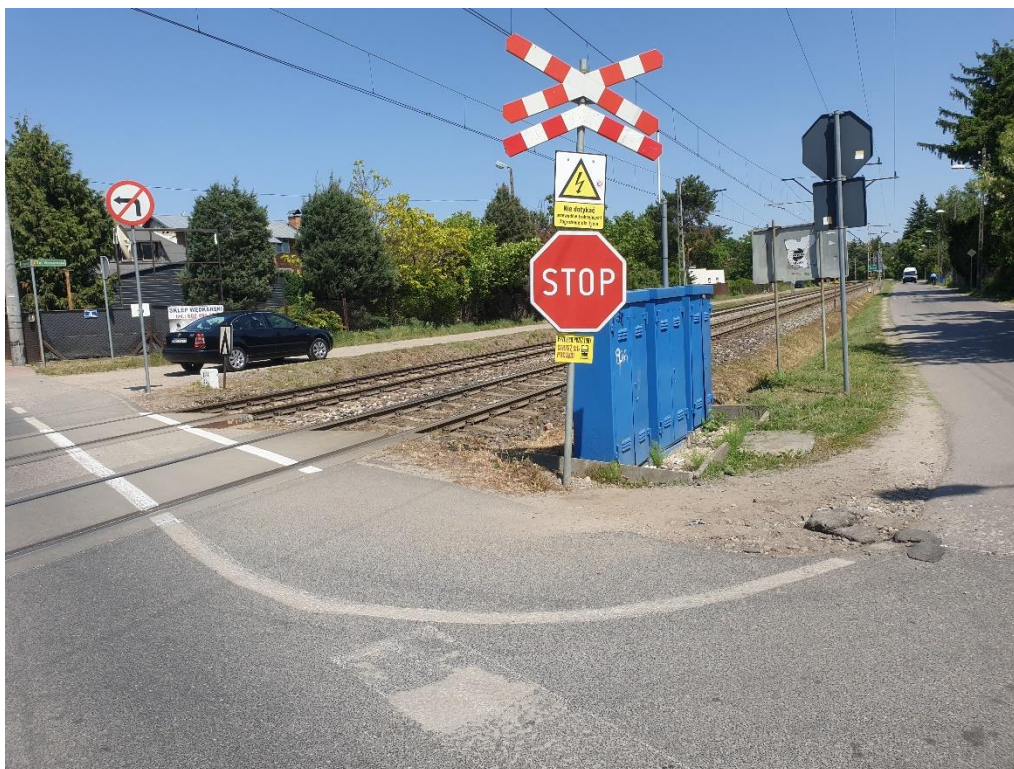
On the left side of the level crossing, from the driving direction of the car, the visibility of the head of trains from 5 m to the right (from the driving direction of the train) was hindered by apparatus cabinets positioned along track no. 2 and road signs positioned at Warszawska Street.

Photograph 4 - Visibility from 5 m from the left side of the level crossing to the right - situation as during the accident (source: PKBWK documentation)

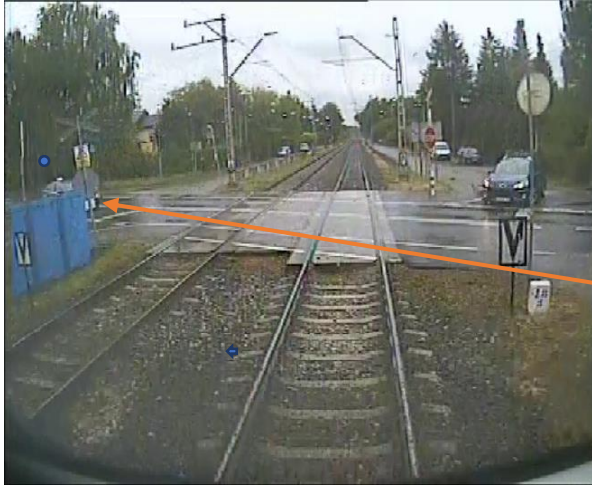
The passenger car involved in the occurrence

Photograph 8 - A view of the foreground at around 1 s prior to the accident recorded by the rail vehicle's camera (source: the railway commission)

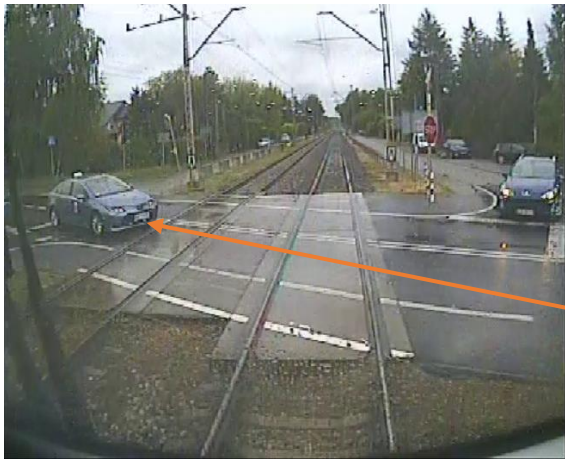
The passenger car involved in the occurrence

Photograph 9 - A view of the foreground at around 0.7 s prior to the accident recorded by the rail vehicle's camera (source: the railway commission)
