STATE COMMISSION ON RAILWAY ACCIDENT INVESTIGATION
Ministry of the Interior and Administration

REPORT No. PKBWK 5/2023

**on the investigation of a railway accident
that occurred on 20 February 2023 at 18:11 hrs on the Chalupki – Krzyżanowice route,
track no. 2, Category B level crossing, at km 47.973
of railway line no. 151 Kędzierzyn-Koźle – Chalupki,
the area of the infrastructure manager PKP PLK S.A. Railway Line Plant
in Tarnowskie Góry**

WARSAW, 19 December 2023

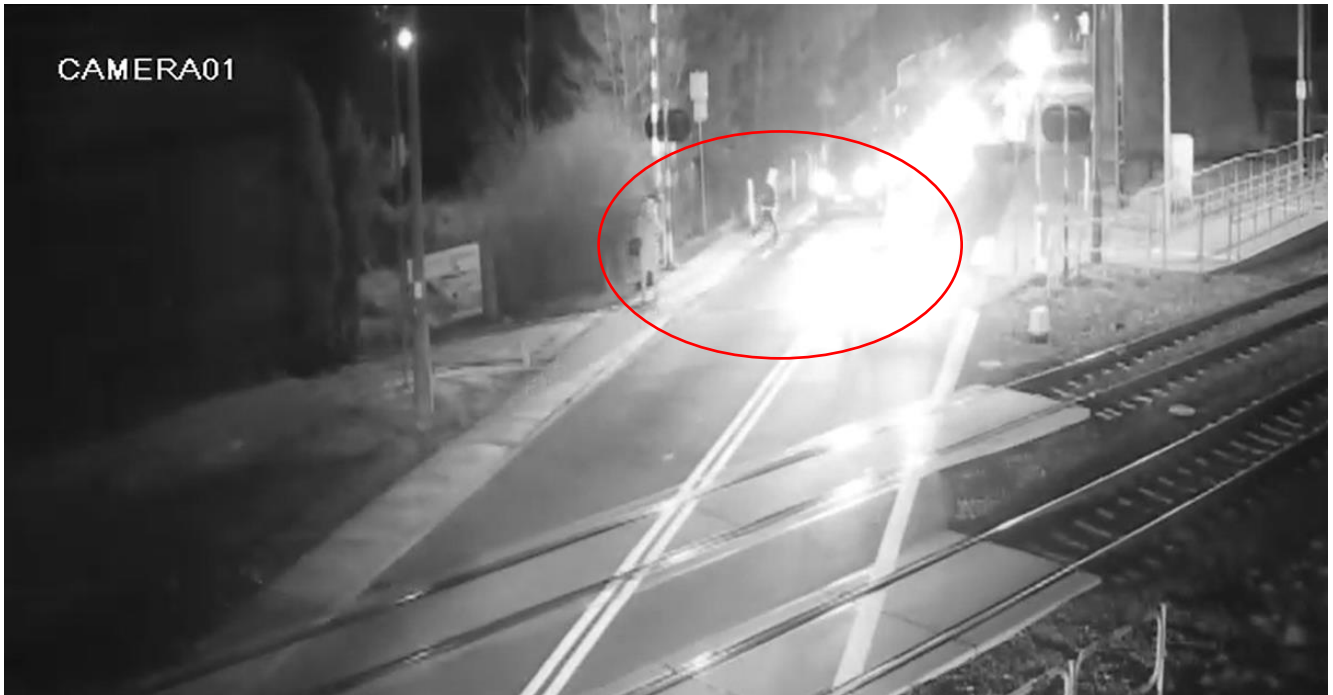
Photograph 1 – Pedestrians entering the pedestrian crossing

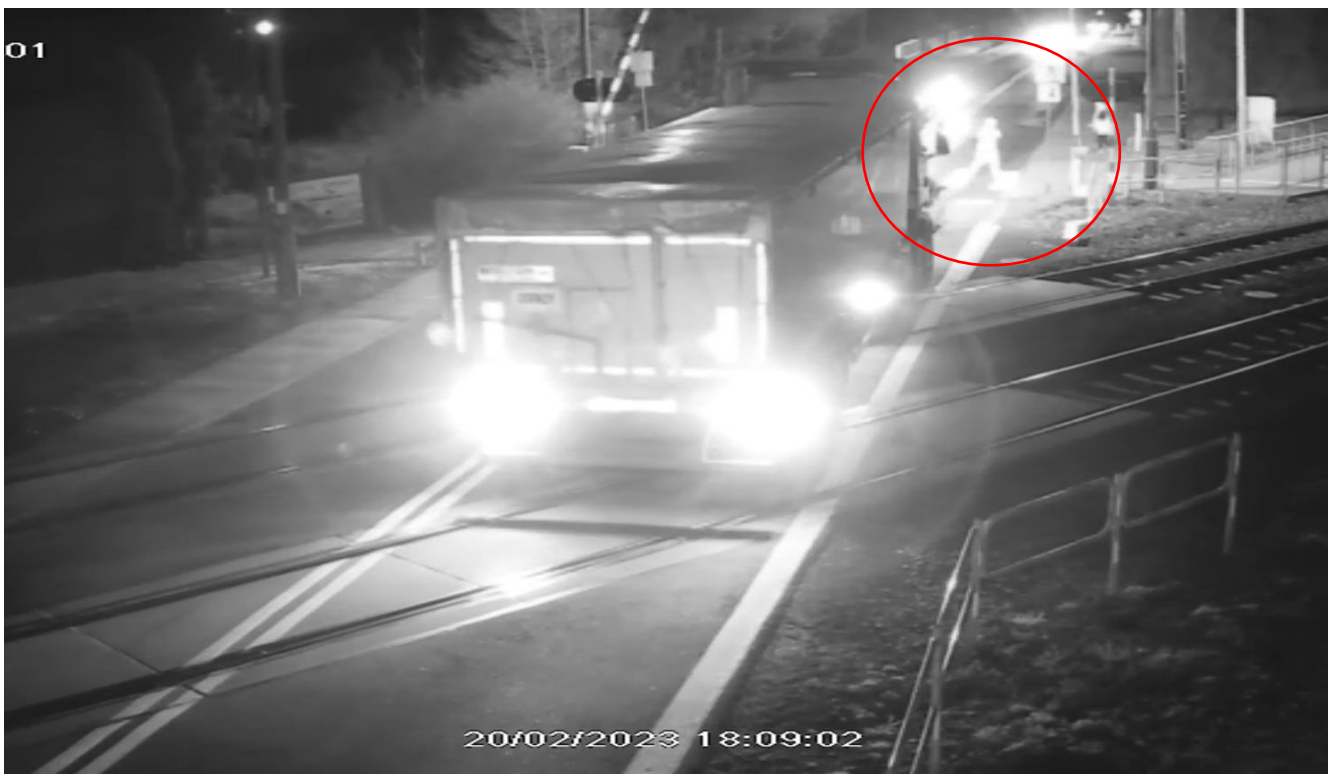
Photograph 2 – Vehicles stationary at the crossing to give way to pedestrians

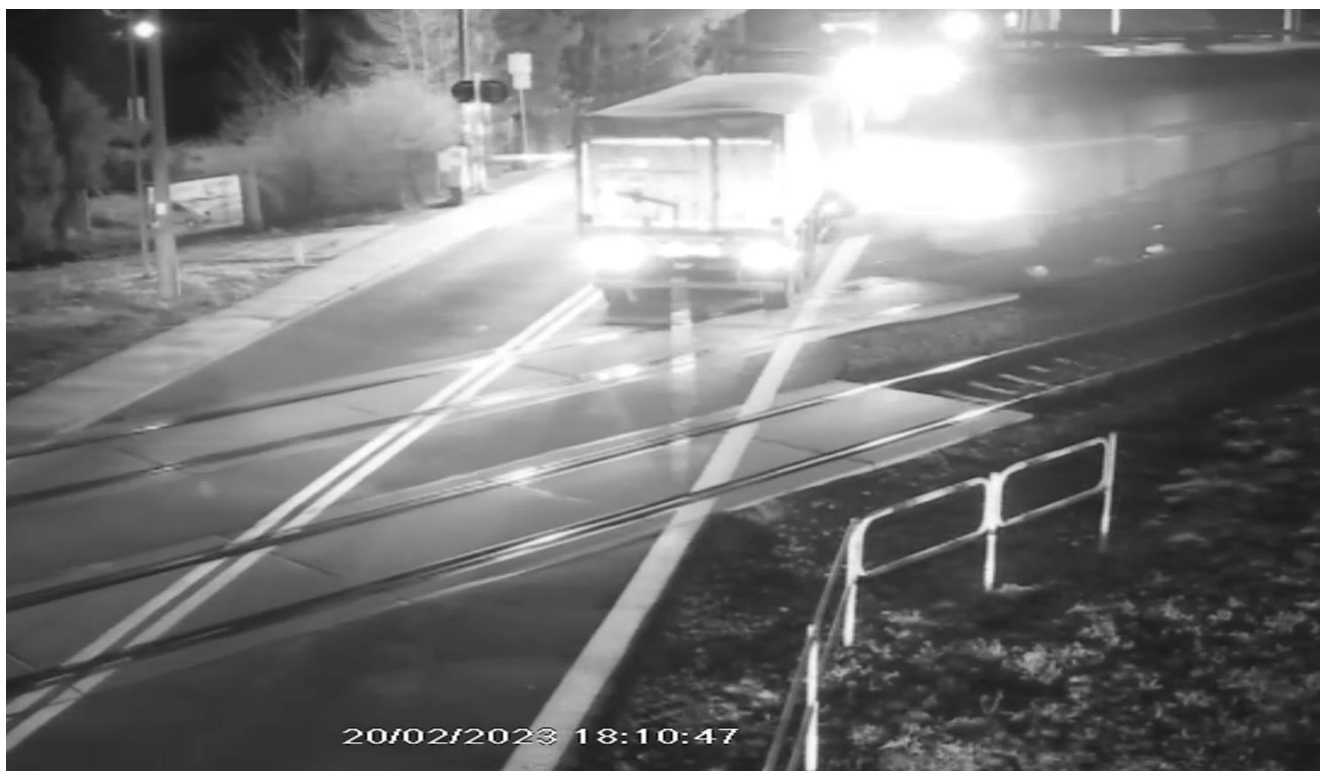
Photograph 3 – The moment of the occurrence

The Investigation Team found that the causal factor for the occurrence was inability of a road tractor with a semi-trailer to exit a Cat. B level crossing due to a passenger car stopping in front of a pedestrian crossing, followed by the road tractor with a semi-trailer being enclosed by an exit barrier, as a result of which a train ran into the road tractor.

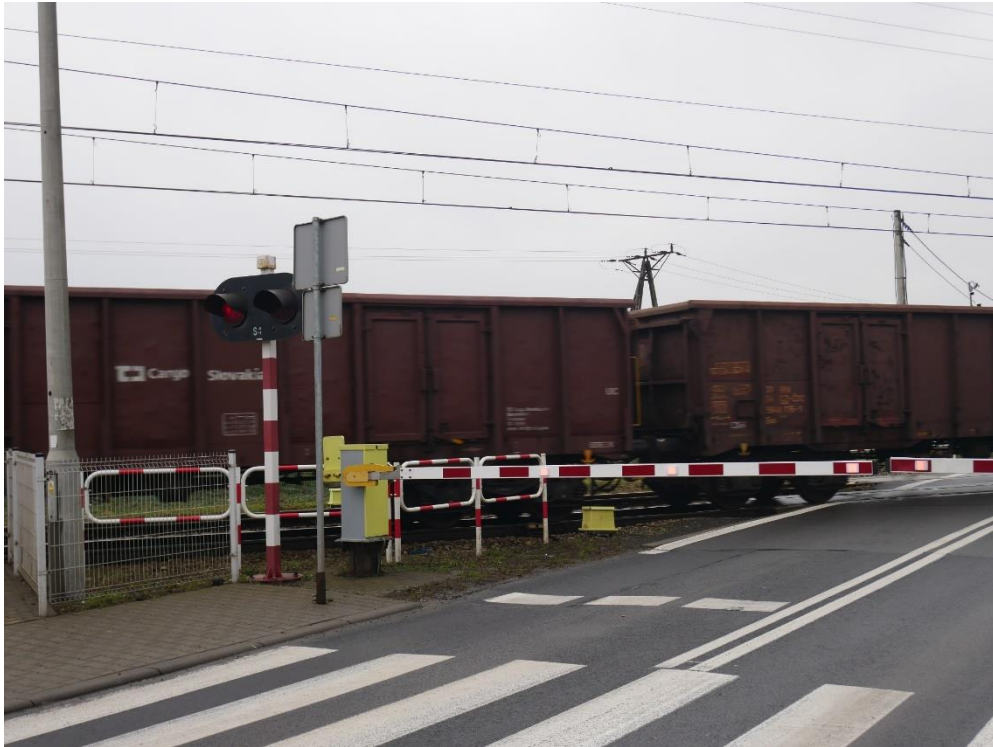
1. Inappropriate organisation of pedestrian traffic in the area of a level crossing.
2. The location of the pedestrian crossing at 2.5 m behind the exit barrier, hindering smooth passage and exit of road vehicles through and from the level crossing.
3. A passenger car stopping at the level crossing in front of the pedestrian crossing to give way to pedestrians, which prevented a road tractor with a semi-trailer following the passenger car from continuing to go.
4. Installation of lockable half-barriers on the exit lane from the level crossing, which prevented raising them manually.
5. Failure to implement recommendation no. 2) in Point 4.2 of the PKBWK's Annual Report 2018 concerning disassembly of exit barriers.

Photograph 6 – Position of the pedestrian crossing

- 3) take immediate actions to relocate the pedestrian crossing from the immediate vicinity of the level crossing to at least 22 metres away from the entrance barrier on the entry lane (the recommendation is under implementation).

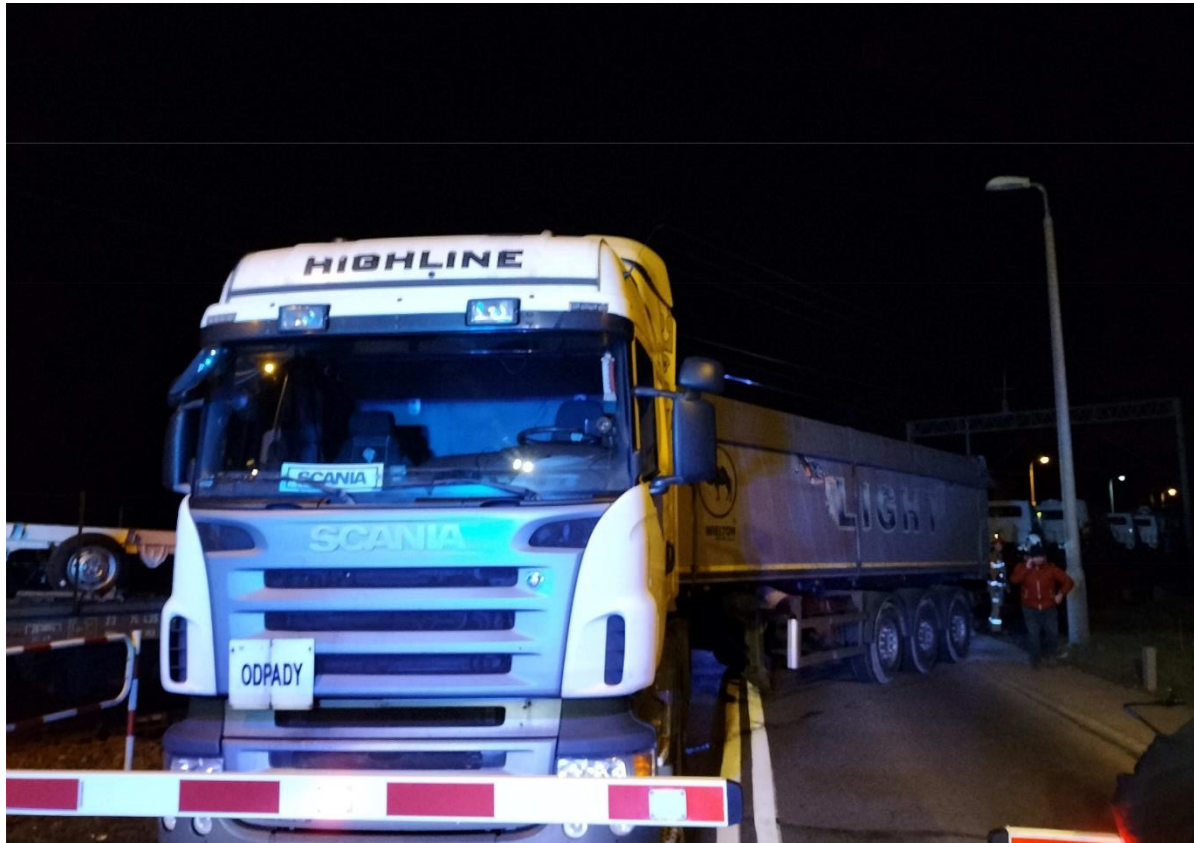
Photograph 7 – The place where the head of the road tractor stopped after the collision (material provided by the railway commission)

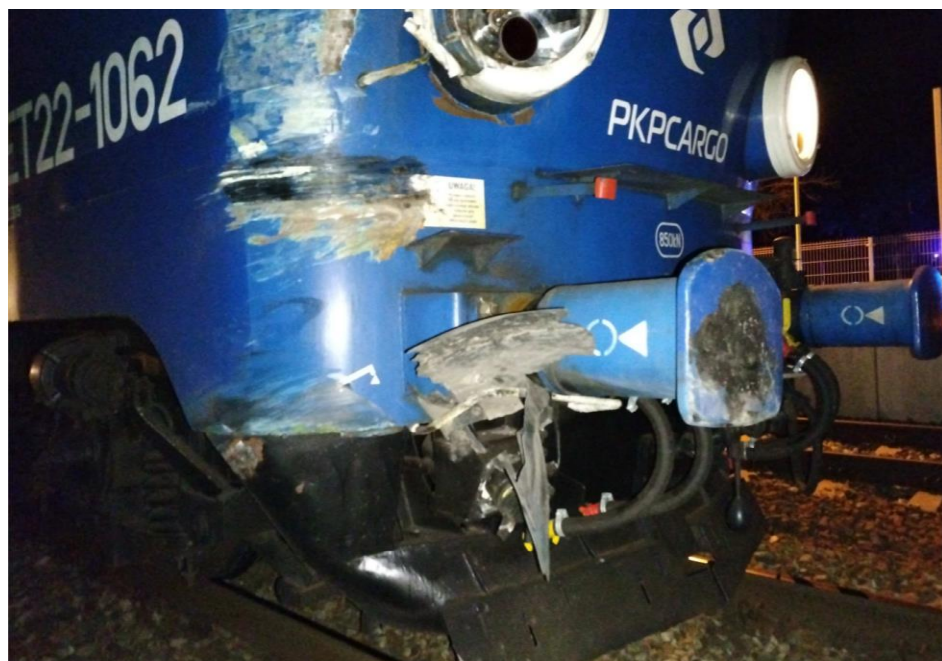
Train no. 441008 was not derailed. As a result of the collision, the ET22-1062 locomotive sustained the following damage: - deformed and grazed front on the right side of cabin A, from the rail fender to the corner window,

- broken corner window pane together with the window frame and seal,
- broken side window fairing on the train driver's side,
- broken and dented head lamp on the right side of the cabin,
- damaged train heating box and jumper, warped tubing with pipes,
- bent step and handle for climbing on the head of the locomotive and cowling,
- grazing and shear on the right bumper.

Photograph 10 – Damage sustained by the ET22-1062 locomotive (material provided by the railway commission)

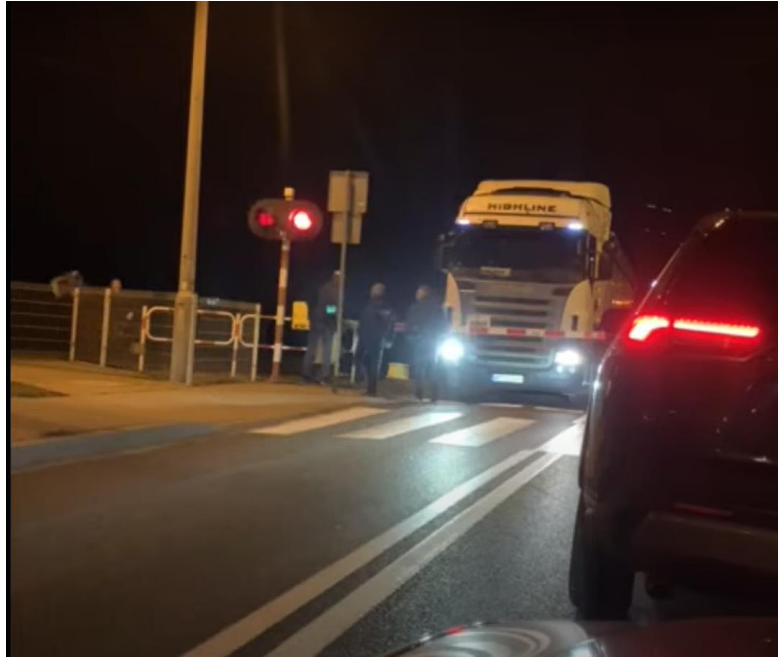
- The electrical drives are fitted with locking devices that prevent manual lifting of the exit half-barrier.

Photograph 11 – Attempts to lift the barrier bar undertaken by the witnesses (source: Youtube)

"Infrastructure managers shall remove exit barriers in automatic crossing systems at Category B level crossings where solutions with four half-barriers are employed. Such a configuration is inconsistent with the provisions of Point 6.2 of Annex no. 4 to the Regulation of the Minister of Infrastructure of 3 July 2003 on the detailed technical conditions concerning road signs and signals and road traffic safety devices, and on the conditions of their installation on roads (consolidated text: Journal of Laws of 2019, item 2311), which provide that: "barriers U-13a and U-13b which close the entire width of the roadway shall be used at Category A level crossings, whereas half-barriers U-13c shall be used at Category B level crossings. Half-barriers shall be positioned so that they close the right half of the road on each side (also where half-barriers are installed on one-way roadways)".
