STATE COMMISSION ON RAILWAY ACCIDENT INVESTIGATION
Ministry of the Interior and Administration

REPORT No. PKBWK 04/2023

on the investigation of a railway accident
that occurred on 12 December 2022 at 02:35 hrs on the Kozięglowy – Poznań Piątkowo
route,
track no. 2, km 11.788 of railway line no. 395 Zieliniec – Kiekrz,
a Category C level crossing
area of the infrastructure manager PKP PLK S.A. Railway Line Plant in Poznań

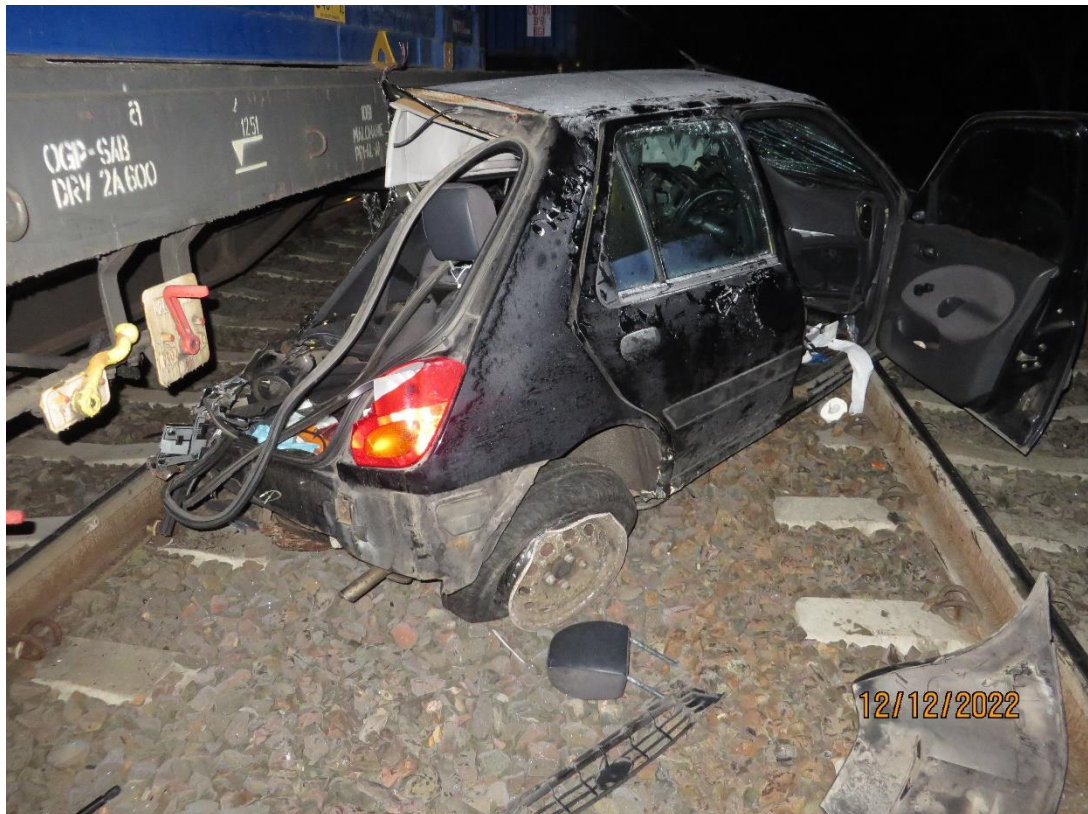
Consequences of the occurrence: As a result of the occurrence, a passenger car was destroyed and an ET22 -1082 locomotive was damaged. The driver of the road vehicle sustained injuries and was taken to hospital. The train was not derailed.

Photograph 1 – Outcomes of the occurrence (footage provided by the railway commission)

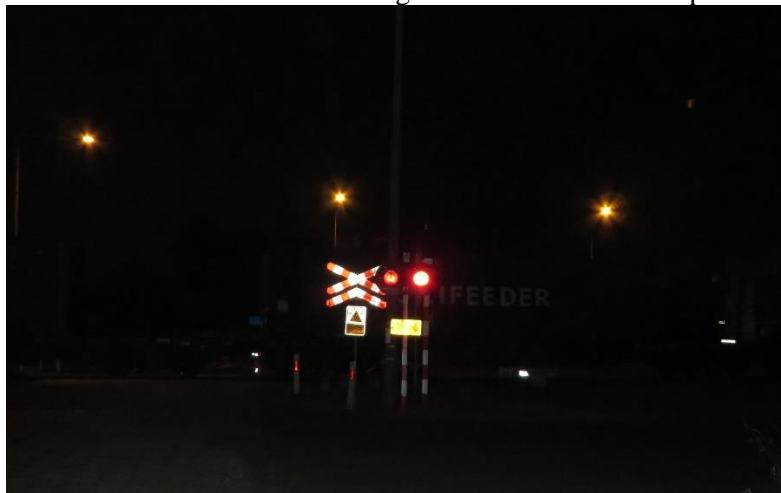
The signals had the board hung on them that read "Signalling out of order" (Polish: *Sygnalizacja uszkodzona*), without the B-20 "STOP" sign (Photograph 2).

Photograph 2 – A view of level crossing signalling immediately after the accident (source: the railway commission).

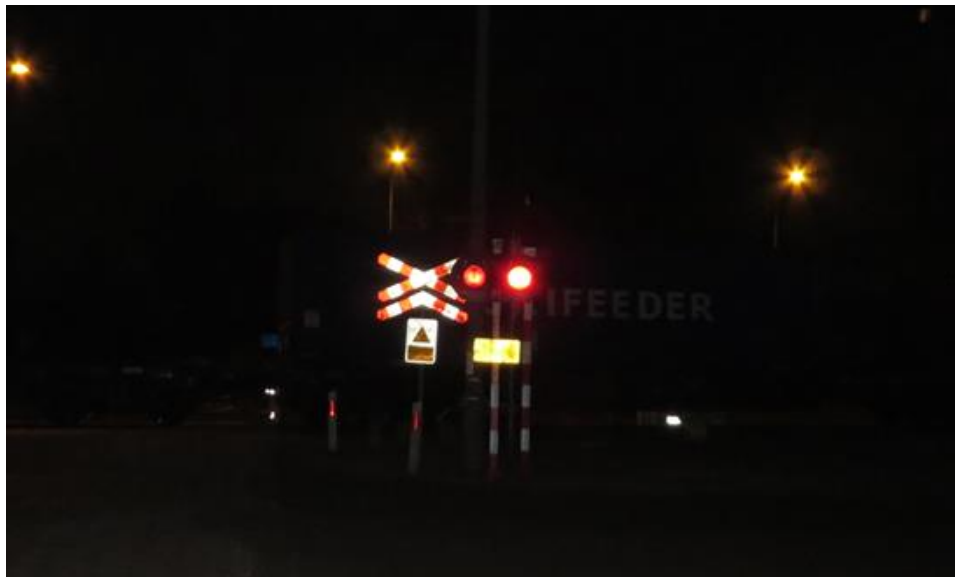
Due to the malfunction of the Automatic Crossing System (SSP), boards reading "Signalling out of order" were put on the signals. In the event of unserviceability of SSP devices, the infrastructure manager is required to mark the level crossing concerned with the sign B-20 "STOP". The sign was not there at the moment of the accident (Photograph 3).

Photograph 3 – Signage of the level crossing immediately after the accident (footage provided by the railway commission)

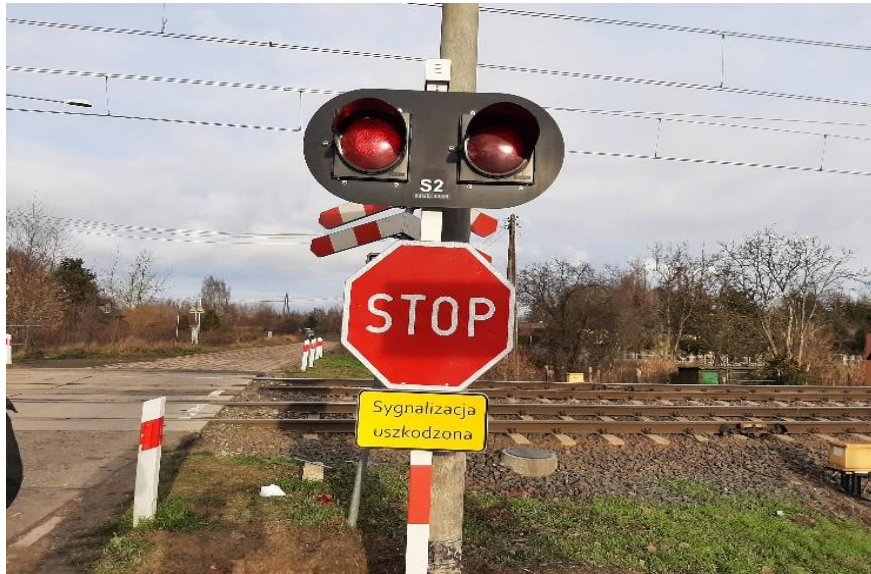
According to it transpires from interviews with employees of the infrastructure manager, the B-20 „STOP” sign placed after the malfunction occurred on 11 December 2022 had been stolen. Based on an analysis of the investigation material gathered and photographic documentation made immediately after the accident, the Investigation Team was unable to state clearly whether the level crossing had been marked with a B-20 "STOP" sign following the malfunction. Following the receipt of the theft report, the police communicated on 22 December 2022 that no request for punishment had been brought to court as no perpetrator(s) had been found. In accordance with applicable regulations, a Category C level crossing should be marked with *inter alia* sign G-4 "St. Andrew's Cross". The railway manager did place such a sign, but its positioning does not ensure good visibility for road users, for it is obscured by a roadside signal S2 of the Automatic Crossing System (Photograph 4).

The sign B-20 "STOP" was placed in the morning of 12 December 2022.

Photograph 4 – Signage of the level crossing after the arrival of PKBWK representatives

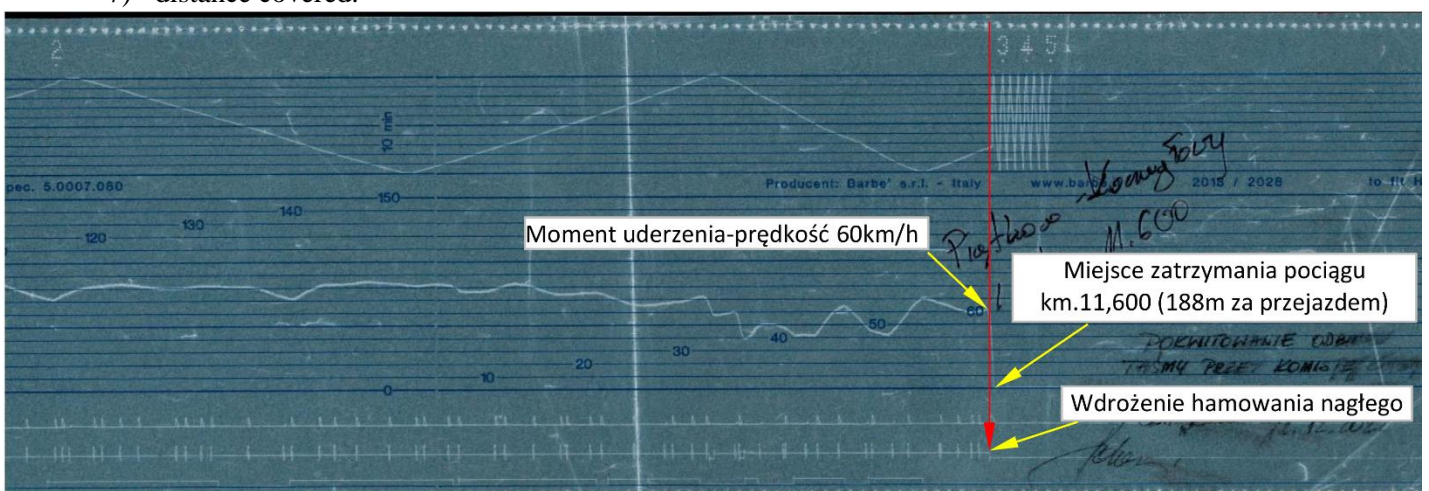
Photograph 5 – A scan of the speedometer tape with the performance characteristics of train no. 872000

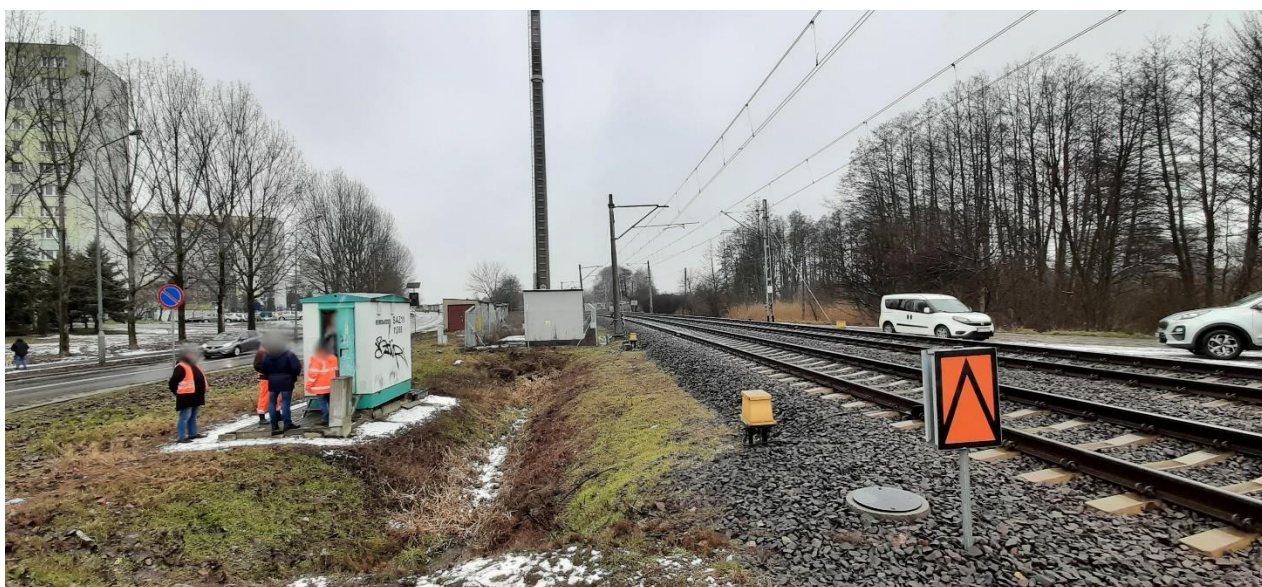
The level crossing at Nad Różanym Potokiem street is located behind an elevation relative to Stróżyńskiego street. The approach to the crossing from Stróżyńskiego street is inclined by 4.195% along the length of 17.5 metres. At the point of measurement of the visibility triangle from 5 metres, looking to the left (from the direction of a moving car), there is a container with a GSM-R mast. The structure obscures visibility of trains incoming from the left for drivers of road vehicles. The structure also obstructs visibility for drivers of trains during observation of the approach leading to the level crossing. Photographs 6 and 7 show visibility from the road onto track no. 2 from 5 metres, and from track no. 2 onto the approach and level crossing at km 11.788 from around 80 metres before the level crossing.

Photograph 6 – A view of track no. 2 from the road from the distance of 5 metres from the outermost rail

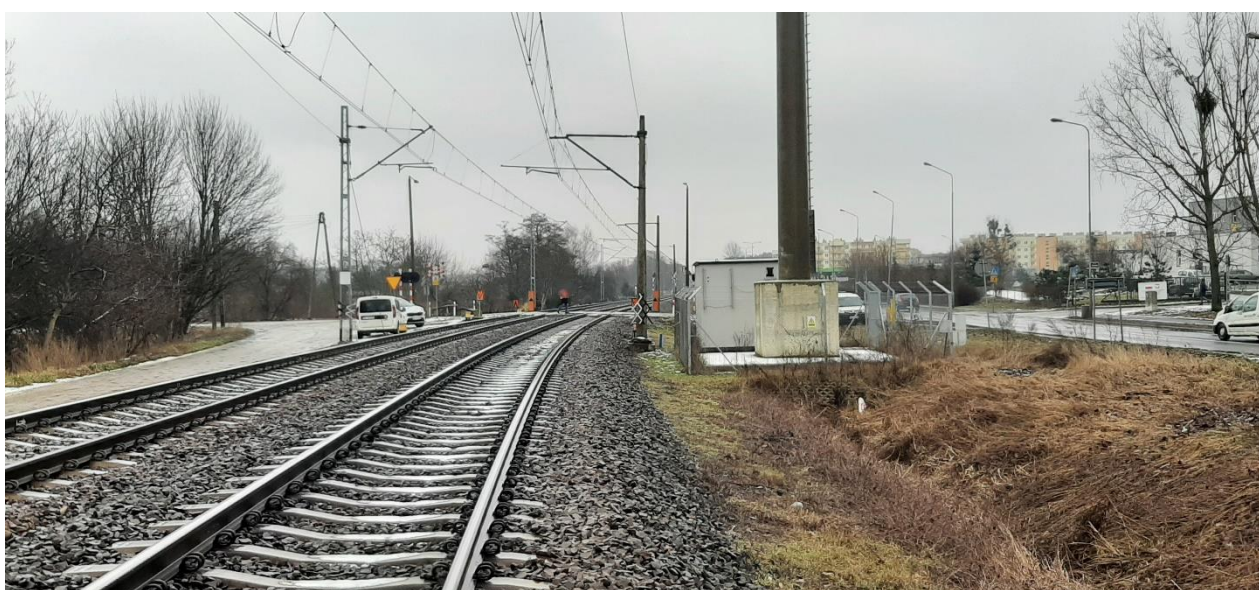
Photograph 7 – A view from track no. 2 on the access road and the level crossing at km.11.788 from the distance of around 80 metres

Erecting the GSM-R container and mast within the visibility triangle at 5 m significantly reduced visibility for road users, making it more difficult to notice a train incoming on track no. 2, and also leaves the train driver with very little reaction time if he notices any irregularities in the behaviour of road vehicle drivers. A road vehicle that stopped before the level crossing is practically invisible for the train driver from the distance of around 80 metres before the level crossing. In accordance with the provisions of Paragraph 15, Part B, Annex 3 to the Regulation of the Minister of Infrastructure and Development of 20 October 2015 on the technical conditions to be met by crossings of railway lines and sidings with roads, and on their positioning (Journal of Laws of 2015, items 1744, as amended), "Within the boundaries of visibility triangles, no objects that reduce visibility shall be placed, in particular construction works, trees, shrubs and other high-growing plants, advertisements, elements of acoustic protection". The erection of the construction works in the 5 m visibility triangle started in 2019. PKP PLK S.A. is the investor. Photograph 8 shows boards placed on the object.

- 6) Infrastructure manager PKP PLK S.A. shall take effective actions to synchronise time in the electronic time system which it operates.
- 7) Authorised infrastructure managers shall include in their hazard records hazards related to any structures erected within the visibility triangle. In each case, they shall conduct a risk analysis at the stage of designing structures close to level crossings, taking into account the local conditions of a given level crossing.

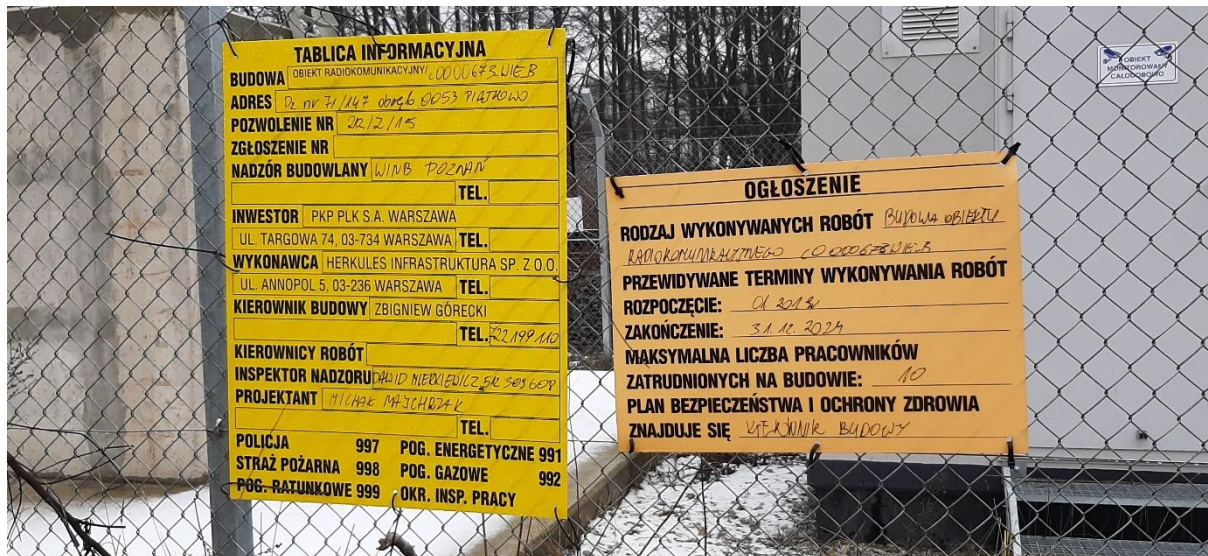
Photograph 8 – Boards placed on the fence of the construction work
