**STATE COMMISSION ON RAILWAY ACCIDENT INVESTIGATION**  
**Ministry of the Interior and Administration**

**REPORT No. PKBWK 4/2024**

**on the investigation of a railway incident**  
**which occurred on 8 May 2023 at 07:26 hrs on the Góra Włodowska – Zawiercie route,**  
**track no. 1, km 212.400 of railway line no. 4 Grodzisk Mazowiecki – Zawiercie,**  
**the area of the infrastructure manager PKP PLK S.A. Railway Line Plant**  
**in Częstochowa**

**Warsaw, 18 March 2024**

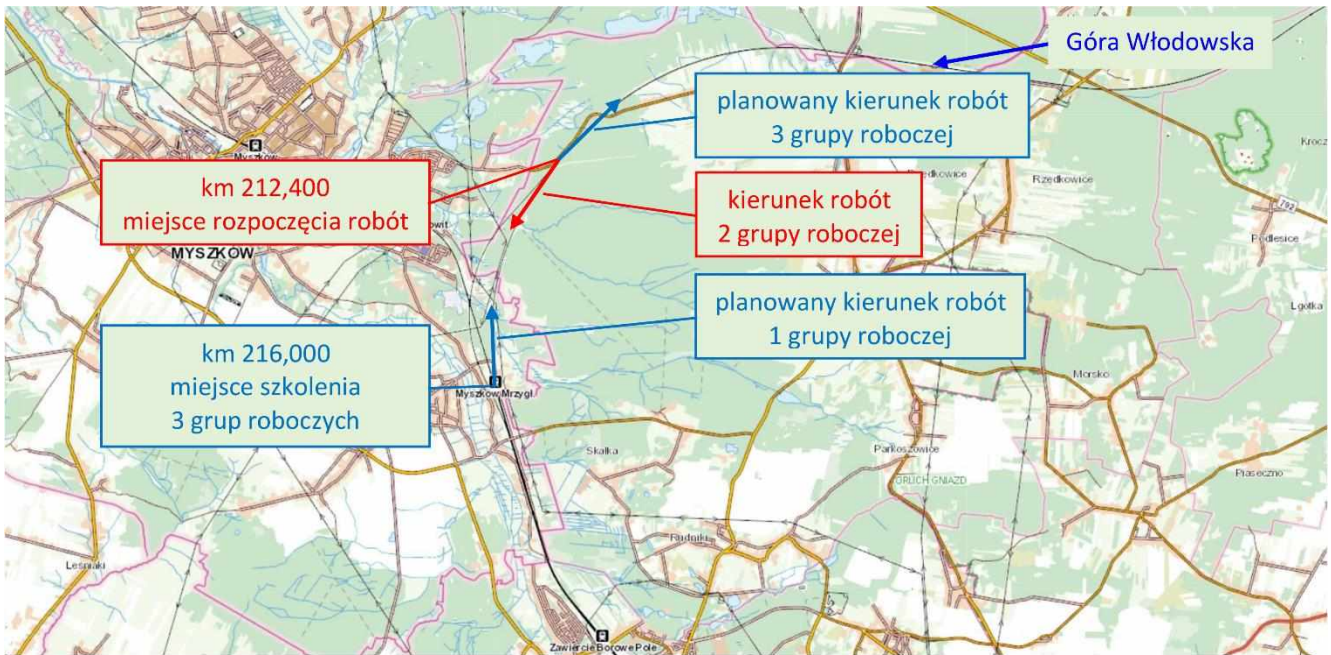
**Figure 2 – Planned organisation, start and end location of works as of 8 May 2023 (source: Geoportal)**

Approaching the work site from the side of track no. 1, group 2 (see Fig. 2) was the first to arrive and immediately, at 07:00 hrs, commenced dismantling (disengaging) the rail attachments in active track no. 1, instead of closed track no. 2. The work progressed in the direction of the line's ascending chainage. That group had managed to disengage ca. 200 m of track no. 1 when the third group arrived on site. Noticing that the second group was disengaging track no. 1, the supervisor of the third group notified the work organisation manager immediately by telephone, and the latter ordered the trackmaster in the second group by mobile phone to start re-engaging the rails in the track. Meanwhile, at 07:24 hrs, train no. 14001 departed the Góra

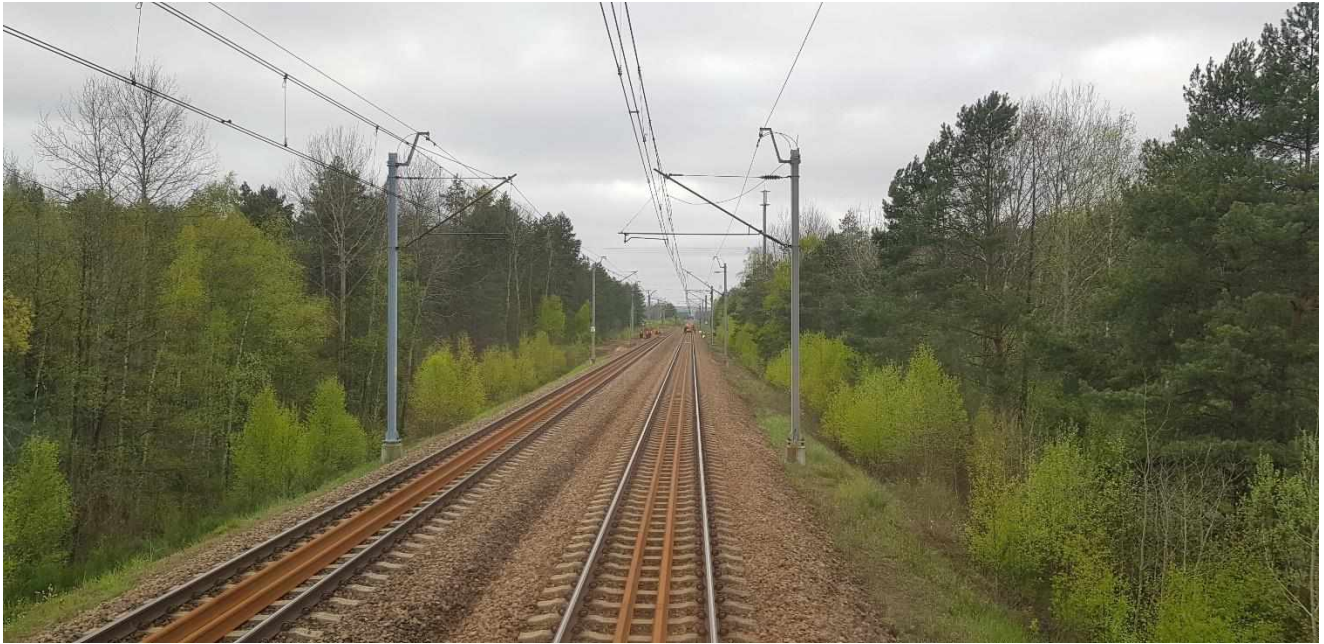
**Photograph 1 – source: a photo taken by the driver of train no. 14001.**

Włodowska station to the Zawiercie station on track no. 1. The train driver had been informed in a written "O" order that train speed limit on track no. 1 of that route had been reduced to 120 km/h due to works carried out on track no. 2. Approaching km 211.800, the train driver noticed persons in high-visibility vests working on active track no. 1 on which he was going. He immediately gave the Rp1 "Attention" warning signal and executed emergency braking until full stop. The head of the train stopped at km 212.200 at 07:26 hrs clear of the section with the rail attachments disengaged, ca. 200m ahead of the working group, who were hastily leaving the trackway. The station master who dispatched train no. 14001 from the Góra Włodowska station did not know that there was a group working on active track no. 1 of the Góra Włodowska – Zawiercie route.

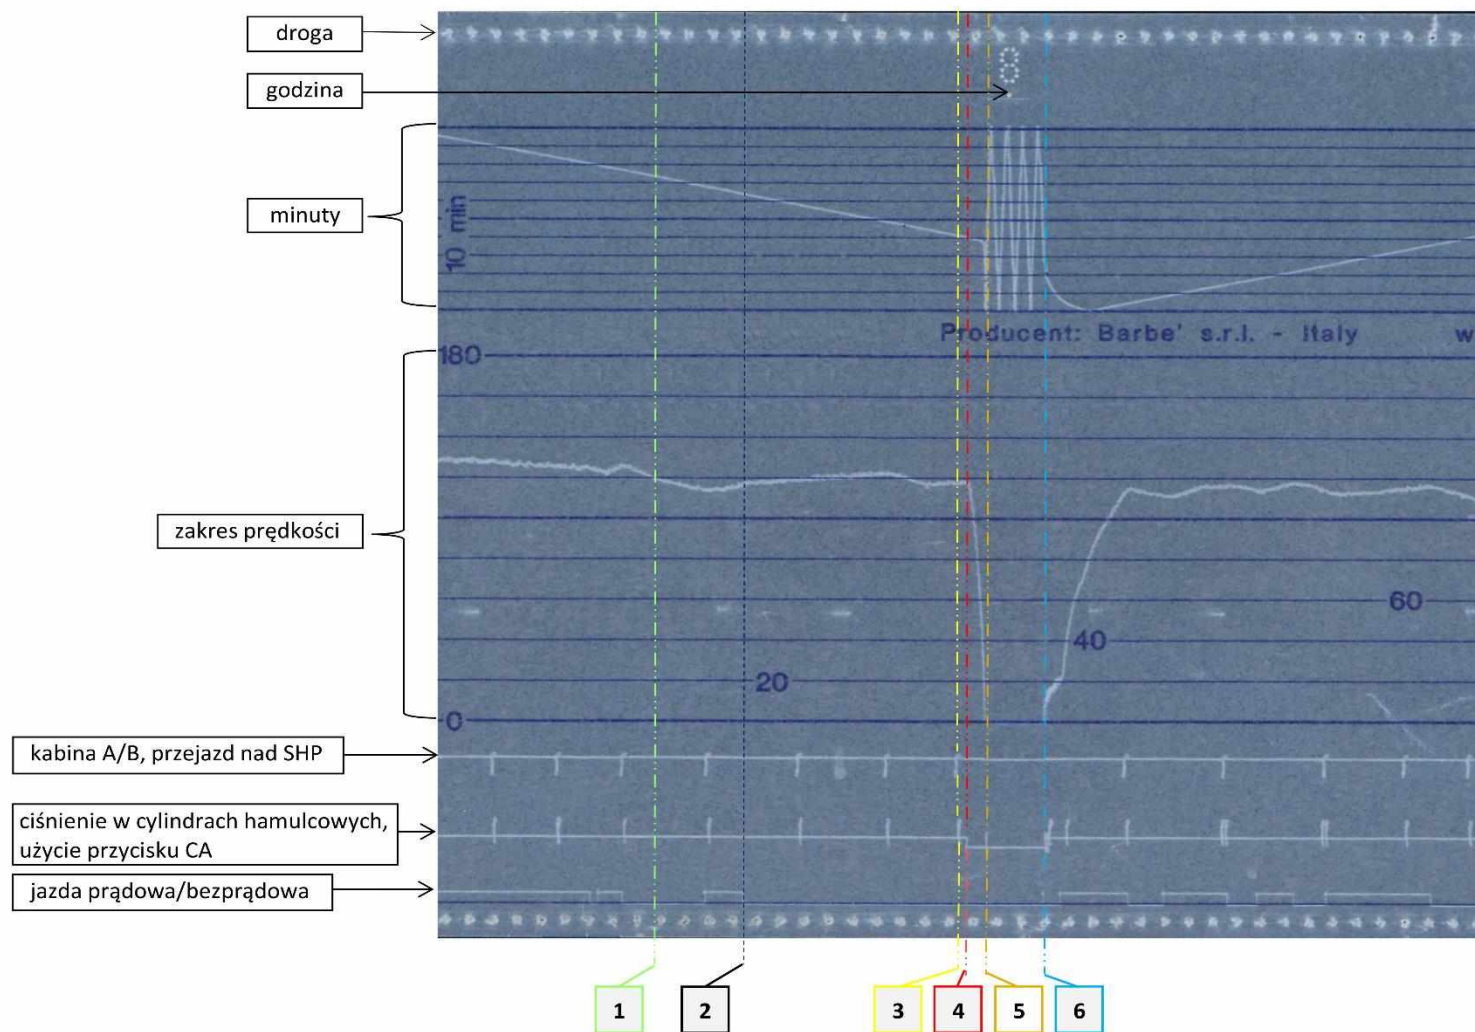
Figure 4 - A chart of the locomotive's driving parameters

A description of the driving characteristics of train IC no. 14001 operated between Warszawa Wschodnia and Bohumin on the section between Włoszczowa Północ and the place of the occurrence (legend for Figure 4). Departure from the Włoszczowa Północ station at 06:57 hrs, control from Cabin A., electric drive, travel with the speed in the range between 120 km/h and 130 km/h on the distance of 49.5 km until 07:23 hrs;

- 1 - 07:23 hrs, from km 204.900 on - travel at the speed of 120 km/h (an *ad hoc* speed limit imposed for the duration of railworks between km 205.401 and km 222.689),
- 2 - 07:23:30 hrs, non-electric drive, maintaining the speed below 120 km/h,
- 3 - 07:26 hrs, travel over an automatic train stop magnet, non-electric drive at the speed of 120 km/h, use of the vigilance button,
- 4 - 07:26 hrs, at the speed of 119 km/h the system recorded a pressure drop in the train's brake cylinders, non-electric drive, speed down to 0 km/h on the distance of 400 m,
- 5 - 07:26 hrs, the head of the train stops at km 212.200, use of the vigilance button,
- 6 - 08:48 hrs, the train is restarted and continues its travel in the direction of the Zawiercie station.
