PRELIMINARY REPORT

ACCIDENT

Warsaw Chopin Airport (EPWA), RWY 11

Airplane, DHC-8-402

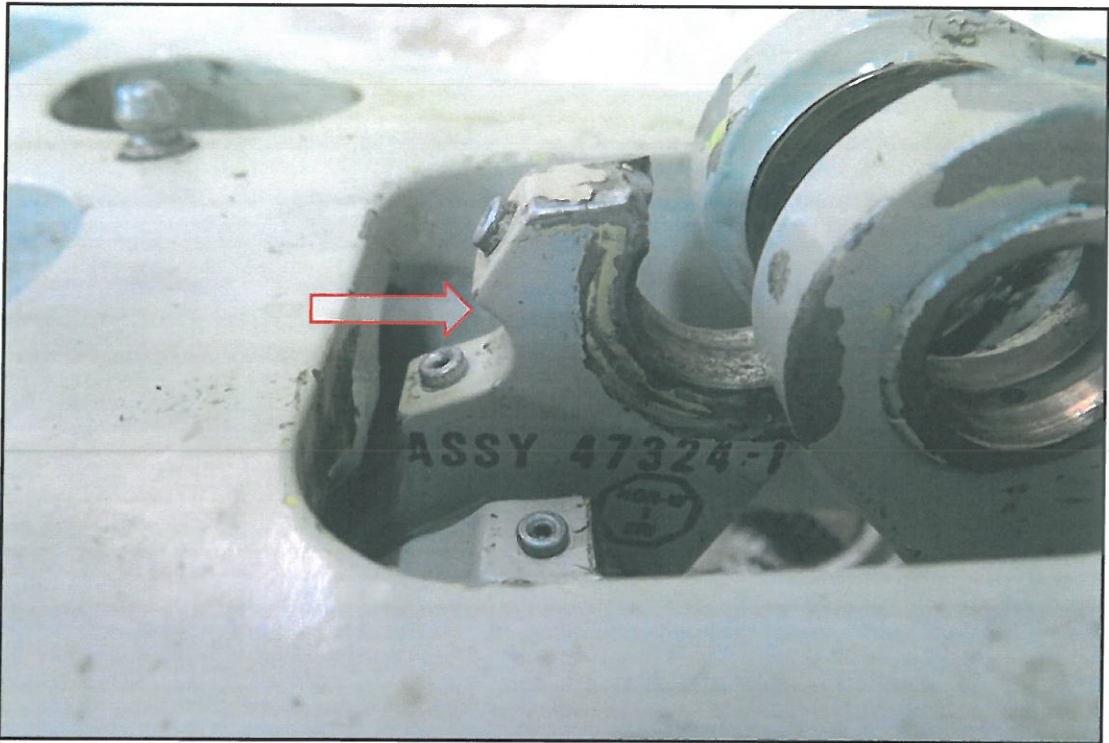
Figure 1. Lower Lock Link 47324-1

The Bulletin was applicable to DHC-8 Aircraft Models 401 and 402, all serial numbers with Lower Lock Link 47324-1 (Fig. 1 and 2) that have completed 8000 flight cycles.

The reason for the Bulletin was: *reports of the bushings on the lock link of the NLG locking mechanism becoming loose. This condition was caused due to insufficient interference fit and results with bushing outer diameter wear/fretting. Dislodged bushing will also cause sealant to break. The broken sealant allows moisture ingress and corrosion that can accelerate free play buildup. Excessive free play at the lock link can result with inability to retract/deploy NLG fully.*

After the accident of 10 January 2018, SB 84-32-153/AD CF-2018-01 were accomplished on 9 out of 10 airplanes of DHC-8-402 Operator's fleet (with the exception of the accident airplane). On all checked aircraft the Lower Lock Links did not meet the technical requirements and were replaced with new ones.

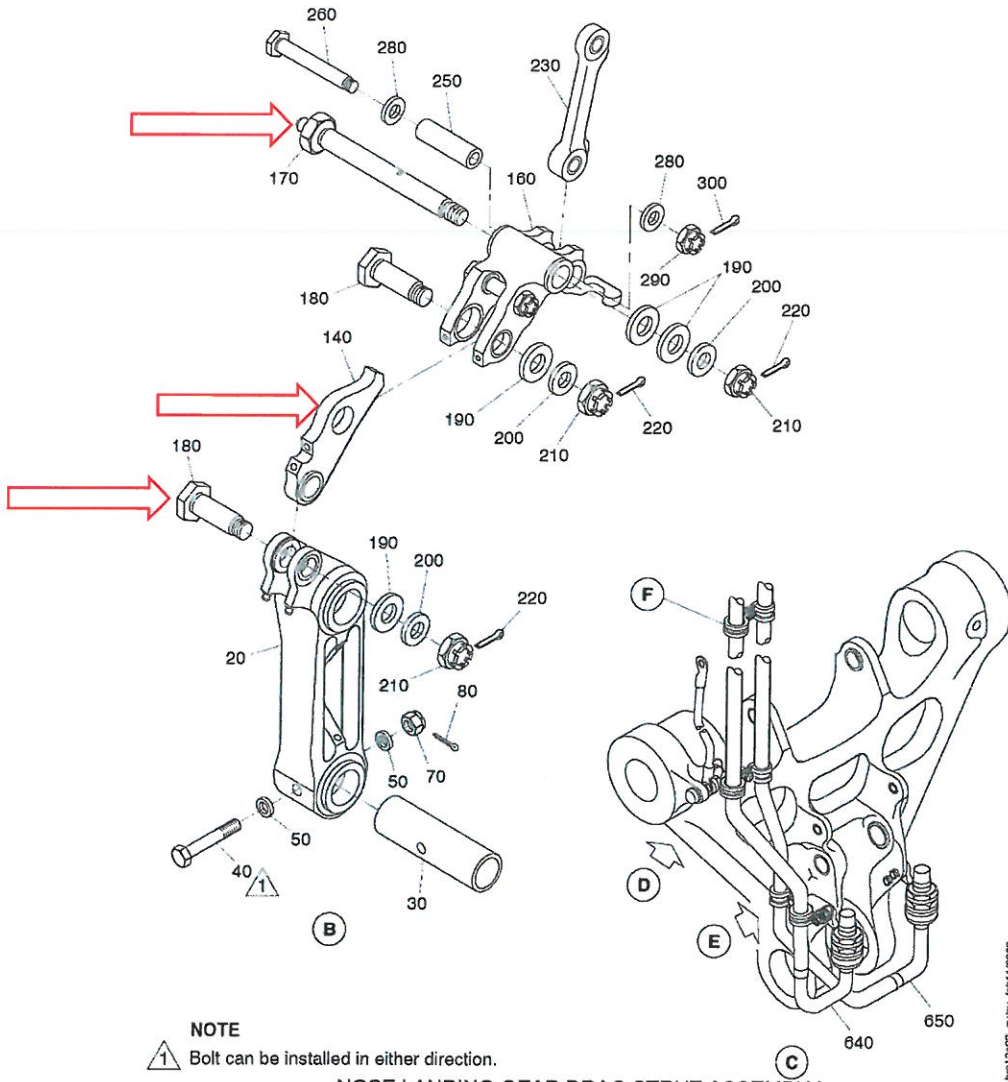
The figures below show the Lower Lock Link P/N 47324-1, which was to be inspected according to SB 84-32-153. In Figure 3 the Lower Lock Link is numbered 140.

P/N 47310-101 and P/N 47309-3 pins numbered 170 and 180 respectively were also damaged.

Figure 3. NLG Drag Strut locking mechanism. Red arrows indicate the damaged components

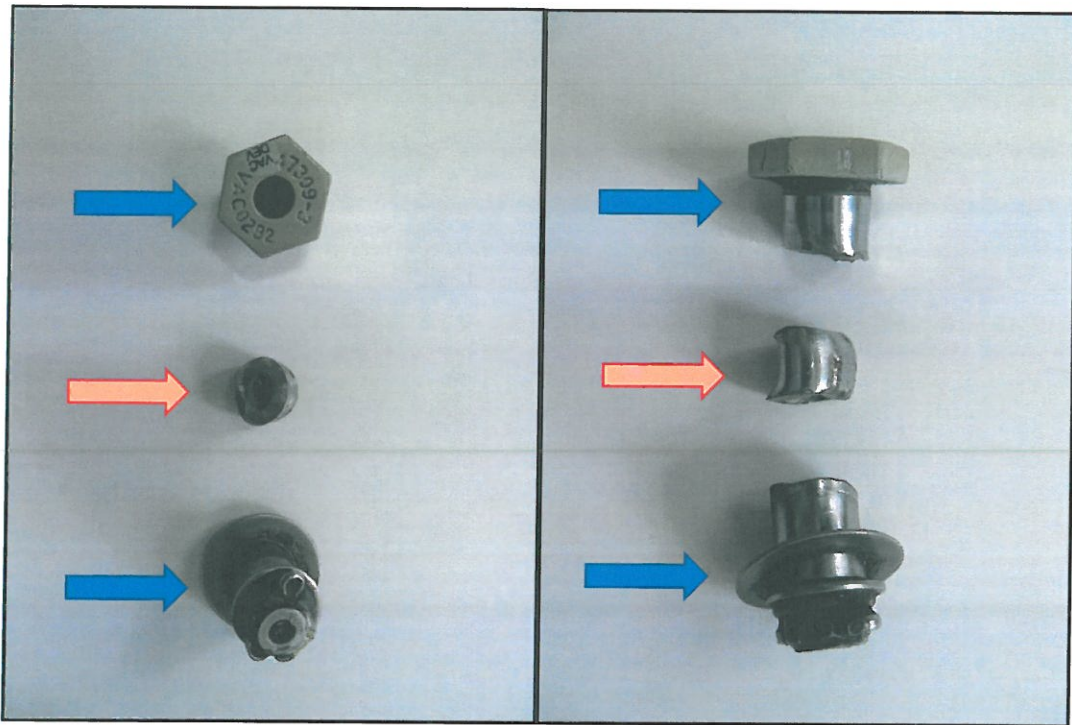
Figure 4. Damaged pin, P/N 47309-3 (the red arrows indicate the part of the pin which was found on the accident site and the blue arrows indicate the parts removed from the Lower Drag Strut (P/N 47313-1).

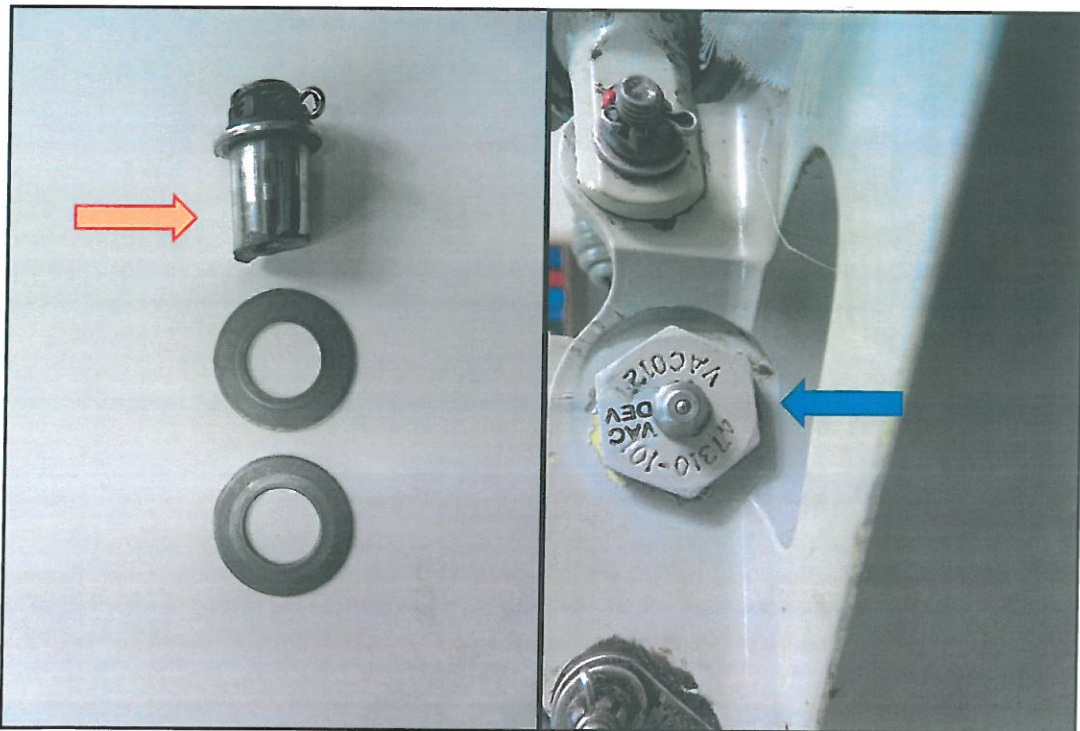
Figure 5. Damaged pin, P/N 47310-101 (the red arrow indicates the part of the pin which was found on the accident site and the blue arrow indicates the part which remained in its seat in Upper Lock Link (P/N 47320-3).

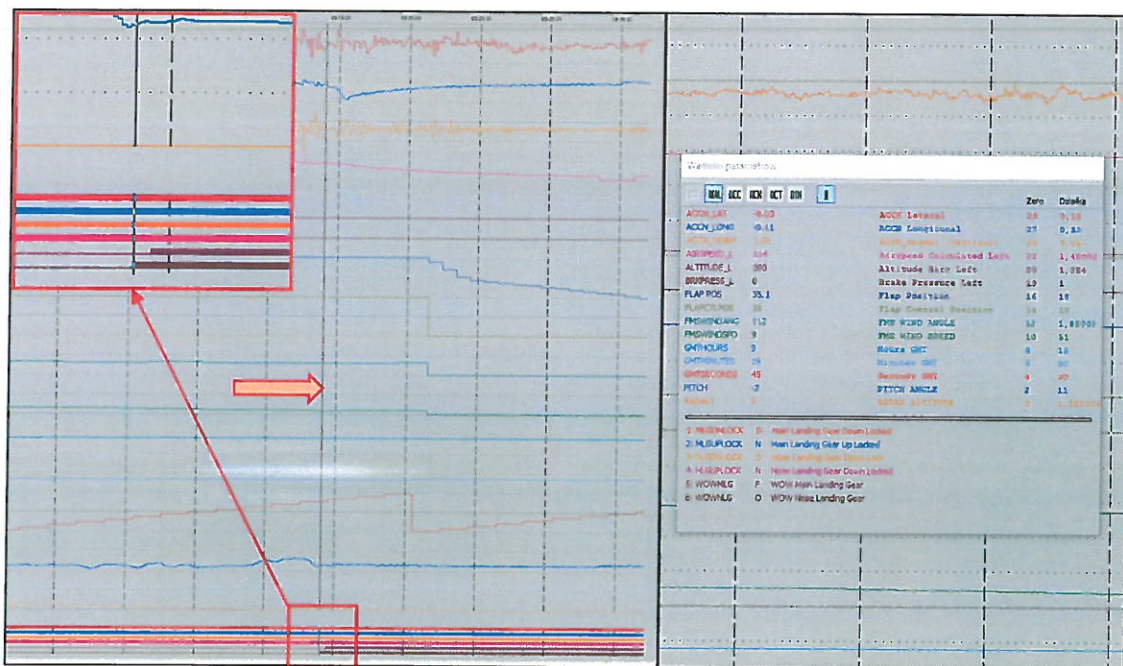
An additional analysis of the recorded parameters showed that there have been numerous cases of landings where the NLG sensor was activated first and only then the MLG sensors.

The data from 1 Jan 2017 to the day of the accident were analyzed. As for SP-EQG airplane, out of 2854 landings in the analyzed period, 69 of such cases were found, including one from the day of the accident. The common feature for the aforementioned landings, in addition to the sequence of the NLG and MLG loading, was the negative pitch angle.

Figure 6. Graphic presentation of FDR recording. The red frame at the top left shows the time of NLG loading (horizontal brown line at the bottom of the frame). The time of the MLG loading is shown by the purple line (the second from the bottom). The values of selected parameters at the time of NLG loading are shown in the frame on the right.
