Photo documentation – Contract 1B.3/2 Phase II – *The construction of docking-mooring infrastructure on Lower Odra River and on boundary sections of Odra River as well as new aids to navigation*

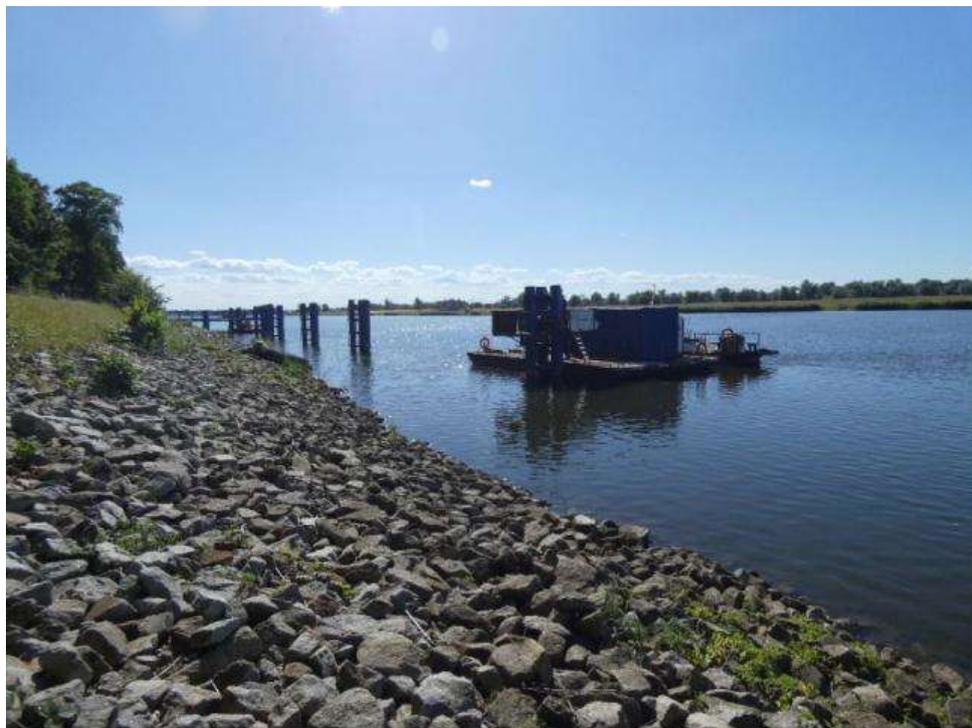
Photo 1. Works carried out from the water side – Zatoń Dolna location

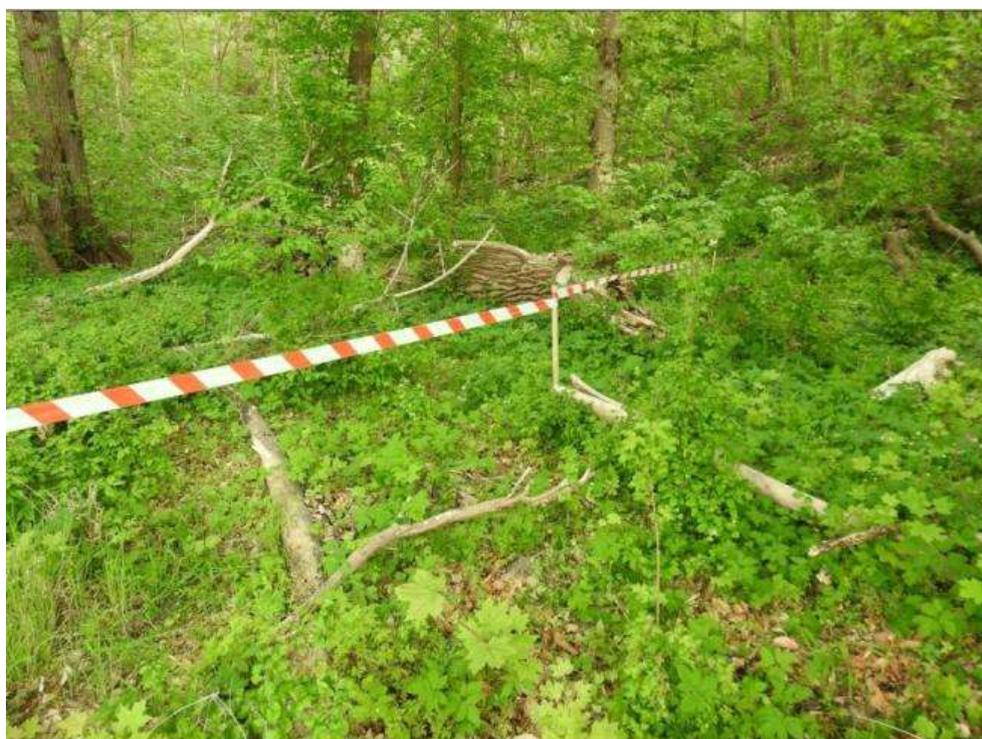
Photo 2. Protected habitat patch – riparian forest 91E0

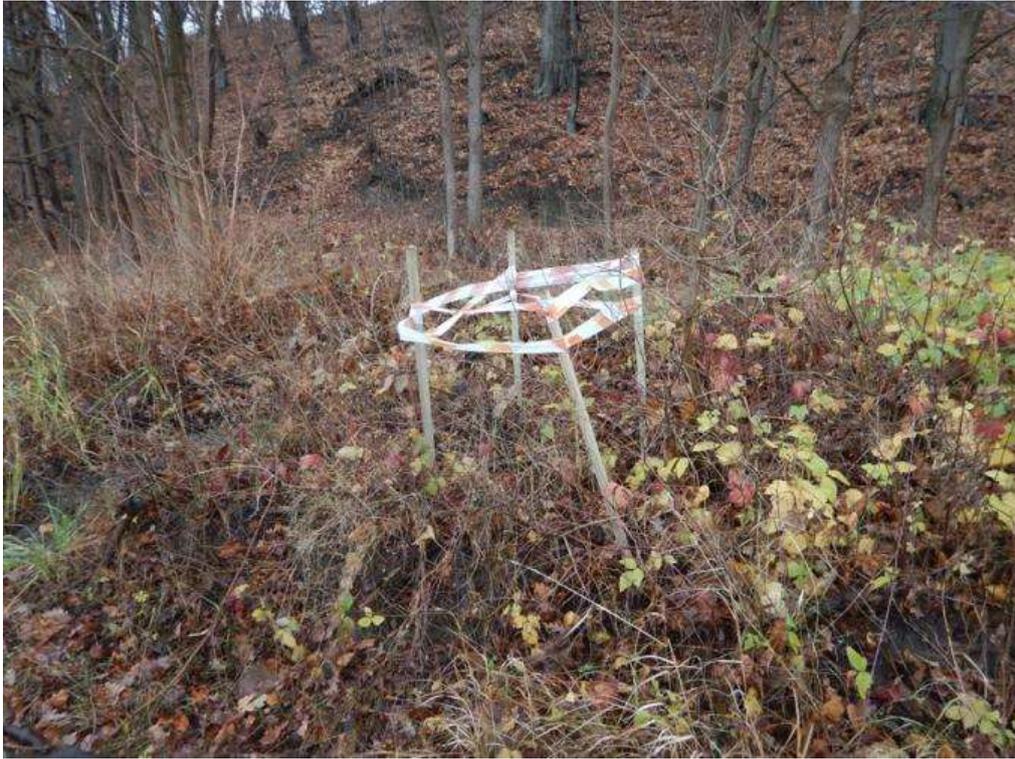
Photo 3. Protected site of the marsh spurge *Euphorbia palustris*

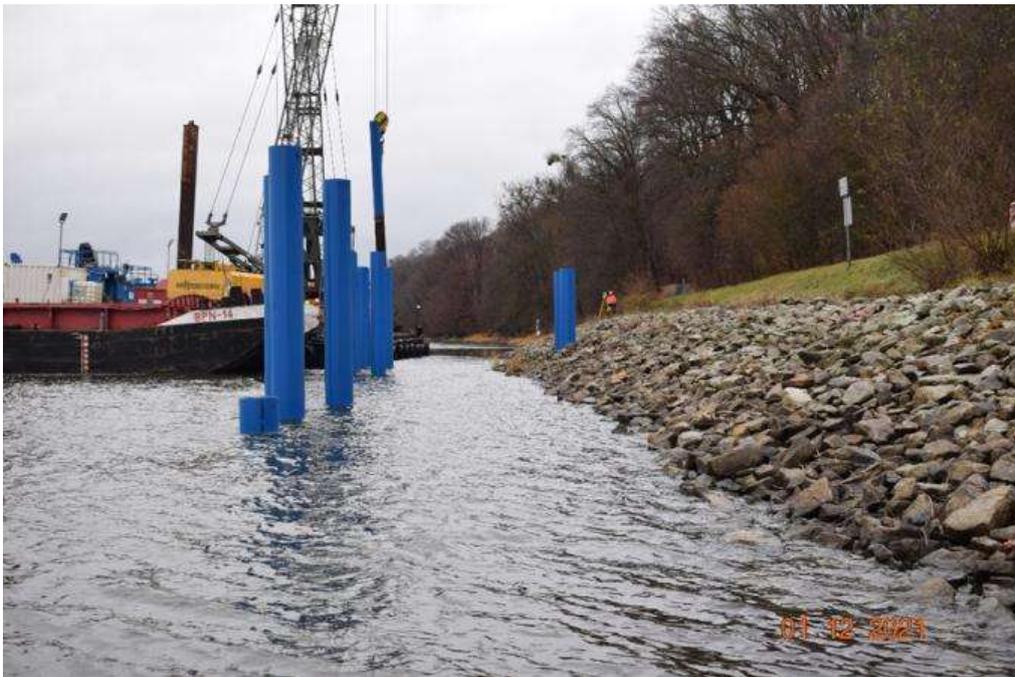
Photo 4 Works carried out from the water side at the Zatoń Dolna location

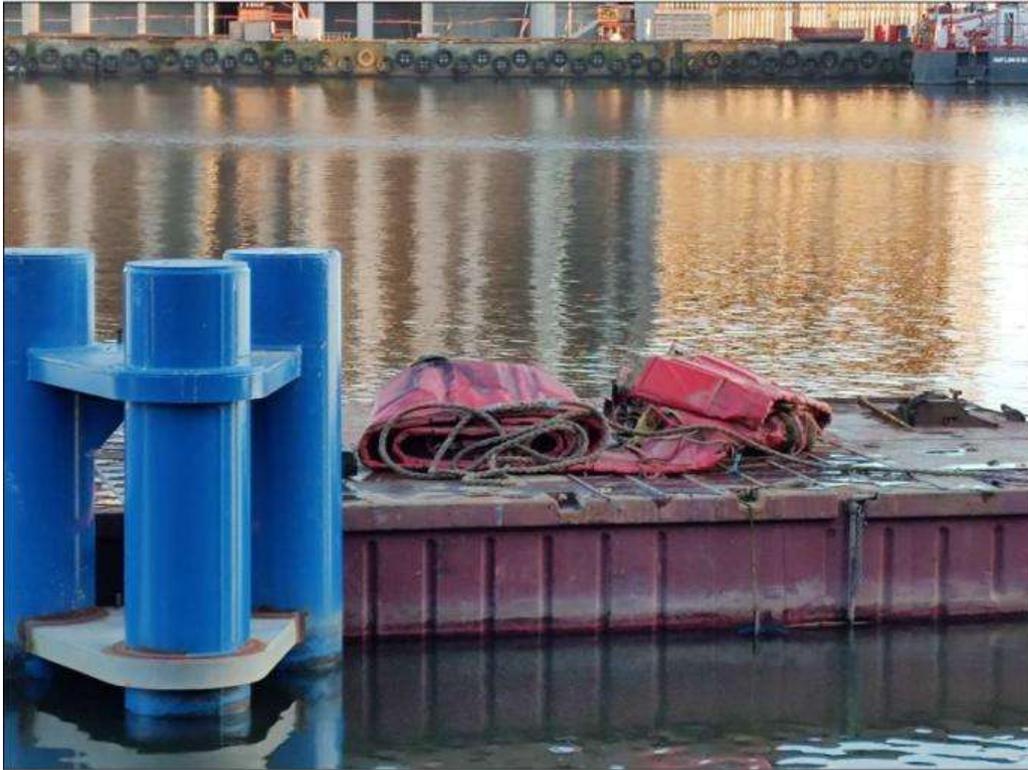
Photo 5 Oil spill containment booms preparation – Szczecin location

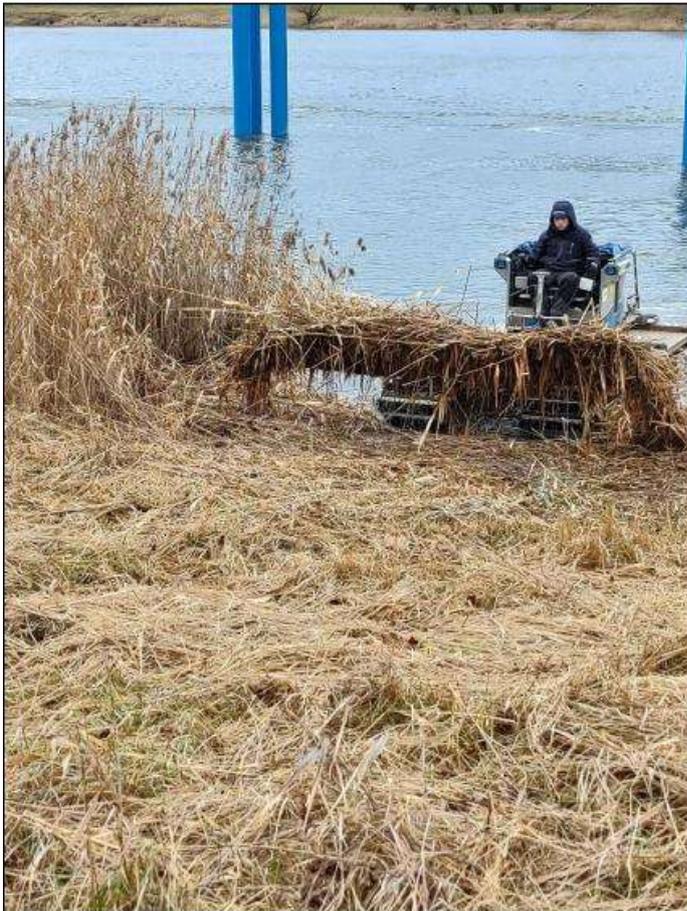
Photo 6 Cutting rushes – Osinów Dolny location

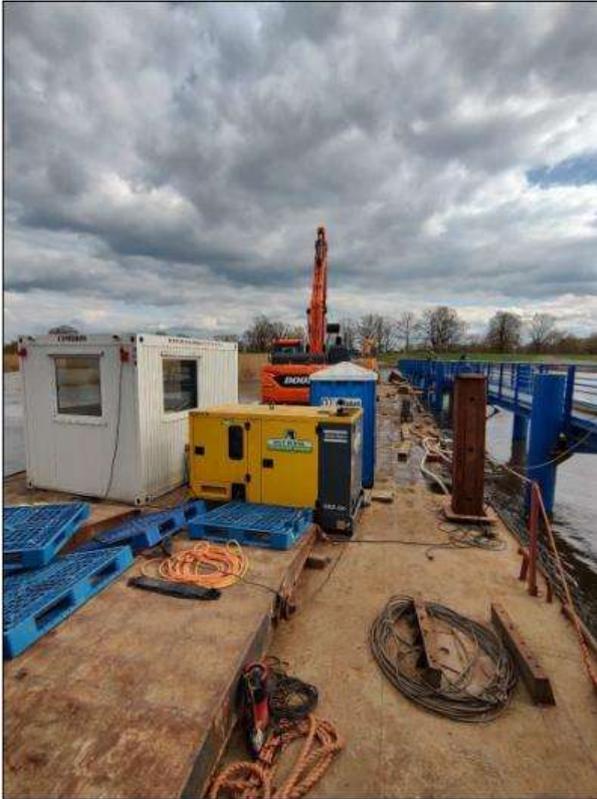
Photo 7 Construction facilities on a vessel – Pławidło location

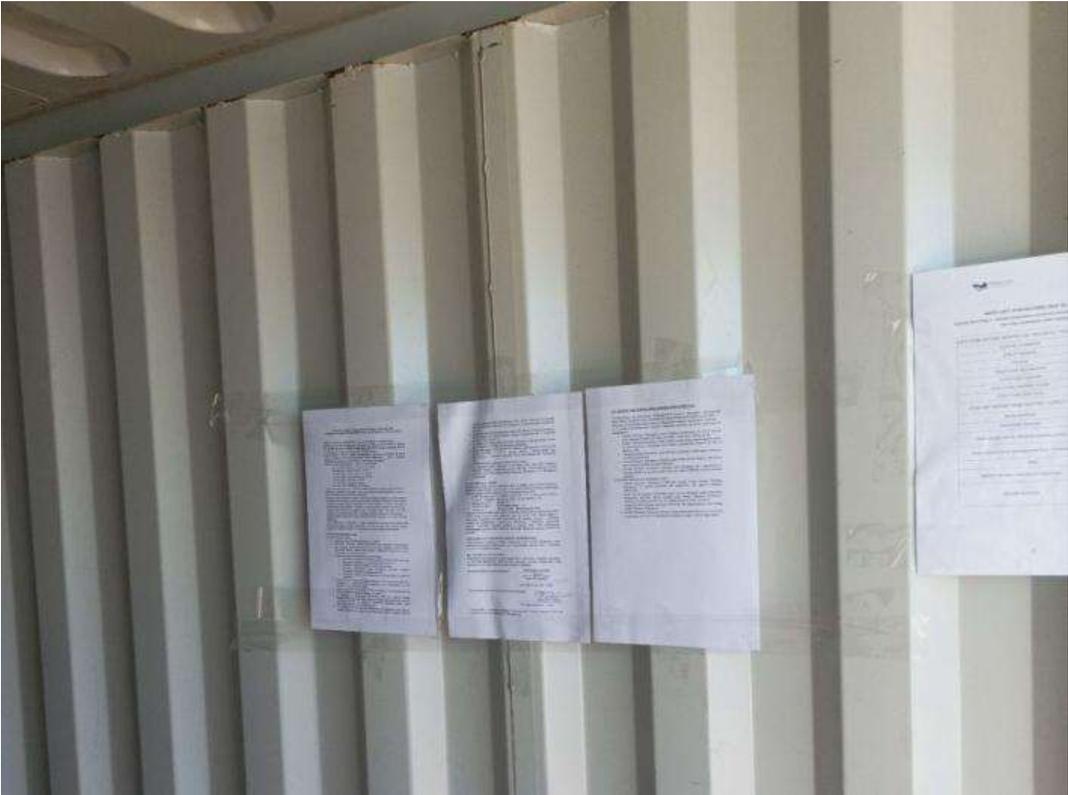
Photo 8 ES Code and OHS list made available to employees

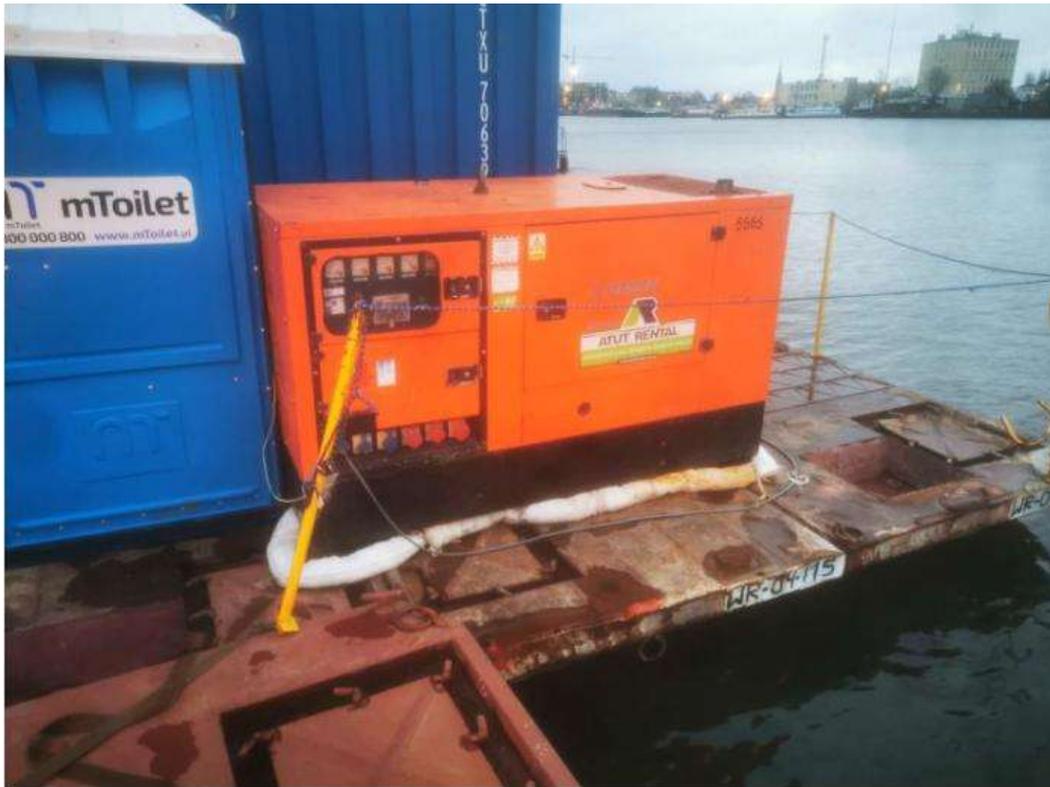
Photo 9 Power generator with additional spill protection on a vessel

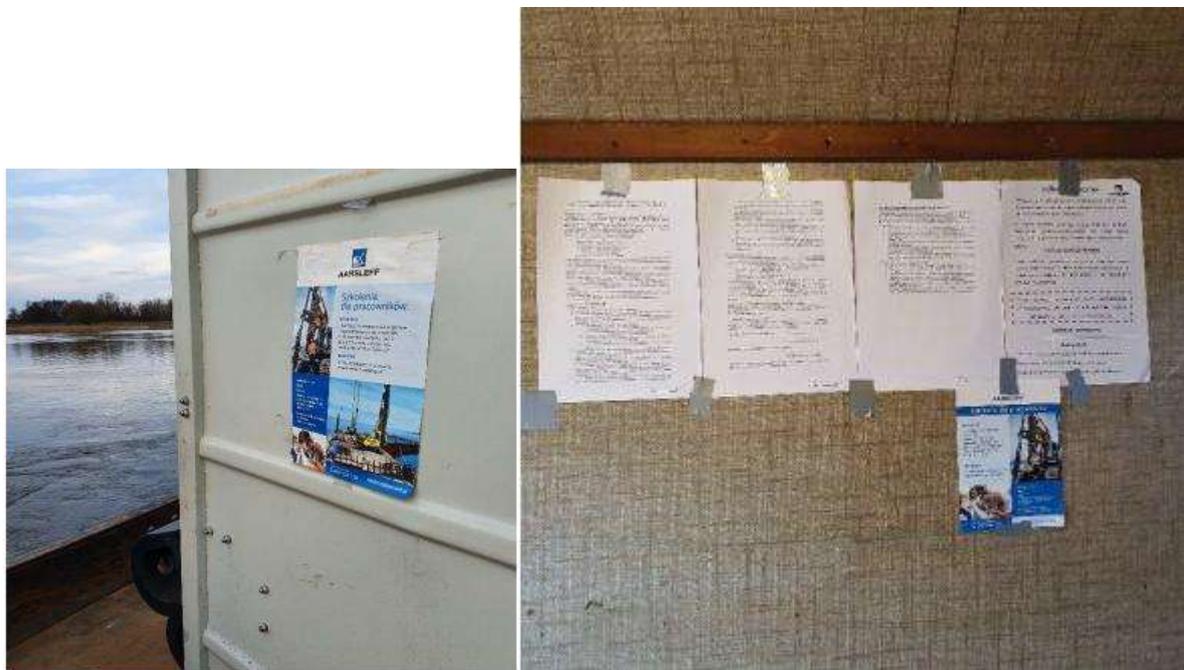
Photo 10 Information leaflets on vessels

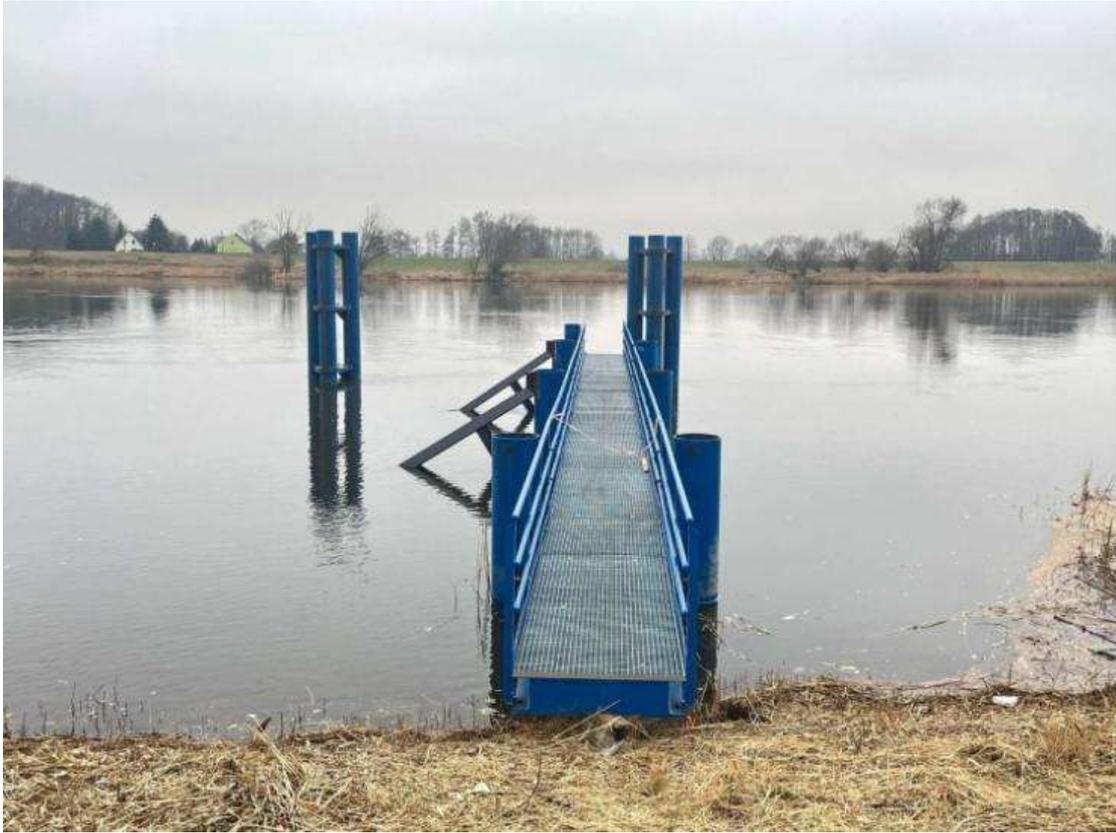
Photo 11 Installed footbridge platform – Osinów Dolny location

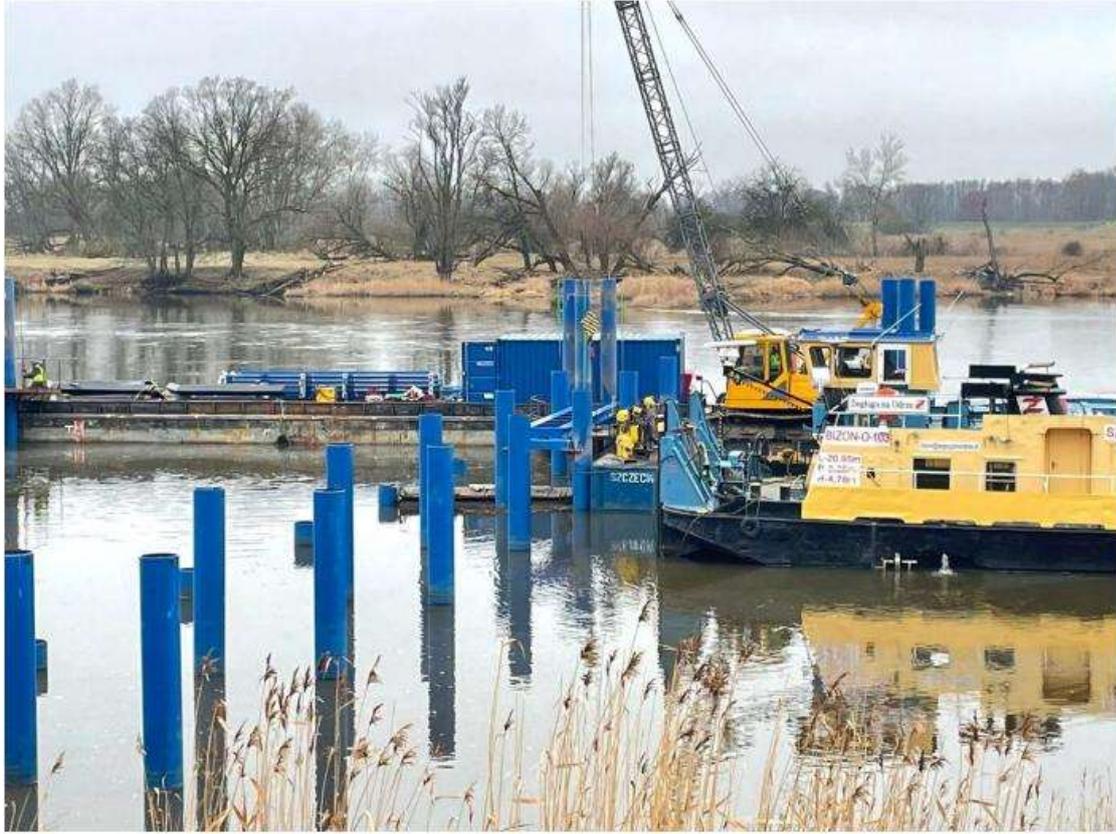
Photo 12 Platform installation – Ługi Górzyckie

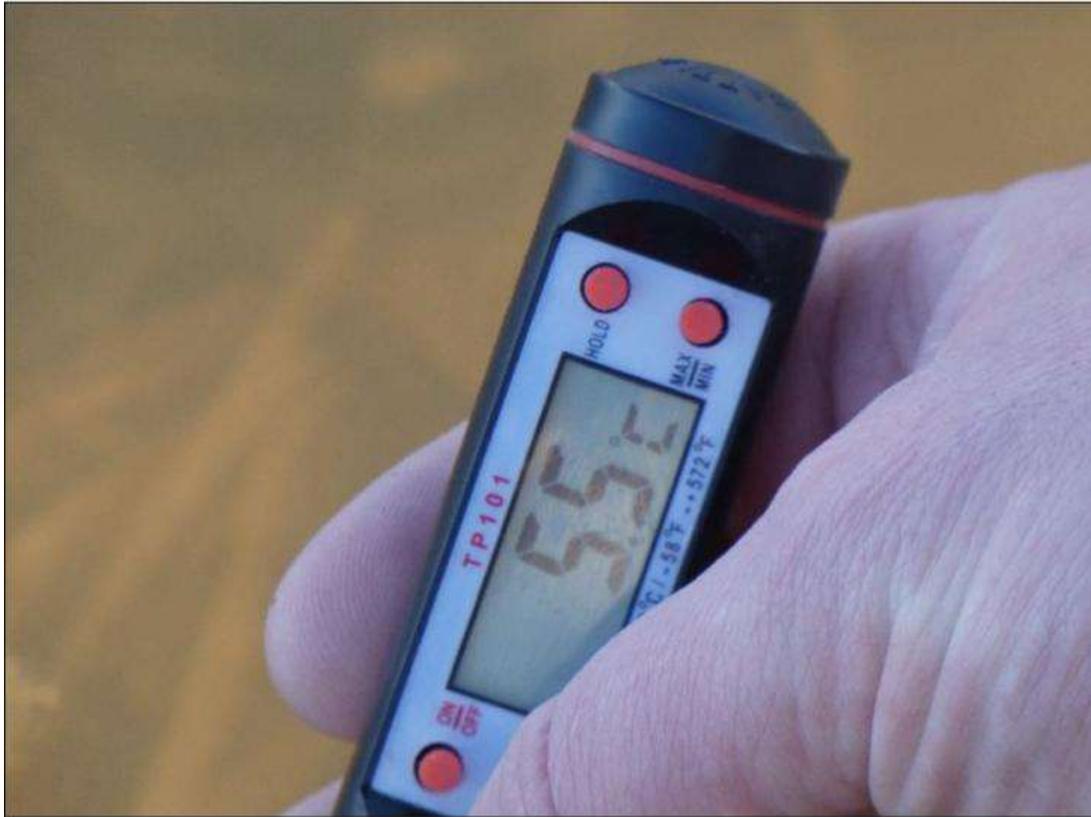
Photo 13 Example of water temperature measurement – Pławidło location

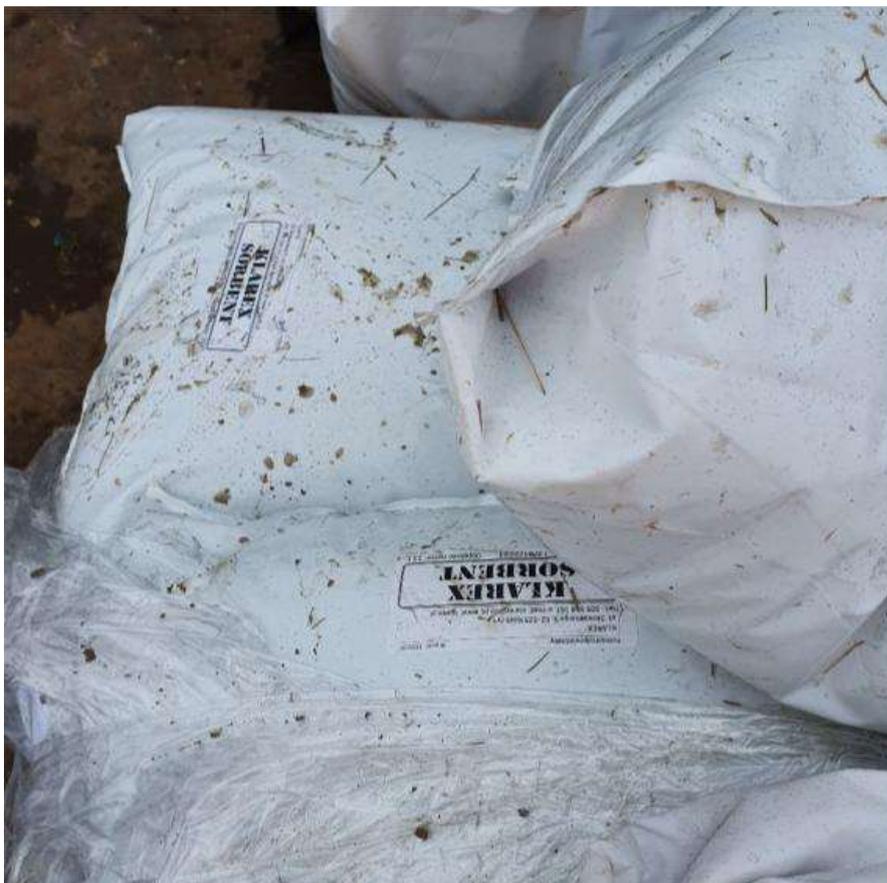
Photo 14 Sorbents on a vessel

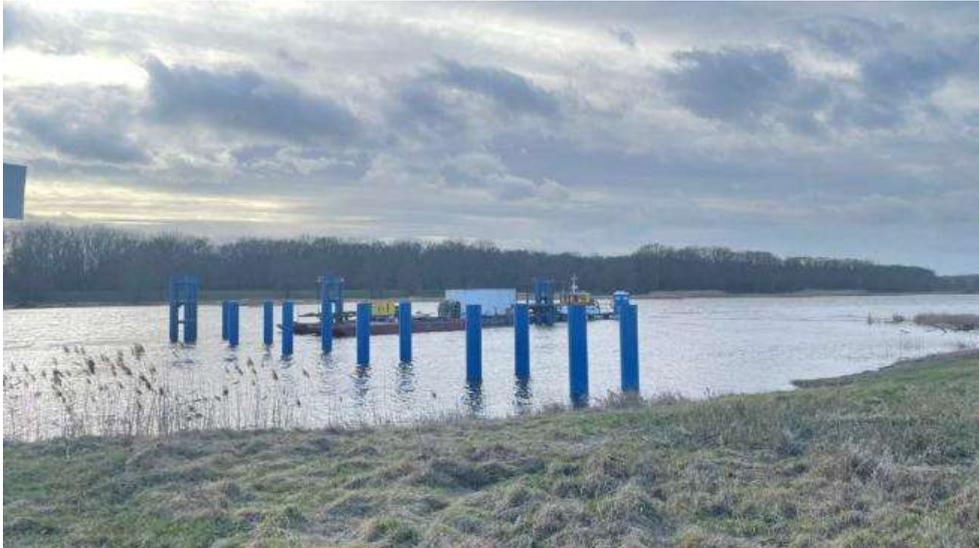
Photo 15 Constructed dolphins – Kunice location

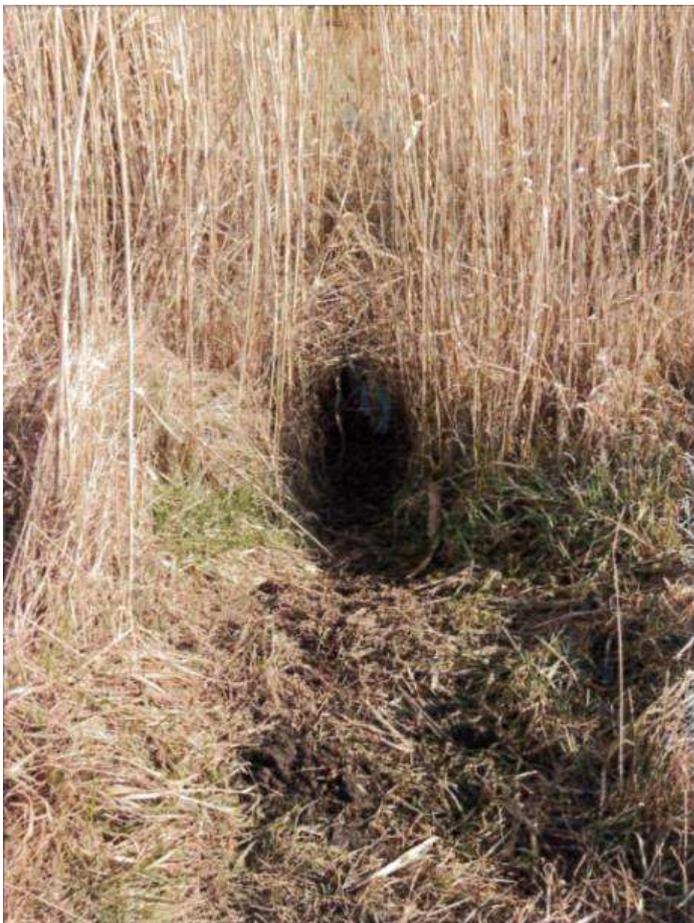
Photo 16 Beaver (*Castor fiber*) path

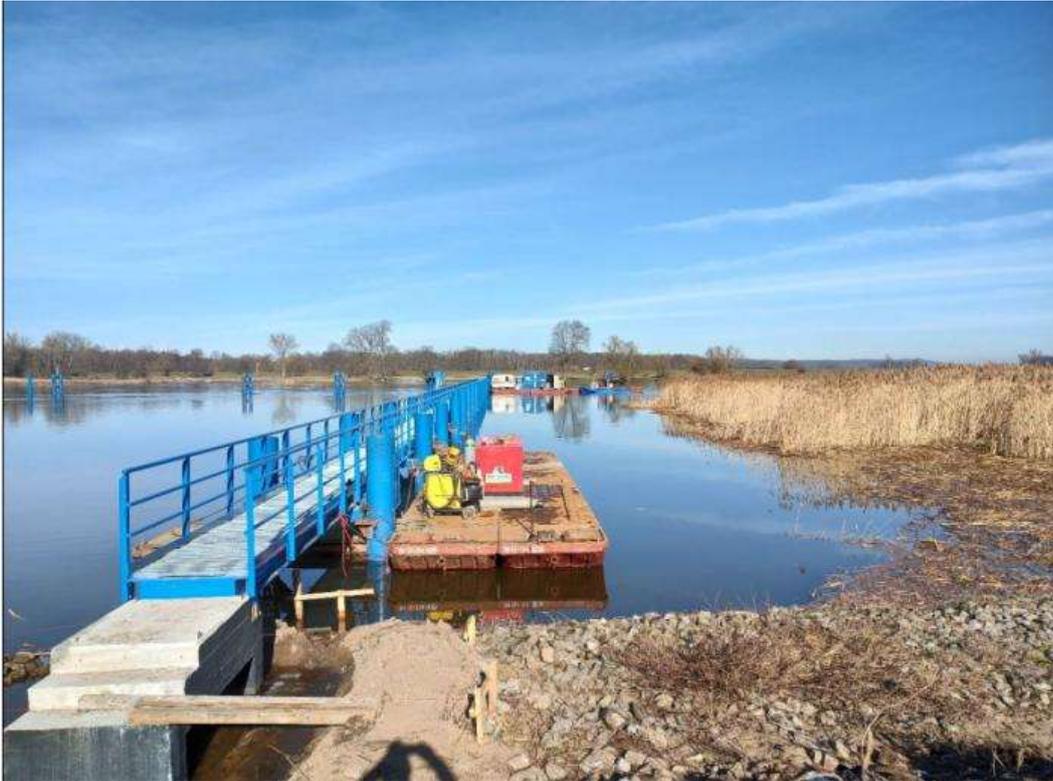
Photo 17 Works carried out from the water side – Pławidło

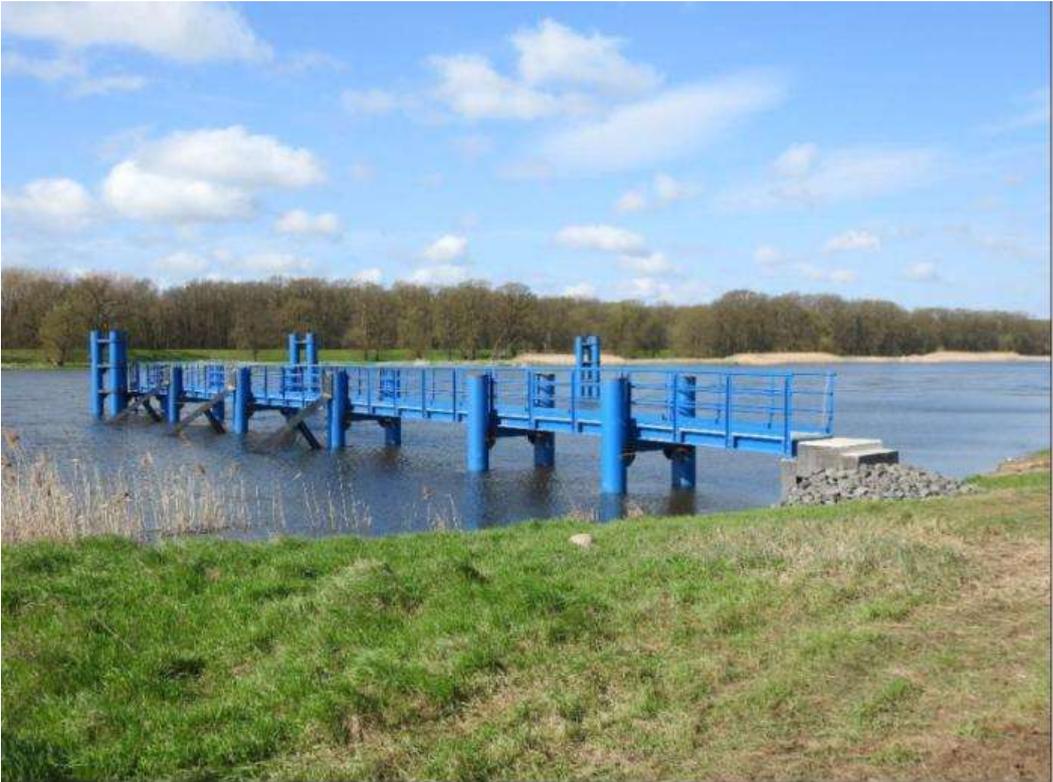
Photo 18 View of the dolphin site – Kunice location

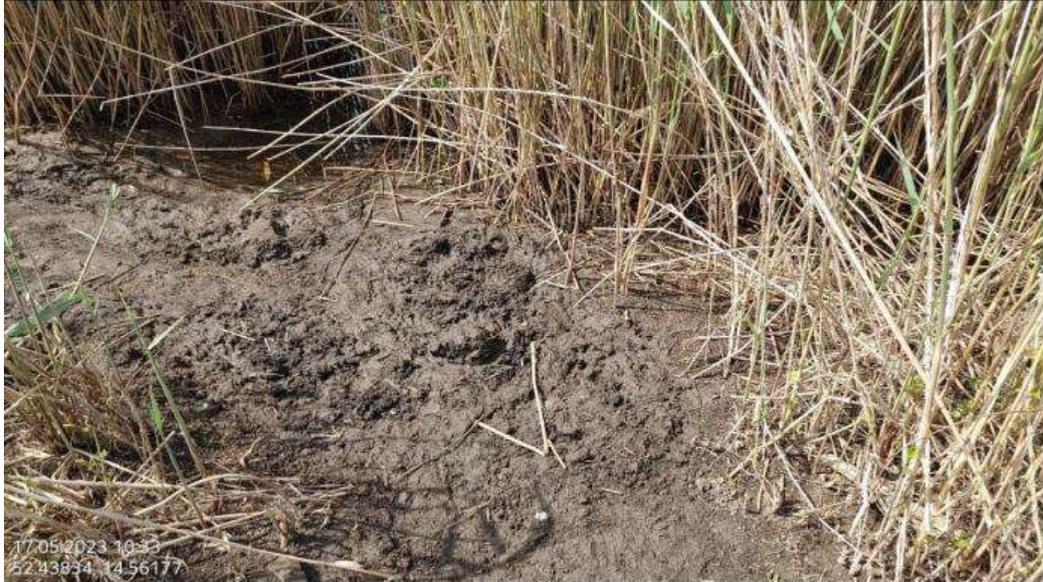
Photo 19 Examples of traces (scent mound) of the beaver *Castor fiber* in the vicinity of the Kunice dolphin site after the completion of the project

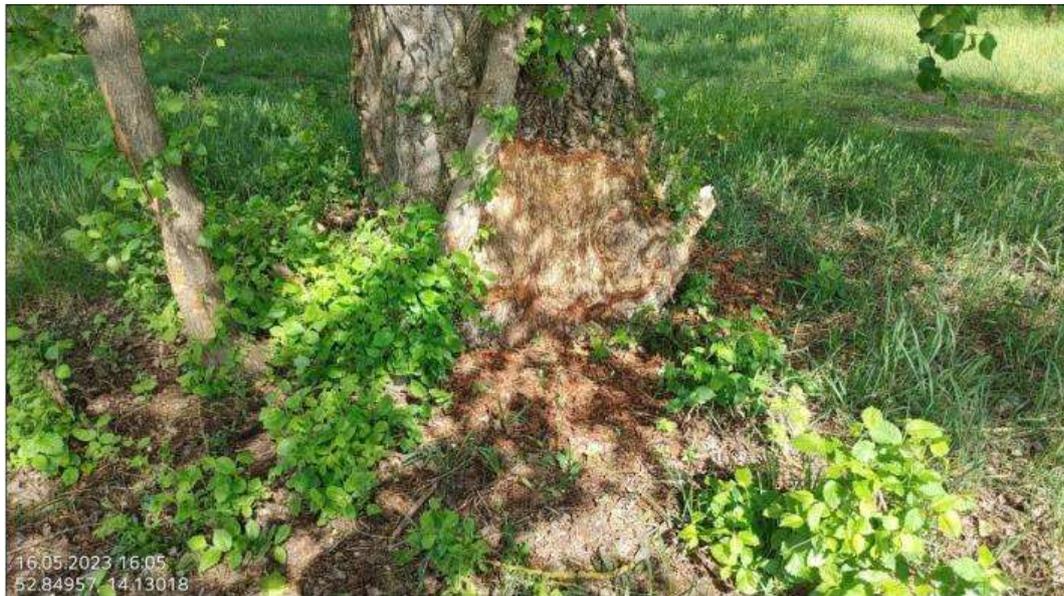
Photo 20 Examples of feeding traces (beaver bites) of the beaver *Castor fiber* in the vicinity of the Kunice dolphin site after the completion of the Osinów Dolny investment project
