**STATE COMMISSION ON RAILWAY ACCIDENT INVESTIGATION**  
**Ministry of the Interior and Administration**

**REPORT No. PKBWK 5/2024**

**on the investigation of a railway accident  
that occurred on 12 April 2022 at 09:22 hrs at Poznań Główny station  
at turnout no. 140 in track 51, at km -0.181 of railway line no. 351  
Poznań Główny - Szczecin Główny,  
the area the infrastructure manager PKP PLK S.A. Railway Line Plant in Poznań**

**WARSAW, 10 June 2024**

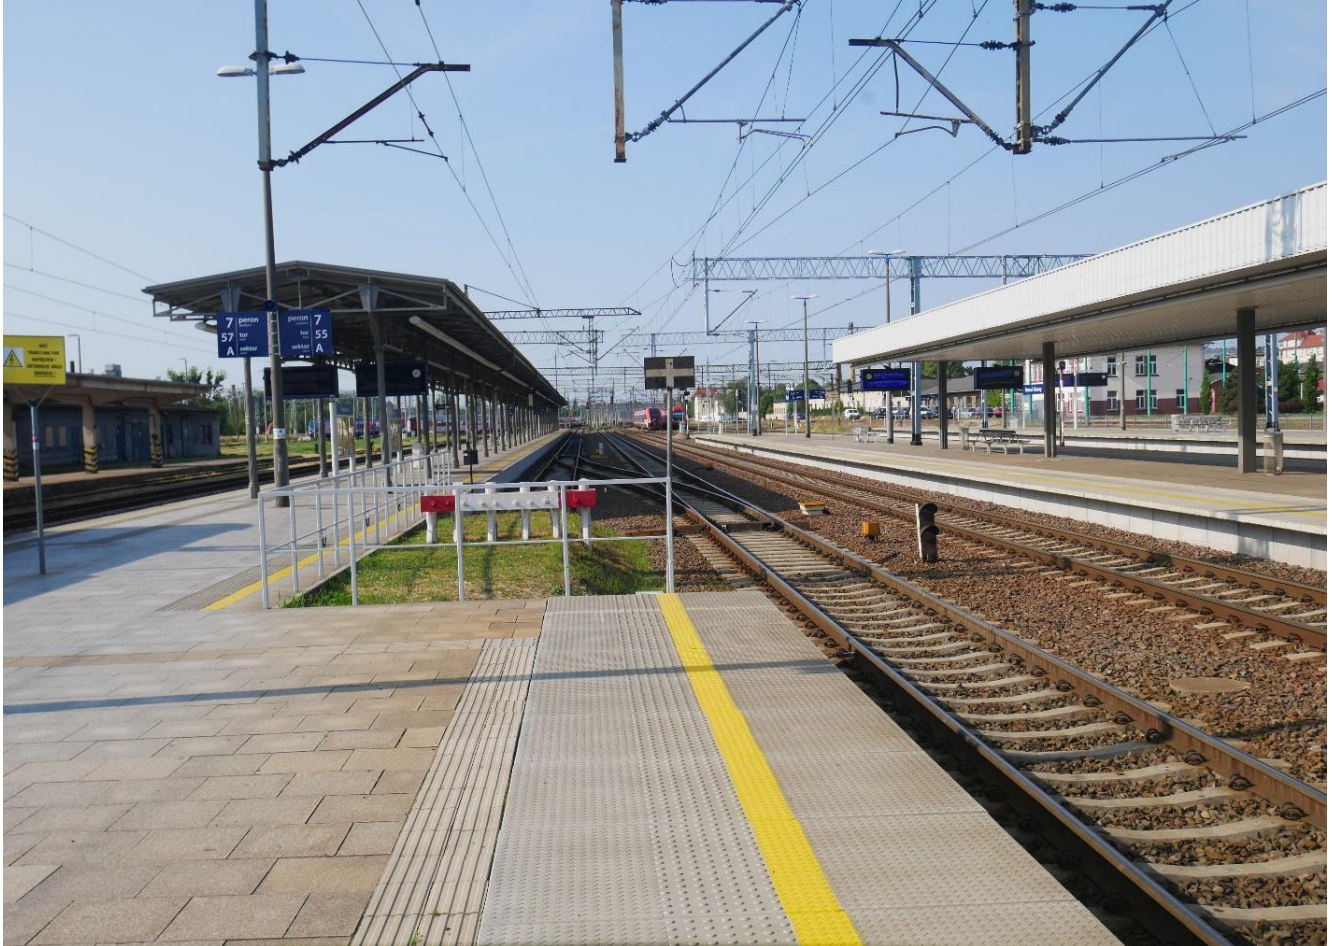
**Photograph 1 - A general view of the occurrence site (source: PKBWK's own material)**

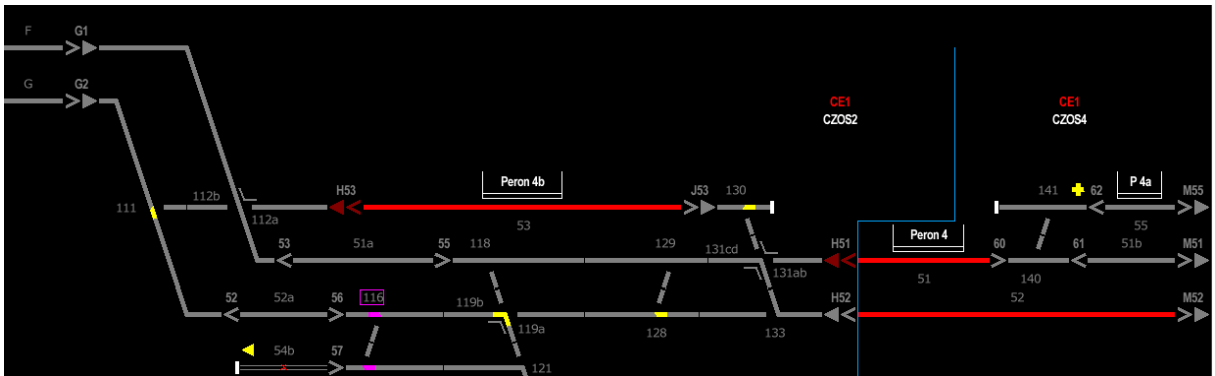
At 09:21:41 hrs, the "station C" signaller issued the special order "ZW" to release the route from Tm60 to signal M51 with the train proceeding at approximately 26 km/h.

Figure 5 - Released route, 09:21:41 hrs (source: Thales)

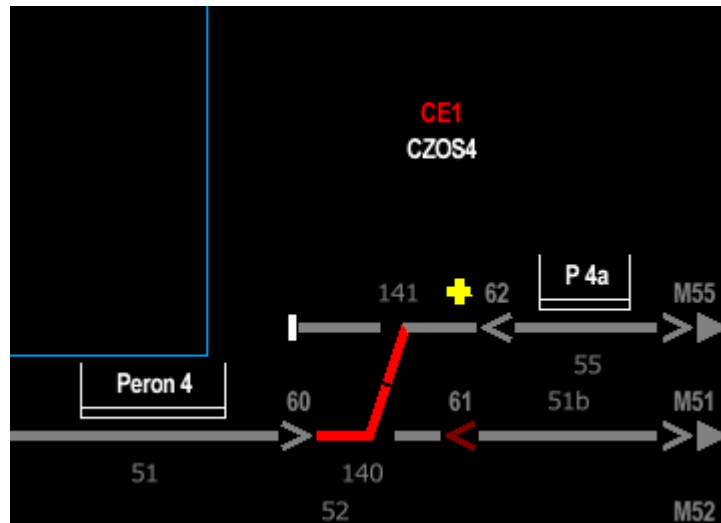
At 09:22:25 hrs, the train occupied switch isolation Iz140, i.e. it drove two axles of the first bogie onto the switch of turnout no. 140 directing straight ahead (plus (+) position) at the speed of 19 km/h.

**Figure 7 - Occupation of switch section IZ140/141 and release of track 51, 09:22:25 hrs (source: Thales)**

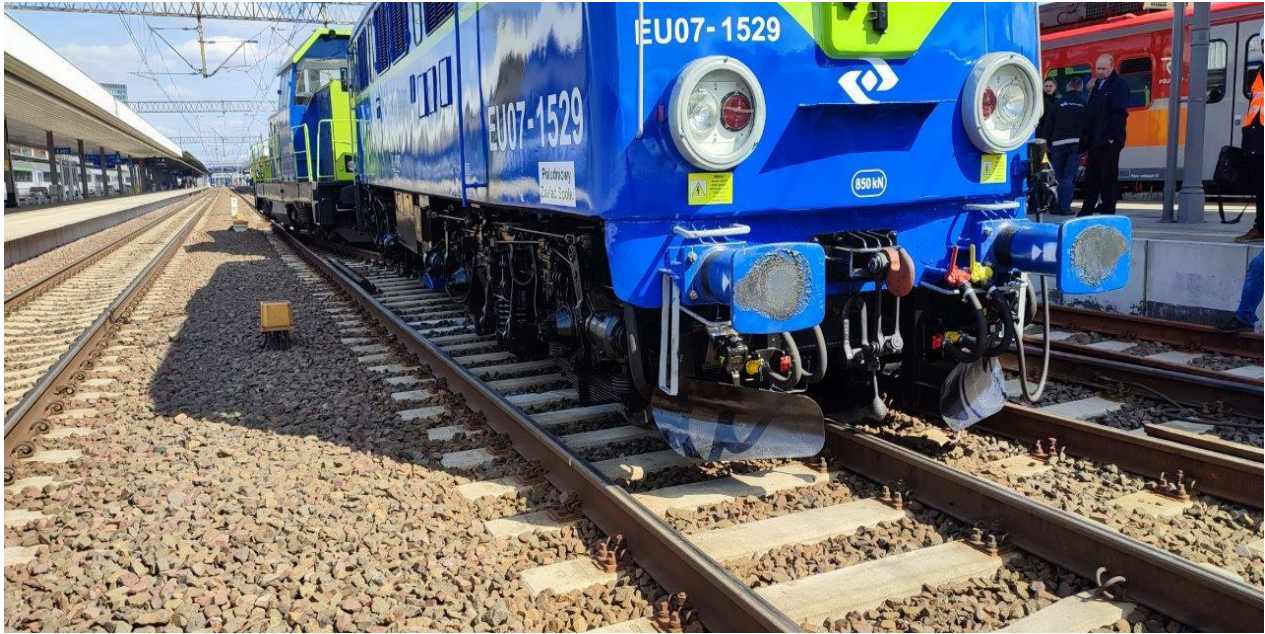
As a result of the derailment of locomotive EU07-1529 leading train THE 575001, the rolling surfaces of three wheelsets were damaged. The locomotive was sent for wheelset reprofiling. There was no other damage to the train set.

**Photograph 2 - A view of the train after the derailment (material provided by the railway commission)**

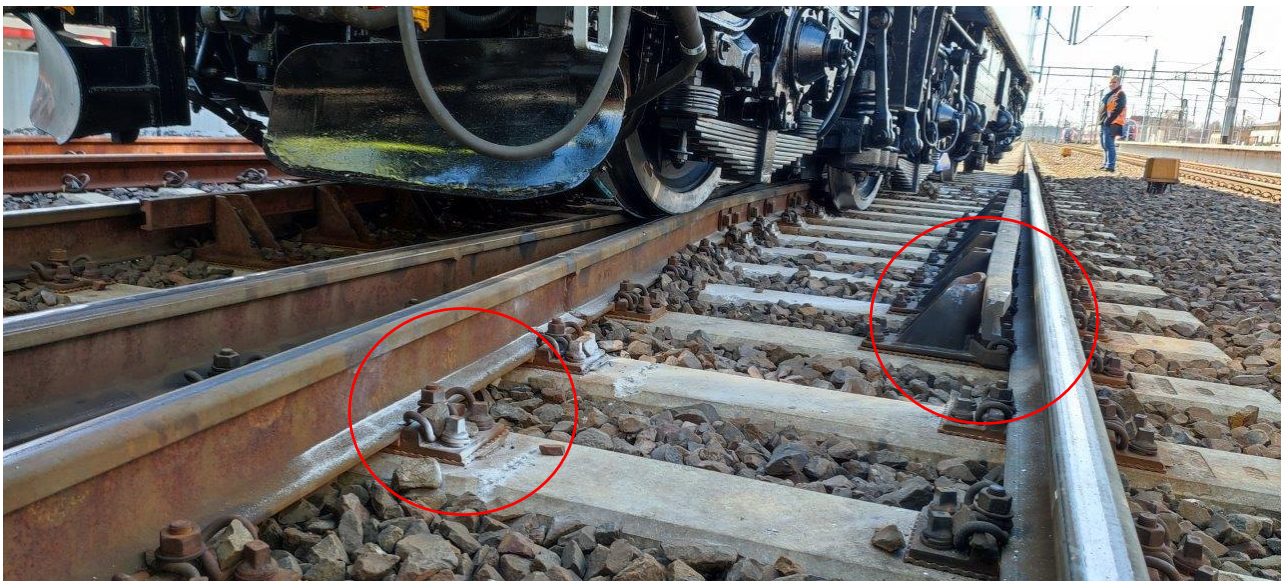
As a result of the double-tracking, the wheel-rail contact is lost and the right wheel of the second wheelset of the first bogie is derailed into the inside of the turnout. As a consequence of the derailment, the said wheel hits the right guide rail of the turnout and the first bogie is displaced to the inside of turnout no. 140. As a result of the impact on the guide rail, the locomotive bumps up violently, the bolt coupling is disconnected and the first wheel set of the second bogie falls inside the turnout, according to TELOC speed recorder at 09:22:35 hrs at the speed of 6.5 km/h. The second wheelset of the second bogie of the first locomotive did not derail. The second locomotive did not derail because it entered the already switched switch of turnout no. 140. Locomotive EU07-1529 travelled approximately 19 m in the derailed state. As a result of the derailment, the bolt coupling between the locomotives was disconnected and they were only connected by the brake coupling.

**Photograph 3 - Traces of the derailed first wheelset of the second bogie (material provided by the railway commission)**

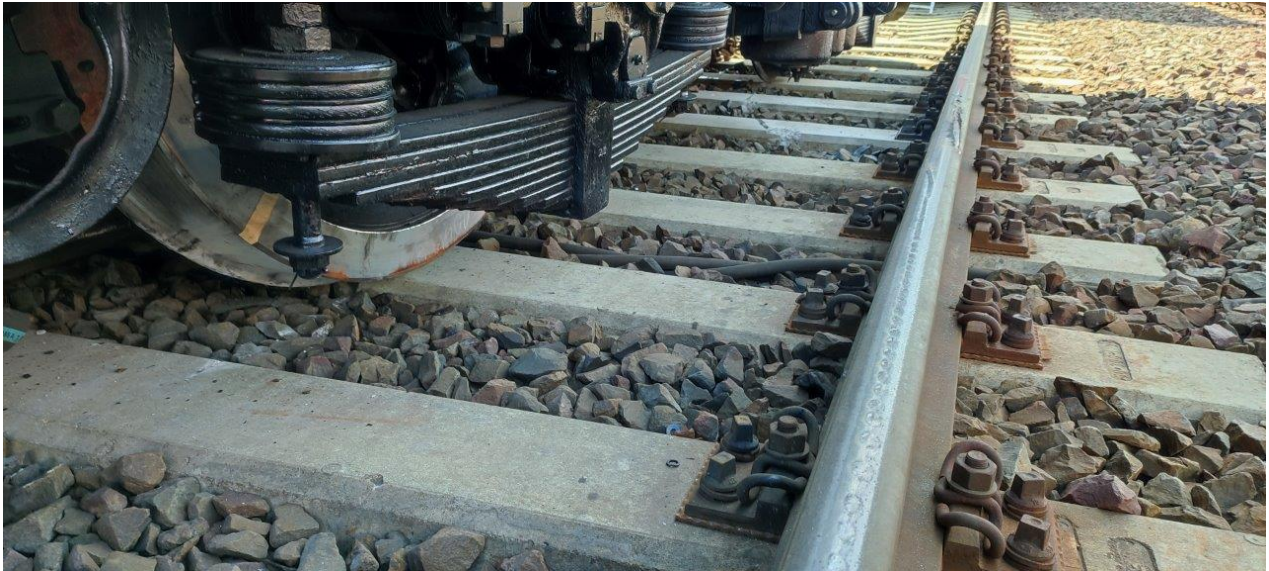
The half switch of turnout no. 140, the wheel detector and 35 alloy bolts were damaged.

**Photograph 4 - The place of derailment of the first wheelset of the first bogie (material provided by the railway commission)**

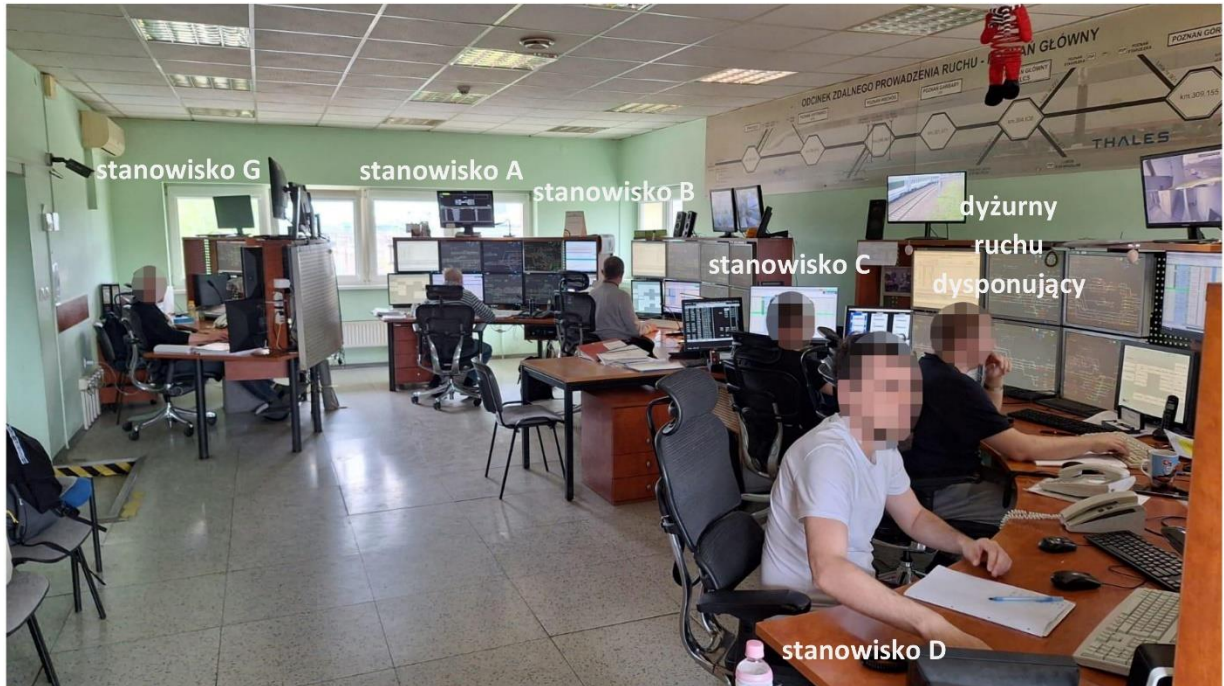
**Photograph 5 - The control room of the PoA command box**

The ergonomics of the signaller workstations at the PoA command box is inappropriate.

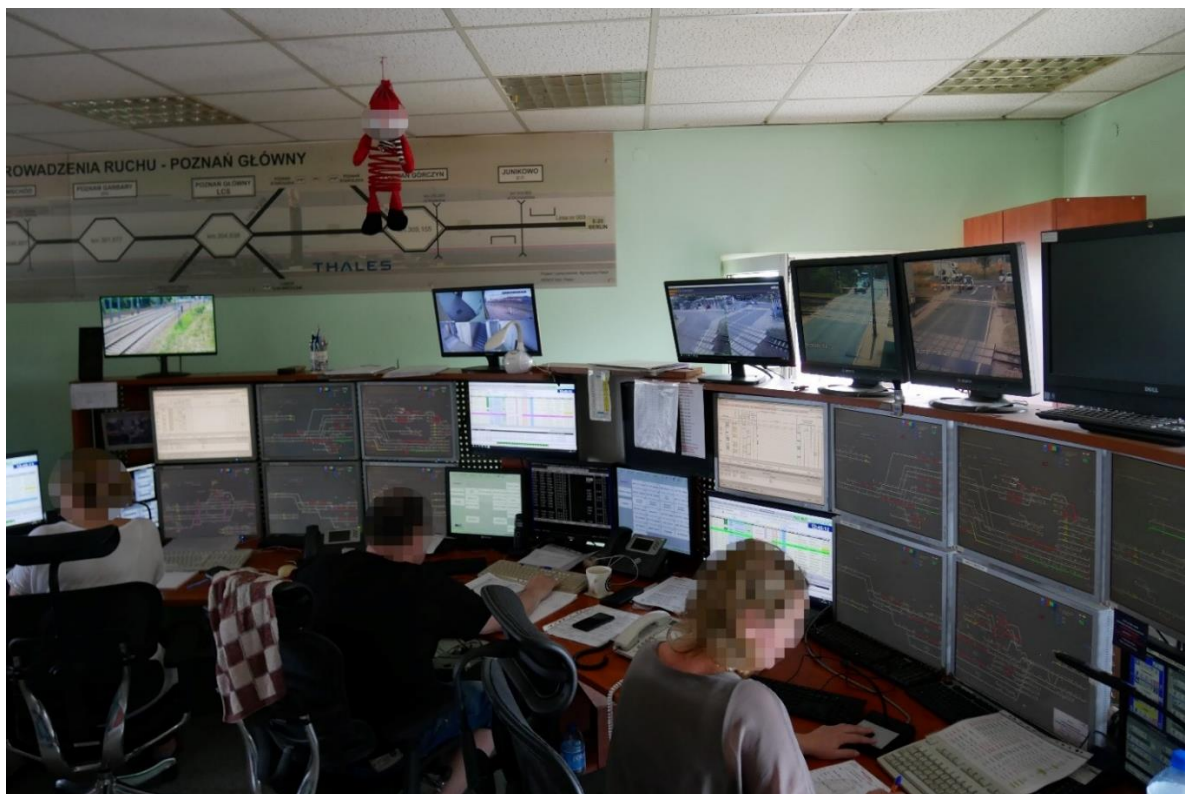
**Photograph 6 - Operator stations of signallers C and D, and operating station of the dispatcher**

The PoA command box room is constantly occupied by six employees who operate train movements and shunting in the assigned sections. Due to the lack of workstation separation, the employees are exposed to noise and distraction. Continuous twelve-hour shift work in such conditions compromises the working comfort, which may lead to a threat to the safety of train traffic.

- 8) PKP PLK S.A. IZ Poznań shall take actions to rectify the irregularities referred to in Point 3.4 of Chapter IV, i.e. to improve the ergonomics of the workstations of signallers at the CTC signal box of Poznań Główny station.
- 9) Authorised infrastructure managers shall include in the Hazard Record the hazard associated with inappropriate ergonomics of signaller duty stations. In addition, they shall verify the ergonomics of signaller duty stations where several duty stations are located in close proximity in the same room; and if any irregularities are detected, they shall take actions to improve the working conditions of signallers.
