**STATE COMMISSION ON RAILWAY ACCIDENT INVESTIGATION**  
**Ministry of the Interior and Administration**

**REPORT No. PKBWK 01/2024**

**on the investigation of a railway accident  
that occurred on 19 January 2023 at 18:37 hrs  
on the Szczecin Podjuchy – Szczecin Port Centralny SPA route,  
km 349.520 of track no. 1, railway line no. 273 Wrocław Główny – Szczecin Główny,  
the area of infrastructure manager PKP PLK S.A. Railway Line Plant in Szczecin**

**WARSAW, 16 January 2024**

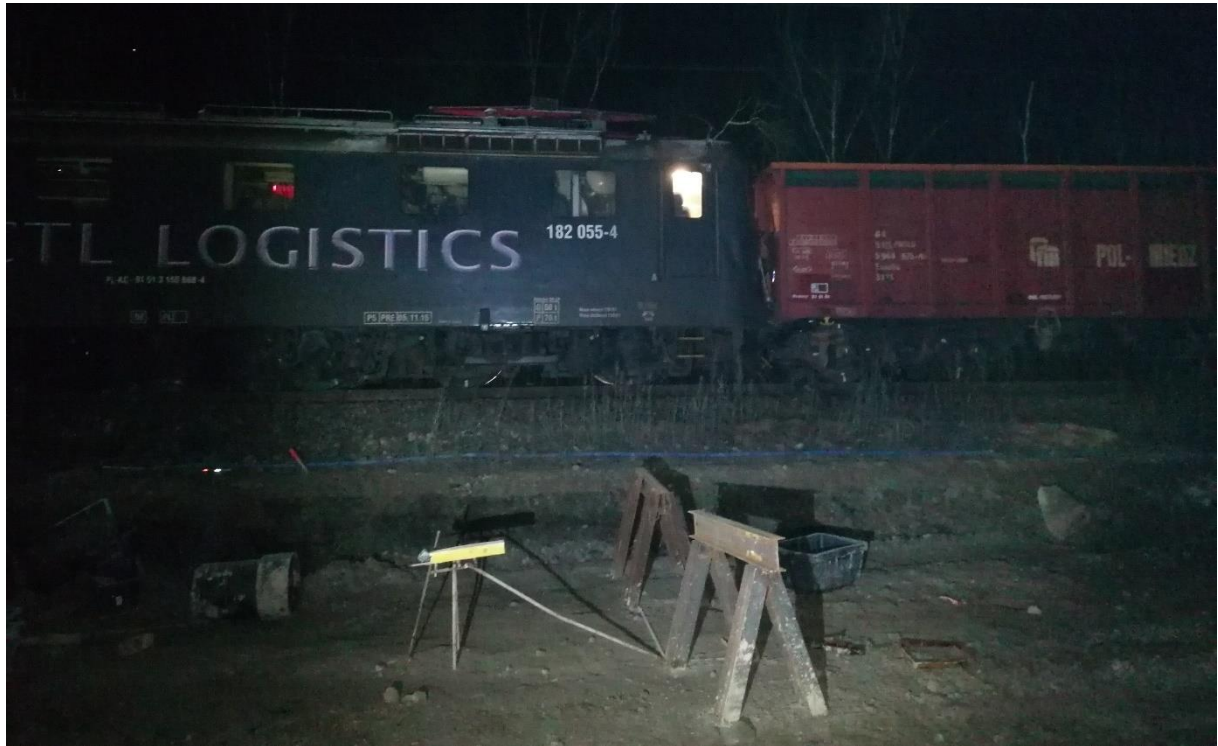
Photograph 1. A view of the occurrence site (source: the railway commission)

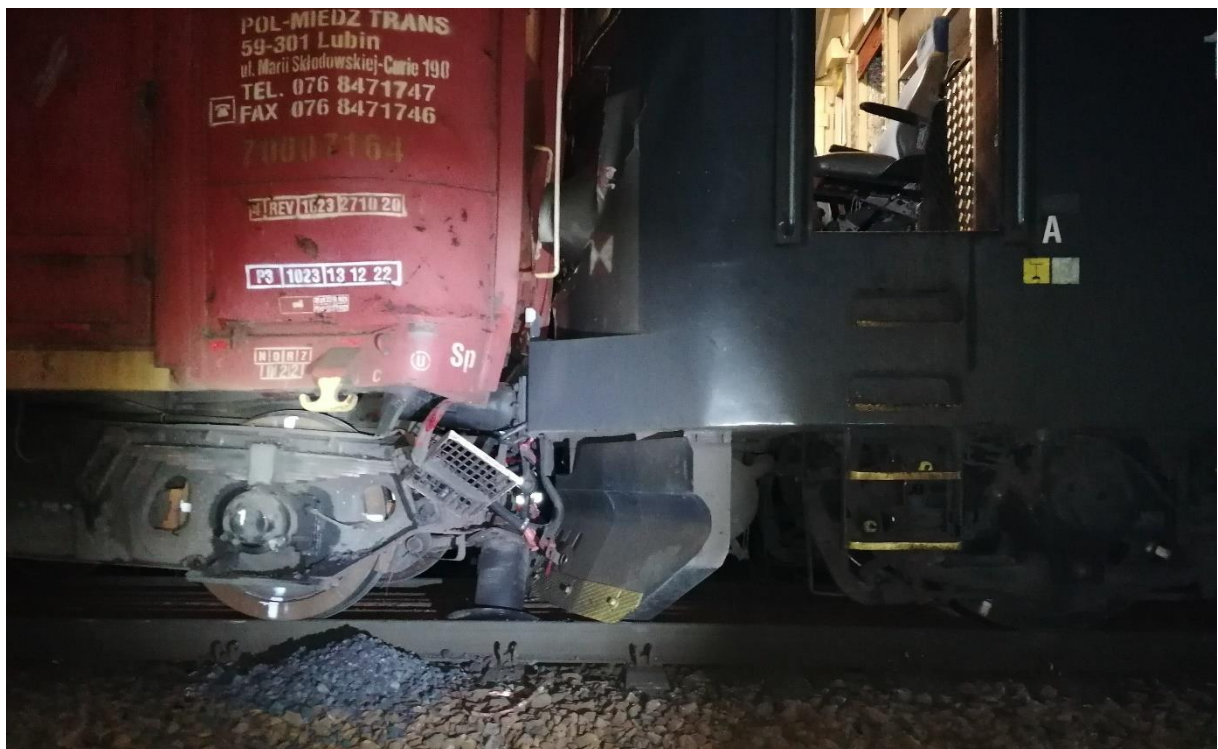
Photograph 2. A view of the effects of the occurrence (source: the railway commission)

As a result of train LTE 785009 running into the last wagon of train TME 684013, the E182 055-4 locomotive was damaged. Damaged were *inter alia* the head wall of Cabin A (the central part at the headlights was indented to the inside of the vehicle), both buffer devices, the draw device, the skin of the front beam, bogie pivots and steps on the head of the cabin together with their mounting.

The damage to the Eamos 84 51 5944 675 4 wagon of train TME 684013 included both buffer devices (the left buffer was knocked into the wagon), the solebar, the end sill, the draw device. Furthermore, there was damage to the lower part of the head wall and a section of the left side wall connected directly with the head wall. Additionally, the shunting step and its mounting were damaged.

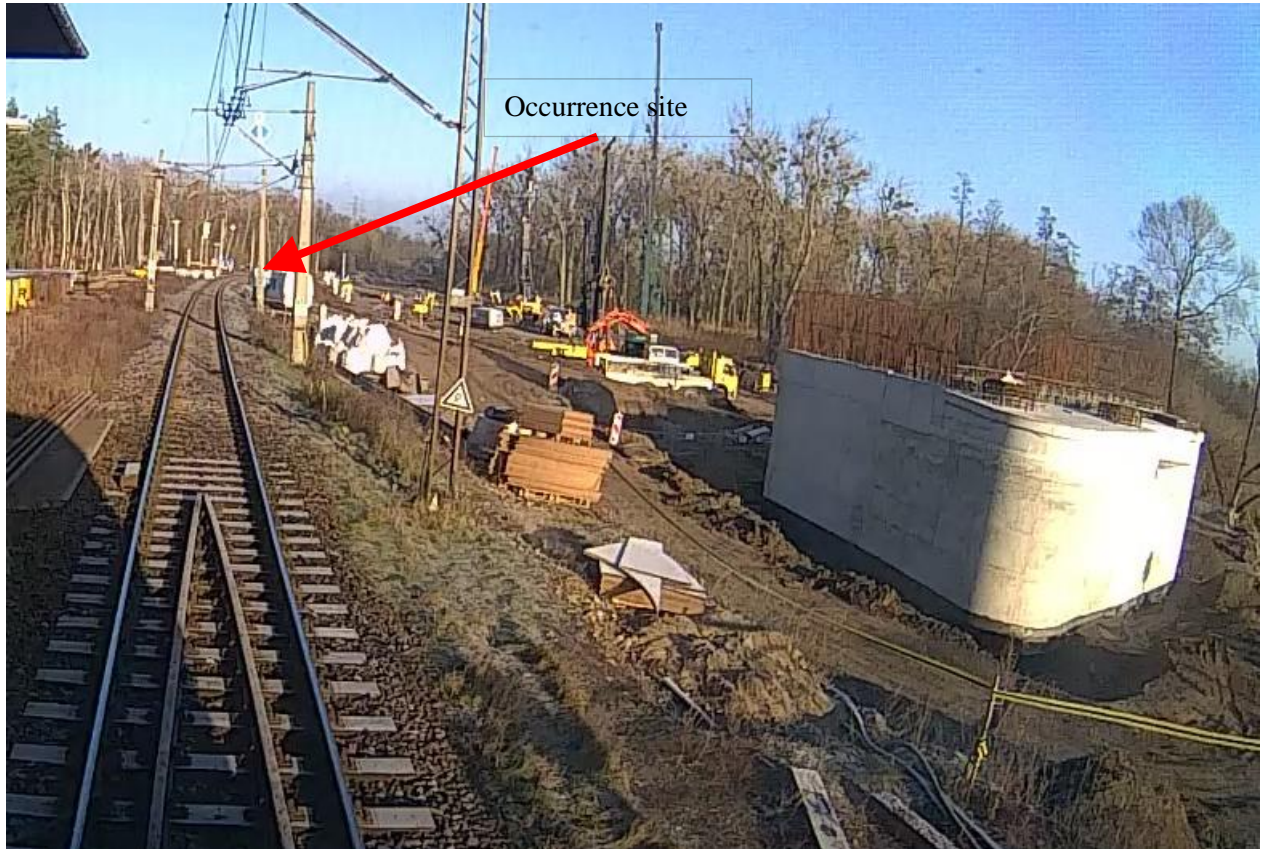
A view of the railway route and the adjacent construction site is show in Photograph 3.

Photograph 3. A general view of the route and the site of the occurrence as seen from the driver cabin in daylight on 19 January 2023. Visible is the construction site whose illumination at nighttime hindered observation of the route by the driver of the rail vehicle (materials of the railway commission).

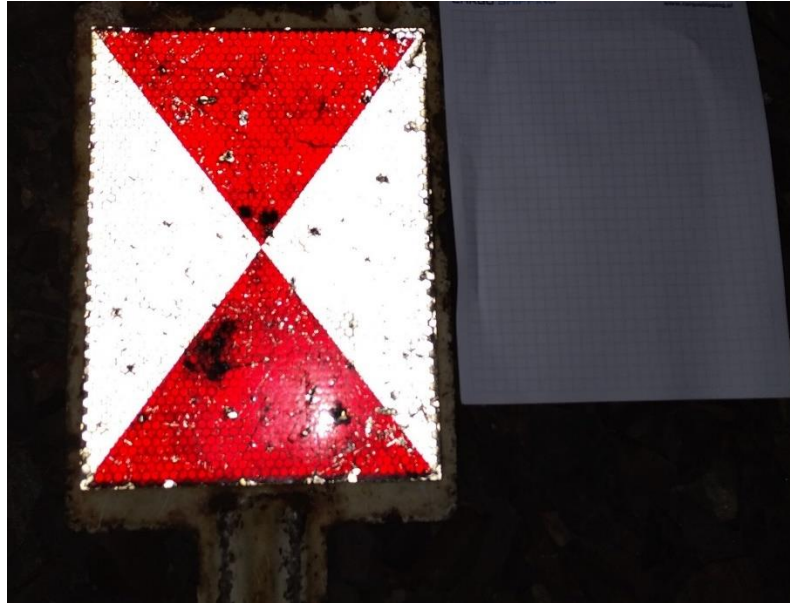
The last wagon of train TME 674013 had train end signals used on German railways, as shown in Photograph 4.

Photograph 4. The train end signal used on train TME 684013 (next to it is a non-reflective sheet of white paper for comparison)

The investigation Team considered that restricted ability to monitor the route on the part of the driver of the CTL Logistics E182-055 locomotive was a contributing factor due to the curve of the track and illumination of the construction site adjacent to the plain track which caused dazzling after clearing the bridge and reduced visibility of reflective signals of the end of the rain on the track. The train end signals used are shown in Photograph 4.

The Pc-5 train end signal disks affixed to the last wagon of train TME 674013 did not meet the requirements laid down in "Technical requirements for indicators and signal disks Ie-102".

- 6) In order to ensure good visibility of the return reflection from Pc 5 signal disks (day) on curves, the railway carriers shall implement the obligation to use Pc 5 signal disks "Marking of the end of a train or another rail vehicle" in accordance with the technical requirements laid down in Part II of Instruction Ie-102 "Technical requirements for indicators and signal discs" on freight trains operating on railway lines managed by PKP Polskie Linie Kolejowe S.A.

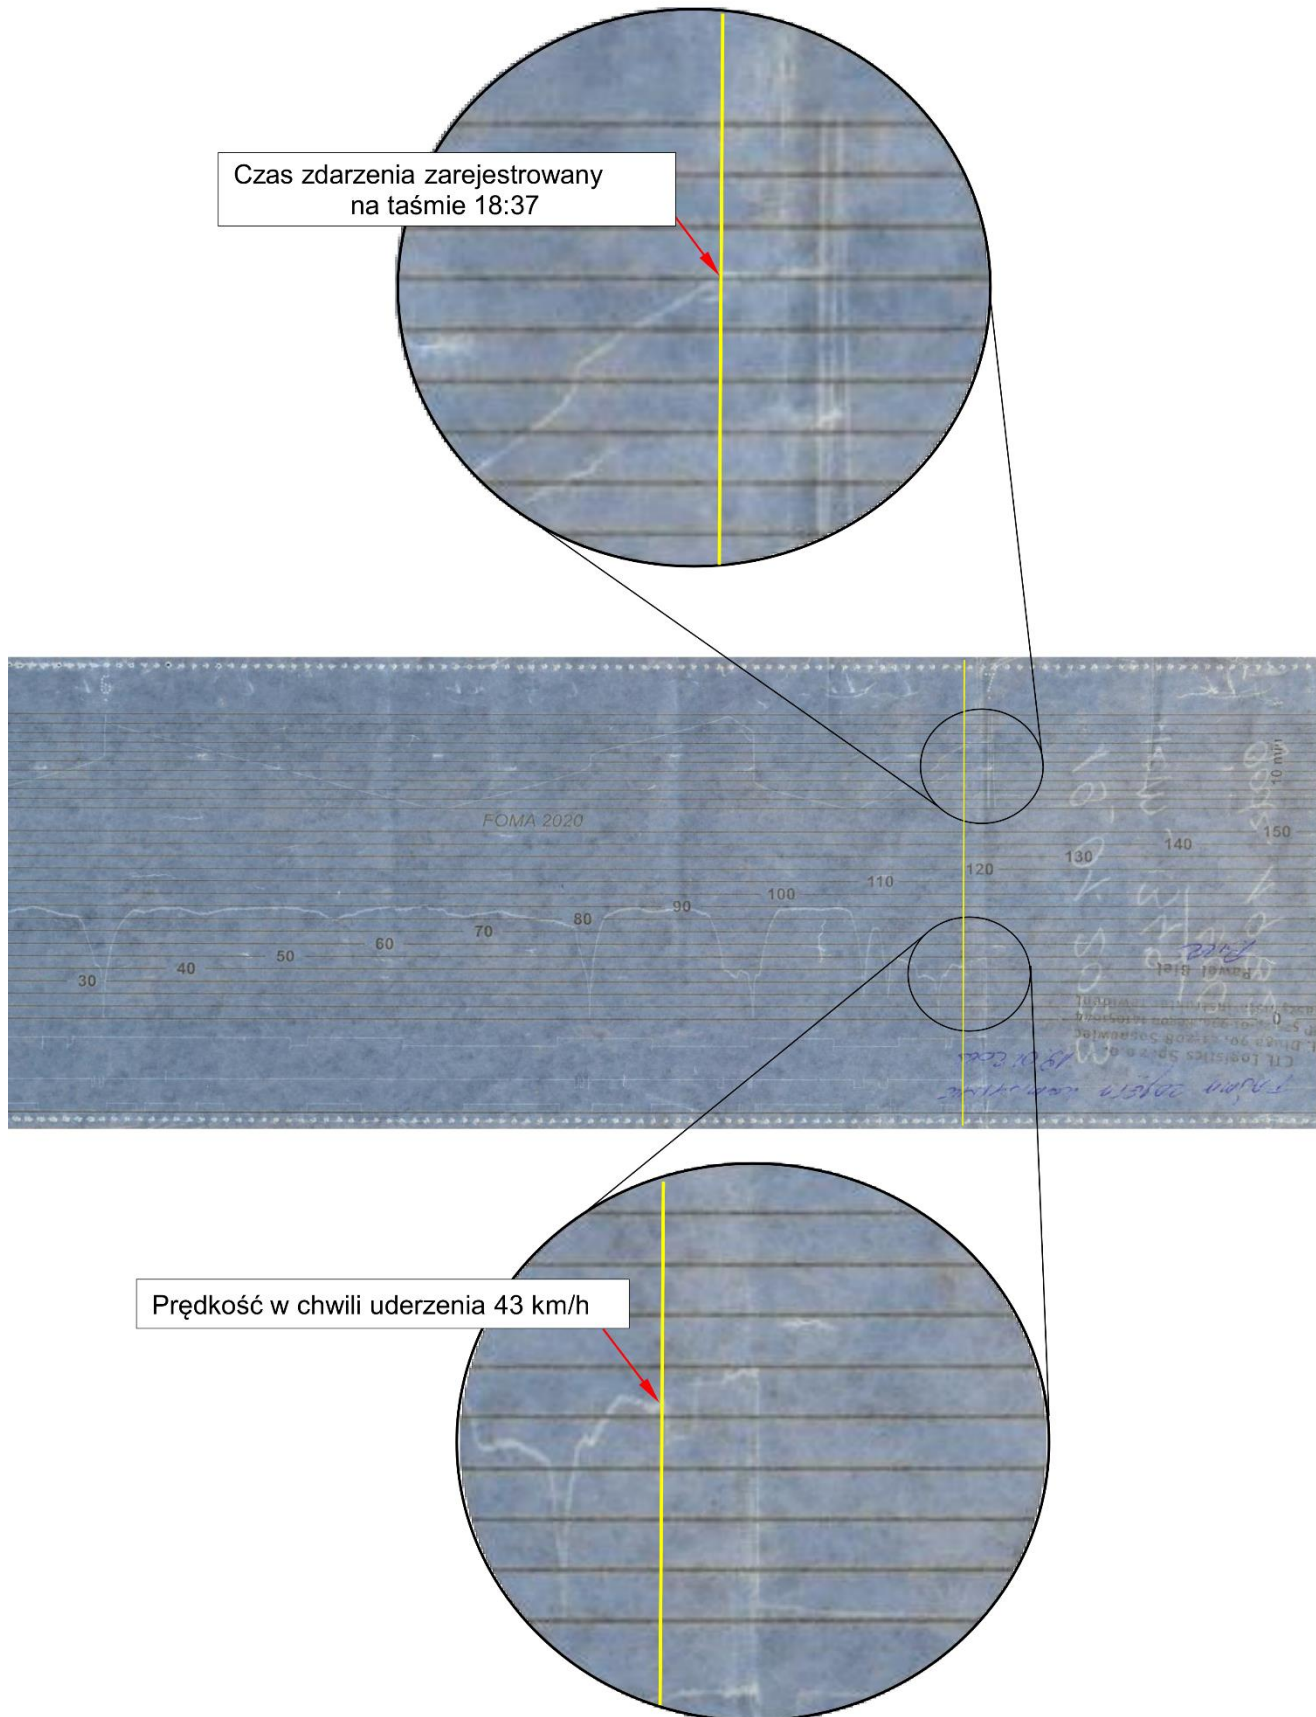
The time recorded on the tape is inconsistent with the actual time – it is shifted by 12 hours.

Photograph 5. A scan of the speedometer tape from the E182 - 055 loc. (prepared by PKBWK)

- 7) Railway carrier CTL Logistics Sp. z o.o. shall ensure supervision of the correct setting of the real time in traction vehicle recorders.
- 8) The infrastructure managers shall procure that works contractors eliminate visibility of sources of light illuminating their construction sites in the area of active railway tracks which dazzle drivers of rail vehicles.

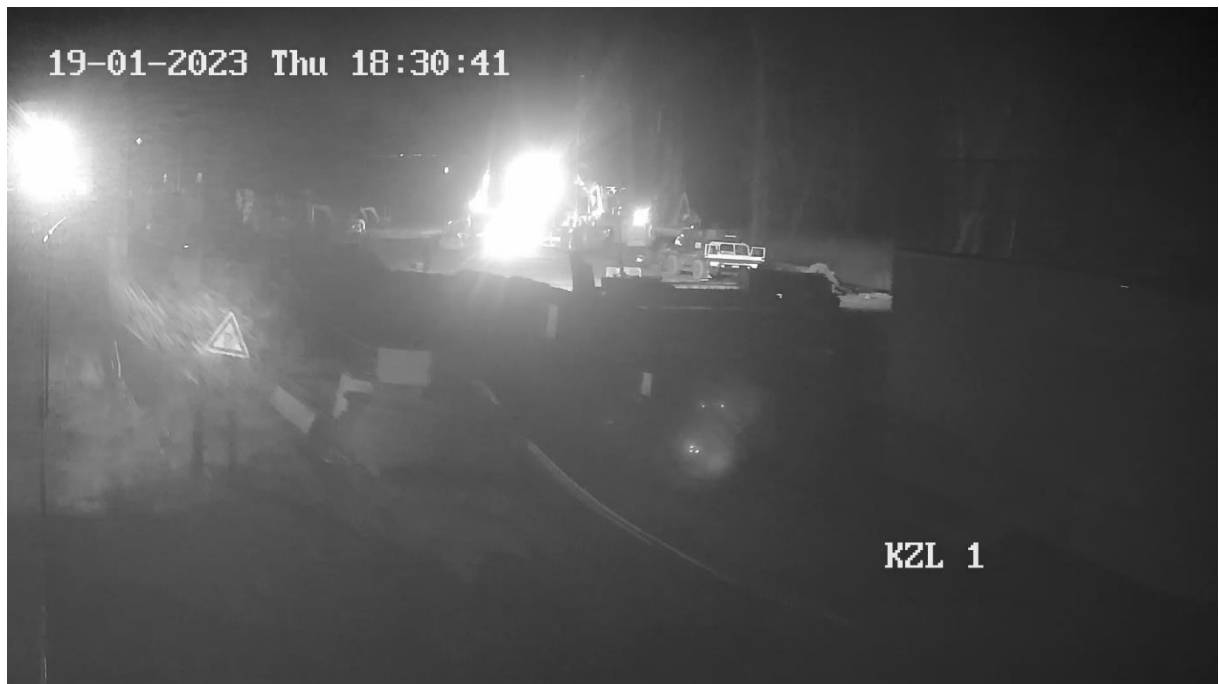
Photograph 6. A general view of the route immediately after clearing the bridge over the Regalica River (a frame from the footage recorded by the rear right mirror camera of the locomotive of train TME 684013)

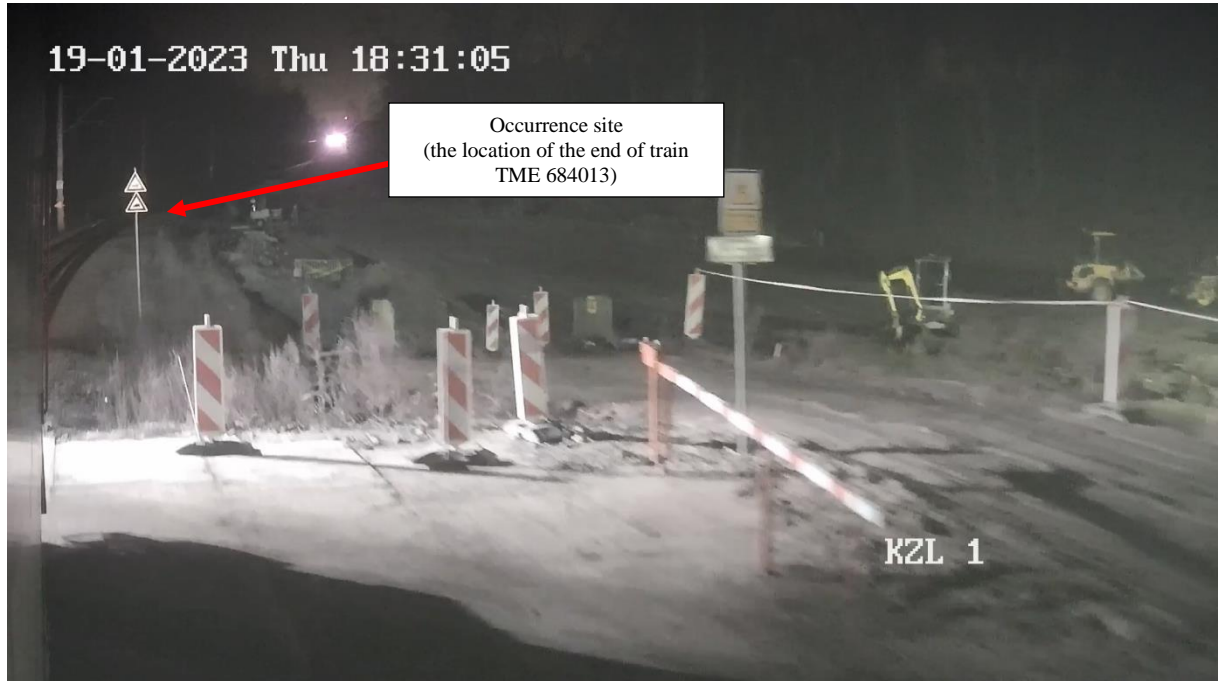
Photograph 7. A view from around 100 m ahead of the occurrence site (a frame from the footage recorded by the rear mirror camera of the locomotive in train TME 684013)
