**STATE COMMISSION ON RAILWAY ACCIDENT INVESTIGATION**  
**Ministry of Interior and Administration**

**REPORT No. PKBWK 03/2023**

**on the investigation of the railway accident  
that occurred on November 3, 2022 at 18:45  
at Krzcięcice passenger stop on track no. 2, at km 244.636  
railway line no. 8 Warszawa Zachodnia - Kraków Główny  
area of the infrastructure manager PKP PLK S.A. Railway Line Department in Kielce**

**WARSAW, September 7, 2023.**

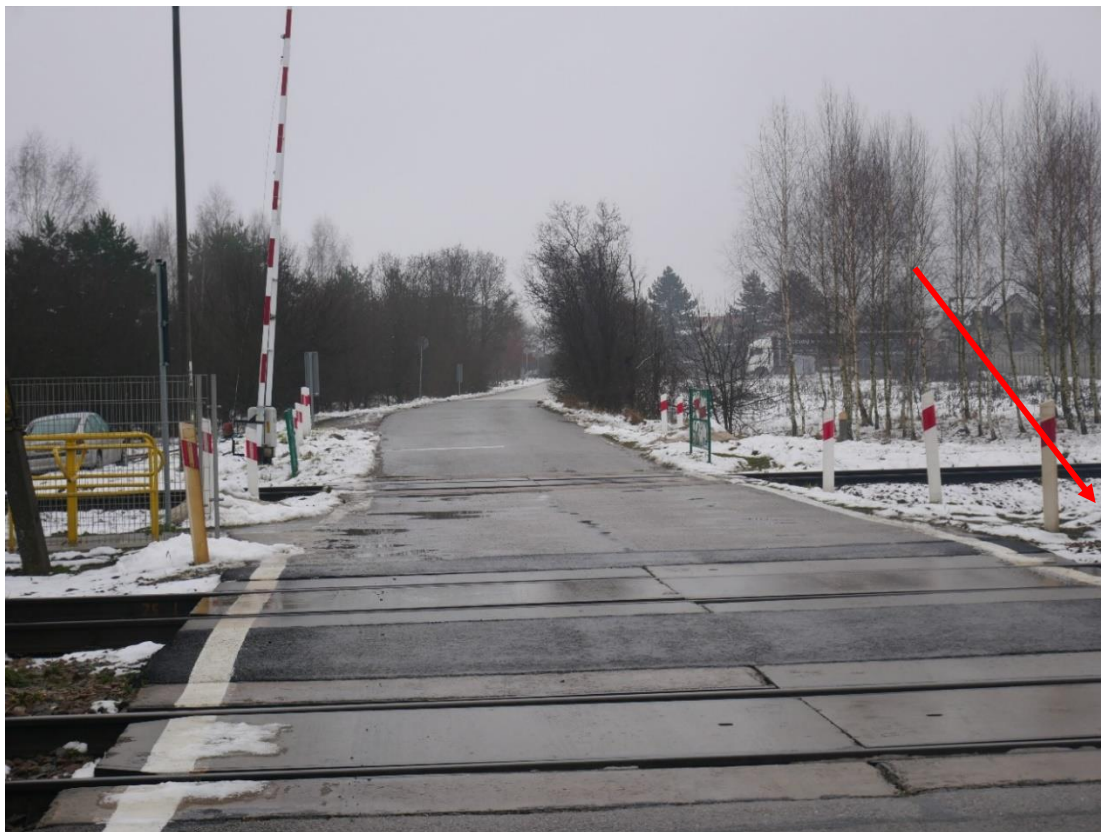
**Photo 1 - Site of the occurrence during daylight hours (PKBWK's own material).**

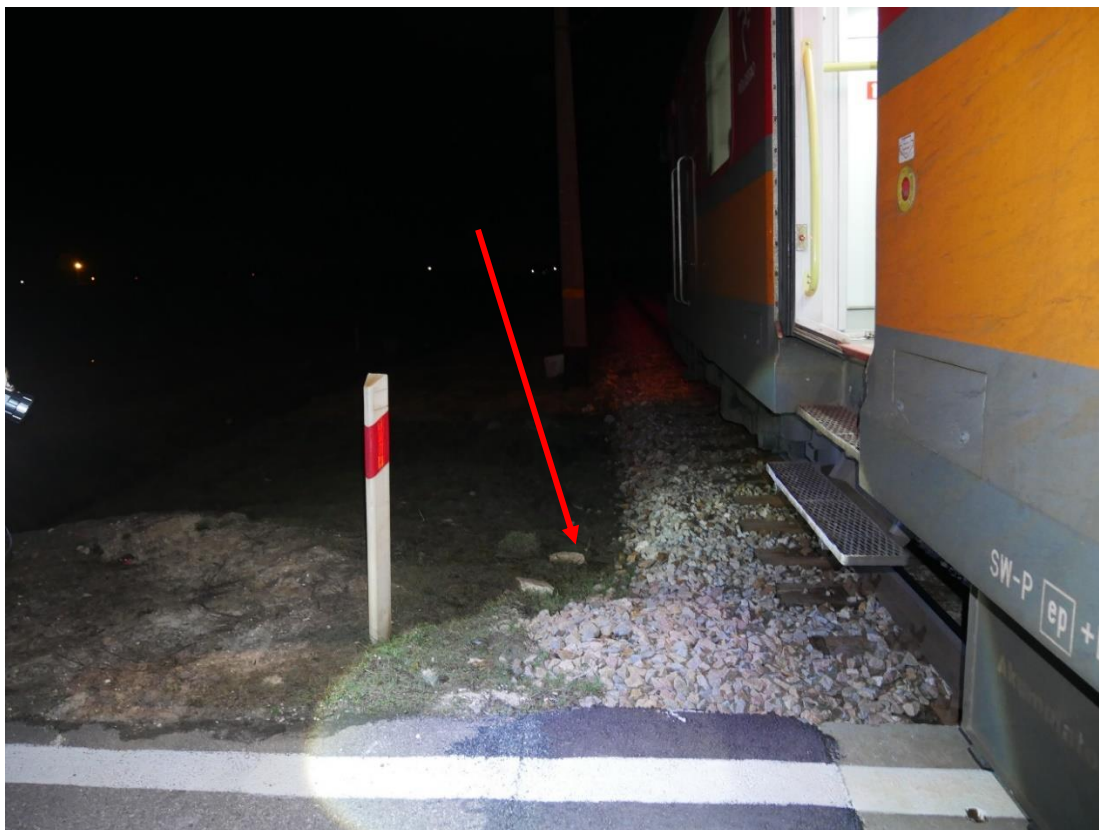
Photo 4 - The site of the occurrence at night (PKBWK's own material).

Photo 5 - The site of the occurrence at night with handheld flashlight illumination by the Investigation Team (PKBWK's own material).

The category A level crossing at km 244.630, to which the exit from platform 2 is directly adjacent, is operated by the traffic controller of Krzcięcice "Kr" block post. The 33 m long level crossing crosses two railway lines: No. 8 (double-track) and No. 65 (single-track), on which there are two traffic lights, which is not in accordance with §88 of the Regulation of the Minister of Infrastructure and Development of October 20, 2015 on the technical conditions to be met by intersections of railways and railway sidings with roads and their location (*Journal of Laws, item 1744*), which states: "*The number of light points shall be determined depending on the length and width of the railway crossing or road crossing, taking into account the values of illuminance and uniformity of illumination according to the standard EN 12464-2 Light and illumination.*" The underexposure of the site is shown in photos 4 and 5.

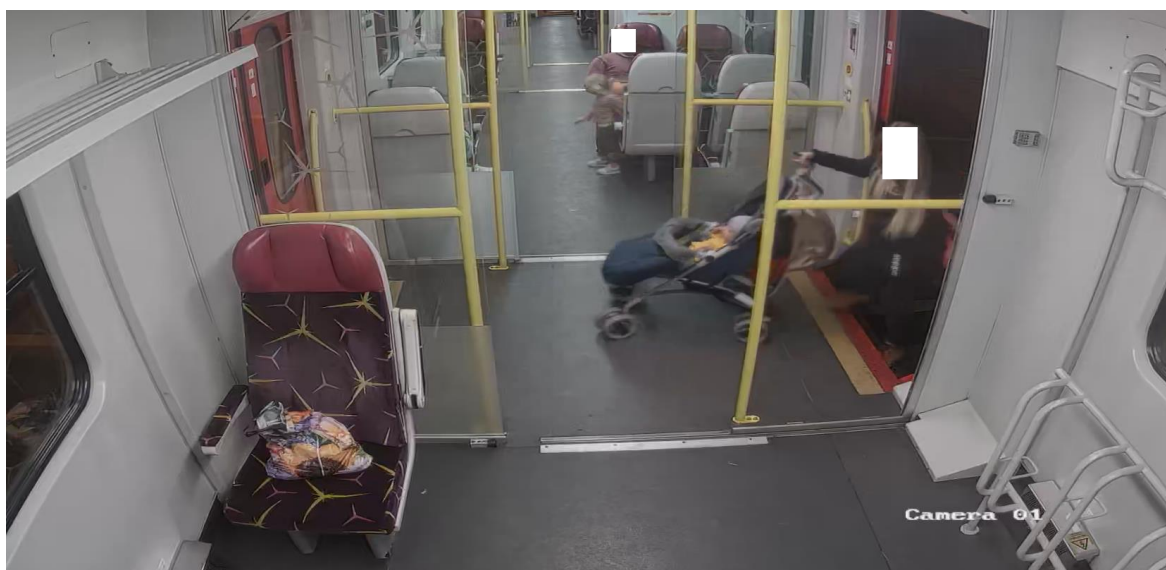
Photo 6 - Recorded image of a traveler getting off the train (vehicle monitoring)

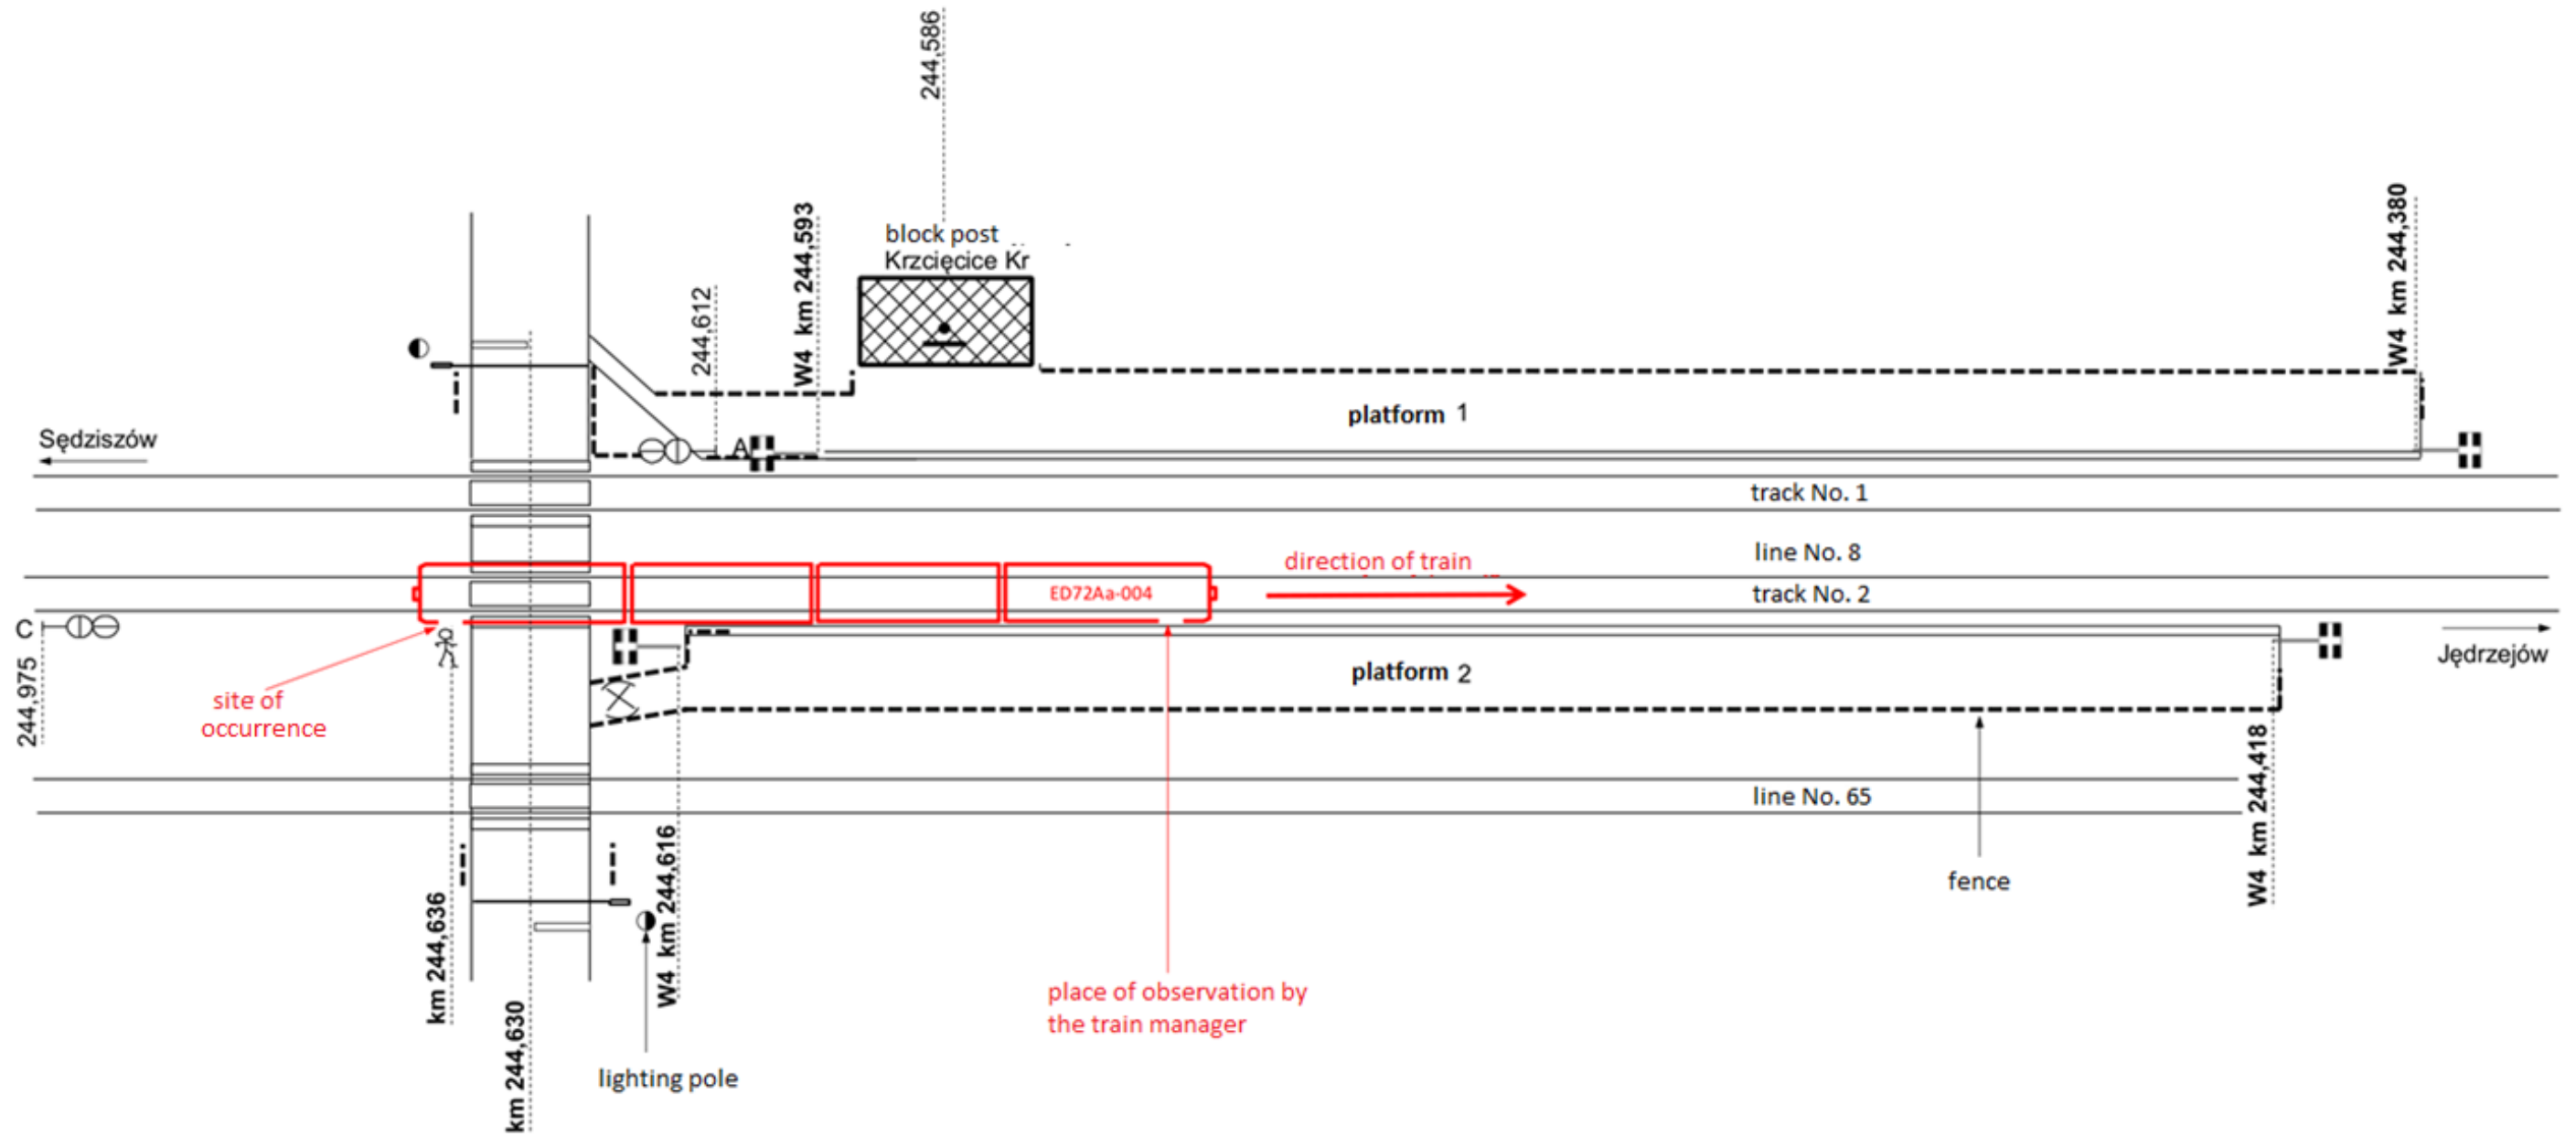
Figure 2 - Sketch of the accident

The driver's improper stopping of the front end of the 87-meter-long MOJ 32318/9 train and the failure of the train dispatcher to react to the improper stopping of the front end of the train and the location of the fourth section of the train set outside the platform were considered by the Investigation Team to be causal factors and contributed to the occurrence of the accident. and contributing to the occurrence of the accident.

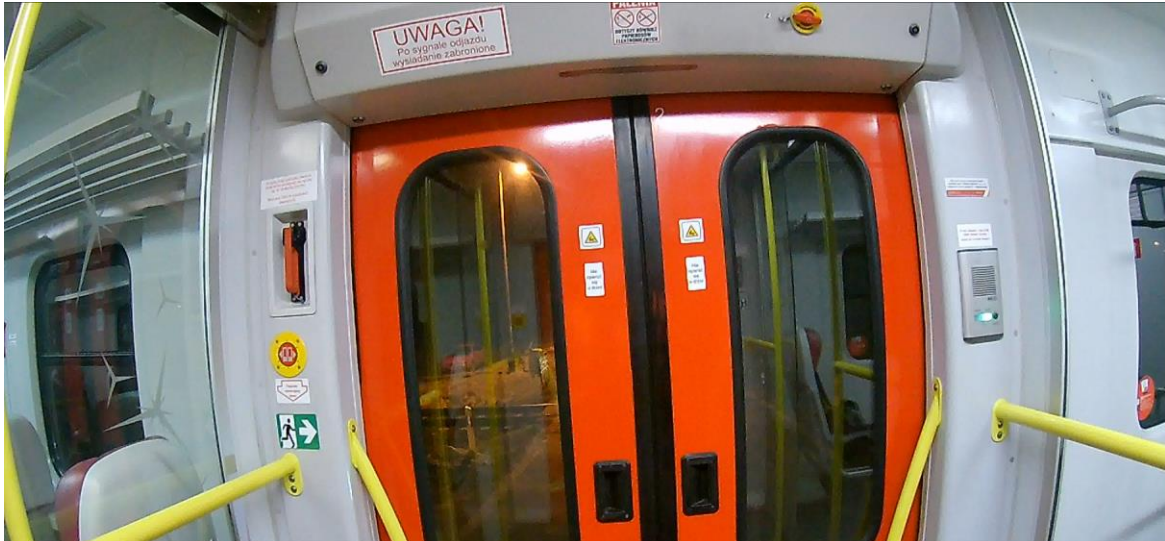
RU POLREGIO S.A., which supplies the rolling stock, is responsible for its efficiency, technical condition and compliance with the vehicle maintenance process. The electric multiple unit ED72Aa-004 had a railway vehicle type certificate and a current technical efficiency certificate. RU provided documentation of the last technical inspections of the rolling stock. The Investigation Team did not find any irregularities in the maintenance of the rolling stock. The technical condition of the rolling stock had no influence on the accident. However, the Investigation Team found that the internal devices for communication between the passenger and the train crew were inadequately described and the rules for their use were unclear to passengers. In addition, these devices come in different configurations and are installed in different locations, which confuses passengers.

Photo 7 - View from inside the vehicle of the installed intercom at the front door (vehicle monitoring).

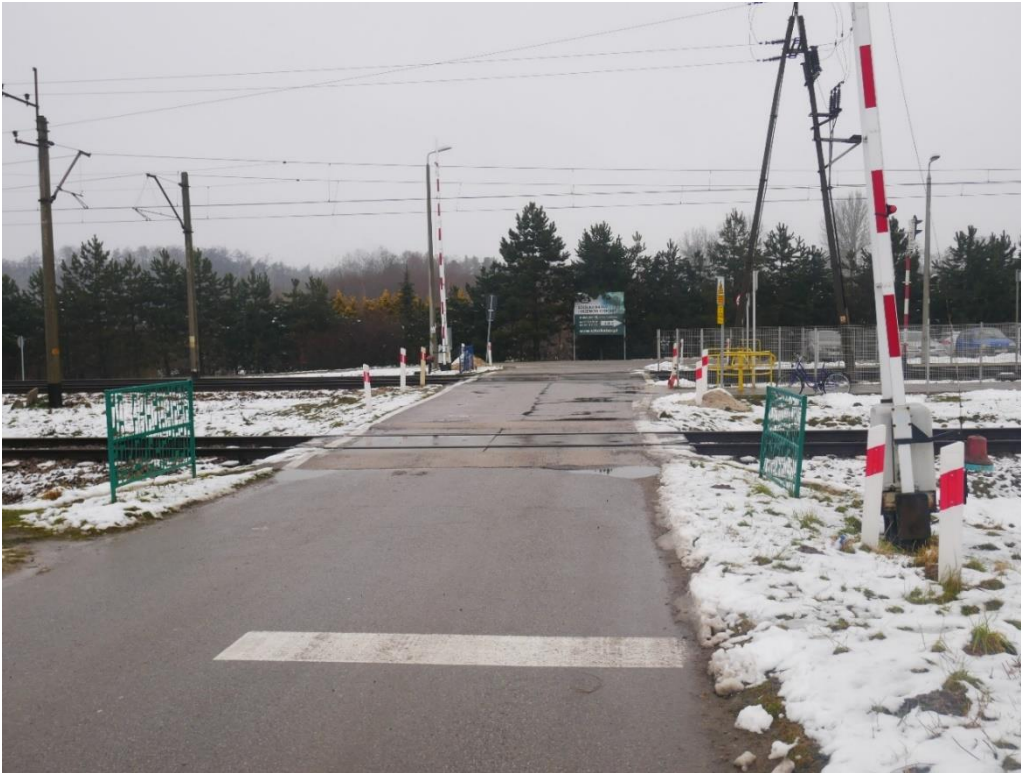
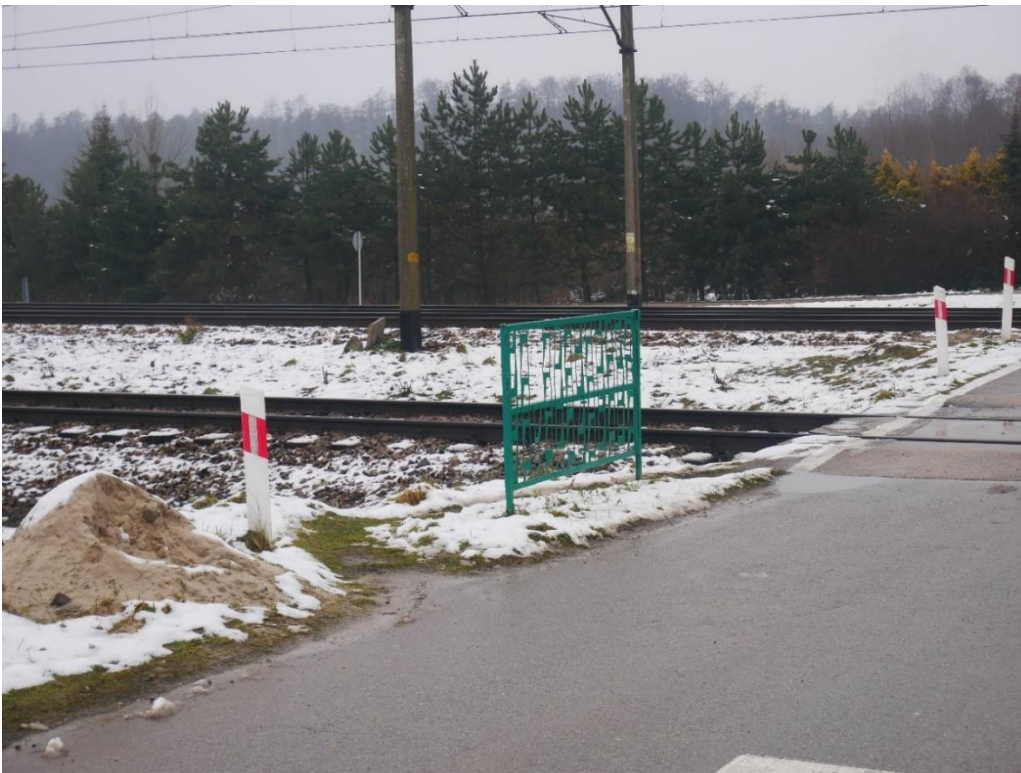
1. *At a cat. A level crossing with a length of 33 m, which crosses two railroads: no. 8 (double-track) at km 244.630 and no. 65 (single-track) at km 311.347; two light points are installed, which is not in accordance with § Article 88 of the Regulation of the Minister of Infrastructure and Development of October 20, 2015, on the technical conditions to be met by crossings of railway lines and railway sidings with roads and their location (Journal of Laws, No. 1744), which states "The number of lighting points shall be determined depending on the length and width of the railway crossing or road crossing, taking into account the values of illuminance and uniformity of illumination in accordance with PN-EN 12464-2 Light and Illumination".*

2. *Unnecessary absolute stop lines P12 at the Cat A crossing at km 244.630.*
3. *The fencing of the cat. A crossing km 244.630 inconsistent with Regulation of the Minister of Infrastructure and Development of October 20, 2015, on the technical conditions to be met by intersections of railway lines and railway sidings with roads and their location (Journal of Laws, item 1744), which states The sections between the track and the horns shall be separated by handrails preventing access to the track bypassing the horns, if the location of the horns allows it. The ends of the handrails closest to the track shall be located 3 m from the outermost rail.*

Photo 9 - View of the Cat A crossing km 244.630 with fencing (PKBWK's own material).

Photo 10 - View of the Cat A crossing km 244.630 with fencing (PKBWK's own material).

The above anomalies affect the safety of passengers using the platform and the safety of users of the crossing. These irregularities may contribute to the occurrence of occurrences and accidents involving travelers. The study team sees the need to eliminate them.

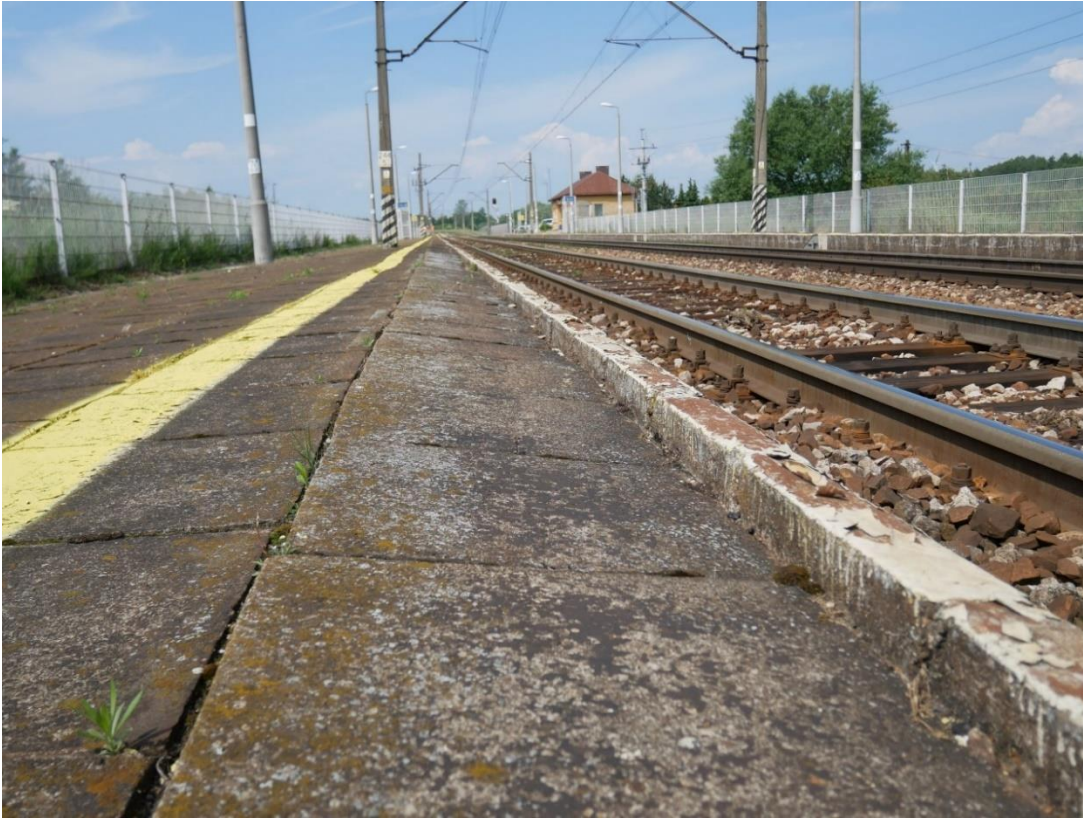
- Platform 2, which is made of paving slabs, has unevenness that is a difficulty when boarding and alighting travelers.

**Photo 11 - View of Platform 2 with uneven pavement (PKBWK's own material).**
