STATE COMMISSION ON RAILWAY ACCIDENT INVESTIGATION
Ministry of the Interior and Administration

REPORT No. PKBWK 06/2024

**on the investigation of a railway accident that occurred on 24 August 2023 at 12:05 hrs
at Skierniewice station, at turnout no. 13, at km 64.282
of railway line no. 1 Warszawa Zachodnia - Katowice
the area of the infrastructure manager PKP Polskie Linie Kolejowe S. A.
Railway Line Plant in Łódź**

WARSAW, 1 August 2024

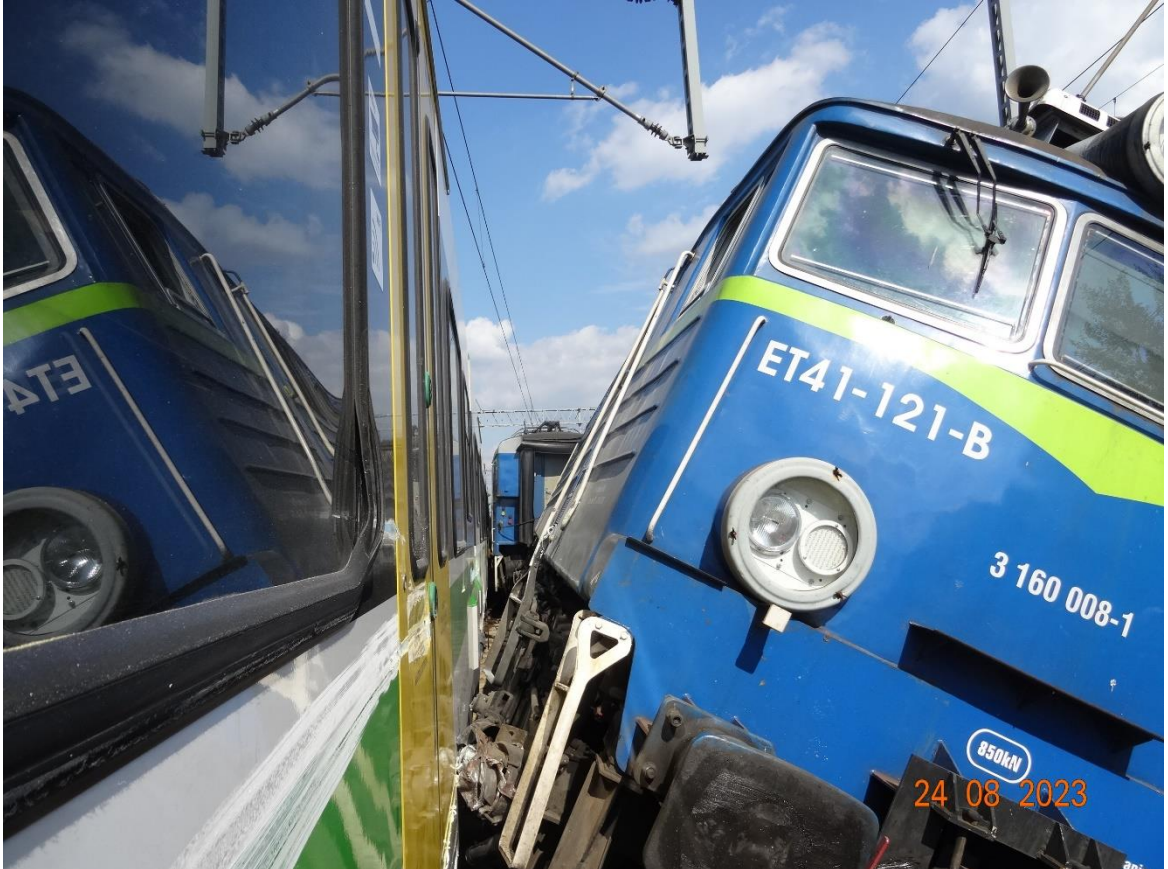
The occurrence resulted in the derailment of the first B section of the ET41-121 locomotive with all bogies and the second A section of the locomotive with one bogie. The derailed section B was tilted by an angle of approx. 30° from the vertical to the left, looking in the ride direction. Sections A and B of the locomotive were partially uncoupled. Section A of the locomotive was coupled by a screw coupling and air hoses to the train set. Damage was sustained by:

- locomotive body: damaged section B skin, steps, handrails, battery box, gangway between sections, outer floor skin under cab B;
- bogie frames: torn off fender on bogie 4 - right hand side, damaged front fenders on section B, side supports on bogies II, III and IV, brake cables and sand tubes on bogies III and IV;
- wheelsets: structure bonding brushes on bogies II, III and IV, structure bonding cables, installation from the Mirel system transmitter to the connection box;
- braking equipment: brake cylinders on bogies II, III and IV - right-hand side, pneumatic piping of brake cylinders;
- current collectors and WS: II and III current collector - bent DSA-150 heads.

As a result of the occurrence, the following damage was sustained by the EMU ER160-22 to the skin of the left side of the carriages in the ride direction:

- L-4423 22C: skin scratches on the yaw damper support, C-E side;
- L-4423 22E: damaged skin along the entire length of the carriage, deformed door D6P, door D5P - damage to the left panel and both platforms; perforation of the skin in the area between the support points of the carriage and entrance 6P (lower beam), deformation of the skin (more than 10mm) of the carriage from the support point to the 3rd window (counting from the rating plate);

- L-4423 22D: damage to the skin along the entire length of the carriage; damage to 4 door panels and both platforms; damaged window seals - 3 pieces; damaged (dented) skin at the vehicle's waste disposal point - to be replaced;

- L-4423 22A: damage to the skin (scratches along the length of the entire carriage); damaged D2P door panel; perforation of the skin at the front of the carriage above the body-body absorber support; damaged yaw damper - 1 piece, and inter-carriage dampers CE, ED, AD - 3 pieces.

Photograph 5 - A view of the damage to the railway vehicle after the accident (source: documentation prepared by the railway commission)

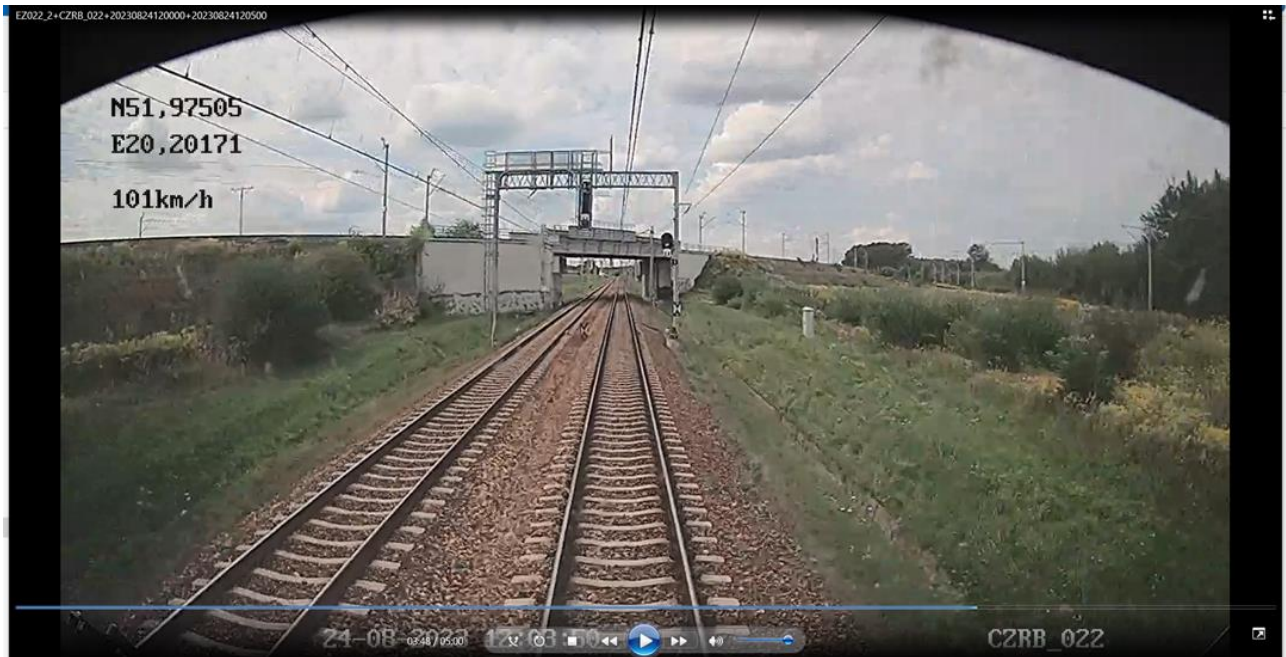
Photograph 6 - Driving foreground - a view of the ToJ1 warning disc from the camera of the EMU ER160-22

The driver's failure to pay attention to the aspect of the home signal B^{1/4} and, subsequently, the ToJ1 warning disc, might also have been influenced by the voice message from the signaller of Skierniewice station - eastern position, namely: *"Roger, go ahead"*. With these words, the signaller acknowledged the driver's report that the entrance door malfunction had been fixed and that the journey would continue, without providing any further information. The form of the message given by the signaller might have contributed to reducing the alertness and attention of the driver operating the passenger train. This situation did not exempt the driver from observing the aspects of the signals or responding to them accordingly.

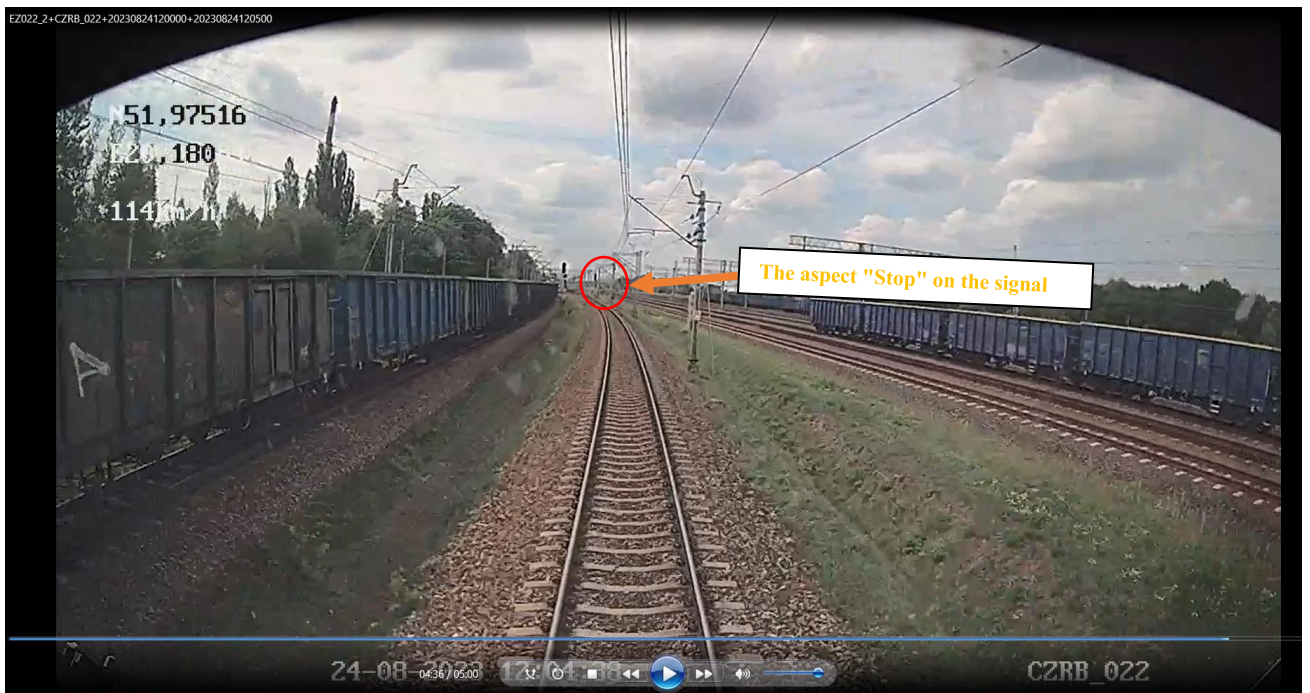
Driving at the speed of 111 km/h, the driver of the passenger train terminated the call at 12:04:39 hrs when the head of the train was 166 m ahead of the signal J1^{1/2/3/m} showing the aspect S1 "Stop", and implemented braking.

Photograph 8 - Driving foreground - a view of the intermediate signal J1^{1/2/3/m} from the camera of the EMU ER160-22

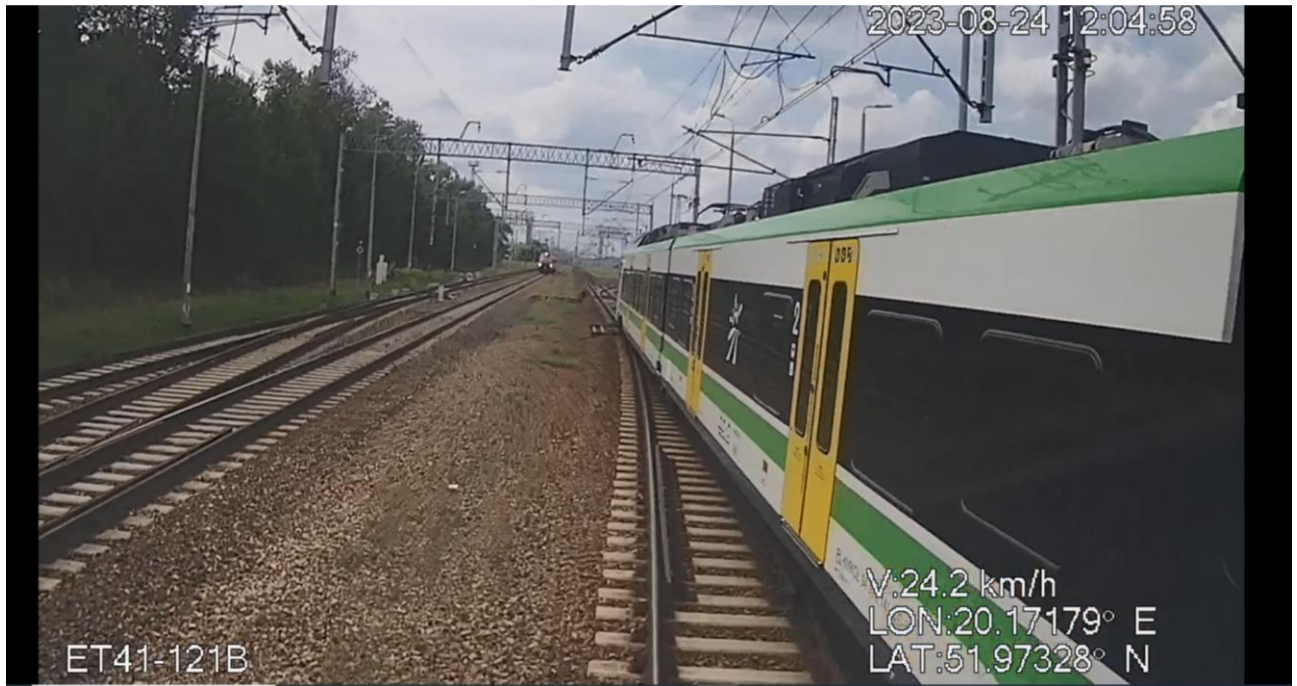
The driver of the passenger train applied the air brake reducing the speed to 78 km/h, and it was at that speed that he passed, at 12:04:46 hrs, the intermediate signal J1^{1/2/3/m} showing the aspect S1 "Stop" while at the same time pushing the Rp1 signal button "Attention". Despite applying the brake, the passenger train overtook the head of the freight train, entered turnout no. 13, "ran through" the switch, and found itself on route that had been correctly set up for the moving freight train. What happened at turnout no. 13 at km 64.282 as a result, was that the head of the ET41-121 locomotive drove into the left side of the first unit of the passing passenger train. The driver of the freight train transmitted the Rp1 signal "Attention" and after a while used the radio emergency signal "Radio-stop". The collision resulted in the derailment of the ET41-121 locomotive (the consequences of the occurrence are covered in Clause III.1.4 of the Report). The head of the freight train stopped at km 64.306, and the head of the passenger train at km 64.374.

Photograph 10 - Driving foreground - a view of the passenger train entering the route of the freight train - a view from the camera of the ET41-121

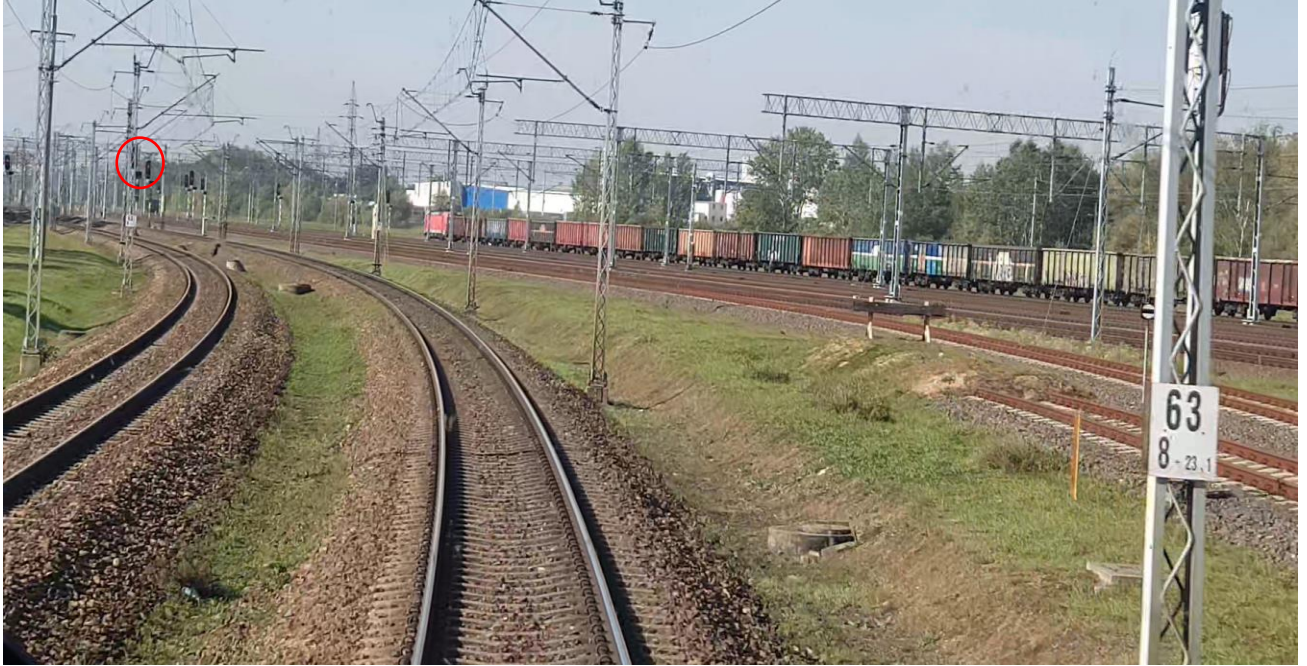
The catenary poles positioned in the curve of the railway line make it difficult for train drivers to see, the aspects shown on the intermediate signal J1^{1/2/3/m} from the required distance (375 m), which the Investigation Team finds to be a contributing factor.

Photograph 11 - A view of the signal J1^{1/2/3/m} 340 m (own material of PKBWK)

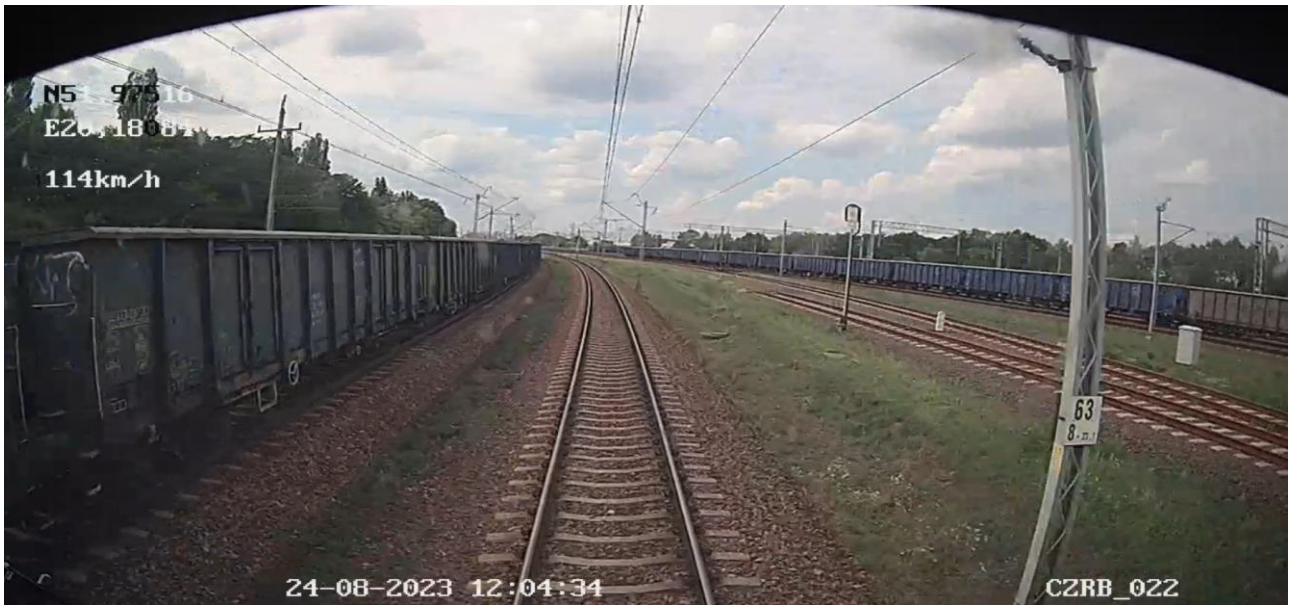
Photograph 12 - A view of the signal J1^{1/2/3/m} from 340m on the day of the occurrence, with another train running on the adjacent track at the same time.

Other trains travelling on track 2 (the other one) are an additional reason why the visibility of the signal J1^{1/2/3/m} is hindered.

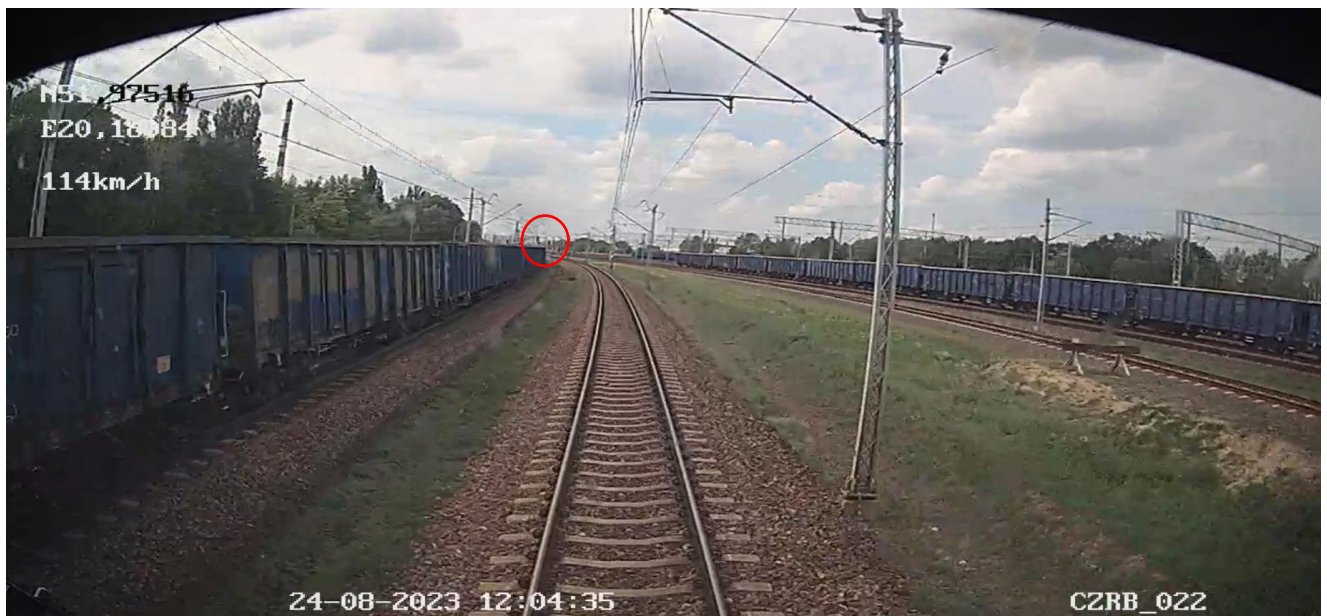
Photograph 14 - A view of the intermediate signal J1^{1/2/3/m} from 300 m on the day of the occurrence.
