STATE COMMISSION ON RAILWAY ACCIDENT INVESTIGATION
Ministry of the Interior and Administration.

REPORT No. PKBWK 06/2022

**on the procedure on a railway incident that occurred on 05 February 2021 at 09:37
in Gogolin station track no. 6, 22.400 km of railway line no. 136 Kędzierzyn Koźle – Opole
Groszowice**

WARSAW, 21 July 2022

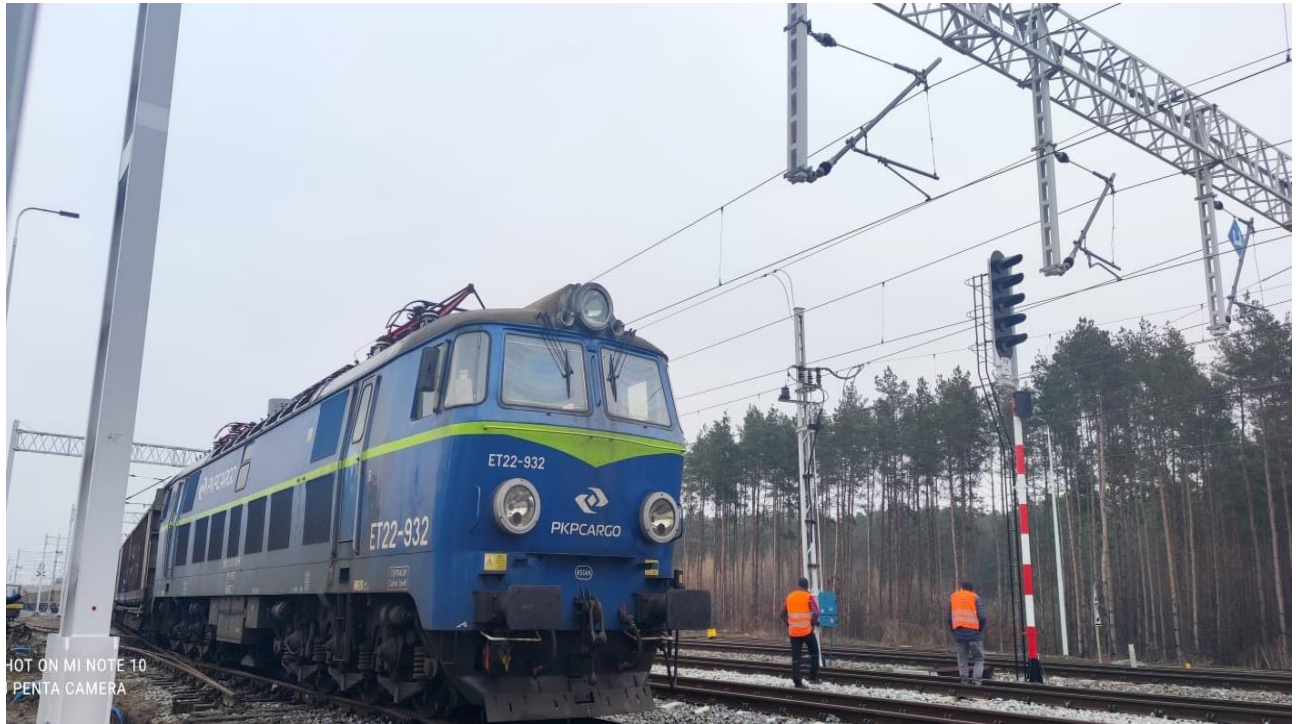
Photograph 1 – View of the site (source: PKBWK)

Event description: Train no. 844000 riding on the route between Szczecin Port Centralny – Chałupki operated by the railway undertaking PKP Cargo S.A. entered Gogolin station at the permissive signal on semaphore $Z^{1/2}$ on the hardened track of the route, travelling from 2_6 . This train moved on an incorrectly prepared route. The incorrectly set switch of turnout no. 42 (not dependent in the journey) was set in the direction of turnout no. 39ab, and later towards non-electrified side track no. 8. instead of towards main auxiliary track no. 6. Having noticed the improperly prepared route, the train driver started immediate stop and lowered the pantographs. The front end of train no. 844000 came to a stop behind the points of turnout no. 39ab on track no. 8 at 22.455 km.

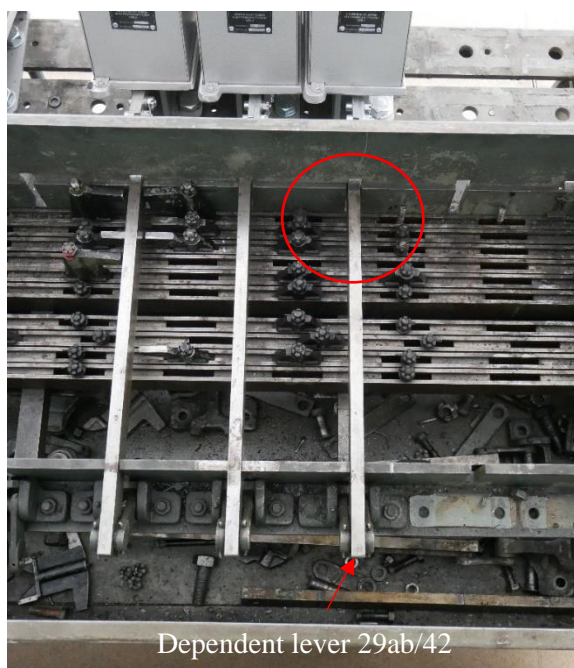
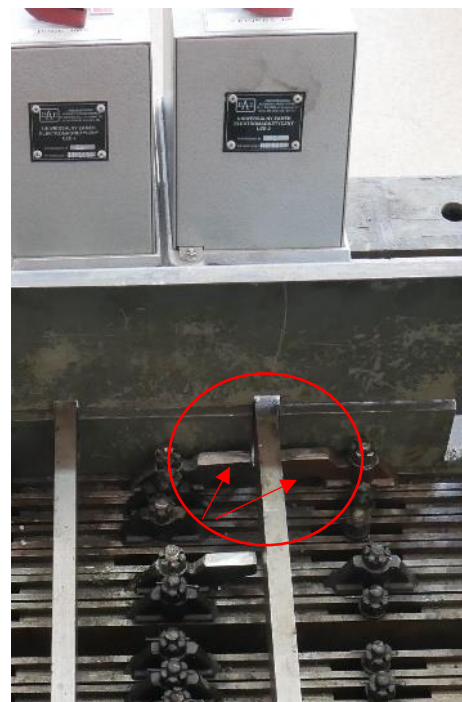
Photograph 3 – View of the combiner without locking dogs (left side – condition after the incident) and with the caps installed after the incident – condition as at 21.04.2021.

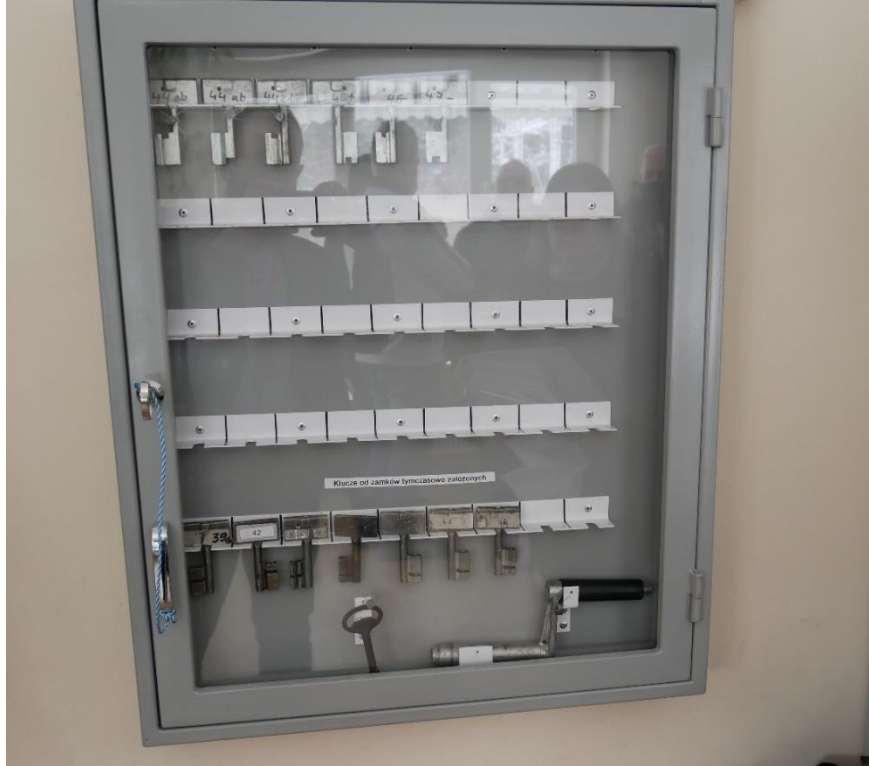
Photograph 4 – Board of spare keys and keys for the locks temporarily installed on the Gg2 signal box

- Placing the active keys for the switch locks built into switches 39ab and 42 in the “spare key cabinet,” which was positioned in an area not visible to the operating personnel, resulting in improper ergonomics of the point operator’s workstation.

- The installation of the pin locks put in place for the duration of the works allowed them to be operated freely, as specified by the designer of the signalling equipment (unsealed keys, accessible to the contractor of the works, placed on the key board in an unsealed manner with a recommendation of accessibility to the contractor, without designing the active key board as a component of the train path).

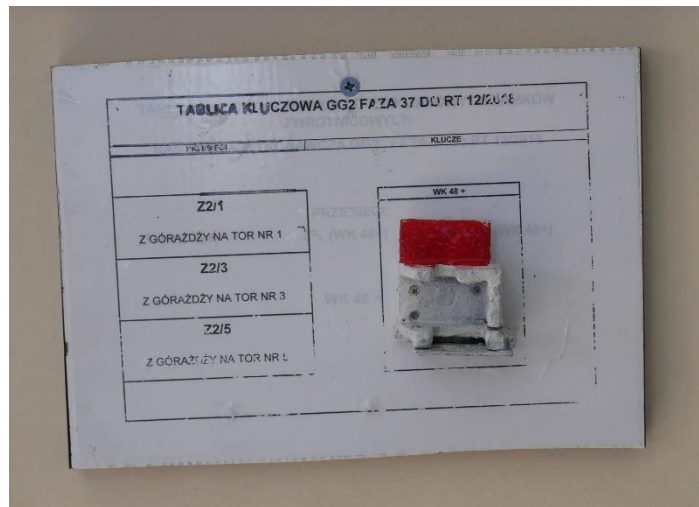
Photograph 5 – Key board of active Gg2 control station made after the incident (during the subsequent stage of works)

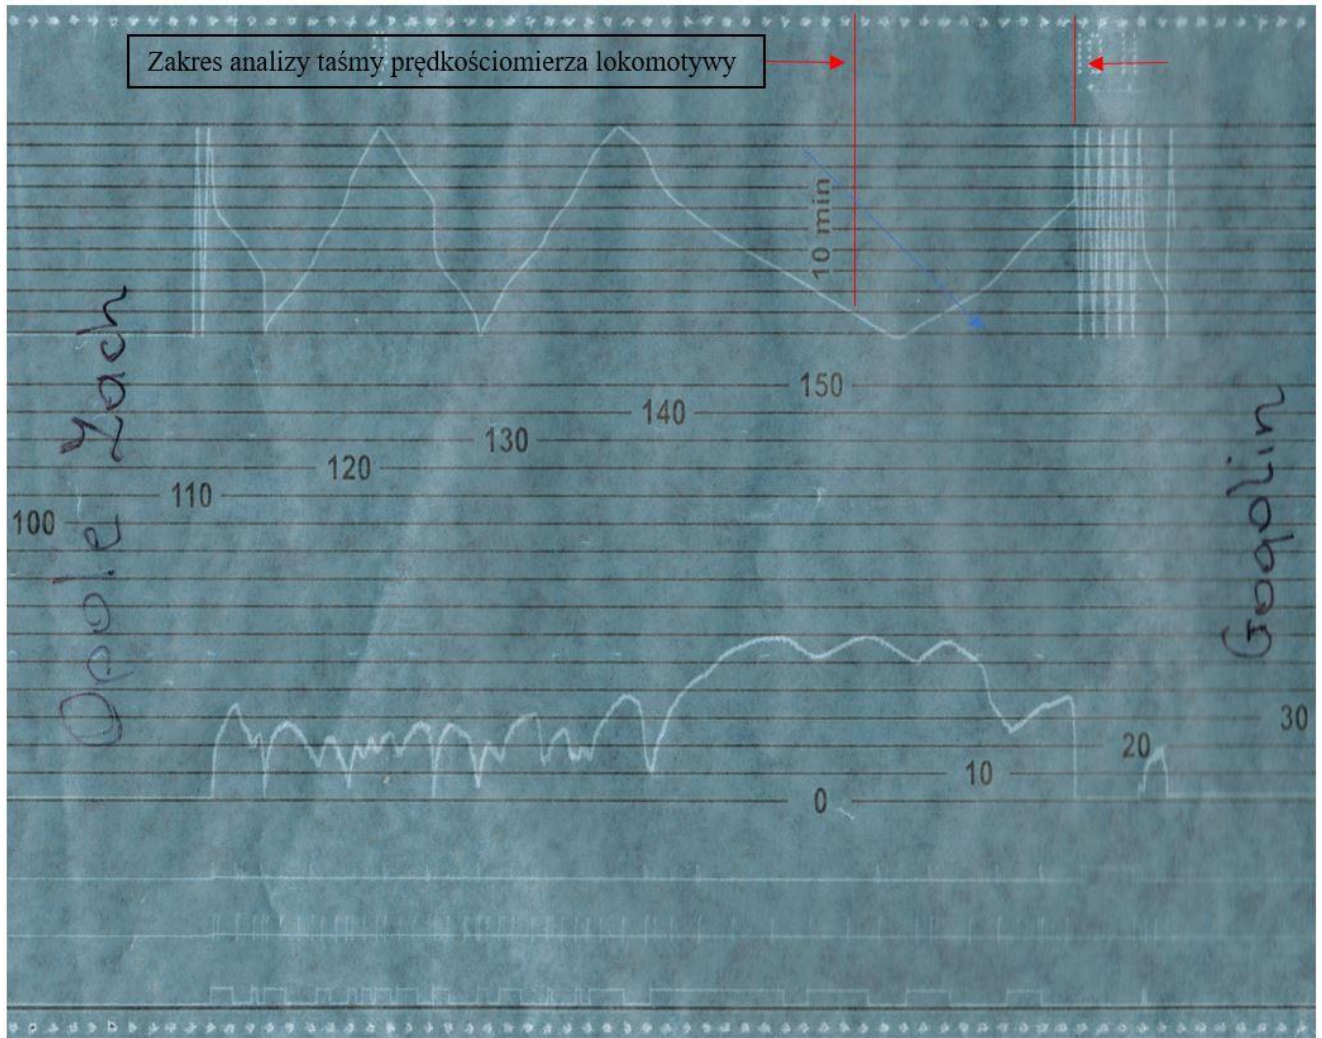
Figure 4 – Diagram of the ET22-932 locomotive running parameters

The Investigation Team analysed the driving parameters recorded on the speedometer to study the driving characteristics of the train immediately before and after the incident. The driving parameters of the train between 09:30 and 09:40 on the route between Góraźdze – Gogolin are shown in the graph below with a description.

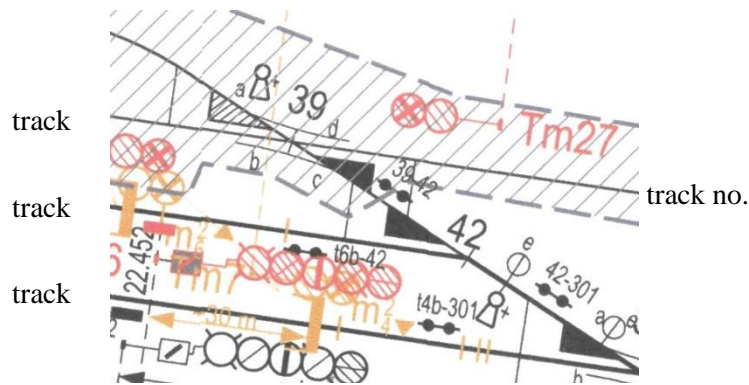
Figure 5 – A section of the schematic plan of Gogolin station

In accordance with the detailed design for the completion of stage 27 of the Temporary Regulation no. 12/2018, the switch of turnout no. 42 must be dependent in the train route from ²/₆ “from Górażdże to track 6” and closed with a pin lock in the default position (directing to track no. 6).

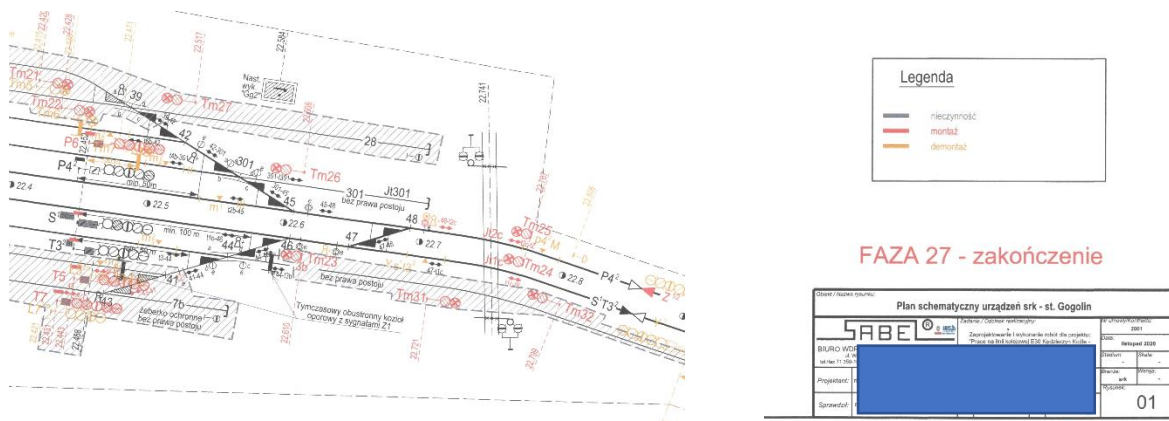
Figure 10 – Excerpt of a schematic plan of the signalling equipment

The contractor provided the aforementioned documentation for Gogolin stations. The supplied schematics of the stations – the schematic plan of the signalling equipment and the schematic plan of the Gogolin RTS station are incompatible, despite the fact they refer to the completion of the same phase of the works. Presented below is a selected excerpt from the documentation supplied to the traffic stations.
