STATE COMMISSION ON RAILWAY ACCIDENT INVESTIGATION

ANNUAL REPORT FOR THE YEAR 2021

FROM THE ACTIVITY OF THE STATE COMMISSION ON RAILWAY ACCIDENT INVESTIGATION

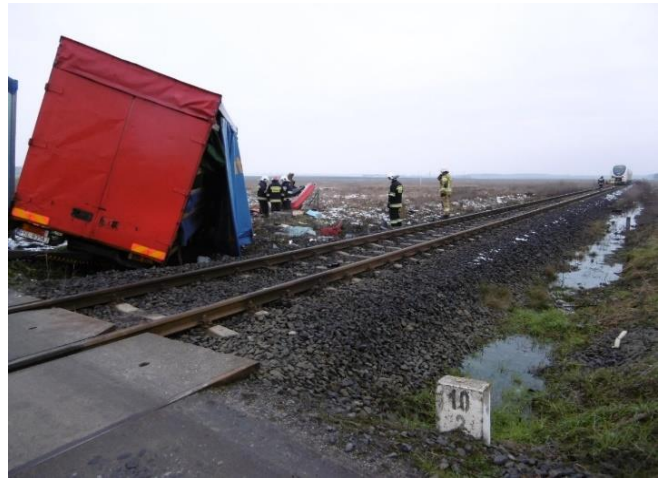
Photograph 1 – View of the site of the incident (PKBWK own material)

- As a result of the incident, the crossing user – the driver of the lorry – suffered a fatality. The train operator’s personnel or the train passengers did not suffer any injuries.
- Mercedes-Benz Atego truck destroyed. The had no load. There was no damage to belongings or luggage carried on the train. Damage to the front of rail vehicle SA139-006.

During the travel of a train on the route between Zbąszynek – Gorzów Wielkopolski on the Zbąszynek – Lutot Suchy route, at a crossing not equipped with traffic protection systems and devices, the driver of a lorry with a trailer drove directly in front of a rail bus travelling as a passenger train. The vehicle entered the crossing from the left side of the moving train. This resulted in a collision between a train and a road vehicle. The rail bus hit the right side of the truck cab. Due to the impact and the forces involved, the driver of the lorry fell out of the cab, which resulted in a fatality. The lorry was destroyed and thrown to the left side of the track in such a way that the cab, including the load bed, remained in the track gauge and the trailer blocked the road. The railway vehicle did not derail.

- A recommendation has been renewed for the municipal road manager for the missing signs to be completed during the commission’s inspection of visibility conditions at the level crossing cat. D at 10.196 km.
- On 01 September 2021, the chairman of the PKBWK issued a recommendation to permanently restrict the running speed of trains to 60 km/h in both directions for a distance of 550 metres before the level crossing cat. D at 10.196 km due to the difficulty in moving through the level crossing due to the fact that the width of the access road does not match the width of the crossing bridge.

- 1) The road manager, the Mayor of Trzciel, shall take measures to immediately remove the irregularities found during diagnostic tests or during inspections at crossings, as stated in the railway infrastructure manager’s findings.

- 3) The manager of the class L municipal road together with the manager of the railway infrastructure shall adjust the access to the level crossing over a length of at least 34 m, to a width of 2 x 2.75 metres (in accordance with the provisions of § 15 section 1 item 5 of the Regulation of the Minister of Transport and Maritime Economy of 2 March 1999 on the technical conditions which must be fulfilled by public roads and their location (i.e. Journal of Laws of 2016, item 124, as amended). The current width of the road meets the requirements set out in §14(3)(1) of the aforementioned Regulation and it is acceptable for the duration of the construction or for the reconstruction of the road.

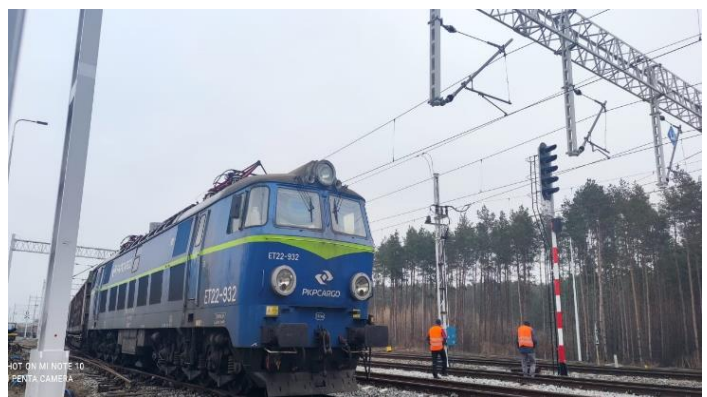
Photograph 2 – View of the site of the incident (source: PKBWK)

- No persons were injured in result of the incident.
- The incident did not cause damage to rolling stock, infrastructure or the environment.

Having noticed the improperly prepared route, the train driver started immediate stop and lowered the pantographs. The front end of train no. 844000 came to a stop behind the points of turnout no. 39ab on track no. 8 at 22.455 km.

On 26 February 2022, the Chairman of the Commission issued an interim recommendation for the Railway Department in Opole to implement the following measures aiming to improve safety in rail transport with respect to Gogolin station:

- b) improve the quality and depth of technical acceptance of individual stages of works in terms of inspecting the conformity of the design documentation with the condition on the ground.

- c) the scope of the trainings for the personnel of the stations must include issues related to the operation of trains in the station and adjacent routes during restrictions, telephonic announcement of trains on the routes, telephonic recommendation and notification of the preparation of routes in the station.

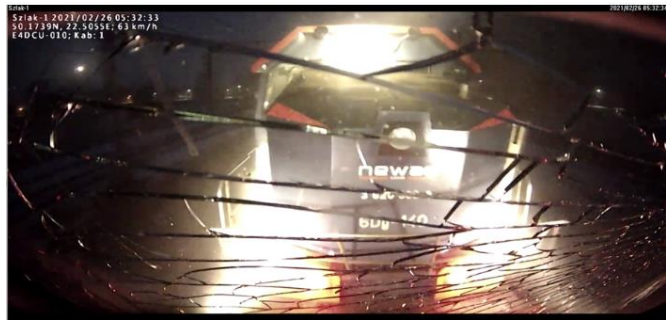
Photograph 3 – View of the site and the results of the incident (PKBWK own material)

- Four persons were injured in result of the incident, i.e. the driver of the locomotive running loose and three passengers on the passenger train.
- Material losses have also occurred, i.e. severe damage to locomotives EU160-010 and 6Dg-140 and 3 passenger wagons with numbers: 50512978054-8, 50513978045-4 and 50512978062-1, and the point machine was damaged.

- 5) The Infrastructure Manager shall implement the recommendation set out in the protocol of diagnostic tests of signalling equipment (Protocol no. IZATA-I/3-22-068/2019 dated 21.06.2021) which reads as follows: *"Provide for the refurbishment of signalling equipment, the replacement of shaped semaphores with luminous semaphores and the installation of Eap interlocking on the adjacent routes to Tryńcza-Leżajsk station."*

- 6) For the purpose of ensuring the safety of train traffic on the routes a¹ b² and a²₃ PKP PLK S.A. Zakład Linii Kolejowych [Railway Facility] in Rzeszów shall restore the technical condition of the infrastructure at Grodzisko Dolne station to match the currently existing technical documentation.

- 8) Railway undertaking LOTOS Kolej Sp. z o. o. is going to implement the order of the President of the Office of Rail Transport No. DBK-550/R03/KB/12 of 30.05.2012, addressed to railway undertakings regarding the obligation to install dashboard recording equipment – digital cameras or video recorders in newly built railway vehicles as well as those that are already in use in accordance with the recommendation of PKBWK – No. PKBWK-076-305/RL/R/11 of 22.11.2011.

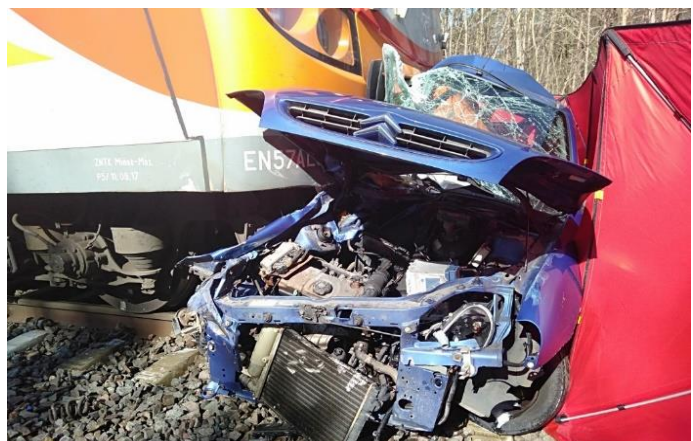
Figure 4 – View of the effects of the incident (source: PKBWK)

- The driver of the road vehicle suffered a fatality due to the accident.
- A Citroen Saxo passenger car was destroyed and the EN57ALc-2207 rail vehicle was damaged.

On 13 April 2021, the Chairman of the PKBWK addressed a letter ref. no. PKBWK.4631.4.2.2021 to the Chairman of PKP PLK S.A., issuing the following recommendations regarding the level crossing at 30.453 km of line no. 354 Poznań Główny POD – Piła Główna:

- 2) measure the visibility triangles of the train head (with Pc-1 signal) using a powered railway vehicle with members of the Commission's Investigation Team. This measurement, among others, is going to serve as the condition for maintaining or altering the V_{ogr} speed as stipulated in Appendix 3, Part B, item 6 to the Ordinance of the Minister of Infrastructure of 20 October 2015 on the technical conditions to be met by level crossings of railway lines and railway sidings with roads and their location (Journal of Laws of 2015, item 1744, as amended).

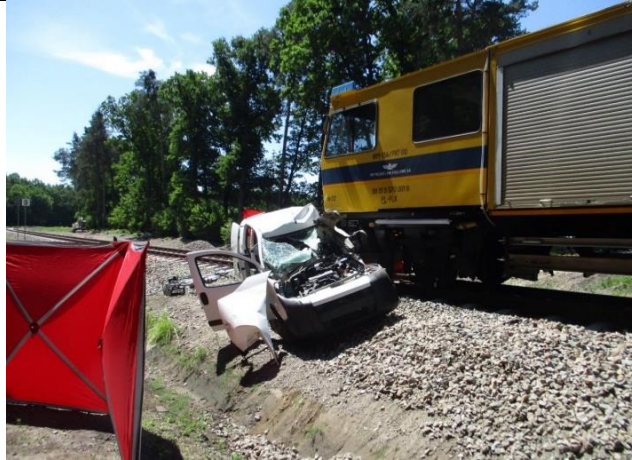
Photograph 5. View of the effects of the incident (source: PKBWK)

- The Citroen Nemo passenger car's movement directly in front of an oncoming WM-15A/PRT-00 motor car resulted in the fatality of the driver.
- The car was completely destroyed, while the WM-15A/PRT-00 No. 02 motor vehicle was damaged on the A-cab side.

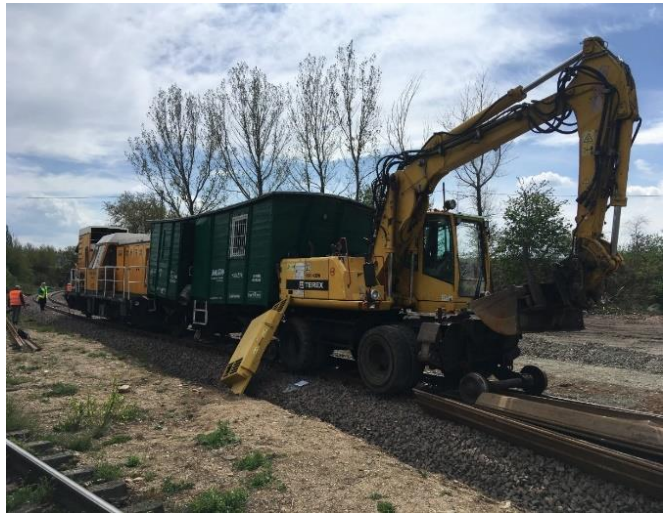
Photograph 6 – View of the site and the results of the incident
(material issued by the Police)

- As a result of the incident, the operator of the rail and road vehicle, an employee of DROMOSTTOR s.c. was seriously injured.
- In addition, a technical and utility wagon was destroyed and a rail welder and a rail-road vehicle were damaged.

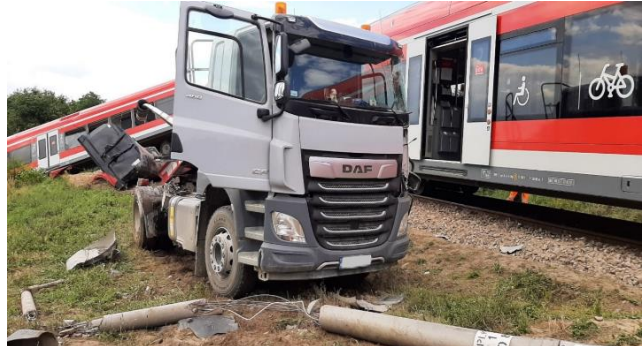
Photograph 7 – Consequences of the Incident (PKBWK own material)

- Nine persons were injured (the train driver, the driver of the road vehicle and seven passengers on the train). The passengers were released home after being treated at the scene. The train driver and the driver of the road vehicle were taken to hospital where they were released home after a medical examination.
- In result of heavy goods vehicle entering directly in front of an oncoming train, the train collided with the semi-trailer loaded with gravel and derailed the first multiple unit type VT646-030. The semi-trailer of the road vehicle was destroyed.

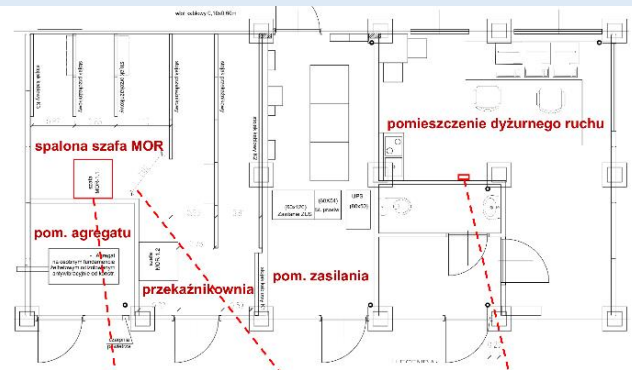
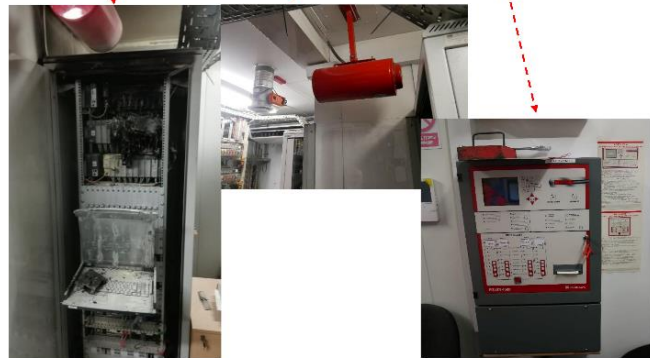
Photograph 7 – Sketch of the layout of the rooms and certain equipment in the Lsz control room 1

- Fire in the MOR-1 system computer cabinet in the relay control room of the Leszczyny station Lsz control room.
