STATE COMMISSION ON RAILWAY ACCIDENTS INVESTIGATION
Ministry of Interior and Administration

REPORT No PKBWK 05/ 2021

**on the investigation of a serious train accident that occurred on
26 January 2021 at 07:39
on route between Zbąszynek and Lutol Suchy, track no 1,
level crossing category D
at km 10.196 of railway line no 367 Zbąszynek - Gorzów Wielkopolski**

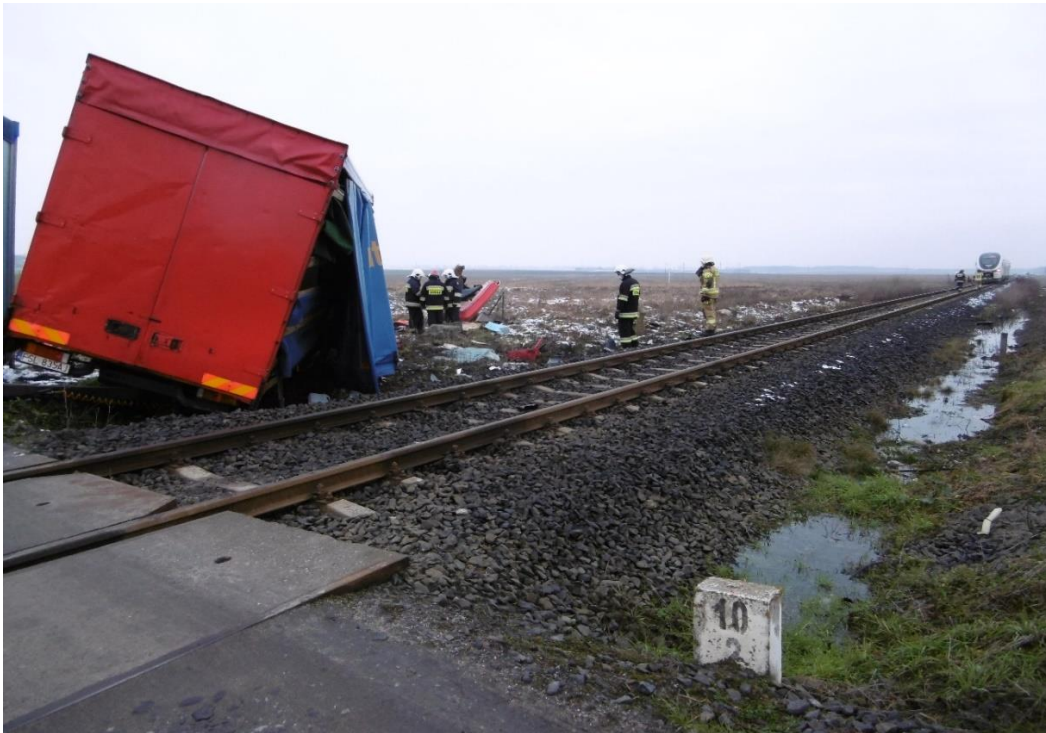
Photo 1- View of the incident site (own material of PKBWK)

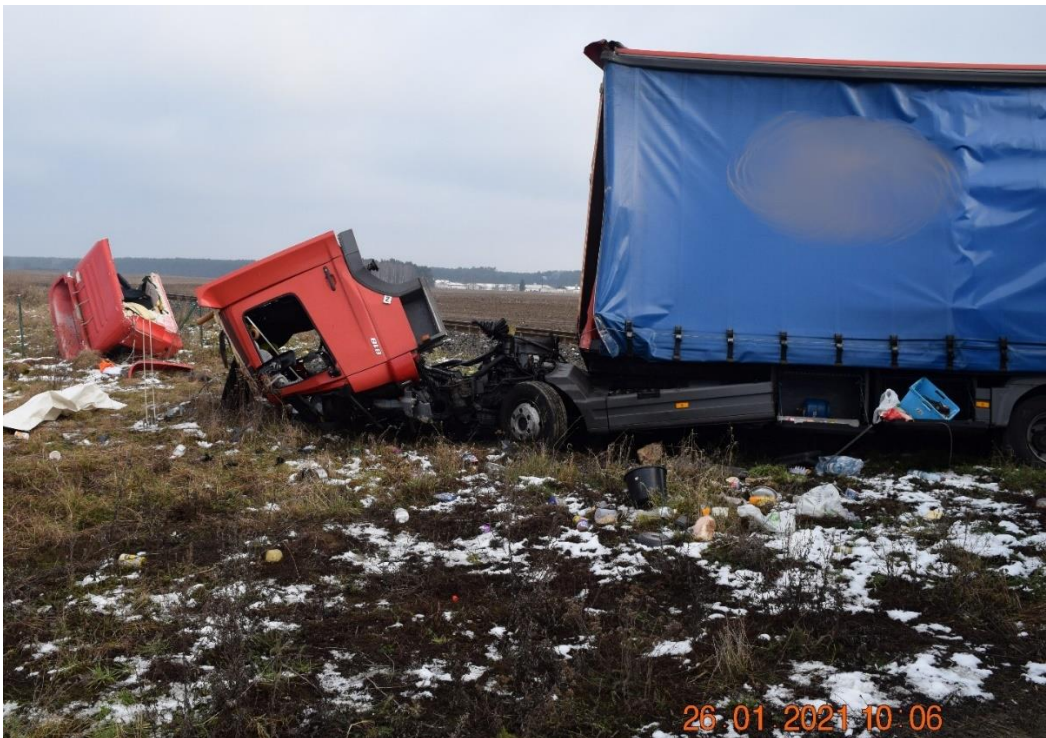
Photo 2- View of the place and consequences of the incident (own material of PKBWK)

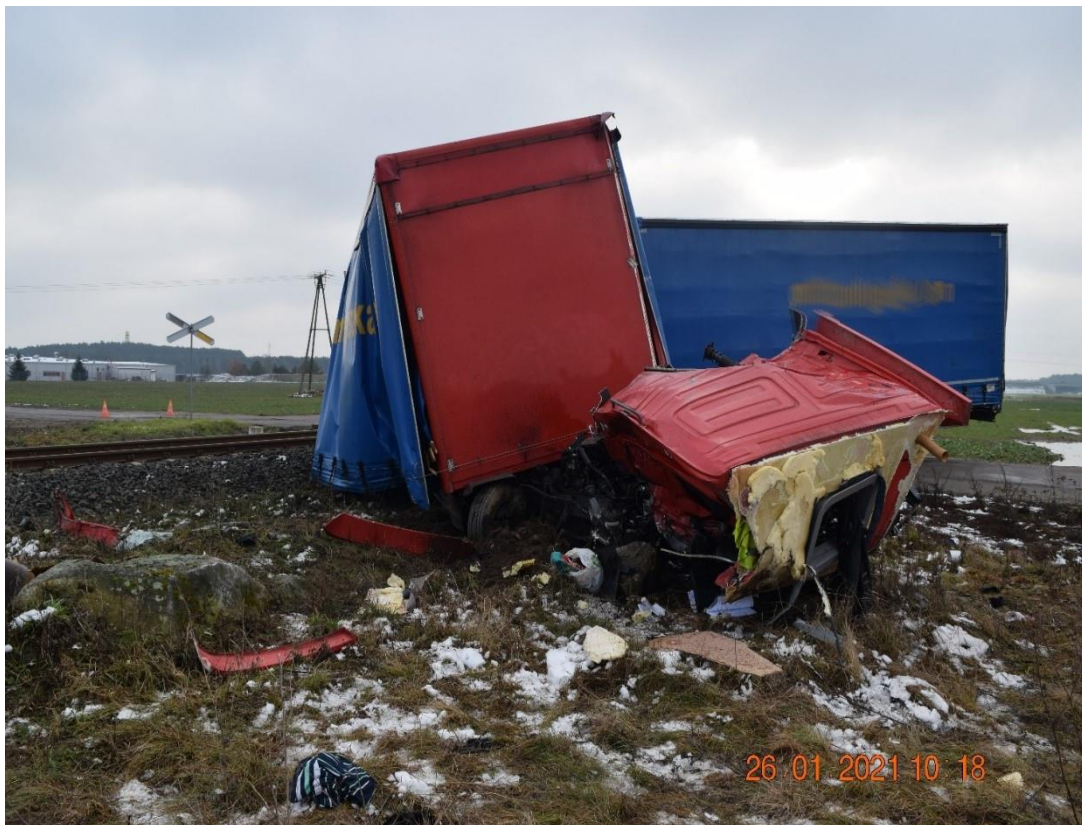
Photo 3- View of the place and consequences of the incident (own material of PKBWK)

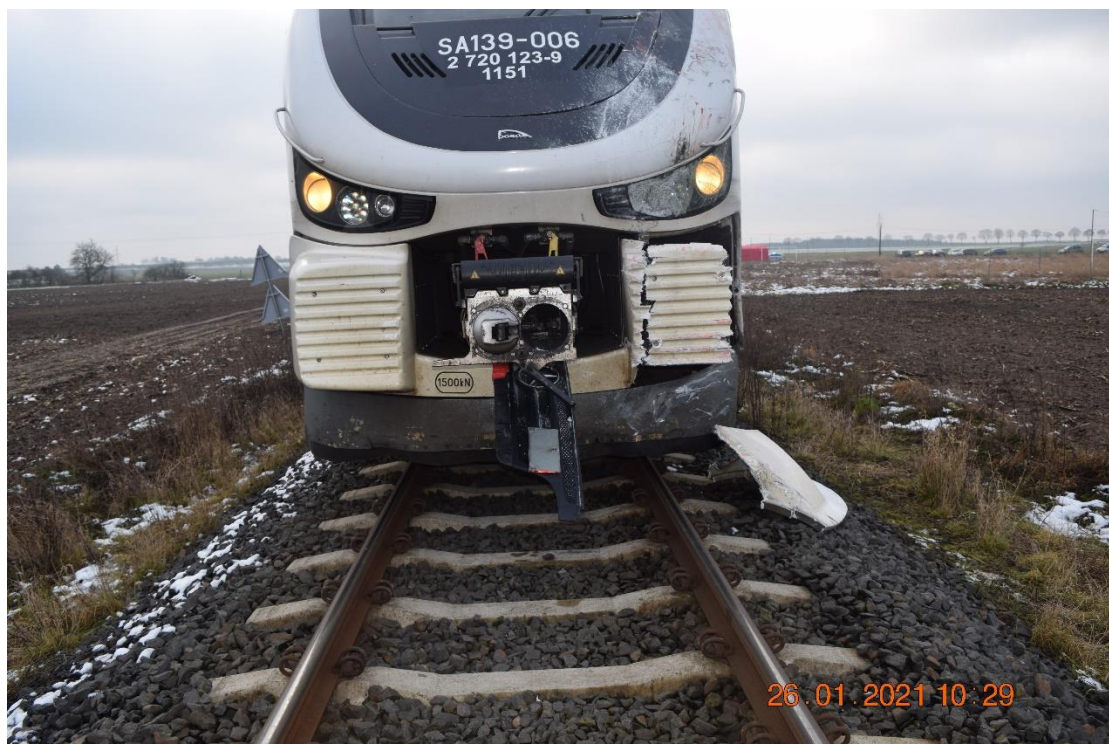
Extent of damage to railway vehicle SA139-006:

- broken wiper mechanism cover and siren,
- damaged left headlight,
- damaged track scraper with cover,
- damaged painting of the cab on the left side and the handrail to the driver's cab,
- defective air hose in the brake indicators,
- damaged absorber cover on the left side,
- curved structure of the obstacle deflector,
- Torn out inner fitting of the coupling cover,
- bent handle over the left headlight,
- a crack in the driver's cab laminate on the outside and inside in the area of the cab's attachment to the wheelhouse and the vehicle body,
- faulty coupling valve,
- Defective coupling cylinder connector,
- a crack in the driver's cab windscreen.

The estimated cost of damage to the vehicle amounted to PLN 92 thous.

Photo 5- View of damage to the front of a railway vehicle after an accident

Damage to the vehicle allowed it to drive to a maintenance facility. There was no damage to the railway infrastructure and no damage to the environment.

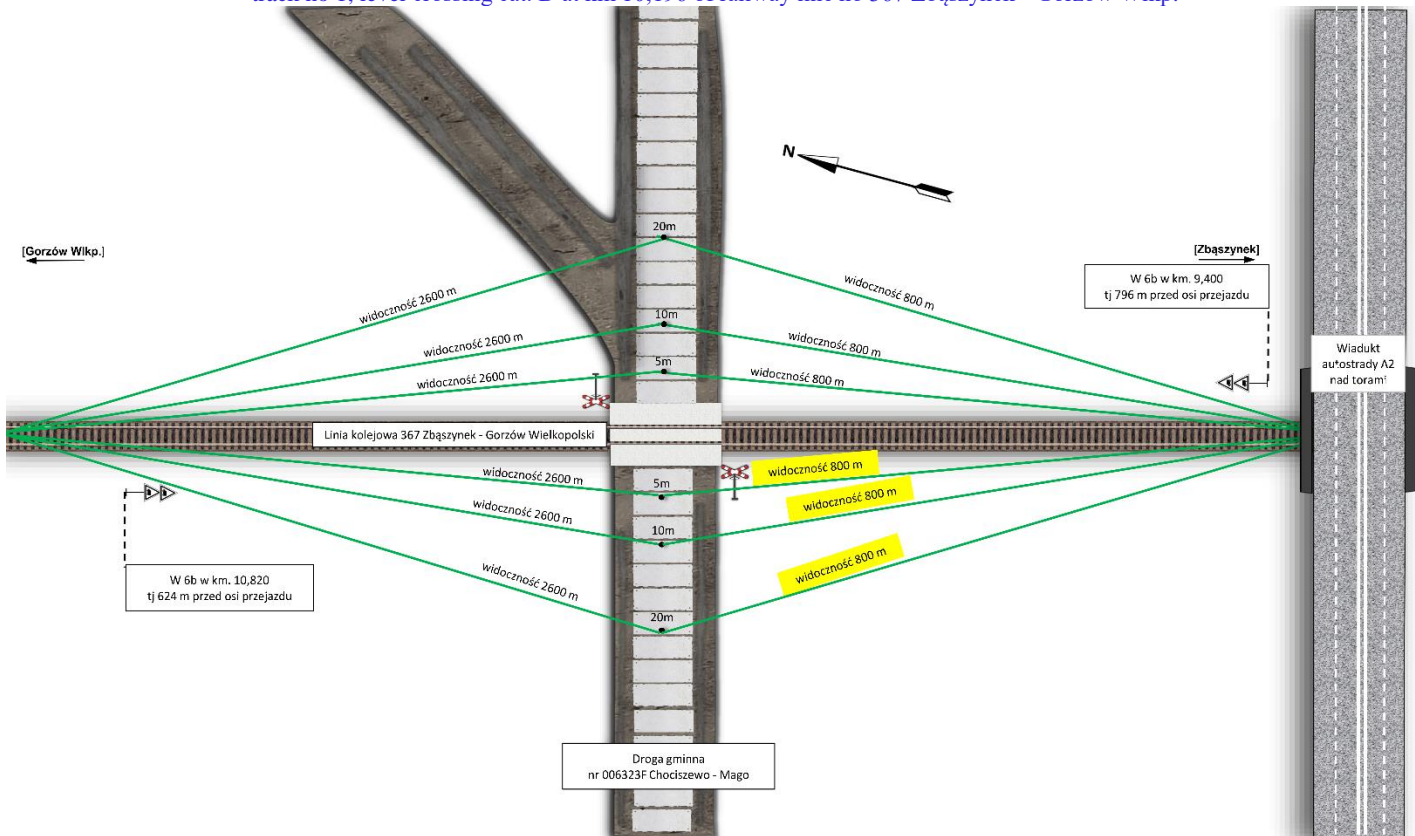
Figure 2- Visibility triangles at level crossing (based on PKBWK)

The yellow marking indicates visibility of train head for the direction from which the road and rail vehicle were running

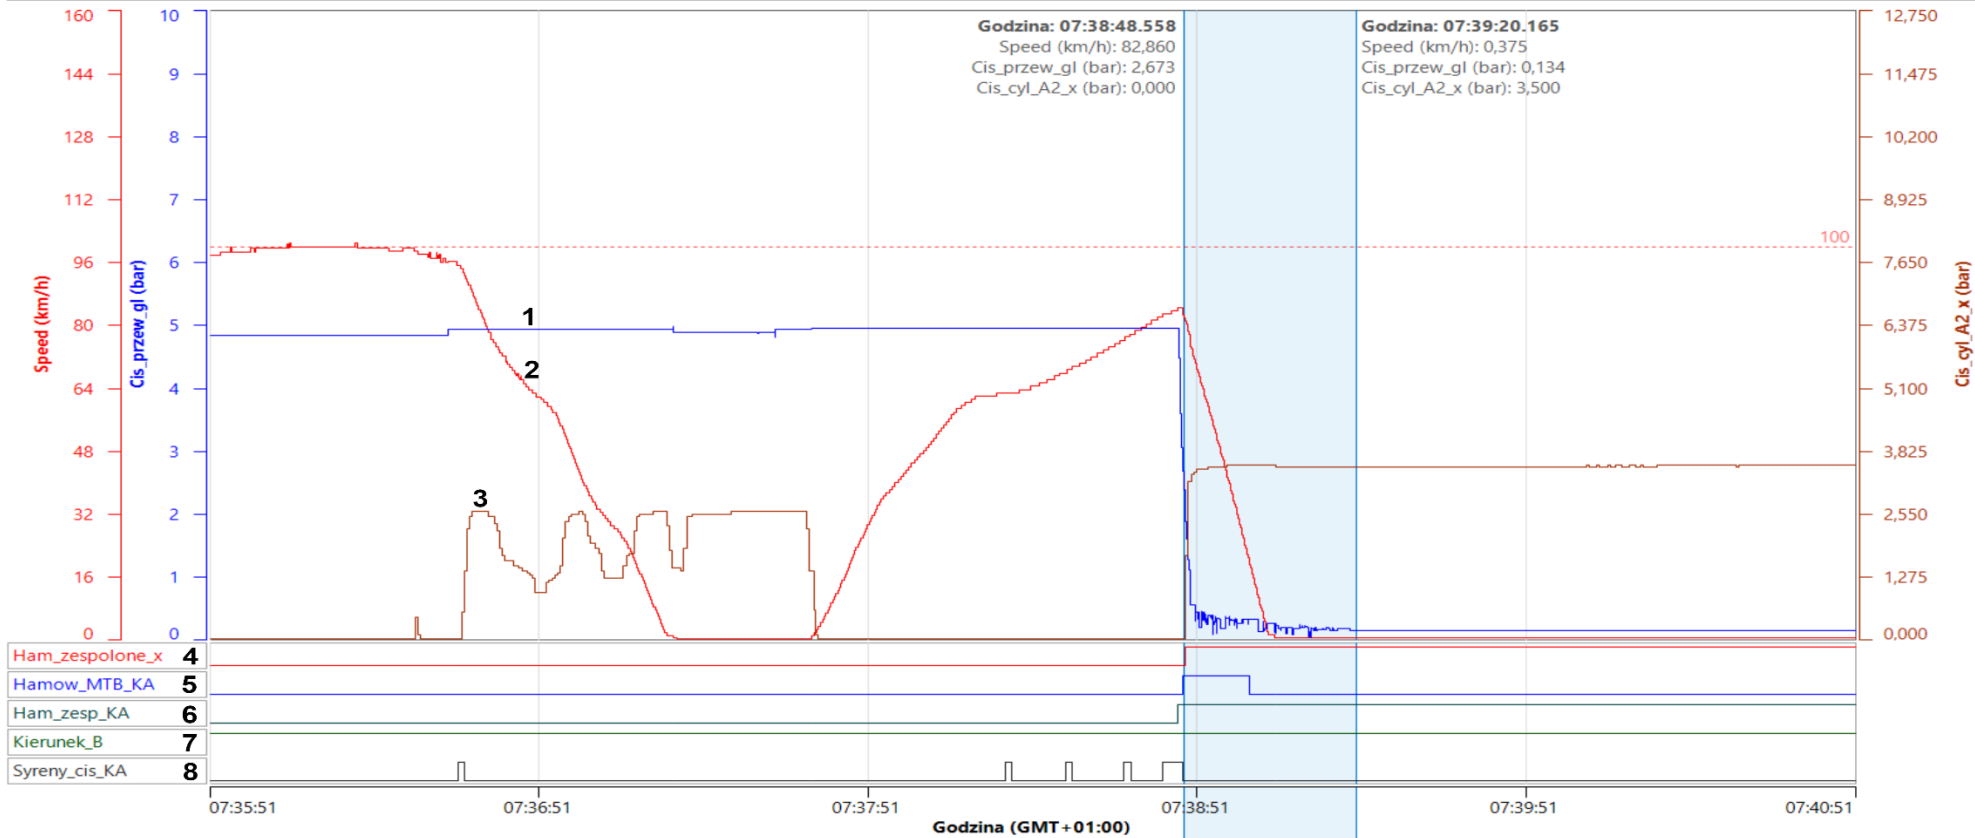
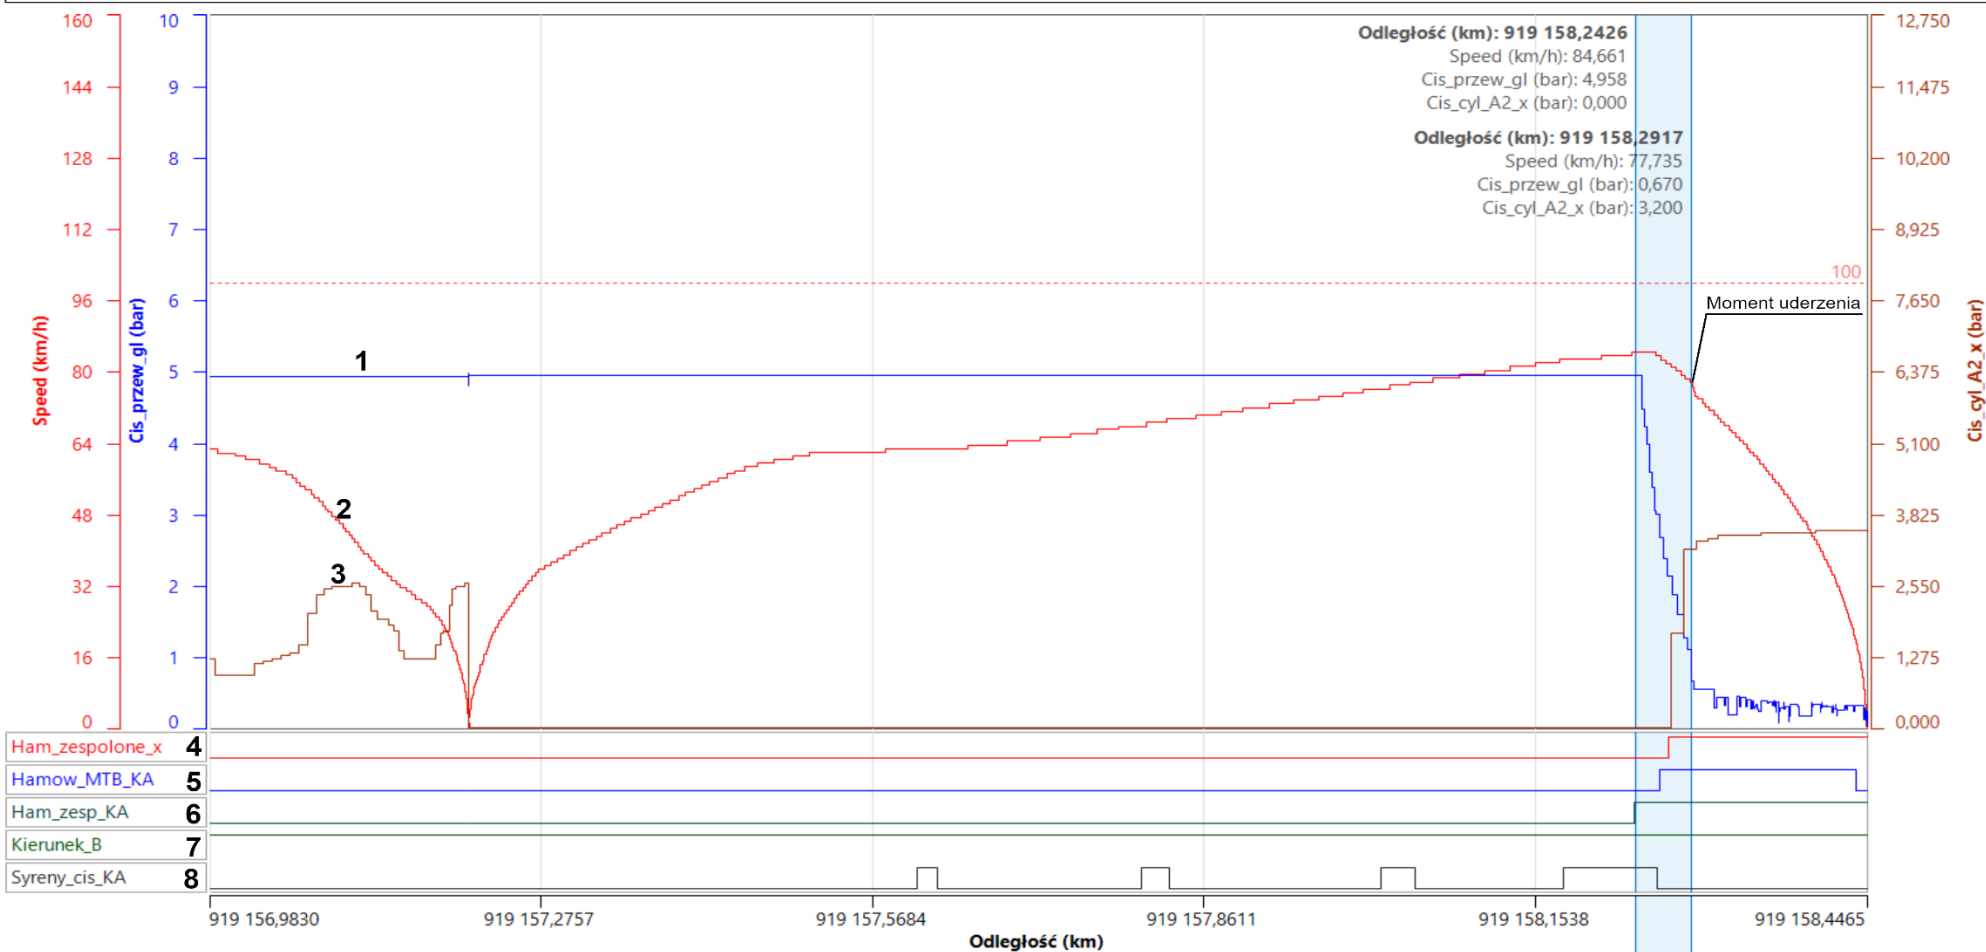
Figure 4- Diagram of the driving parameters of the rail bus SA139-006 as function of distance (elaborated by PKBWK)

1. Main line pressure
- 2 Speed
3. Brake cylinder pressures
4. Operation of the combined brake
5. Brake operation (MTB KA braking)
- 6 Emergency braking application
- 7 Cabin identification - control from cabin B
8. Use of a beep signal.

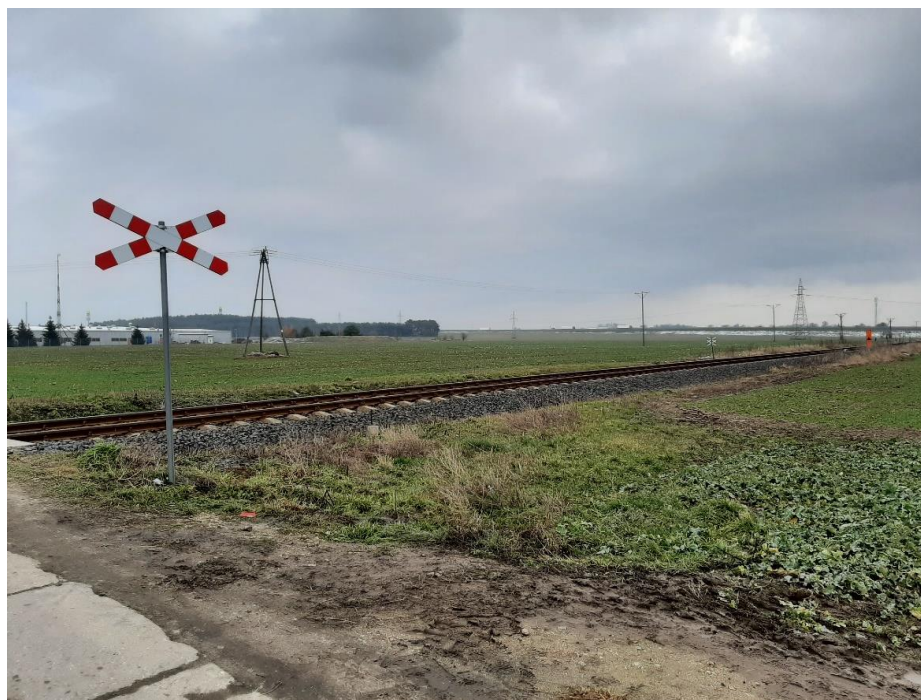
Photo 6- View of the railway track from the access road from 10m (source PKBWK)
