STATE COMMISSION ON RAILWAY ACCIDENT INVESTIGATION
Ministry of the Interior and Administration.

REPORT No. PKBWK 05/2022

**from the procedure regarding a severe train accident that occurred on 15 June 2021 at
10:05 at Kochanówka Pustków station
on track no 1, level crossing category C at km 313.328 of railway line no. 25 Łódź
Kaliska – Dębica
PKP PLK S.A. infrastructure manager area Zakład Linii Kolejowych [Railway Facility]
in Rzeszów**

WARSAW, 31 May 2022

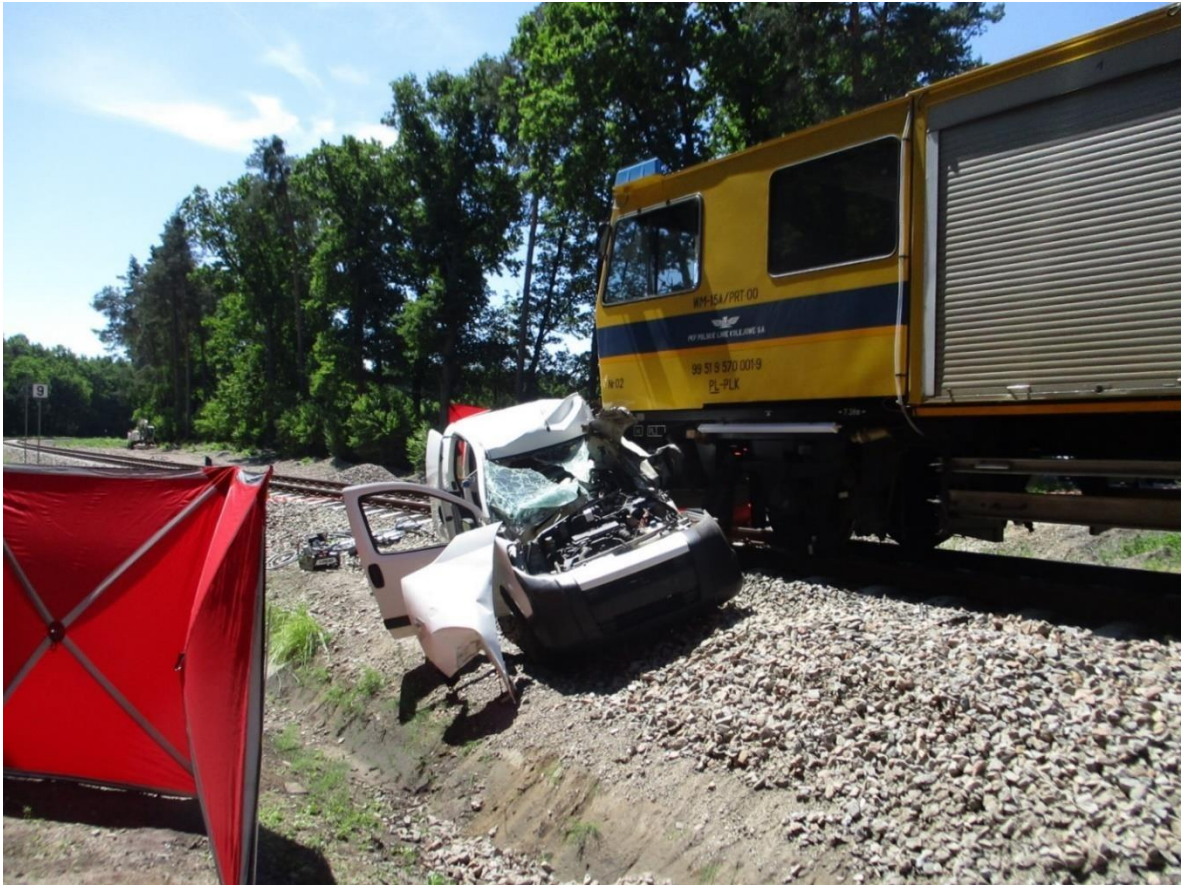
Photograph 1 – Consequences of the Incident (SCRAI own material)

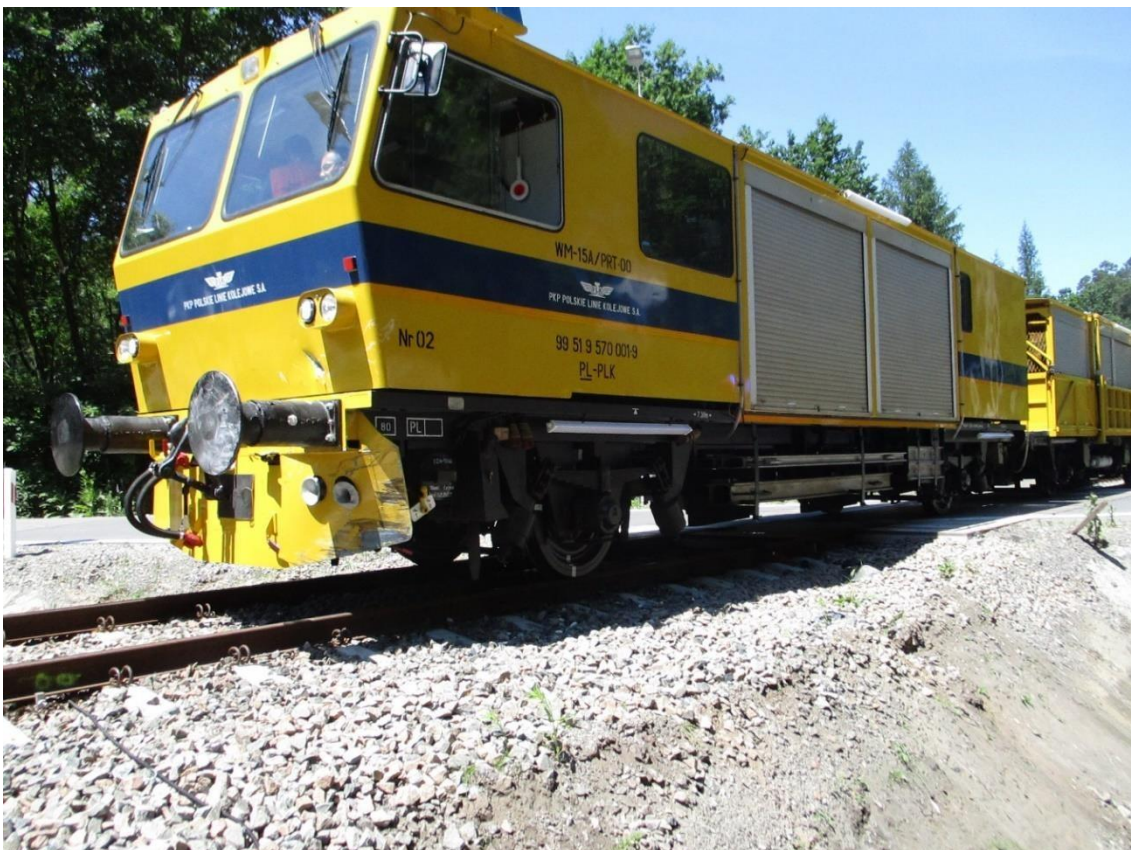
Photograph 2 – Damage to the motor carriage (SCRAI own material)

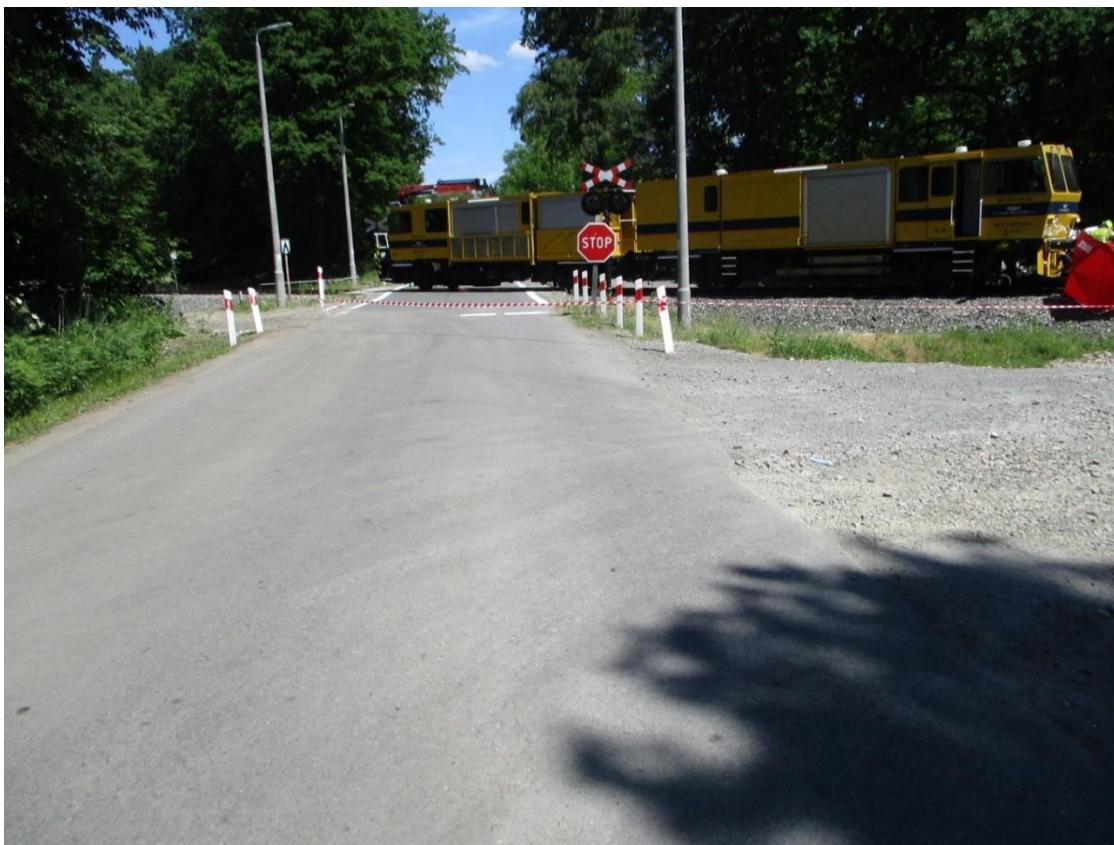
Photograph 3 – Positioning of the motor carriage after the incident (PKP PLK S.A. material)

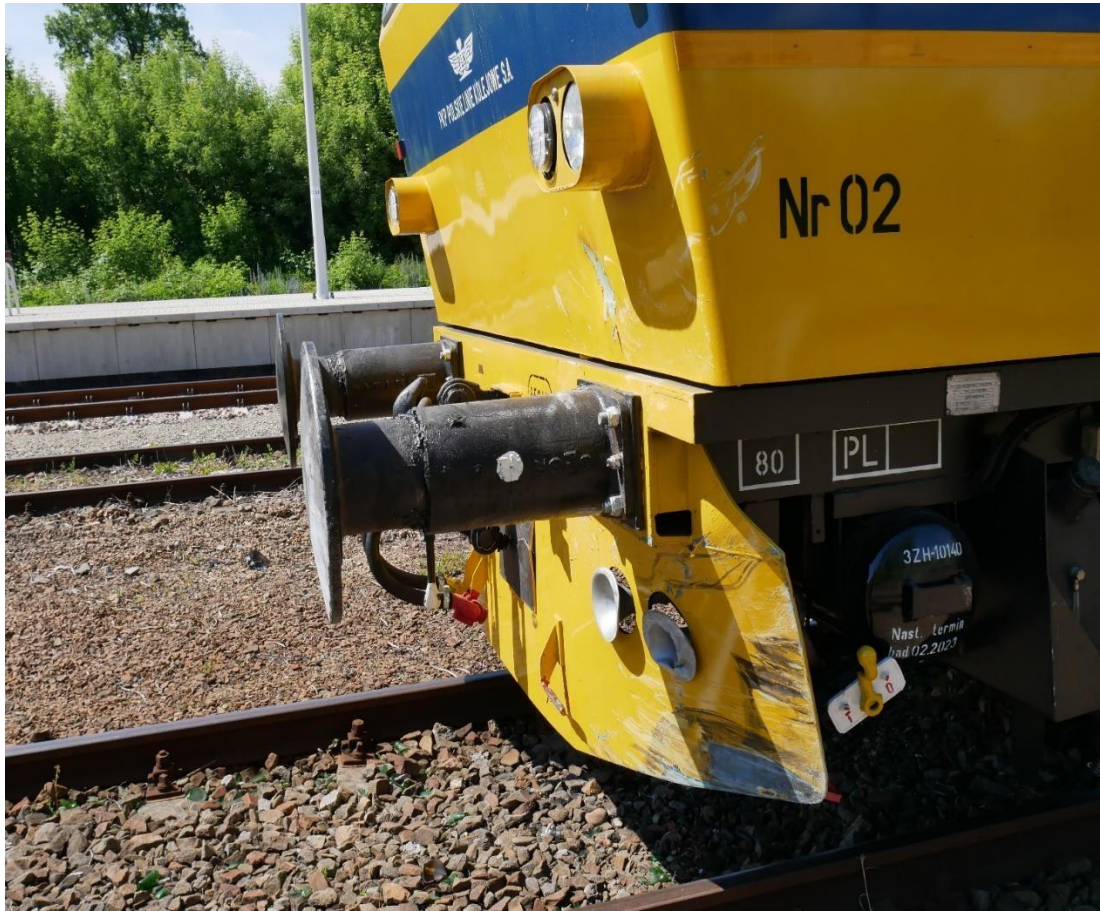
- left bumper to be repaired, right bumper to be checked at the repair station.

Photograph 6 – Damage of the railway vehicle after the accident (by SCRAI)

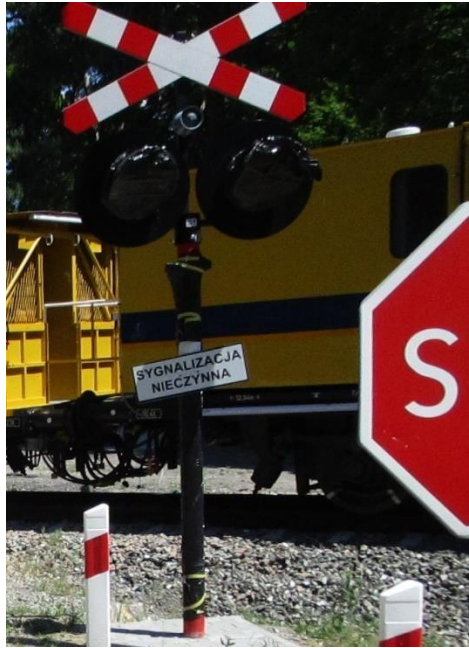
Photograph 7 – “signalling out of order” sign placed on the traffic signal

- the lenses of the traffic signal lights were covered with black film and the signals were not turned in a manner allowing the users of the crossing to see the signalling chambers, which could have caused the passenger car driver to misinterpret that the ssp equipment was operational and the signal was not active because a train was not approaching,

- Recommendations and**
- 1) The Infrastructure Managers shall include an obligation in their internal **their addressees:** regulations to turn away crossing traffic signals and to cover them in a manner that the signalling chambers are not visible to crossing users when the signals are erected but not yet commissioned.

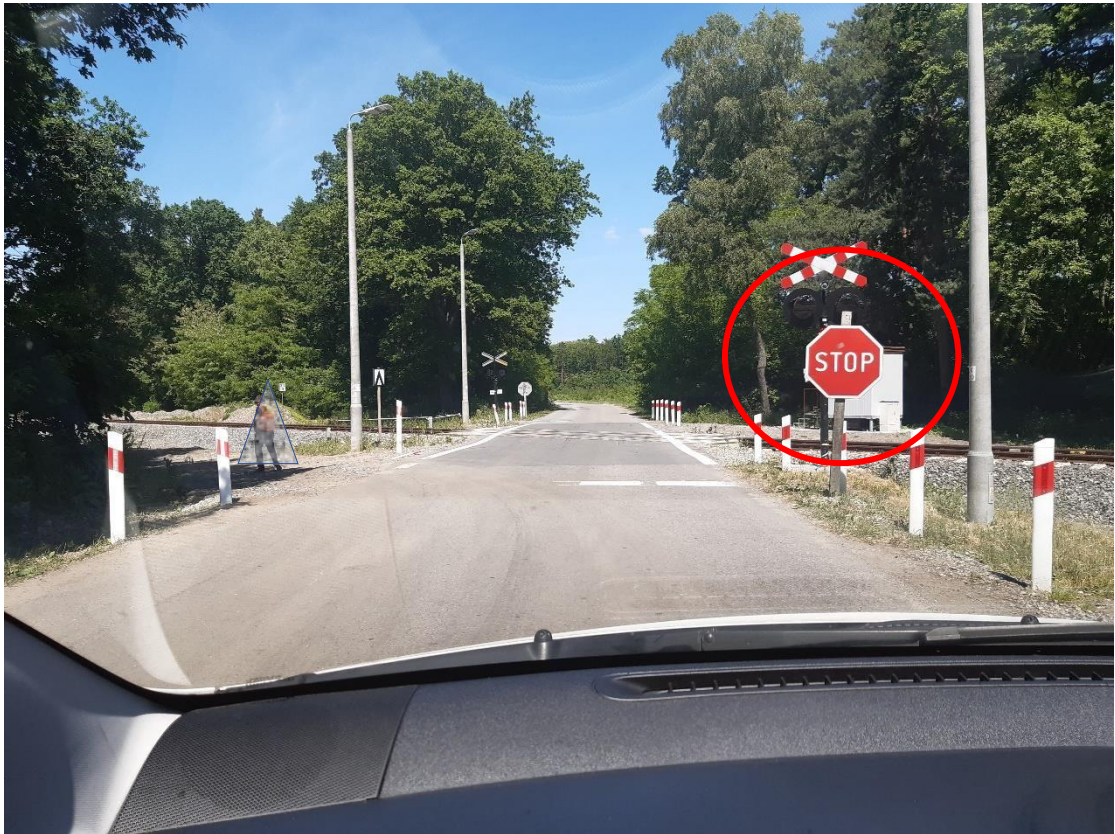
Photograph 8 – Sign B-20 obscuring the “signalling out of order” sign

1. improperly placed B-20 "stop" sign obscuring the plate indicating that the signalling system is out of order – at the side of the the passenger car,
2. The lenses of the traffic signal lights were covered with black film and the signals were not turned in a manner allowing the users of the crossing to see the signalling chambers, which could have caused the passenger car driver to misinterpret that the ssp equipment was operational and the signal was not active because a train was not approaching.

- 1) Labelling the level crossing at 313.328 km of railway line no. 25 at the access roads of district road no. 1283R Brzeźnica – Krownice to the crossing with P12 and B-20 signs pursuant to the applicable laws.
- 2) Introducing a 50 km/h speed limit on road no. 1283R on the accesses to the crossing due to the occurrence of an increased risk of accidents related to excessive speed.
- 3) Setting up temporary A-7 signs on the accesses to the crossing with “Stop” signs stating the distance from the location of the B-20 sign until the formal introduction of a speed limit.

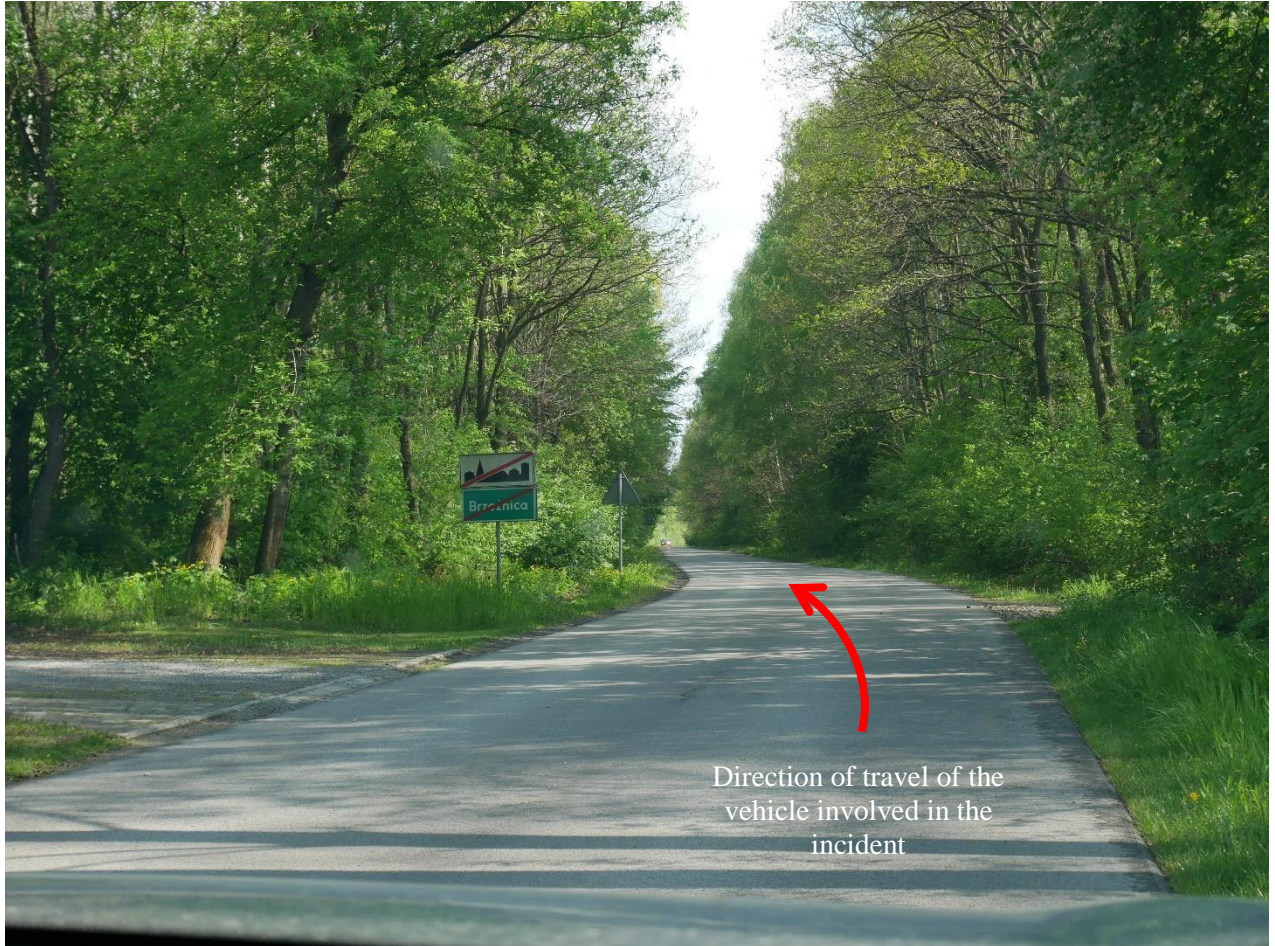
Photo 11 - Road markings in the direction of travel of a car involved in an incident at a level crossing (photo. SCRAI of 09.05.2022)

End of built-up area (50 km/h), start of road in undeveloped area towards the railway/road crossing in question (90 km/h).

- 4) The Road Manager is going to introduce the speed limit up to 50 km/h on the road no. 1283R by the accesses to the level crossing due to the occurrence of an increased risk of accidents related to excessive speed (in accordance with the issued recommendation ref. no. PKBWK.4631.5.2.2021 dated 14 July 2021).
