STATE COMMISSION ON RAILWAY ACCIDENTS INVESTIGATION
Ministry of Interior and Administration

REPORT No. PKBWK 01/2023

**on the investigation of the railway incident
that occurred on October 16, 2019 at 13:51
at Leszczyny station, at km 31.738
railway line no. 140 Katowice Ligota - Nędza**

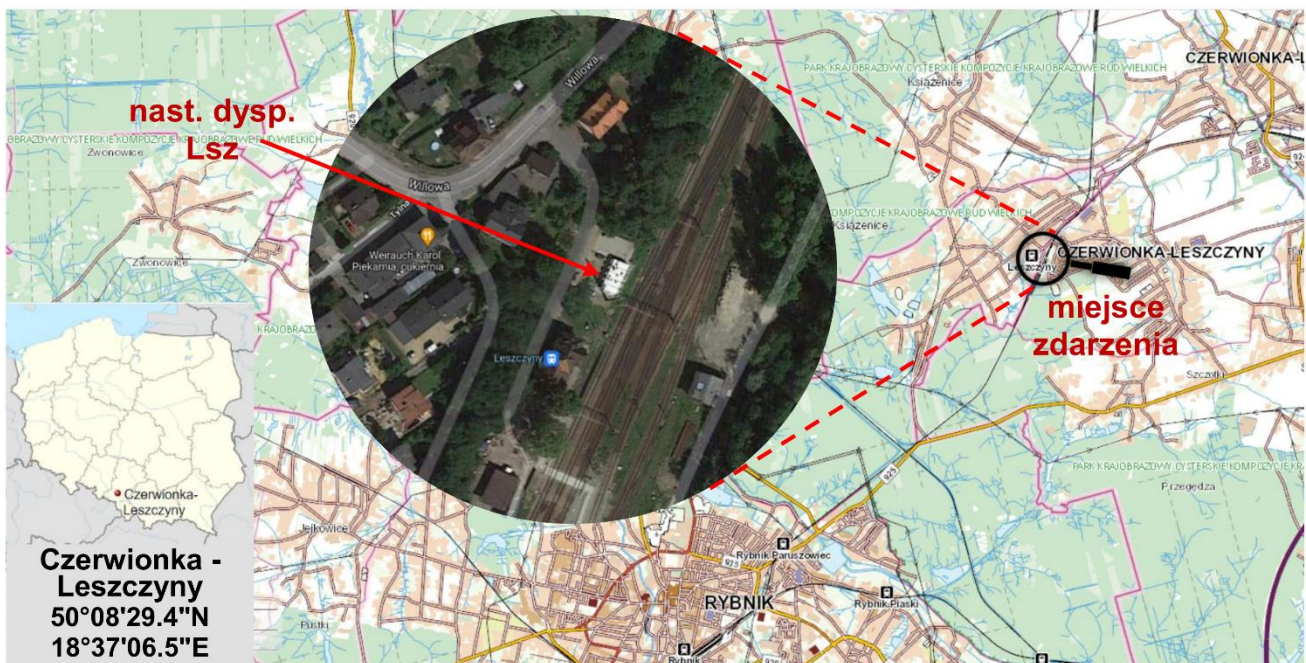
Photo No. 1 - General view of the site.

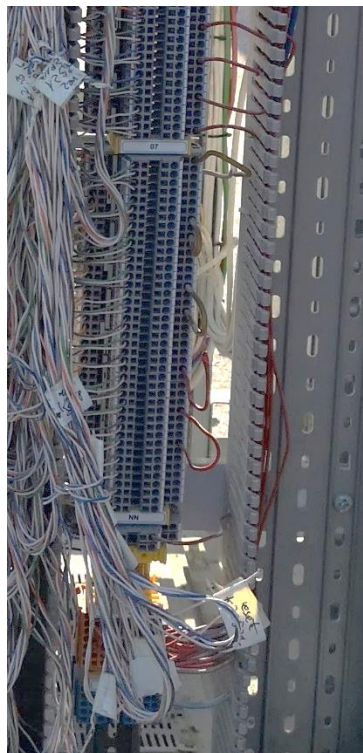
Non-factory connections with wires of 1 mm² cross-section were found on this strip. These connections were not made during the production of the MOR-1.01 system. As a result of the modifications made to the cabinet connections and connections without the knowledge of Z.A. KOMBUD S.A. as the manufacturer of the system, the internal connections in the head No. 07 used for zeroing the axis counter sections were dismantled.

Non-factory bridges were installed in this place. In addition, the cable was installed on top of the 07 head, thus changing the internal connections of the MOR-1.01 cabinet.

The Investigation Team concludes that the factory wiring of the cabinet has been tampered with.

Photo No. 3 - Cable connections after the occurrence

The above-mentioned incorrect connection (contrary to the design) of the power supply to the input module (applying the positive voltage of Ukomp. instead of Usrk.) resulted in a doubling of the supply voltage due to the grounding of the opposite potentials of the two batteries, i.e. SRK battery and Komp. battery.

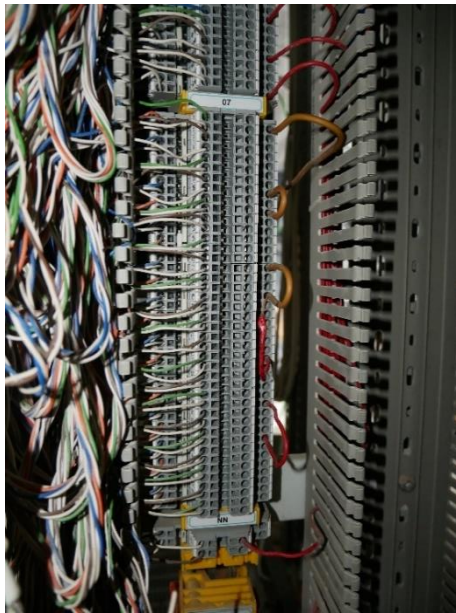
Other connections were made according to the documentation with 0.8 mm² wires. Below are the connections of terminal block #7, which show traces of melting insulation of wires and terminal block inputs not caused by the cabinet fire. The terminal strips show signs of mechanical damage caused by the use of non-factory connections in the form of bridges, which have been repeatedly assembled and disassembled on the strip. The method of attaching wires to the strip, with wires repeatedly inserted and removed, did not ensure proper current flow in the cabinet's circuits, as evidenced by overheating of the wires and terminal strip receptacles not caused by the fire.

According to the Investigation Team, the use of wiring connections in the MOR-1 system cabinet contrary to the manufacturer's solutions and improper connections on the terminal blocks were causal factors in the occurrence.

Photo No. 4 - Terminal strip No. 7 in the MOR-1 cabinet (Photo No.: PKBWK)

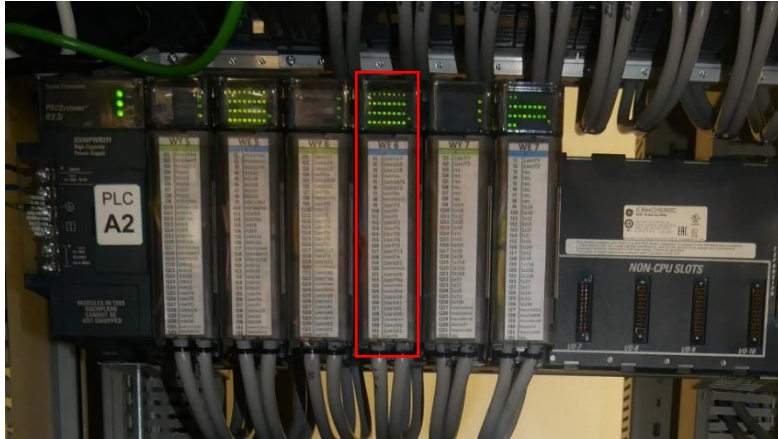
At a critical moment, the continuous opening of the cabinet worsened the thermostat's temperature detection, which led to the failure of the input module. The manufacturer allows a maximum input voltage of 30V.

Photo No. 5 - View of Module 4 - which first reported damage on the day of the occurrence (photo by PKBWK, taken on 05/10/2020 in the new MOR-1 cabinet)

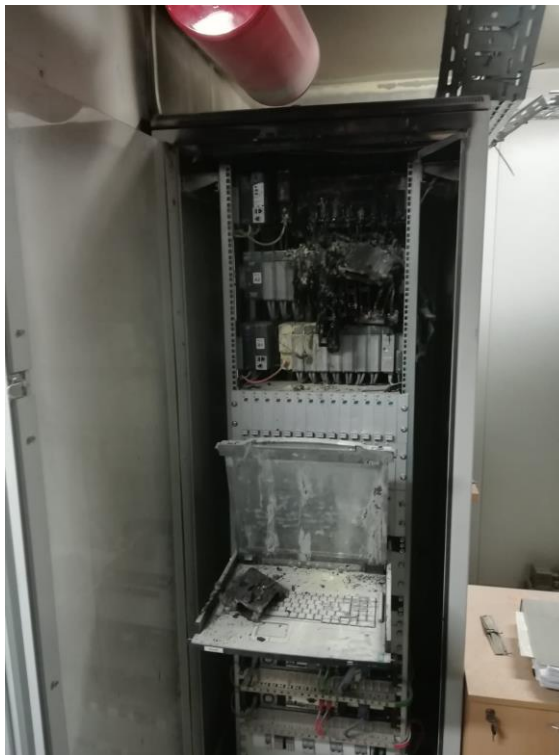
After the fire, all I/O modules in PLC cassette A1 were completely destroyed due to the direct impact of the fire that occurred in one of the modules in PLC cassette A2. The cable bundles connected to the modules burned along with the cable tray. PLC A1 showed no signs of damage. However, the front panel of the power supply of this PLC was found to be deformed. In the PLC A2 expansion tray, the I/O modules from slot 4 upward were destroyed.

Photo No. 7 - Open computer cabinet (Photo: railway commission)

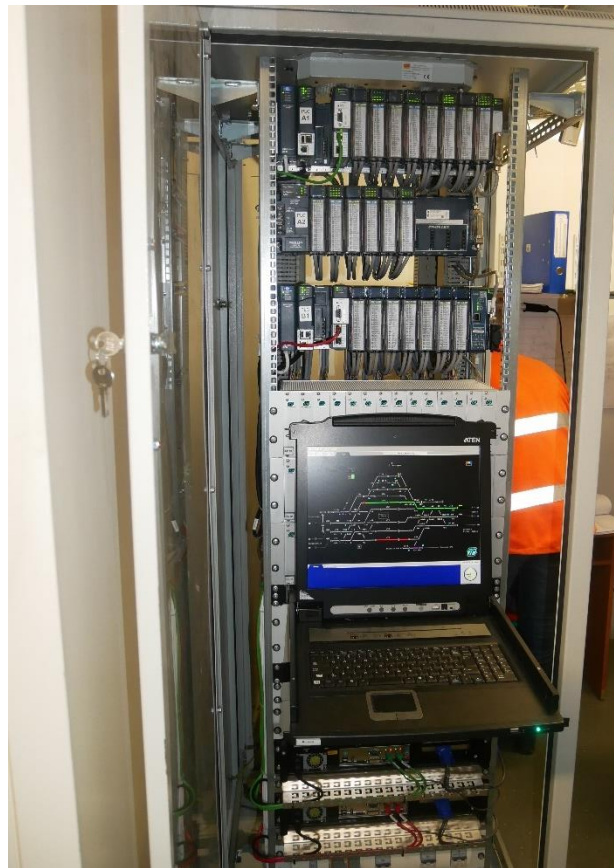
Photo No. 8 - Arrangement of devices in the MOR-1 computer cabinet

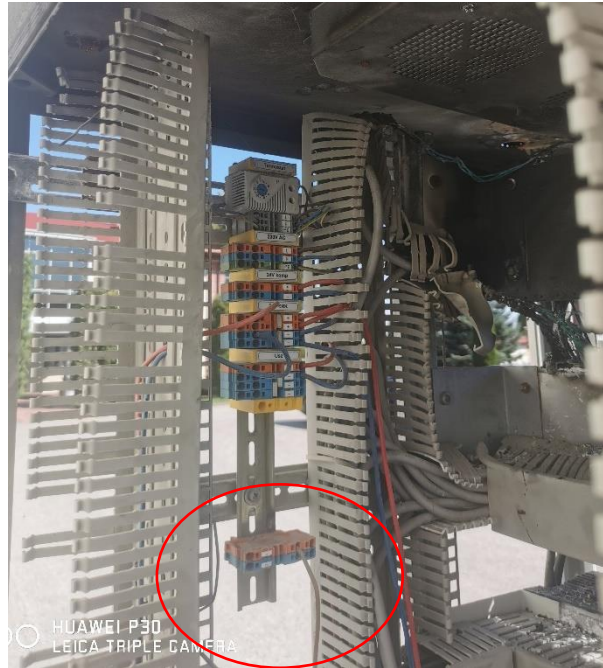
Photo No. 9 - Connections in the computer cabinet of unknown origin that do not correspond to the solutions of the equipment manufacturer (the cabinet was dismantled after the fire and the wires of the connecting cables in the cabinet were cut).

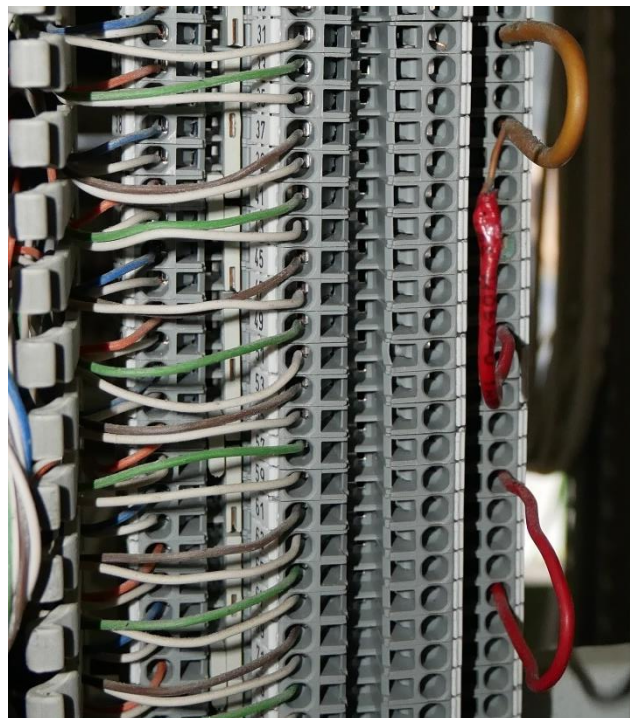
Photo No. 10 - Incorrect connections on terminal block #7 with visible signs of overheating and melting.

According to the Investigation Team, permanent heating at the connection point caused by improper terminal block connections and permanent heating at the top of the computer cabinet caused by a lack of proper cooling contributed significantly to the occurrence.

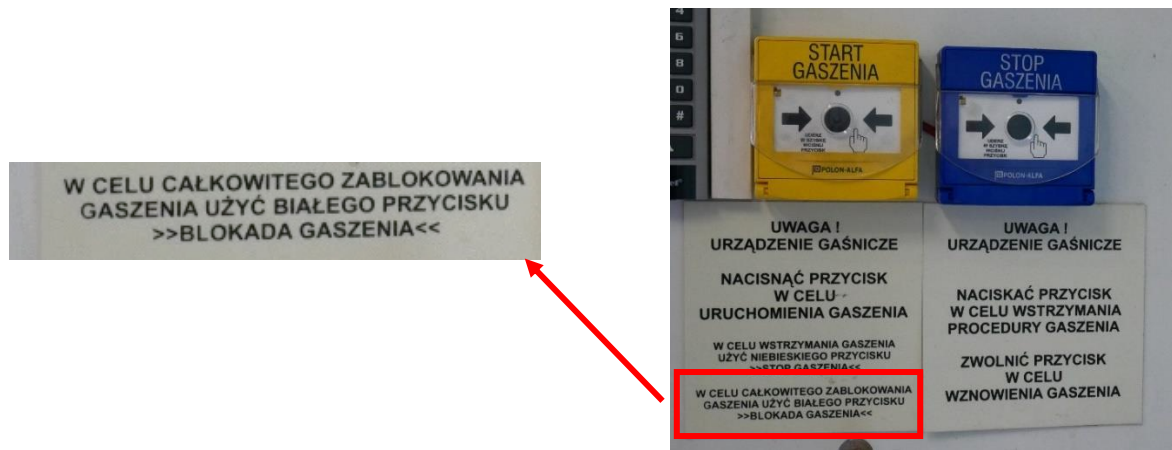
- Lack of all declarations of conformity to the type of the MOR-1 system in the railway traffic control industry's collation report,
- In the relay room of the Leszczyny control room, the fire switches were installed on the wrong side of the entrance door, and the white "extinguishing interlock" button was not installed.

Photo No. 11 - Fire buttons in the relay room

- 4) PKP PLK S.A. shall supplement the records of the Hazard Register in terms of diagnosed risks of fire source of railway equipment.
- 5) PKP PLK S.A. shall change the location of fire switches in the Leszczyny switchyard relay room from the right side to the left side of the door leading out of the relay room, and will install a white "extinguisher interlock" button.
