**STATE COMMISSION ON RAILWAY ACCIDENTS INVESTIGATION**  
**Ministry of Interior and Administration**

**REPORT No PKBWK 08/2022**

**on the investigation of a railway accident  
that occurred on January 14, 2022 at 10:48 am at Kolbuszowa station,  
track No 1Wb, category C level crossing at km 46.925  
railway line No 71 Ocice - Rzeszów Główny  
area of the infrastructure manager PKP PLK S.A. Railway Line Department in Rzeszów**

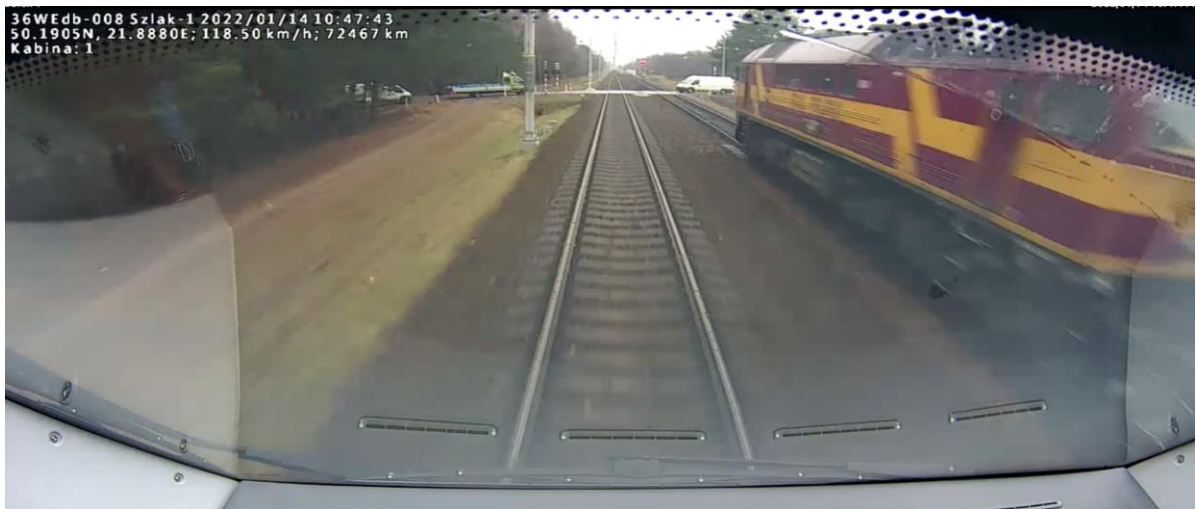
Fig. 2 - View from the driver's cab as the car entered the crossing (2 seconds before the occurrence)

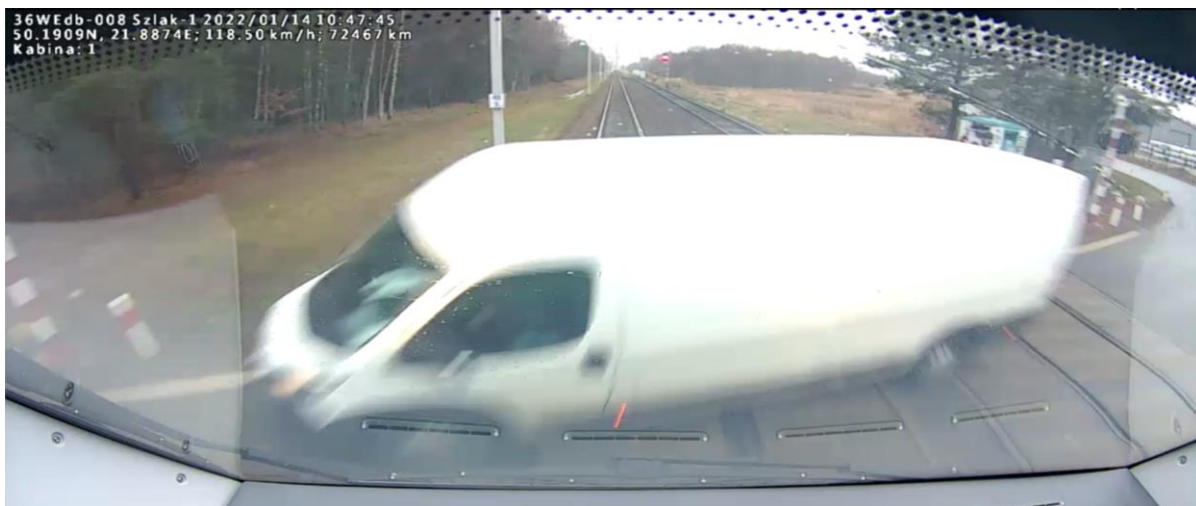
Fig. 3 - View from the driver's cab just before hitting the car

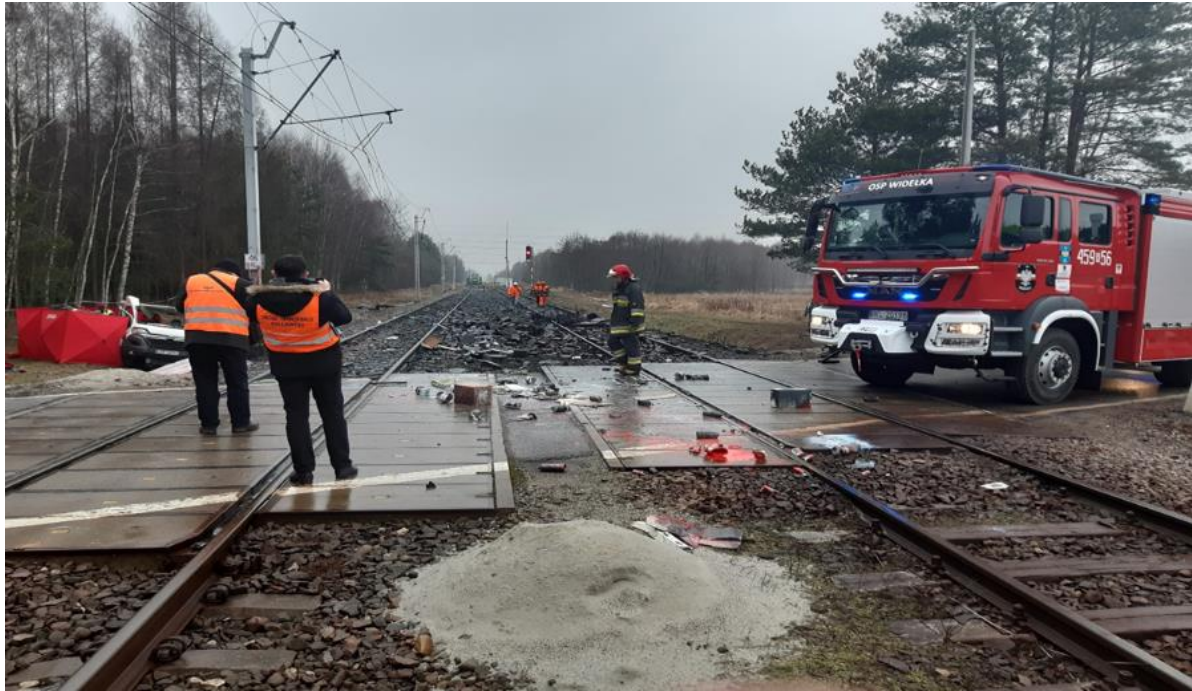
Fig. 4 - The scene of the accident (railway commission material)

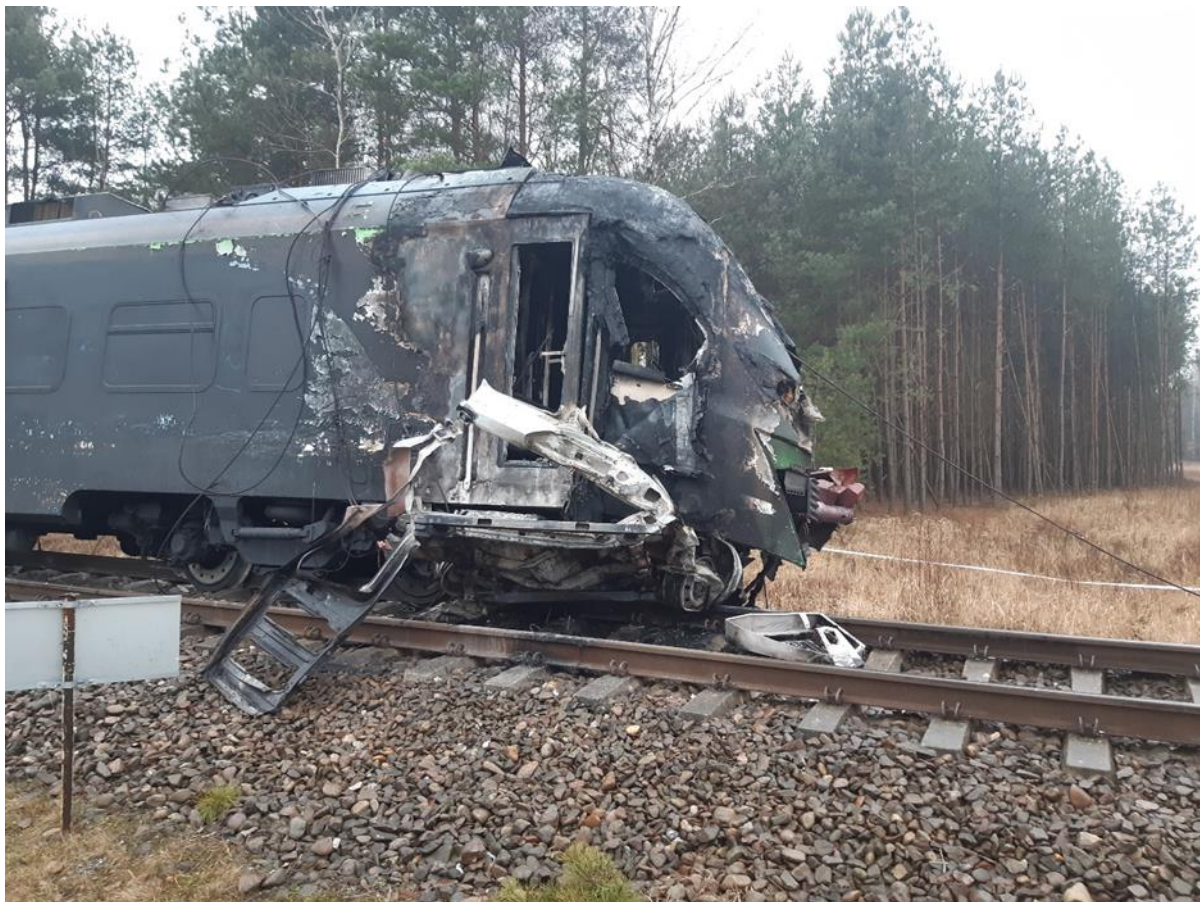
Fig. 5 - The aftermath of the occurrence (railway commission material)

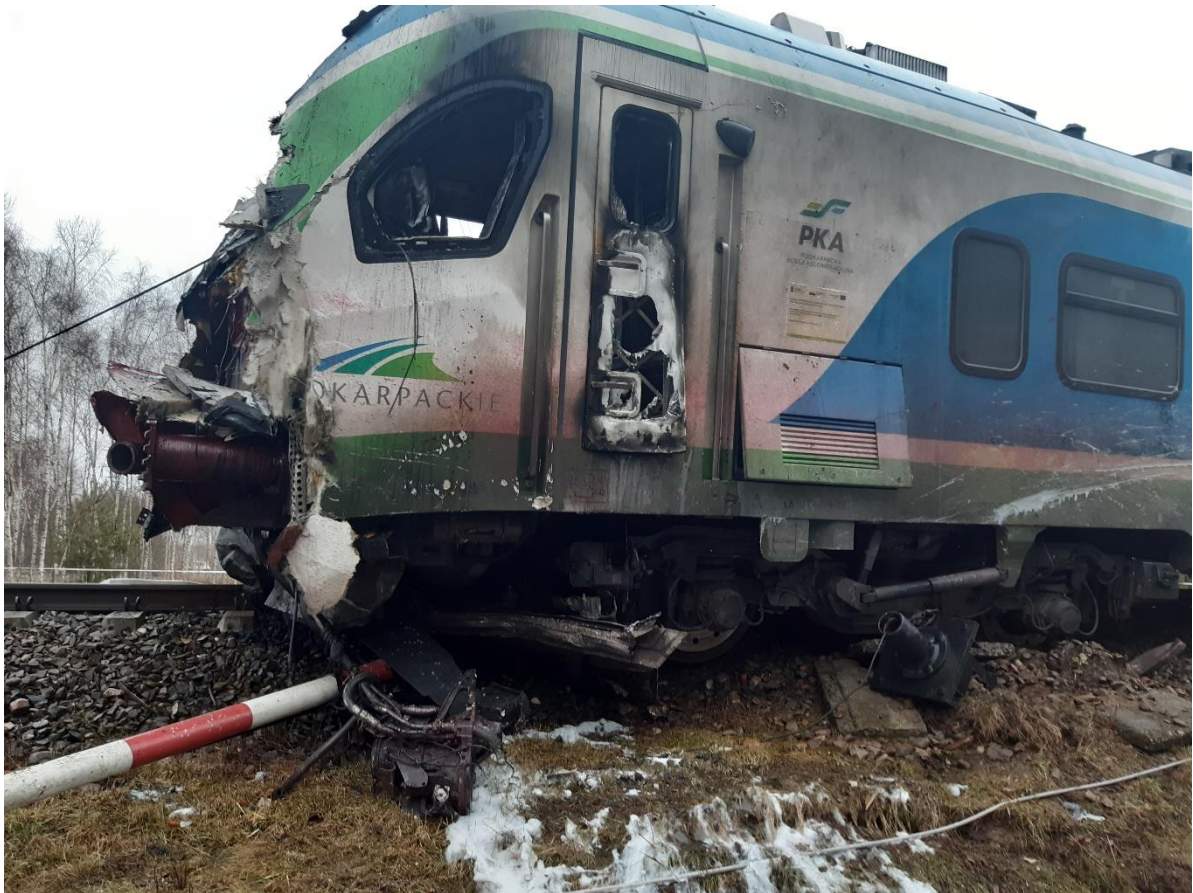
**Fig. 6 - The aftermath of the occurrence (railway commission material)**

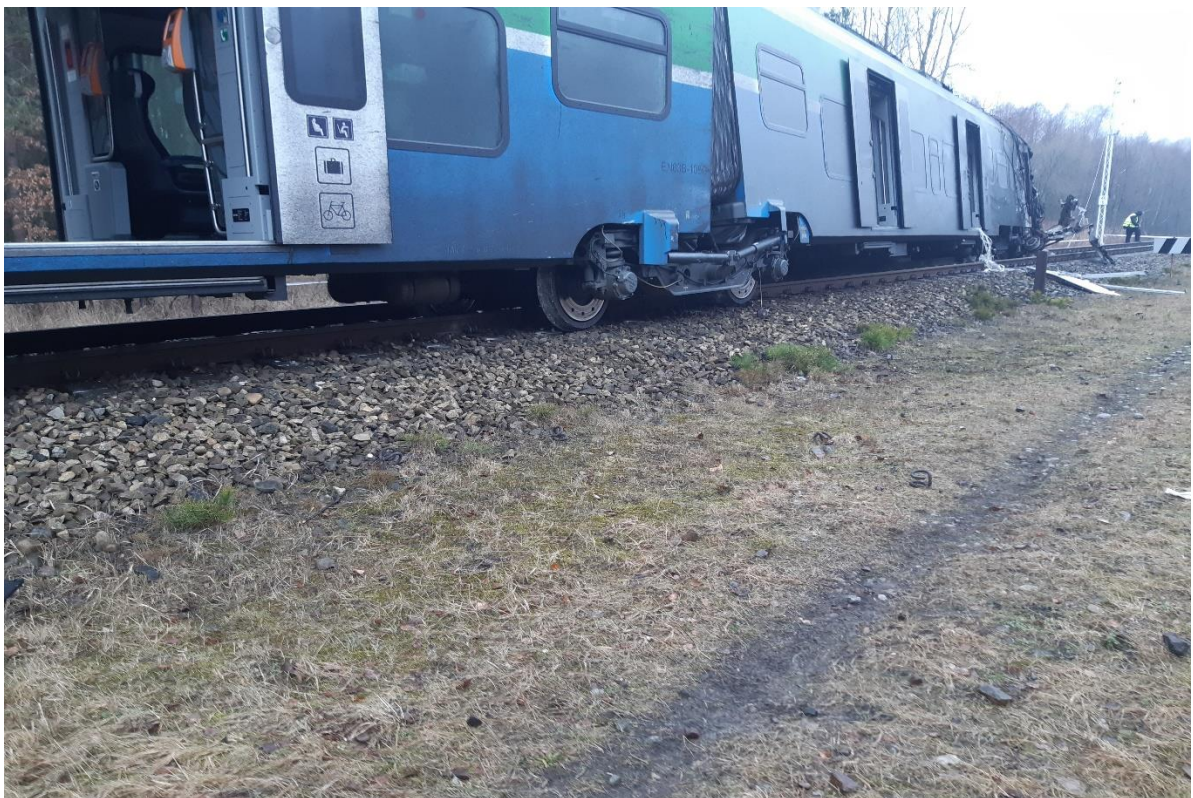
**Fig. 7 - The aftermath of the occurrence (railway commission material)**

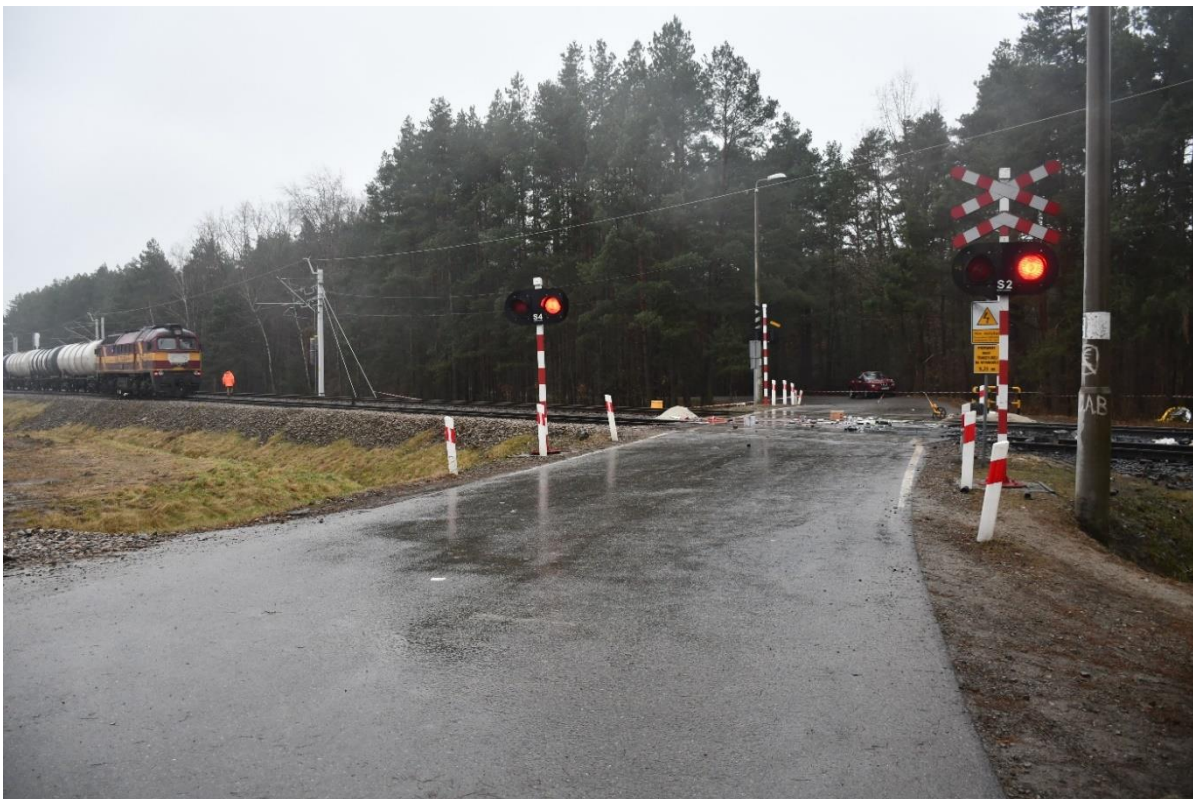
Fig. 9 - View of the crossing from the direction of the van (railway commission material)

(a) On both sides of the crossing, visibility conditions from the road are not provided. Lack of visibility of traffic signals from a distance of at least 100 meters due to the crowns of trees on the approaches to it, which does not meet the requirements of the provision of § 49 (1) (6) of the provisions of the *Regulation of the MINISTER OF INFRASTRUCTURE AND DEVELOPMENT of October 20, 2015 on the technical conditions to be met by intersections of railway lines and railway sidings with roads and their location*, as an implementing regulation under Article 7 (2) (2) and (3) (2) of the Act of July 7, 1994. - Construction Law.

(b) On both sides of the crossing, the conditions of visibility of the crossing from observation points for the permissible speed of road vehicles of 90 kilometers per hour (required 120 meters, actual 50 meters) were not observed, as stipulated in Appendix No. 3, Chapter A, paragraph 1 of the aforementioned regulation.

- 1) Introducing a speed limit of up to 50 km/h on road No. 1214R on the accesses to the crossing in connection with the failure to meet the requirements of the provisions of the Regulation of the MINISTER OF INFRASTRUCTURE AND DEVELOPMENT of October 20, 2015 *on the technical conditions to be met by the intersections of railway lines and railway sidings with roads and their location*, Annex No. 3, paragraph A, 1 as an implementing regulation to Article 7 of the Construction Law.
- 2) Mark the crossing (on the side of Road 9 - the left side of the crossing) with an A-10 sign in accordance with regulations.
- 3) Mark the crossing with P-14 horizontal signs.

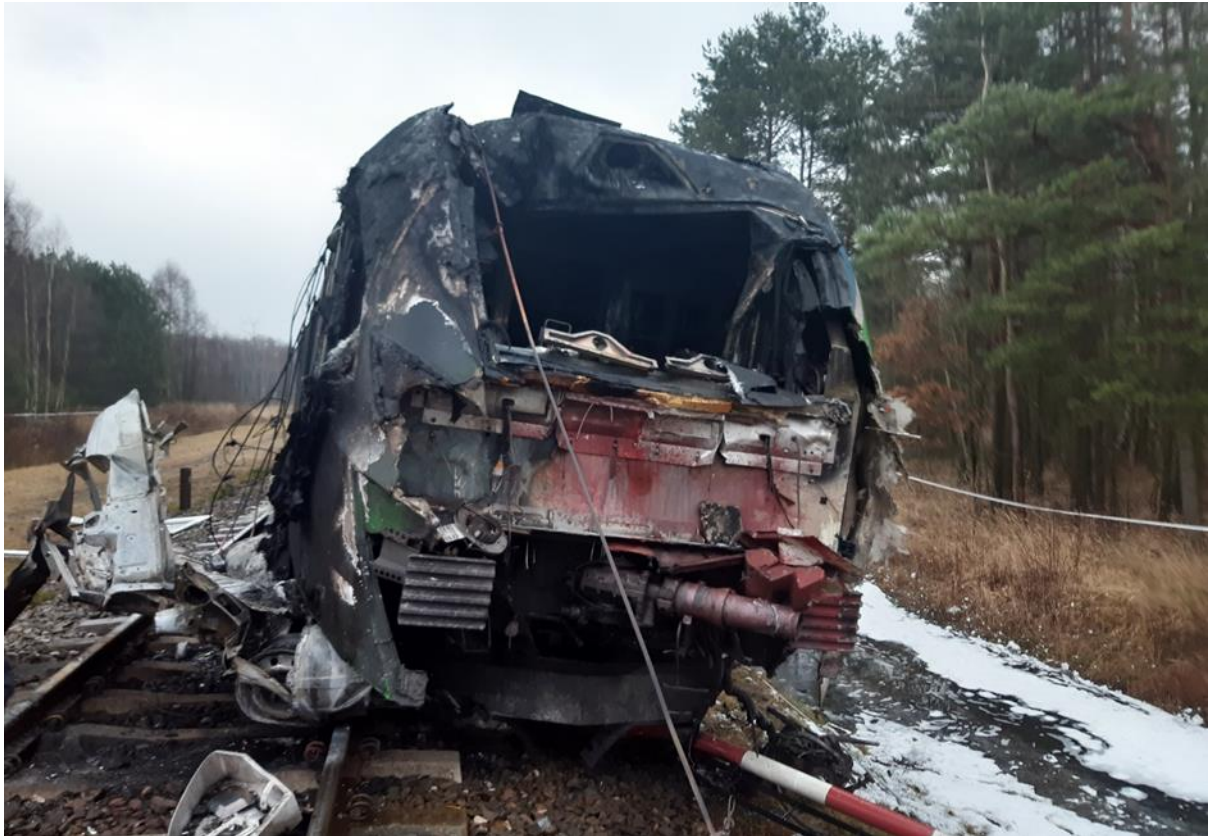
The first section of the EN63B-108 electric multiple unit was completely destroyed. The train was derailed by the first and second bogies, causing damage to the wheelsets.

Fig. 10 - View of the railway vehicle after the accident

As a result of the collision between the train and the road vehicle, there was an explosion in the driver's cab of vapors emanating from damaged packages of flammable goods carried by the delivery truck, causing the door leading to the driver's cab to be torn off and causing serious injury to the train passenger.

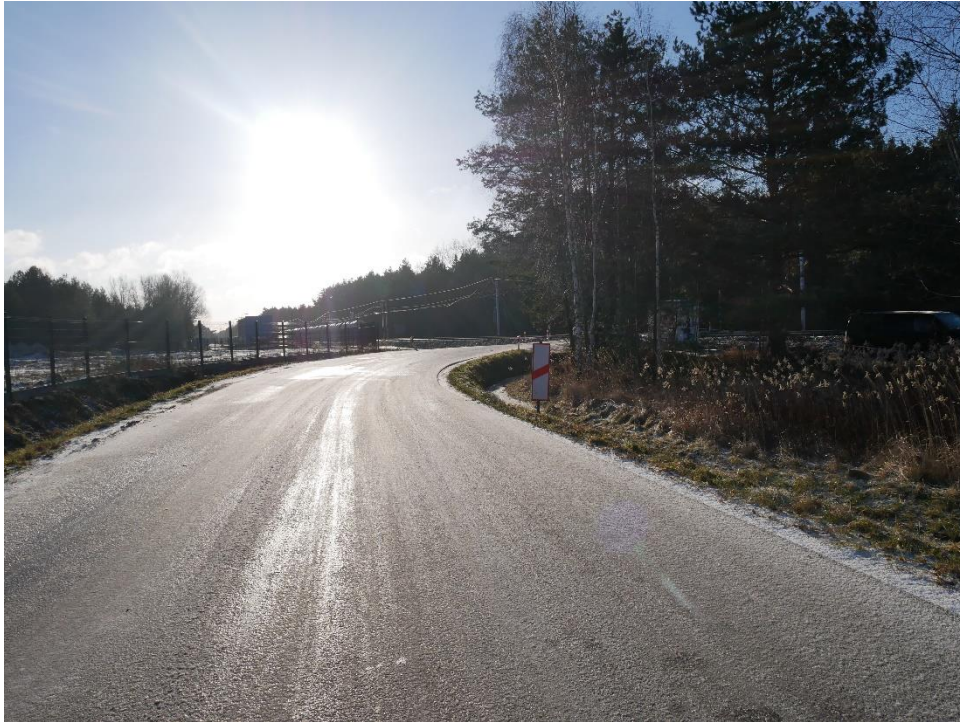
1. Lack of visibility of traffic signals transmitted by traffic signals from 100 meters from both directions of access to the crossing.
2. No P-14 horizontal signs.
3. On the access road to crossing No. 1214R from State Road No. 9 (left side of the crossing) improperly built sign A-10, G-1a and G-1b (improper foundation height).
4. On district road No. 1214R, class Z, the speed limit was 90 km/h with the speed limit for this class of road below 60 km/h.
5. In the area of the level crossing, a fixed point of the jointless rail track in the form of S60 rail dug vertically is located.

**Fig. 11 - Visibility of traffic signals from the direction of the vehicle (PKBWK material)**

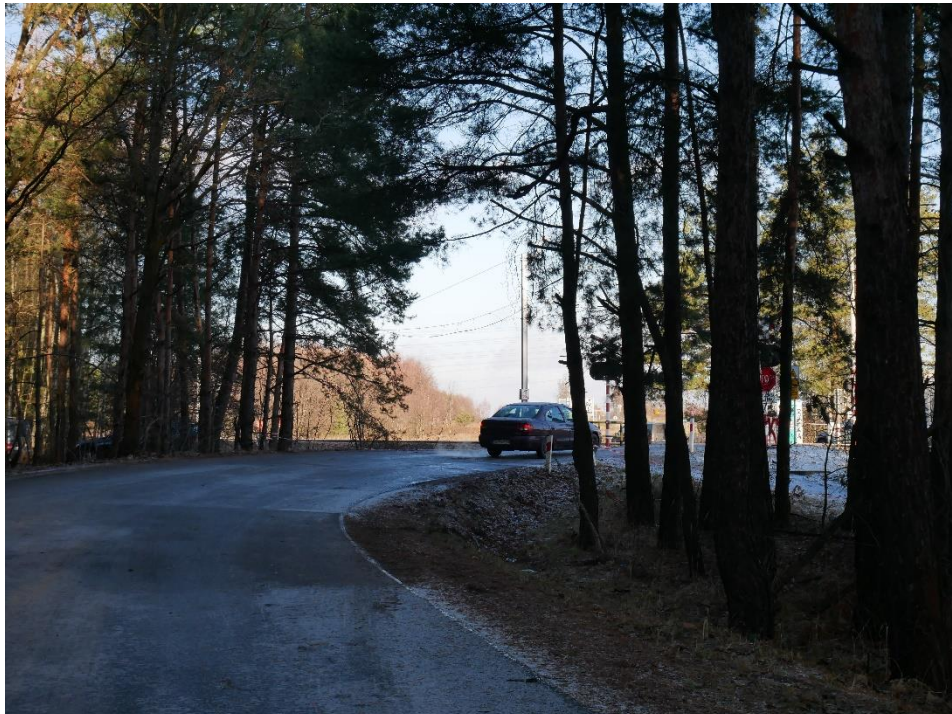
**Fig. 12 - Visibility of traffic signals from the opposite side of the crossing (PKBWK material)**

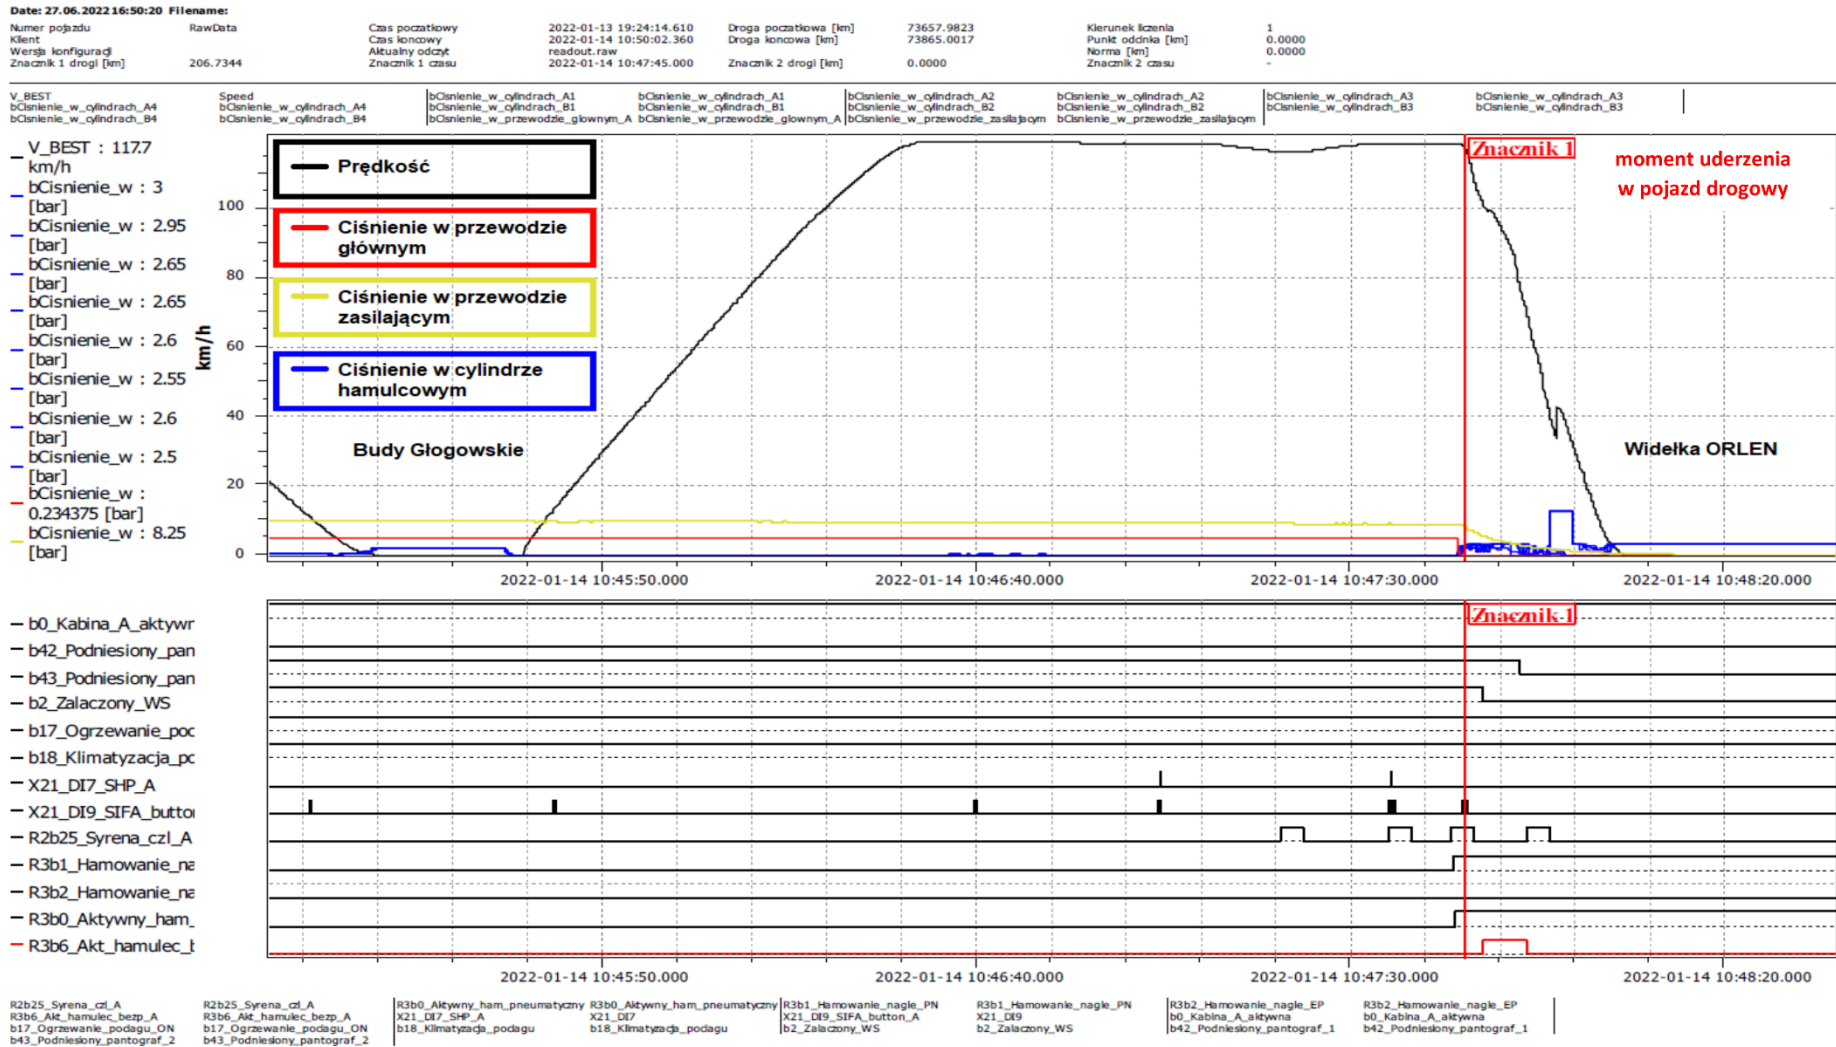
During the operation of the train, the driver's responses to the operation of ABP (Automated Train Safety) equipment - correct. Train operated in accordance with the timetable and Appendix 2 to the timetable and written order "O" issued for this train. Scheduled speed of the train on this section is up to 120 km/h.

Figure 3 - Graph of EN63B-108 locomotive driving parameters as a function of time (PKBWK material)
