**STATE COMMISSION ON RAILWAY ACCIDENT INVESTIGATION**  
**Ministry of Interior and Administration**

**REPORT No. PKBWK 02/2023**

**on the investigation of a railway accident  
that occurred on June 20, 2022 at 12:55  
at the Regalica junction station,  
Poznań Główny POD - Szczecin Główny railway line No. 351 at km 204.079**

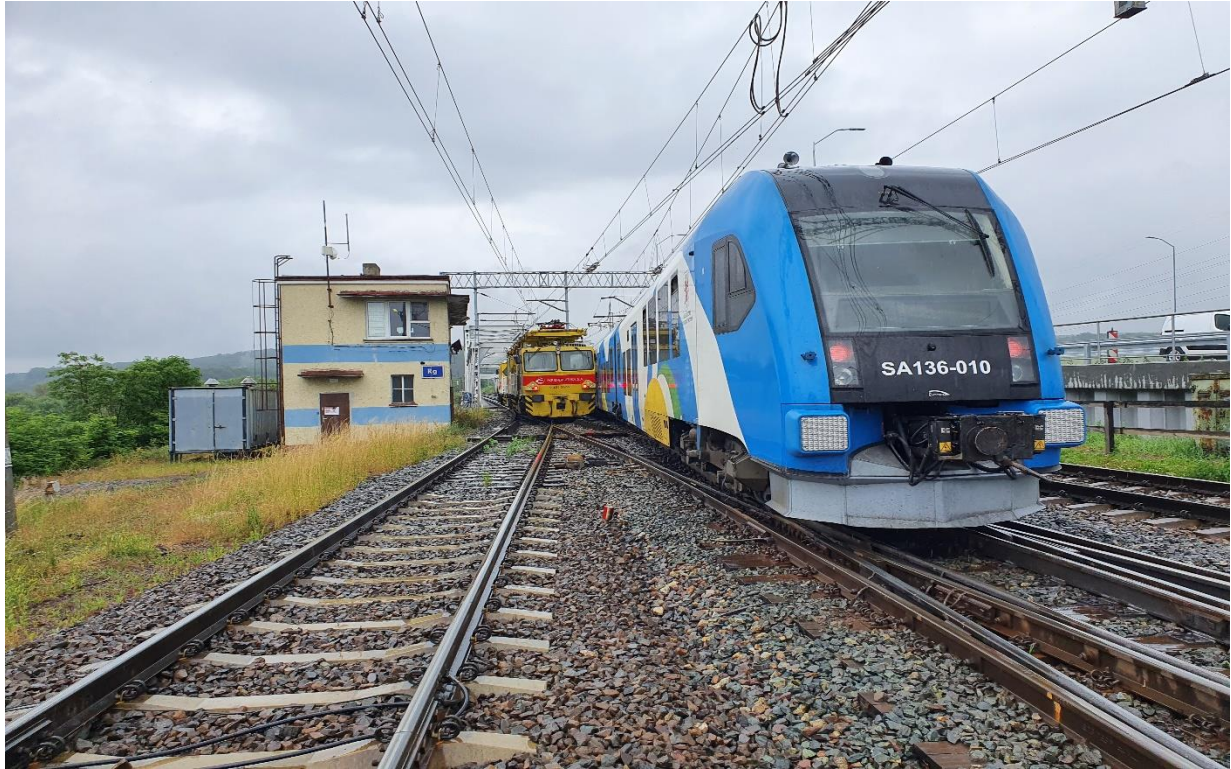
Photo 1. View of the vehicles after the occurrence (source: materials provided by the railway commission)

The SA136 series rail bus, type 219M, suffered damage in form of scratches and perforation of the plating of the left side wall, the left door wing of the first door of the first carriage. The right door wing of the first door of the first carriage was destroyed and torn out.

As a result of the collision, on the WM15P.00/HB-19 maintenance train, the left towing hook on the A-cab side was broken off.

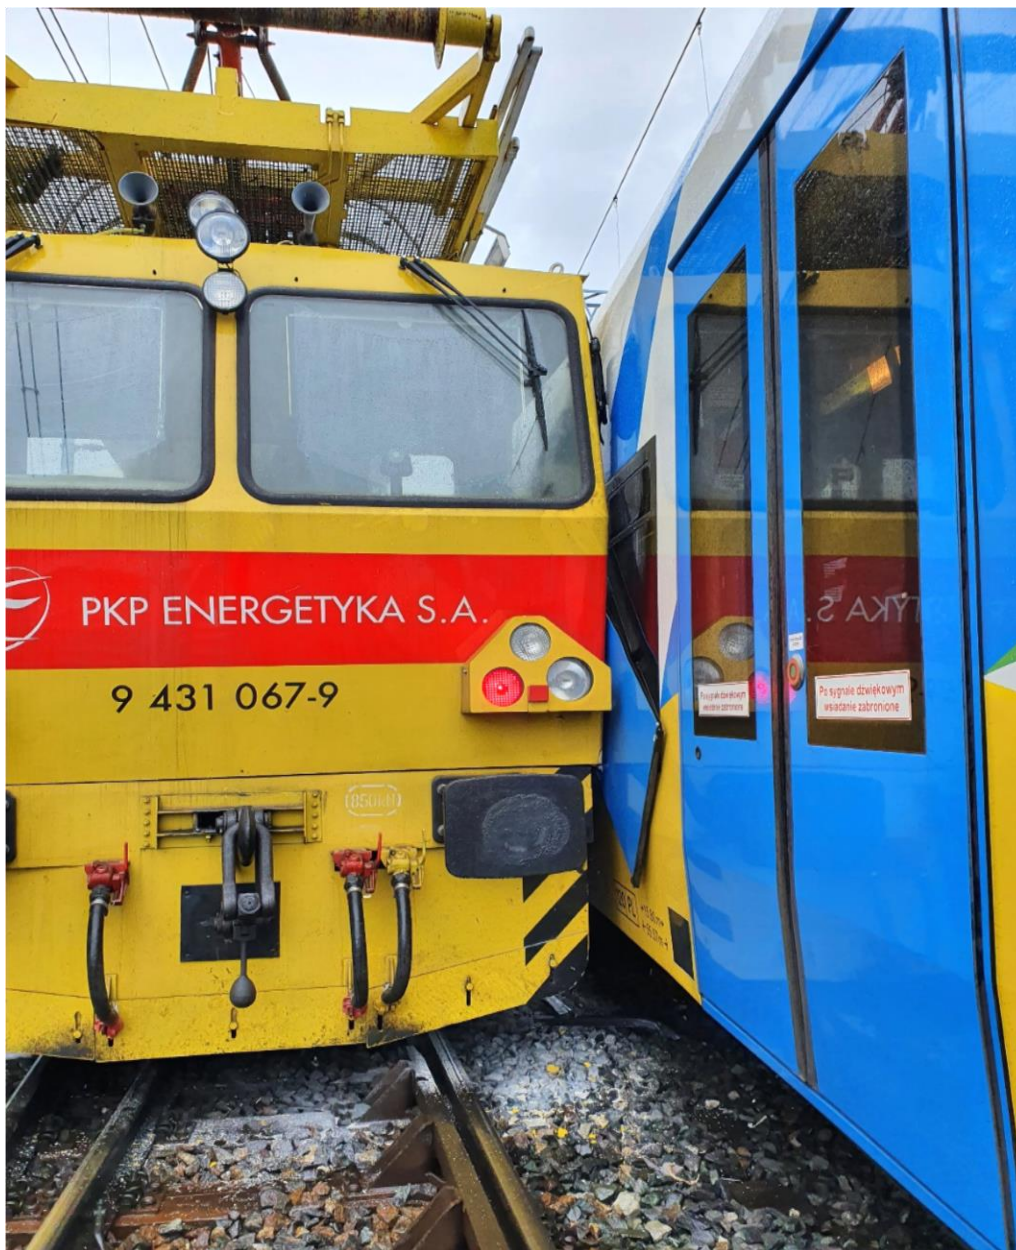
Photo 2. View of the site of the vehicle clash (source: materials provided by the railway commission)

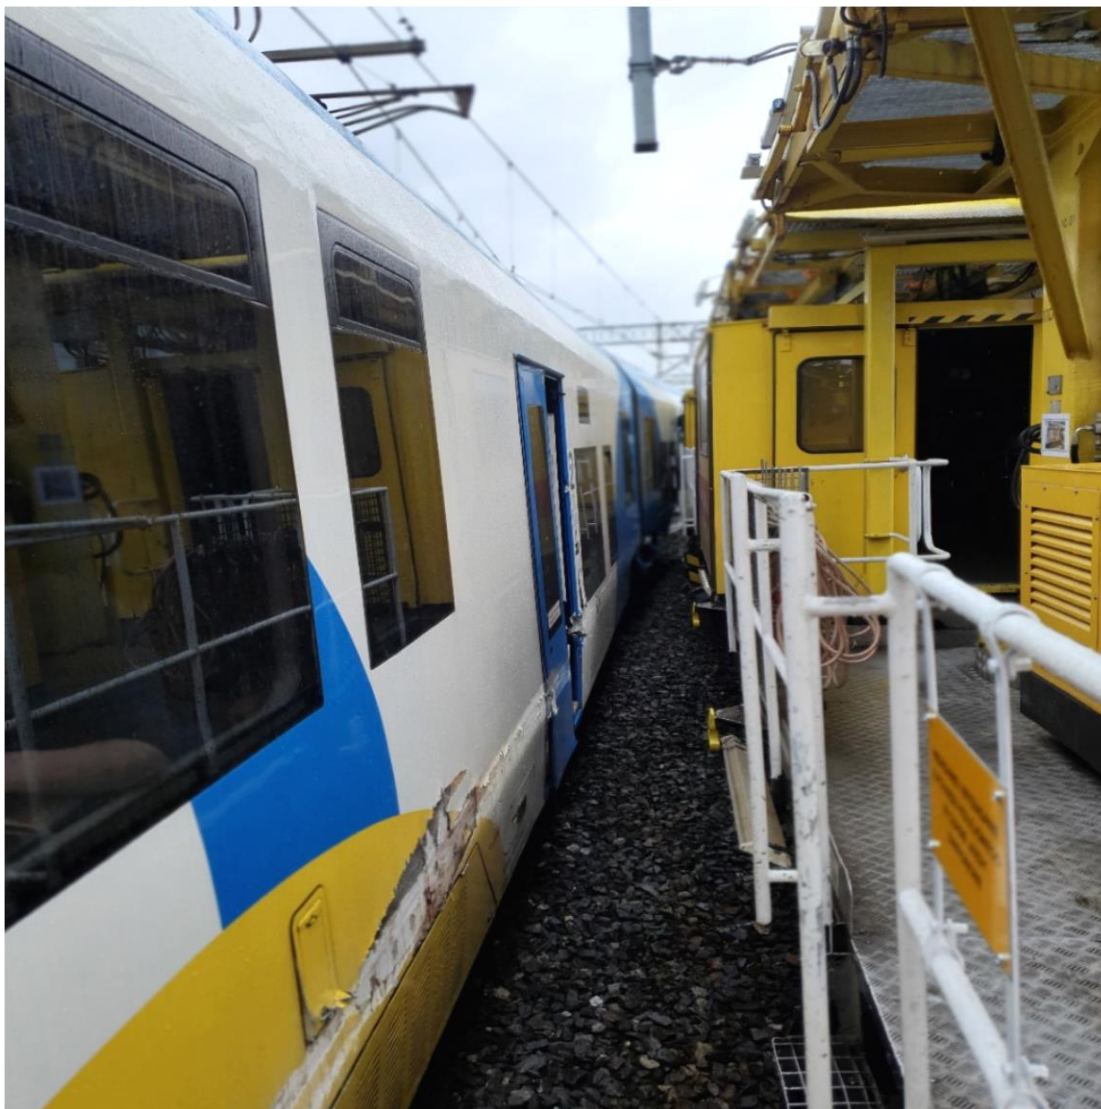
Photo 3. View of the aftermath of the occurrence (source: materials provided by the railway commission)

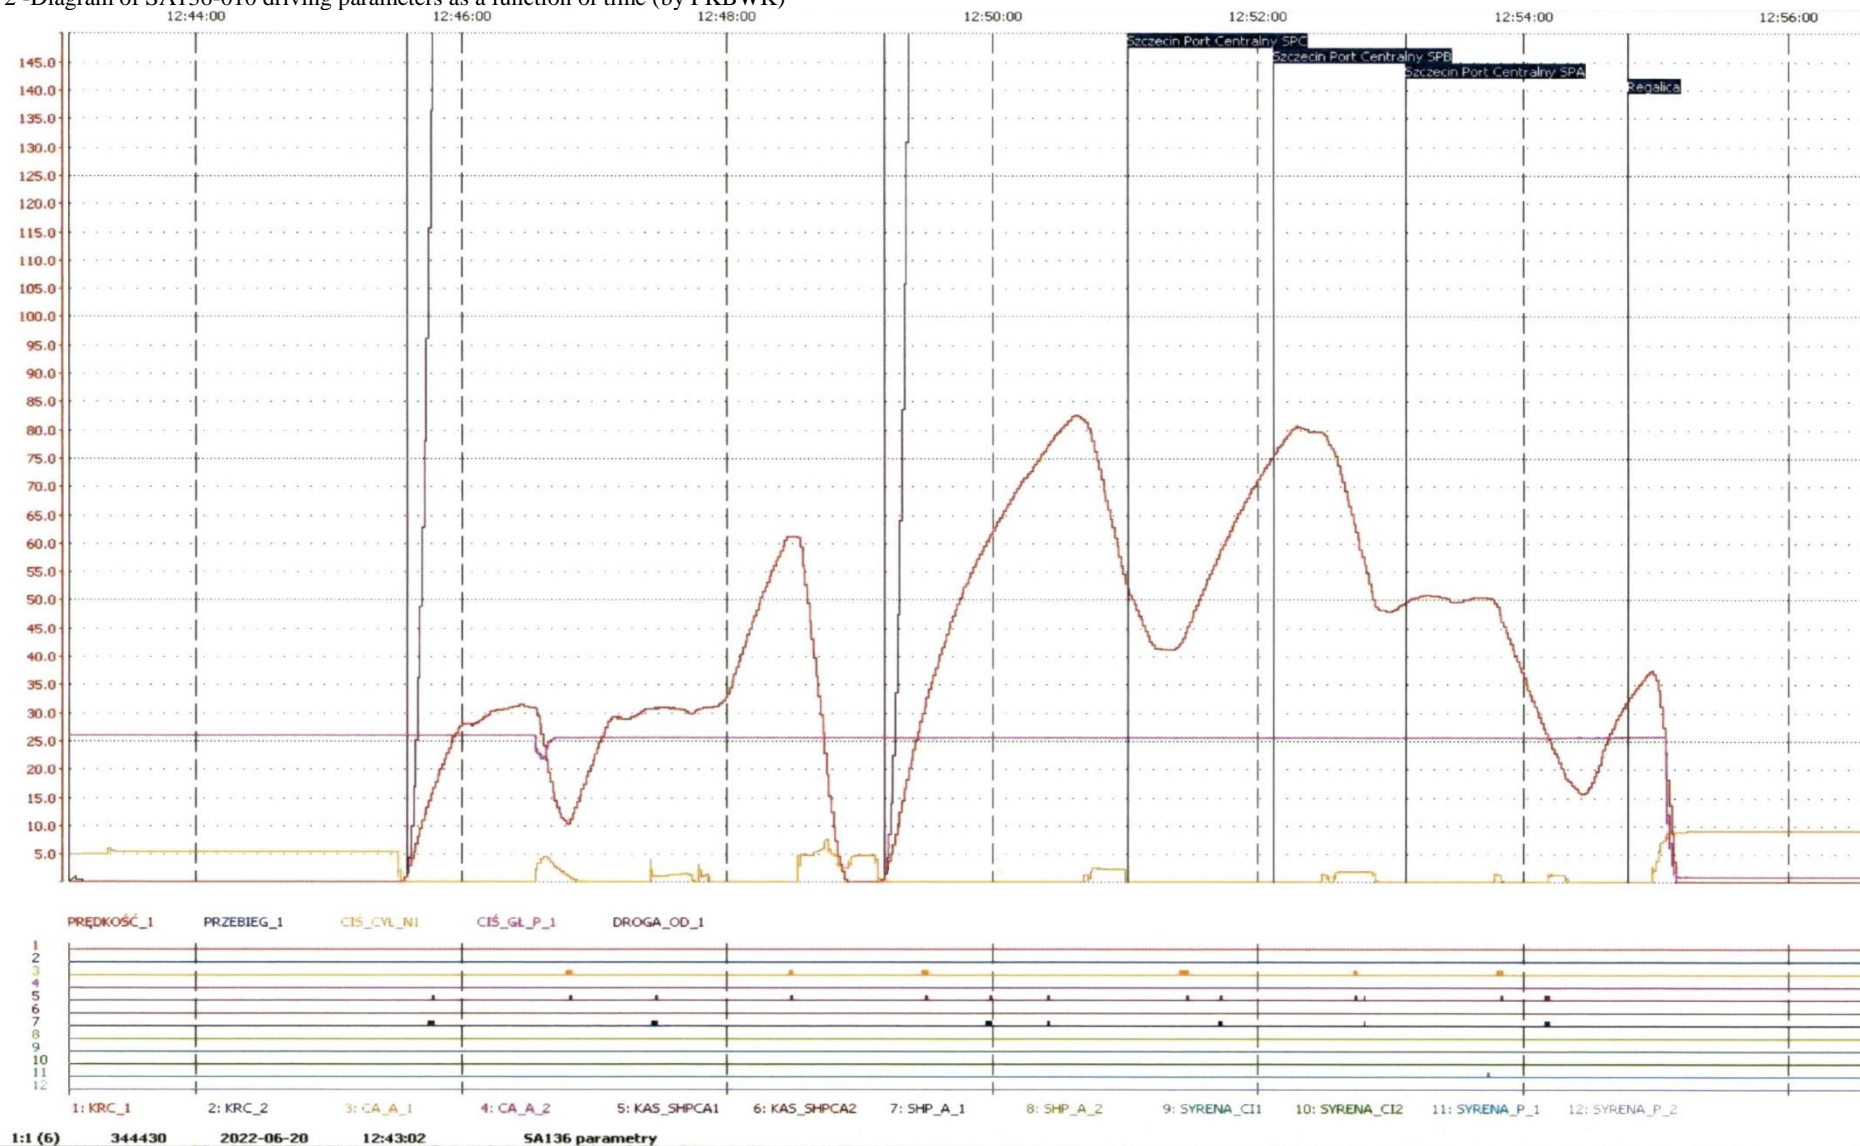
Figure 2 -Diagram of SA136-010 driving parameters as a function of time (by PKBWK)

The parameters of the ROM 88628/9/9 train recorded from 12:45:34 to 12:55 were analyzed.

- 12:45:34 start of the train at the departure station Szczecin Główny, increase of speed to 30 km/h and performing control braking, reducing the speed to 10 km/h,
