STATE COMMISSION ON RAILWAY ACCIDENTS INVESTIGATION
Ministry of Interior and Administration

REPORT No. PKBWK 07/2022

on the investigation of a railway accident
that occurred on February 03, 2022, at 06:14 on the route Warlubie - Laskowice Pomorskie,
on track no. 2, category B level crossing at km 437.386
railway line No. 131 Chorzów Batory - Tczew
area of the Infrastructure Manager PKP PLK S.A. Railway Line Department in Bydgoszcz

WARSAW, December 14, 2022.

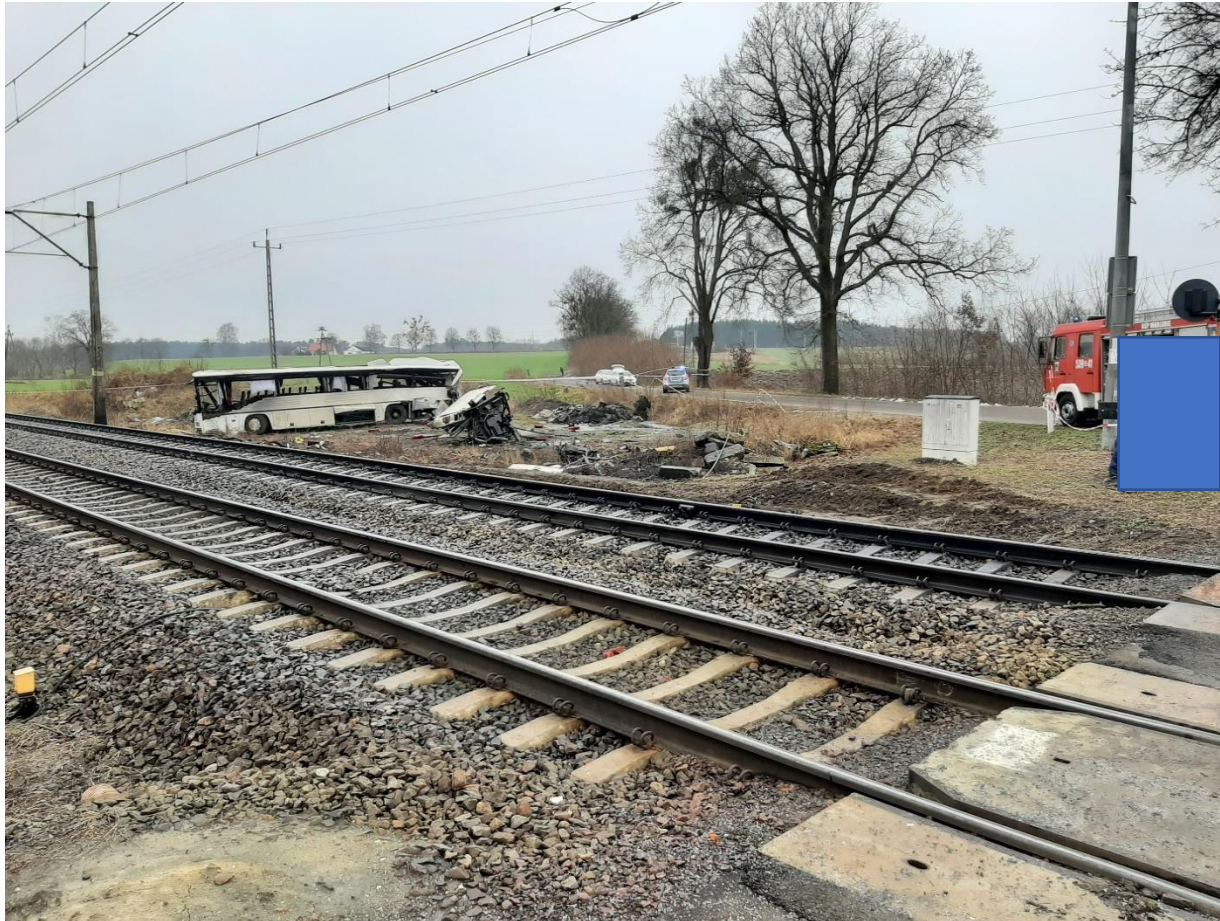
Implications of the occurrence: As a result of the occurrence, the bus driver died on the spot. The bus was destroyed and the EU07A-002 locomotive and two train cars were damaged.

Fig. 1 - The aftermath of the occurrence (PKBWK's own material)

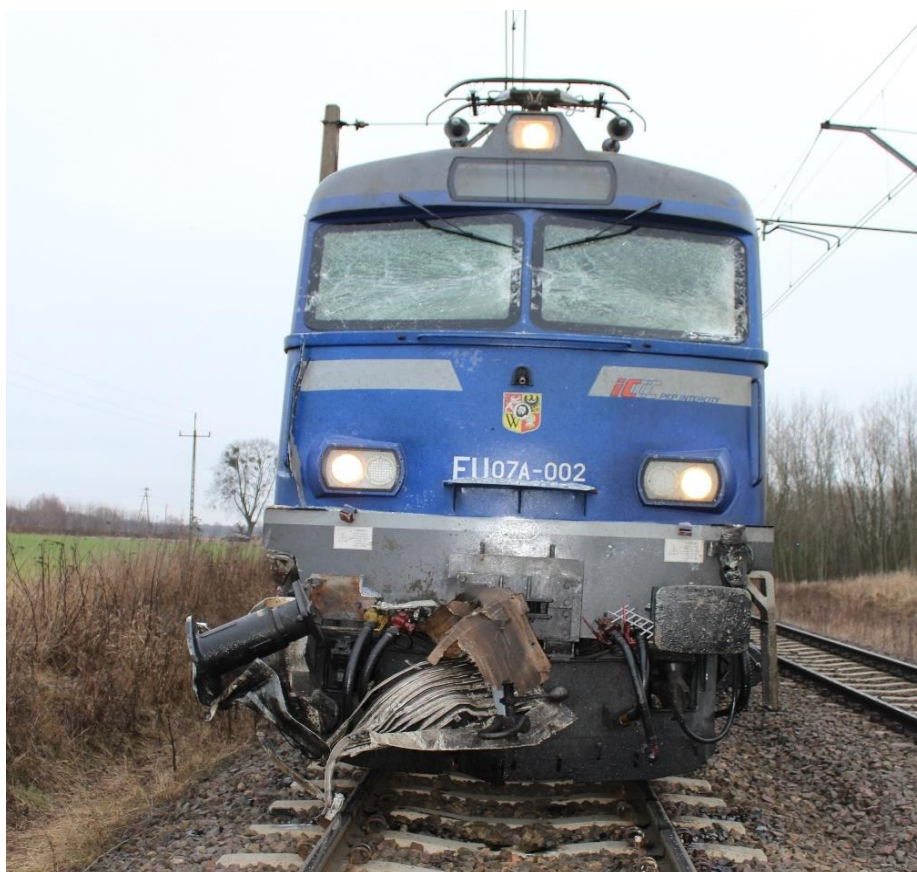
Fig. 2 - The aftermath of the occurrence (PKBWK's own material)

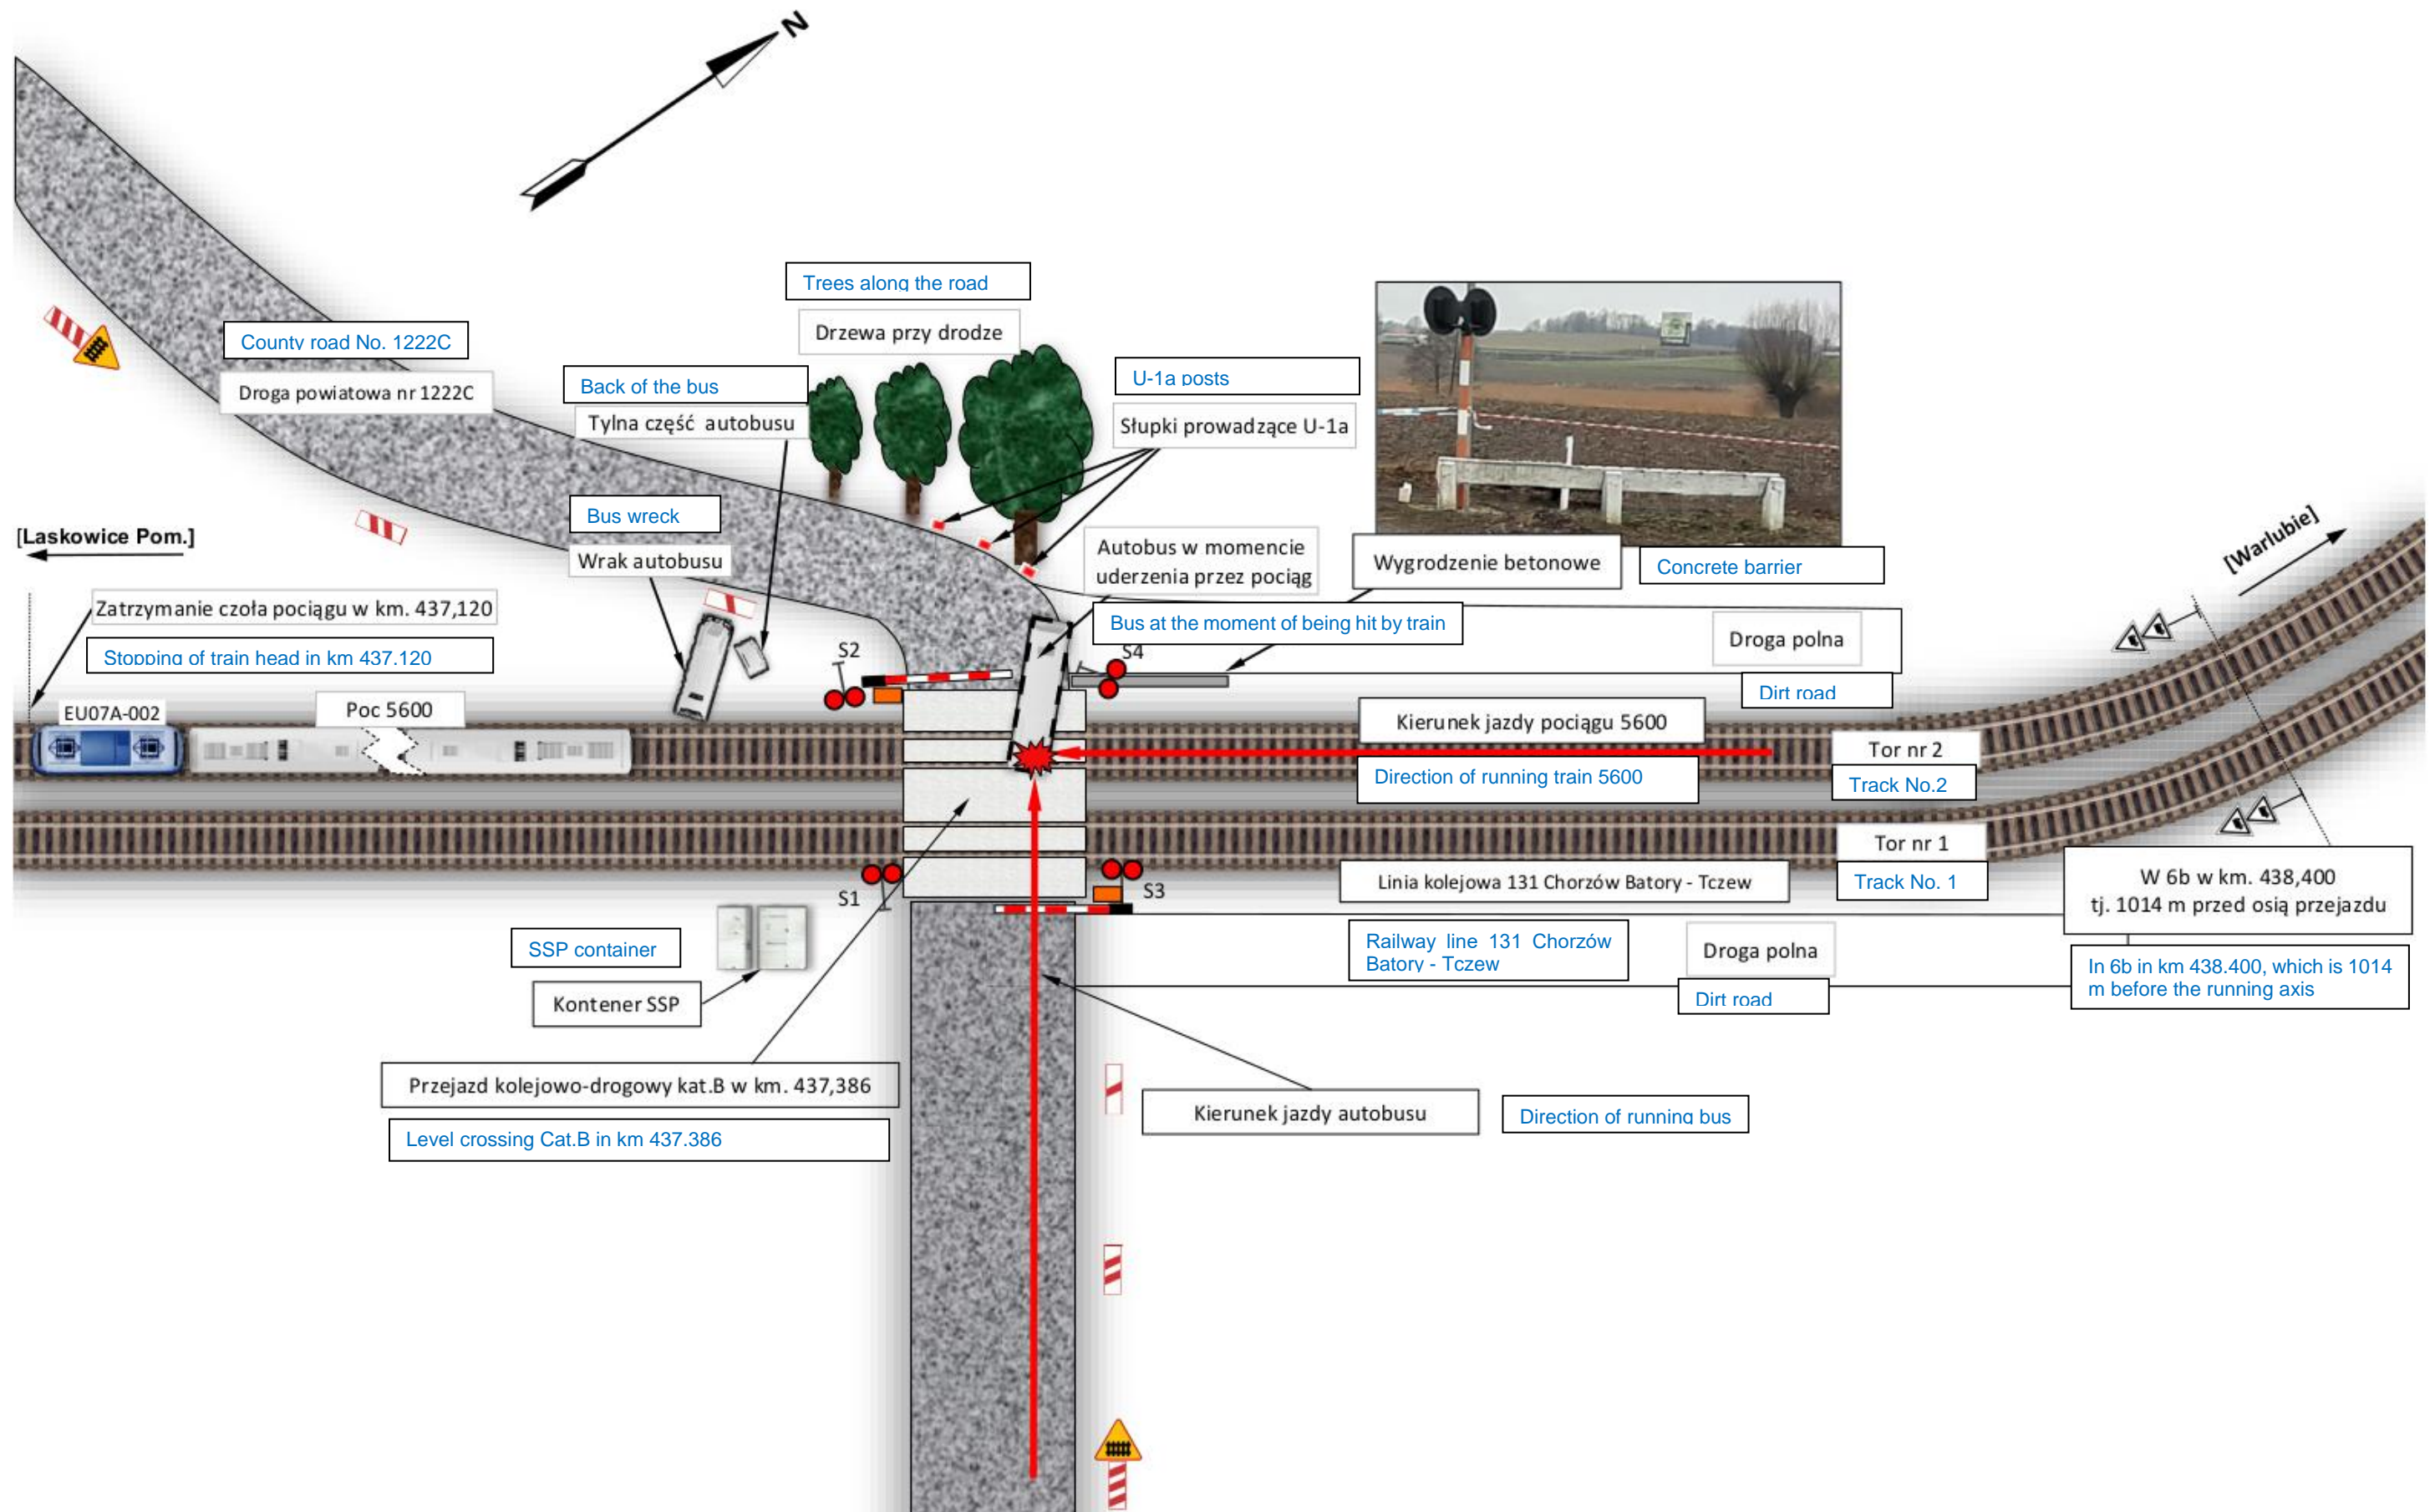
Figure 1 - Sketch of the accident (PKBWK material)

automatic crossing system. The distances of the traffic signals from the outermost rail of track 1 are: S1 - 6.5 m, S3 - 6.7 m, while from the outermost rail of track No. 2 they are: S2 - 6.5 m, S4 - 6.1 m. The crossing is equipped with semi-control barriers that close the entrance to the crossing from both directions of travel on county road No. 1222C. Visibility of signals given by traffic signals correct. At the S4 traffic signal at 5.50 meters from the outermost rail of track No. 2, parallel to the track axis, a concrete fence is built, preventing safe exit from the crossing. In the direction of the village of Bąkowski Młyn (the direction of the bus), there is a tree behind the crossing at 11 meters from the extreme rail of track No. 2, in front of which the road turns sharply to the left (Figure 1). The tree made it difficult for the bus to turn gently to the left to avoid damaging the turnpike devices and for the bus to stay in its lane while turning without occupying the opposite lane. The geographical coordinates of the crossing are 53°34'44 "N 18°36'54 "E. The occurrence occurred during dark season without precipitation or fog, with an ambient temperature of -2°C. No work was carried out in the area of the crossing affecting the occurrence.

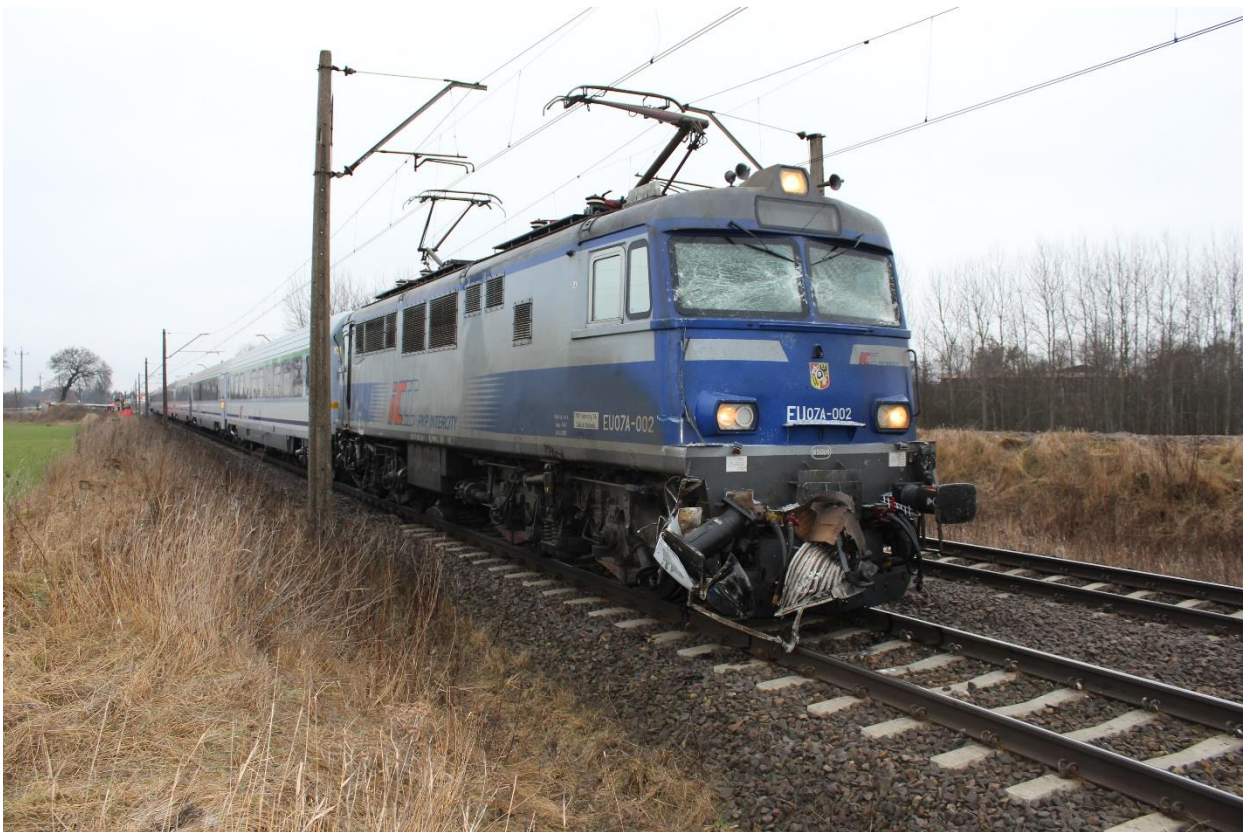
The train was not derailed. The front end of locomotive EU07A-002 - cab A was damaged, i.e. windshields, bumpers, scrapers power and brake lines, windows. In addition, the side plating of the locomotive was damaged, along with brake cylinders and shock absorbers, and the side window of cab B was broken. As a result of the application of sudden braking of the train, flat spots on the wheels in two wagons (the restaurant wagon and the last one in the train) appeared. As a result of the impact of the spare wheel from the road vehicle, the ventilation duct on the chassis of the second wagon in the train set was damaged.

Fig. 4 - View of the railway vehicle after the accident

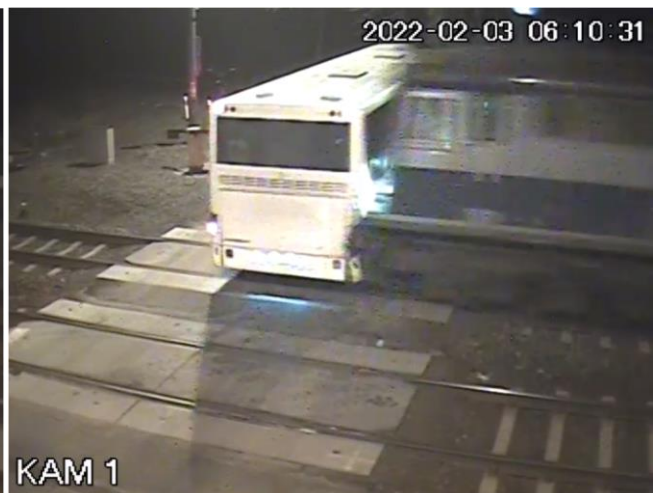
Fig. 6 - Moment of impact

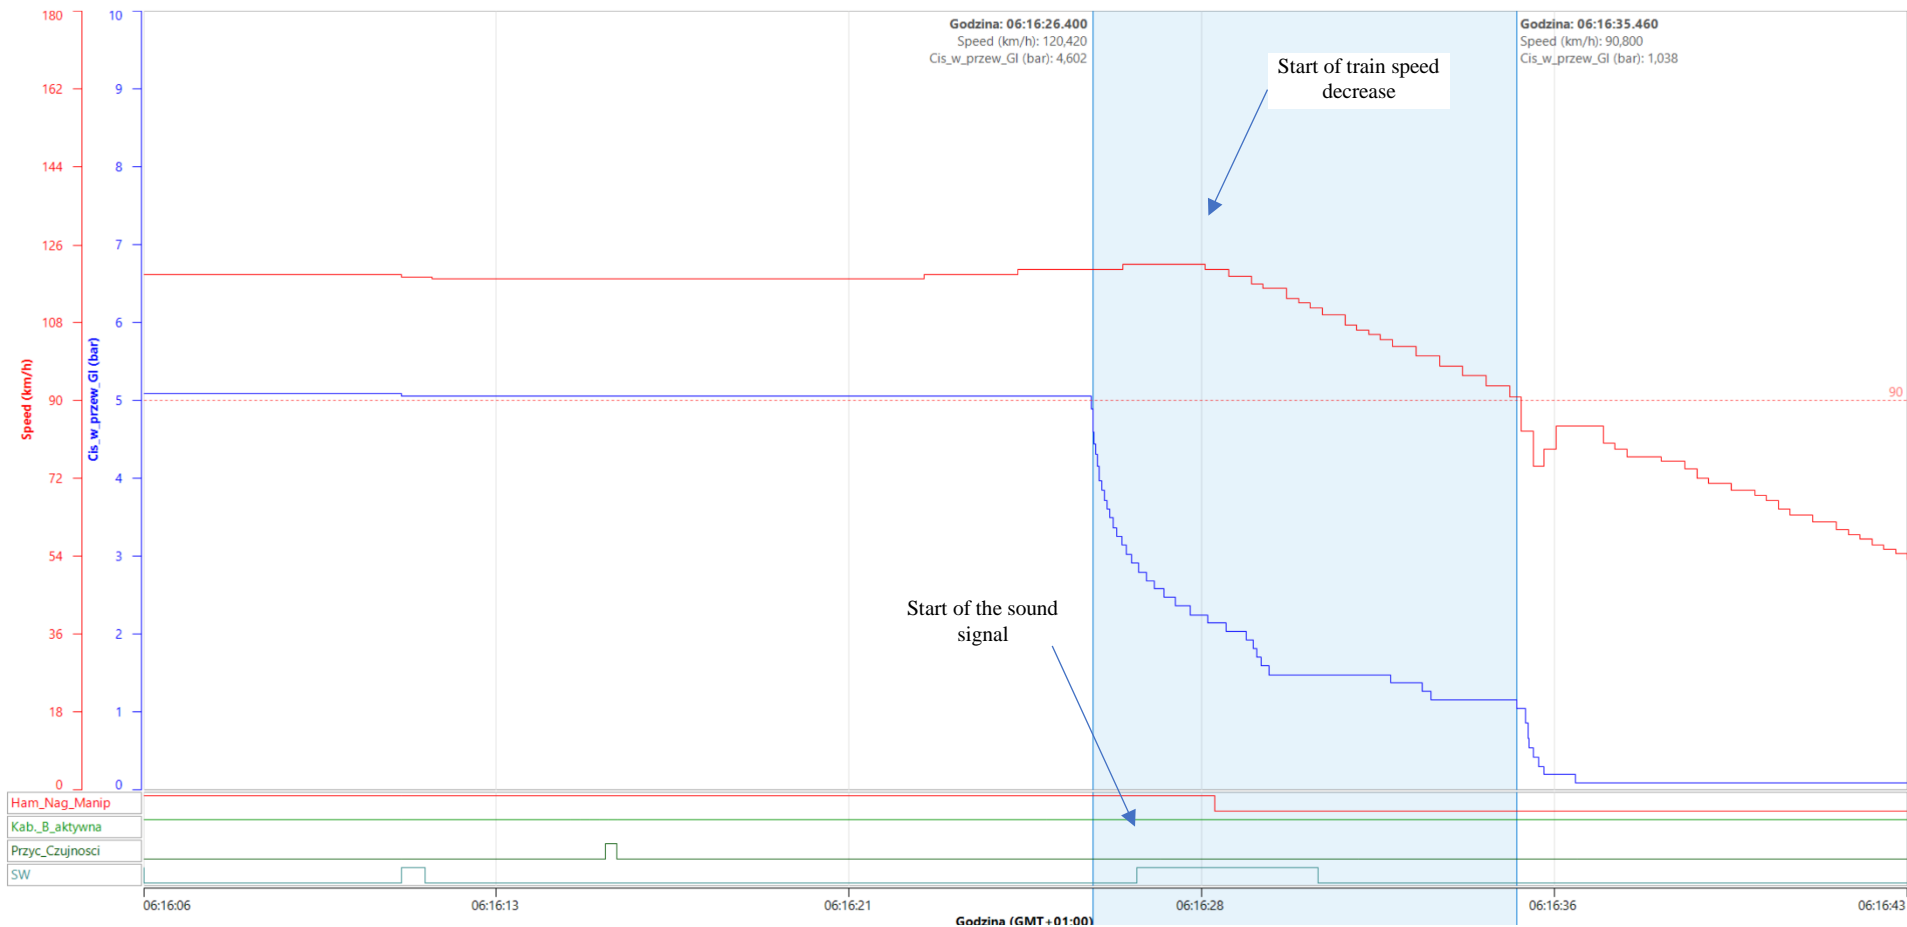
Figure 2 - Graph of driving parameters of locomotive EU07A-002 as a function of time (PKBWK material)

In addition, the investigation into the cause of the occurrence confirmed the correct course of action of the driver, who, upon noticing an obstacle at the crossing, immediately implemented sudden braking of the train with simultaneous giving of the "Attention" signal. An examination of the train driver did not reveal the presence of alcohol in his blood as well as psychoactive compounds.

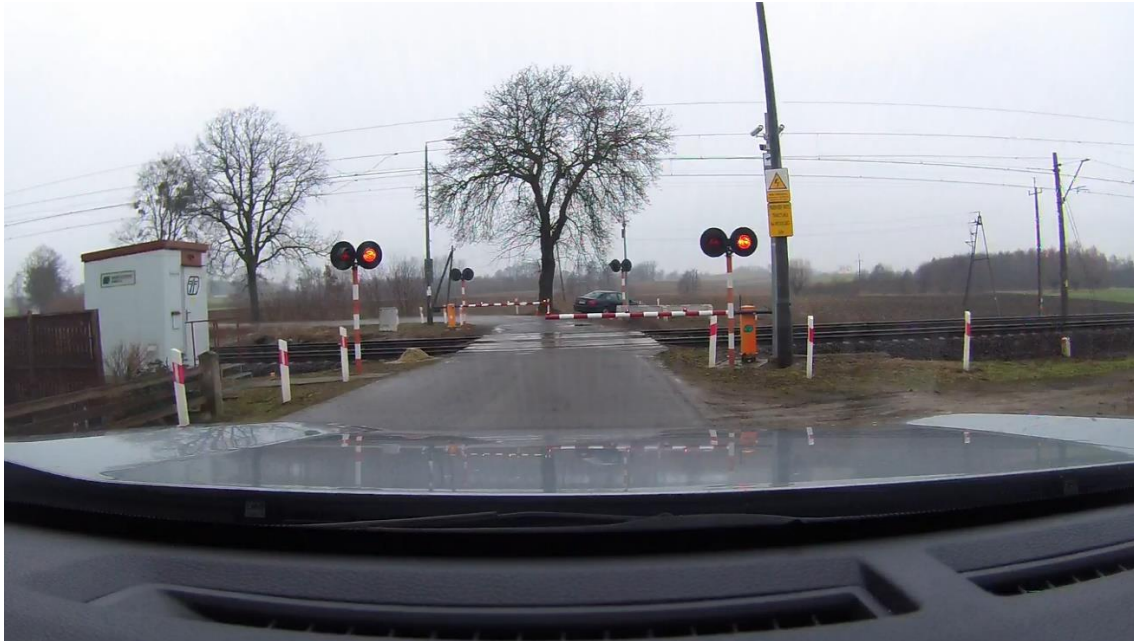
Fig. 8 - View of the crossing from the direction of the bus (PKBWK's own material).

The above Figure shows a view of the crossing in question from the position of the driver of a road vehicle. The essence of the design of Category B level crossings equipped with two half barriers is to protect road users from entering the crossing (inrun half barrier closing the right lane of the road) and to allow safe exit from the crossing (an unclosed exit lane of the road from the crossing) in the event that a road vehicle is on the crossing after the grade-crossing gates start to close. Factors that significantly limit the functionality of the crossing in question are the narrow road, the concrete fence, the sharp left turn of the road behind the crossing and the tree growing on the side of the road 11 meters from the extreme rail. It was difficult and even impossible for trucks and buses to leave the crossing without damaging elements of the railway infrastructure and the road vehicle.

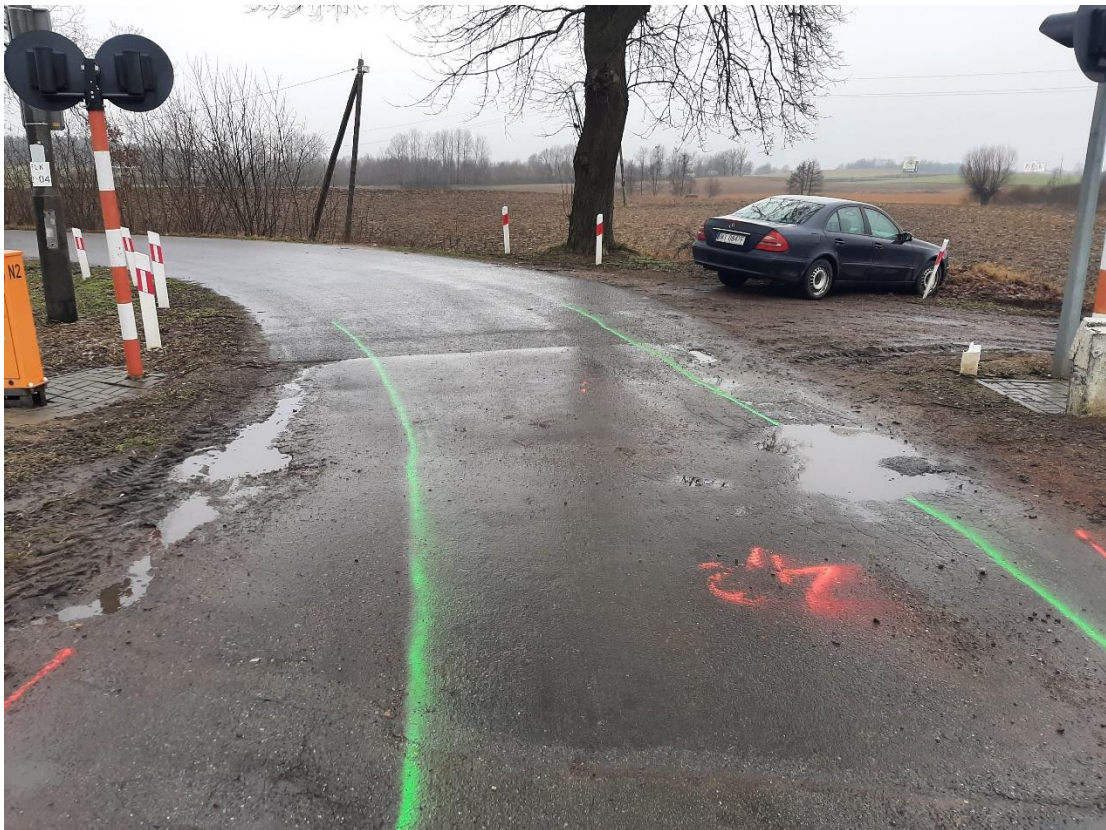
During the on-site visit to the crossing, the Investigation Team observed the way trucks crossed the crossing (Fig. 9 and 10). As can be seen from the location of the road behind the crossing (the width of the road lane is 4.2 m, the growing tree in front and the sharp curve to the left), the drivers of road vehicles, especially trucks and buses, occupy the opposite lane when passing through the crossing with the grade-crossing gates open in the direction of the village of Bąkowy Młyn. Vehicles driving in the opposite direction are exposed to collision. To avoid collision situations, the organization of traffic in the area of the crossing should be changed in such a way that vehicles traveling from the direction of the village of Bąkowy Młyn have priority to pass through the crossing.

Fig. 9 -Truck crossing with open grade-crossing gates (PKBWK's own material)

Fig. 10 -Route of a truck with open grade-crossing gates (PKBWK's own material)

In addition, a recommendation has been made by the Chairman of the PKBWK to remove the tree growing on the left side of the crossing going from the village of Baikki Mill.

- 3) The road manager will develop a new traffic organization project in the area of the cat. B level crossing, considering the topographical conditions of the intersection of the railway line and the road, in such a way that vehicles coming from the direction of the village of Bąkowski Młyn will have priority to cross the crossing.
