STATE COMMISSION ON RAILWAY ACCIDENT INVESTIGATION
Ministry of the Interior and Administration

REPORT No. PKBWK 02/2024

on the investigation of a railway accident
that occurred on 7 February 2023 at 02:00 hrs
at the Wrocław Brochów station,
km 1.701 of track no. 1N of railway line no. 349 Św. Katarzyna – Wrocław Kuźniki
the area of the rail infrastructure manager PKP PLK S.A. Railway Line Plant in Wrocław

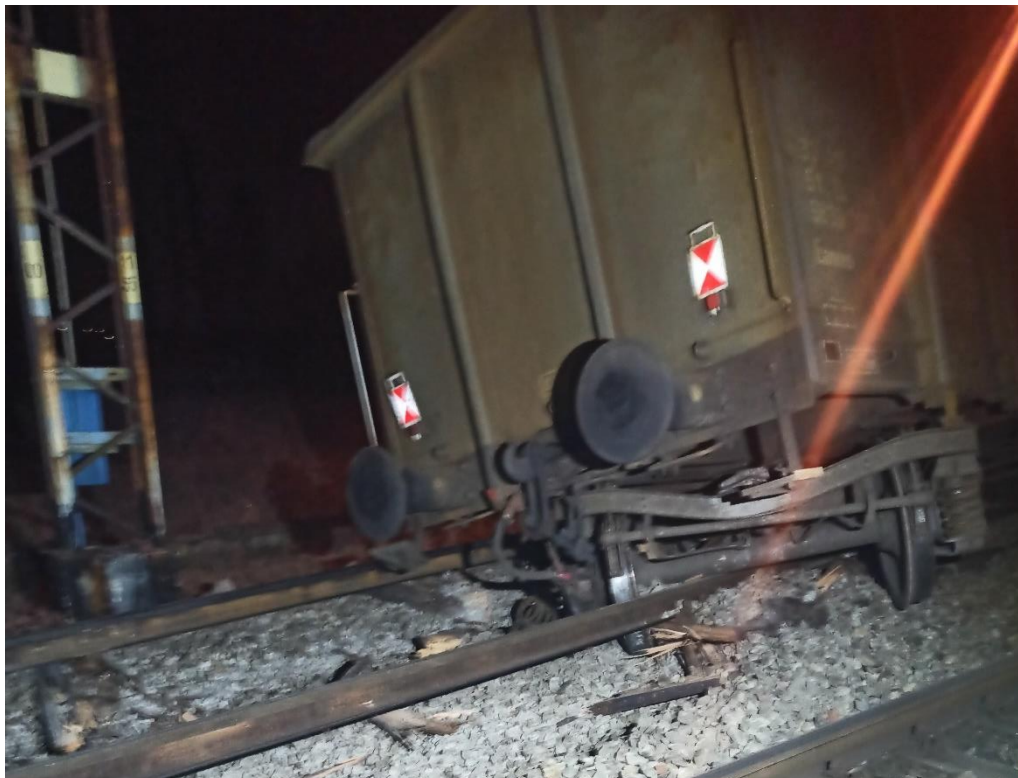
Photograph 1 - A view of the derailed wagon (source: materials provided by the railway commission)

Visual examination of the damaged wheelsets of wagon no. 33 51 5839 055-9 confirmed damage to the wheels and axle boxes qualifying them for scrapping.

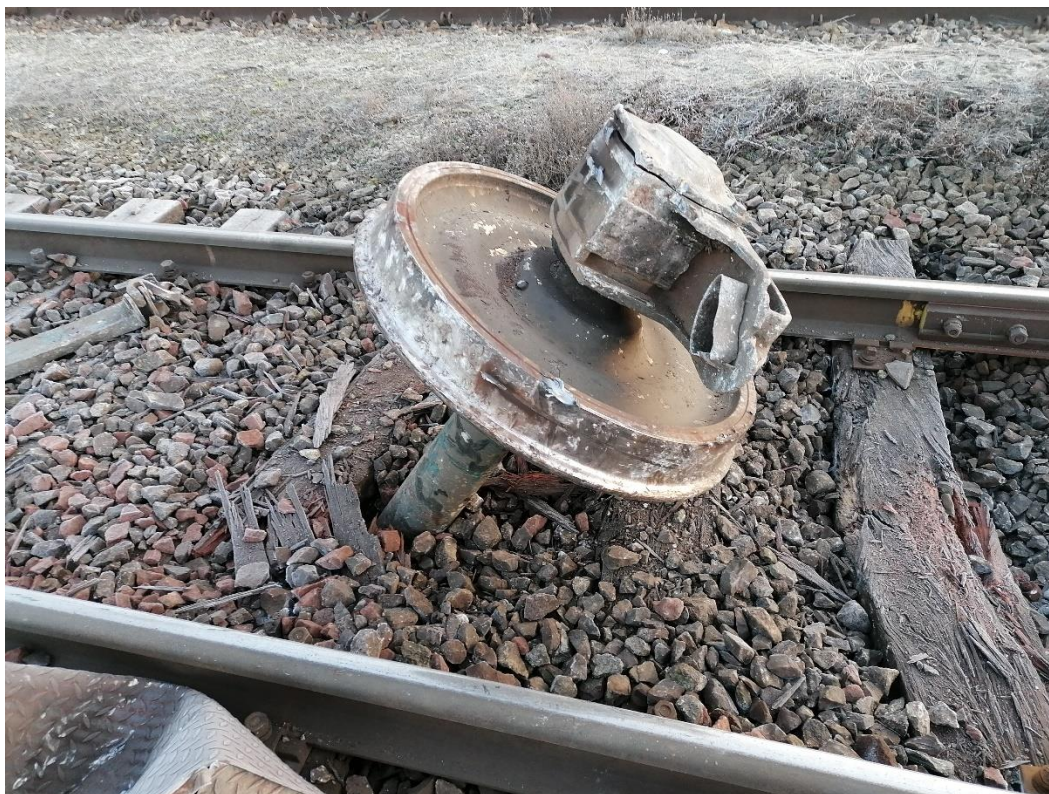
Photograph 2 - A view of one part of the broken axle (source: materials provided by the railway commission)

5. *Metallographic tests of the surface of axle breakage in the area of the crack revealed existence of corrosion; furthermore, the tests revealed clear traces of a tool bit after rough machining of the radius of transition of the wheel seat to the axle centre section. The wagon driving dynamics coupled with the existing tensions became the source of a fatigue crack in the axle. The direction of propagation of fatigue lines visible*

on the axle breakage also confirms the starting point of the axle crack.

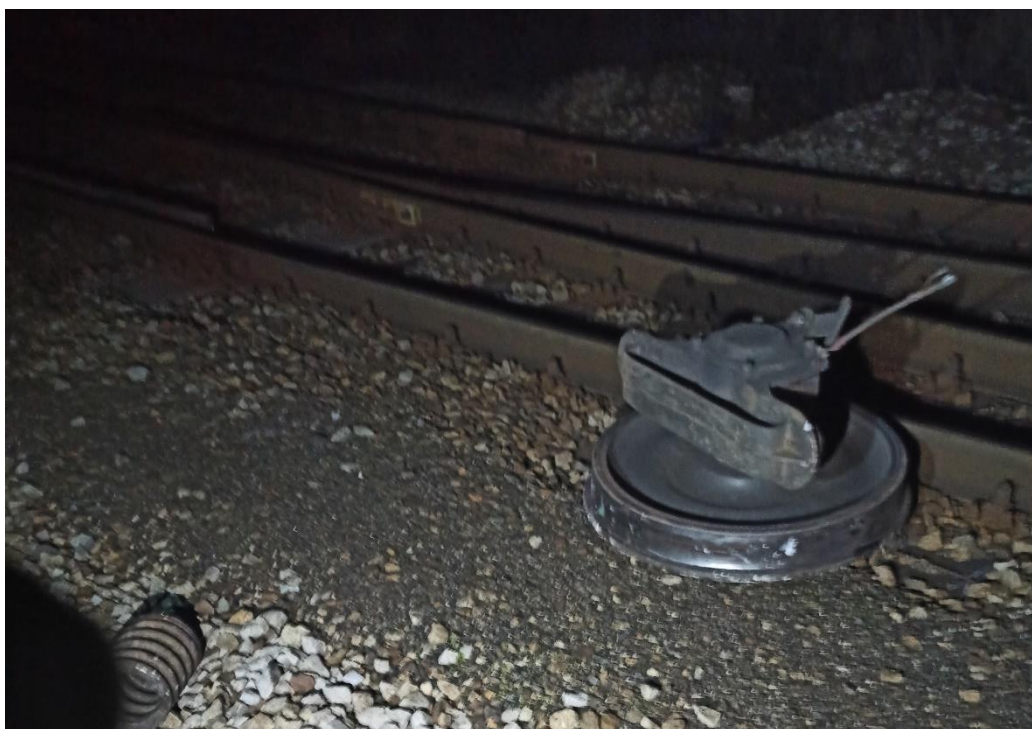
Photograph 3 - A view of the other part of the broken axle (source: materials provided by the railway commission)

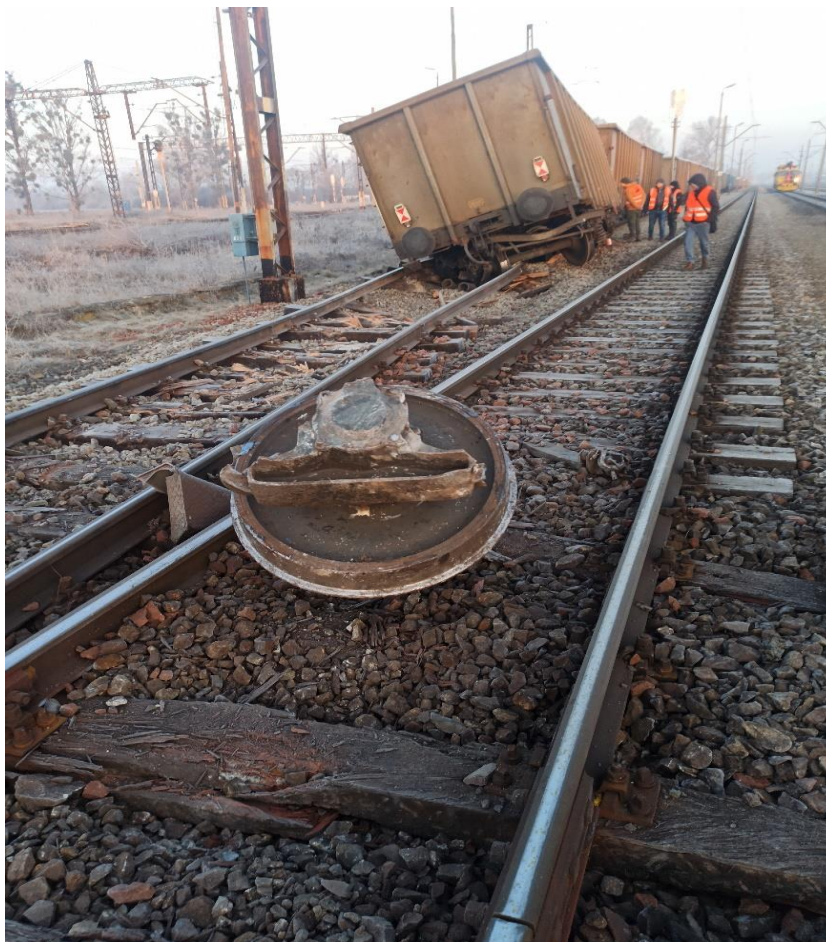
Photograph 4 - A general view of the occurrence site (source: materials provided by the railway commission)

Damage to the rail infrastructure included damage to turnouts no. 501, 502, 503 and 506 on tracks no. 1N and 3N, and turnout segments with turnout bearers, sleepers and other elements of track infrastructure such as elements of turnout heating.

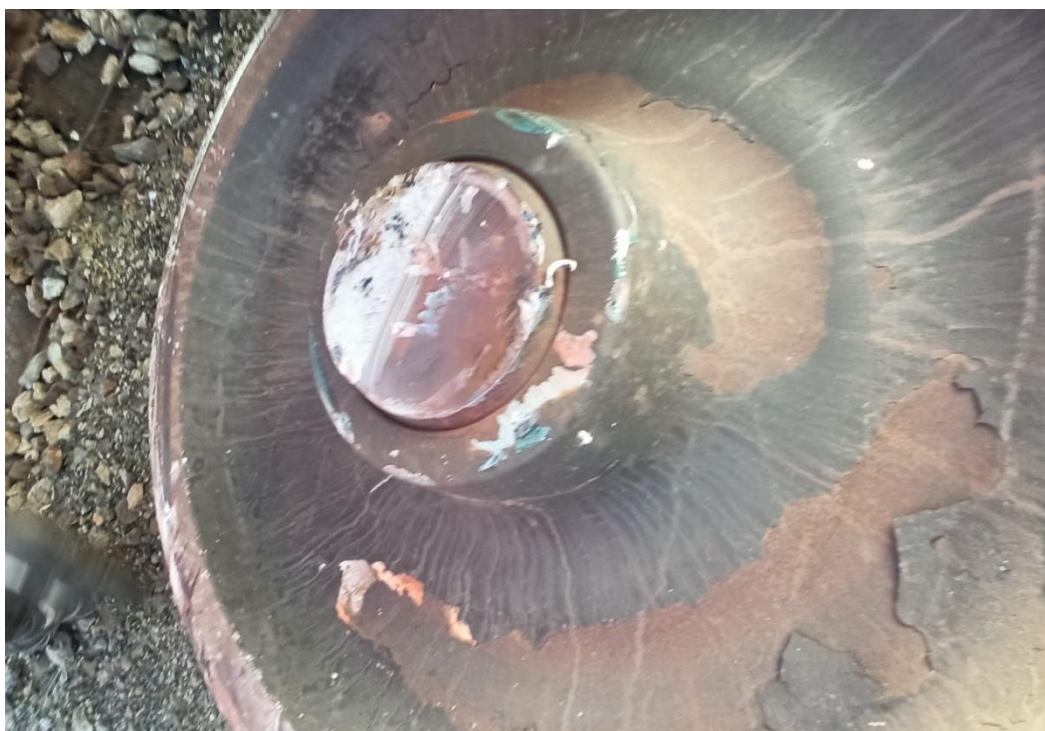
Photograph 5 - A view of the broken axle (material provided by the railway commission)

In summary, it was established that the crack in the axle started probably during the period of intensive operation after the repair carried in 2020, with the roughly machined and corroded surface of the transition of the wheel seat to the axle centre section becoming the place of the crack that propagated during subsequent operation of the wagon. The propagation of the fatigue crack caused the strength of the axle cross-section to deteriorate up to the critical moment where the sudden crack visible in the axle breakage occurred.

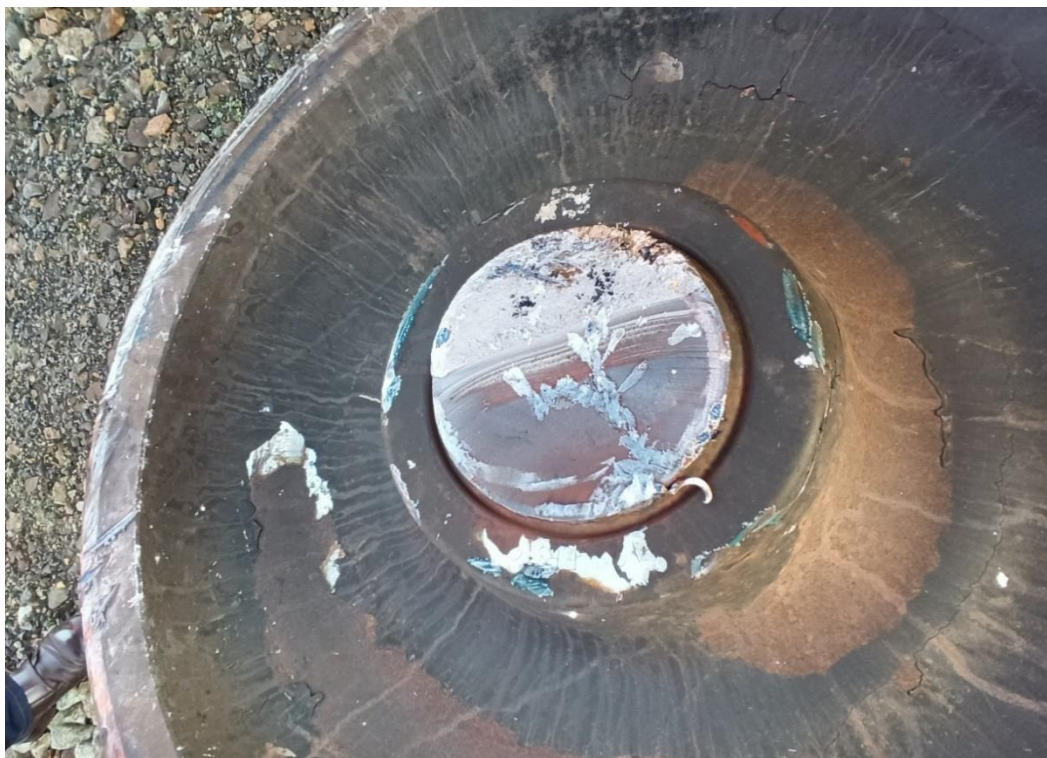
Photograph 6 - A view of the broken axle (material provided by the railway commission)

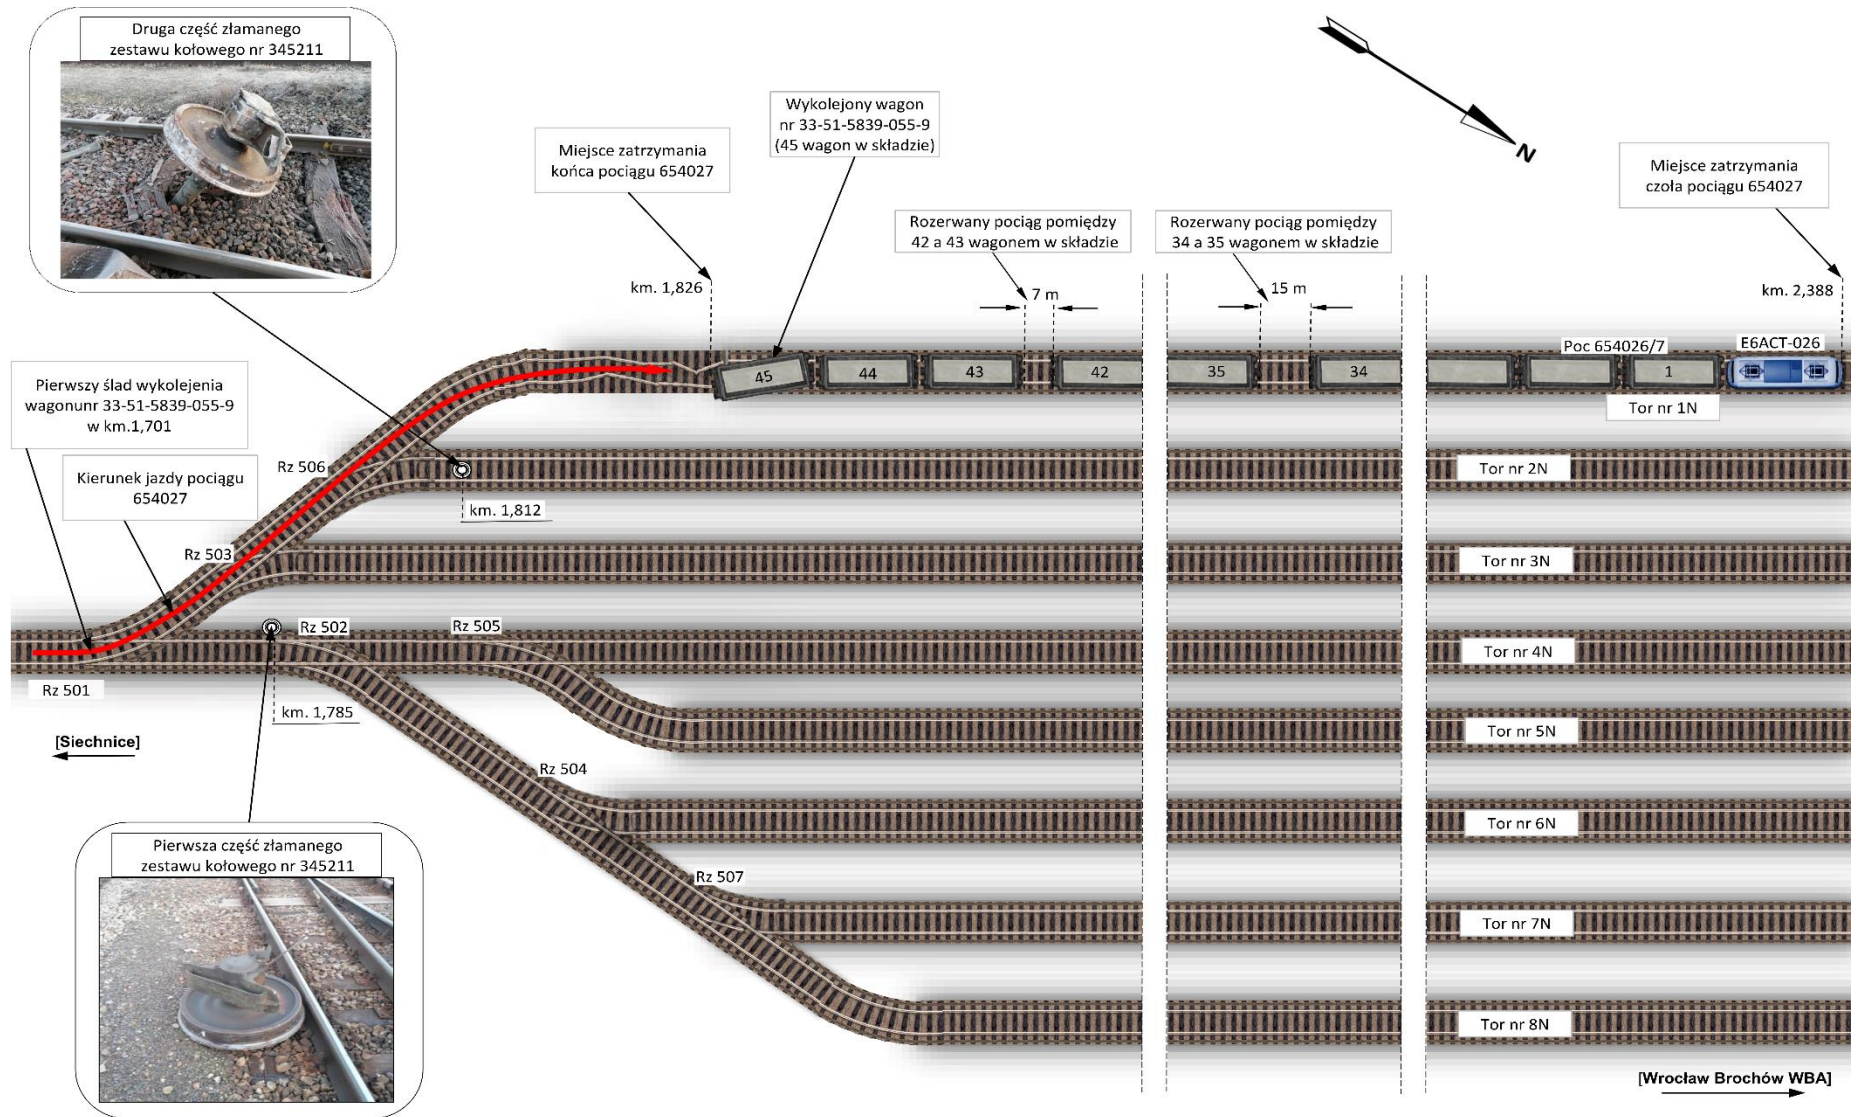
Figure 1 - A drawing of the accident (author: PKBWK)

As a result of the derailing, the train set was broken apart between the 34th and 35th wagon, and between the 42nd and 43rd wagon, counting from the train head.

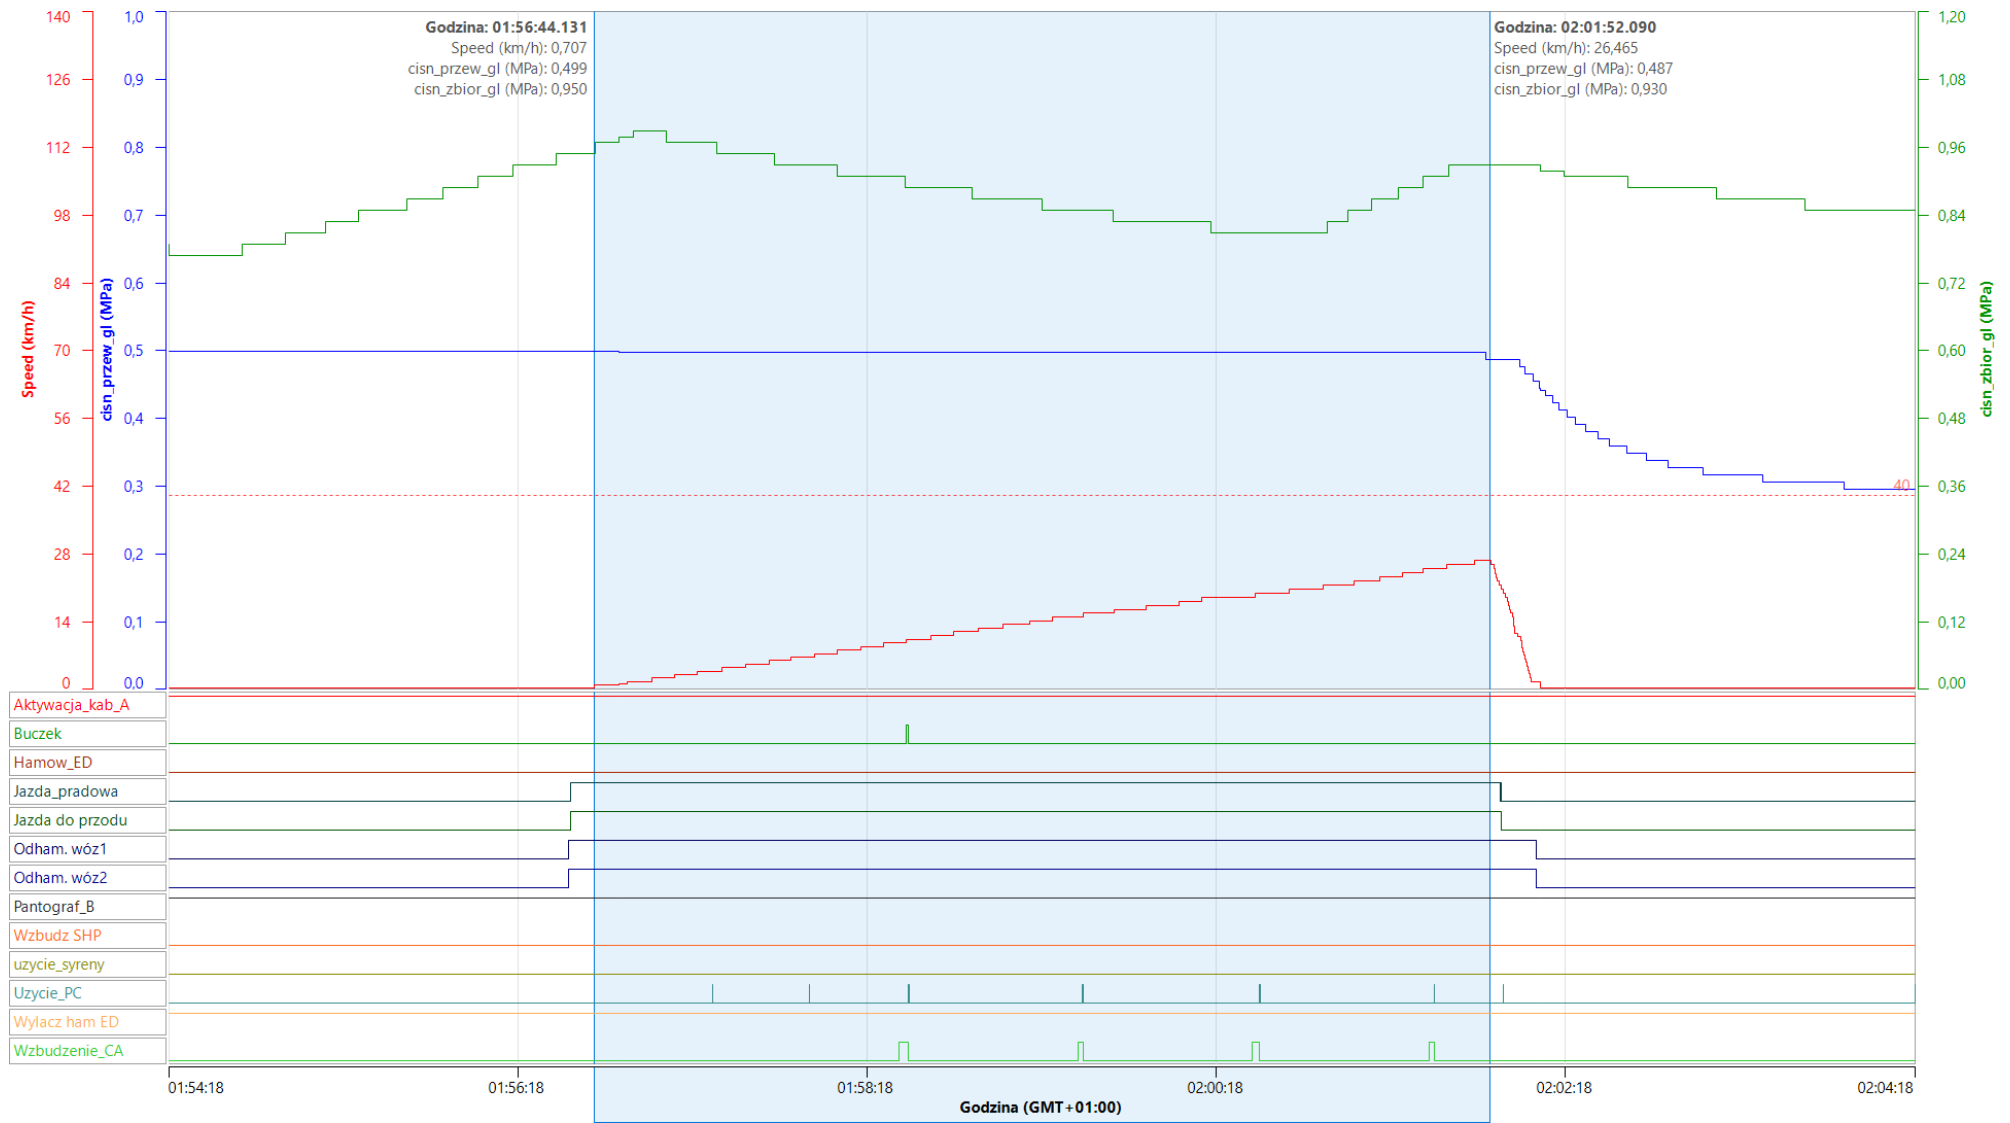
Figure 2 - A chart showing the driving parameters of the E6ACTad-026 locomotive in the function of time (developed by PKBWK)

Analysed were the driving parameters of train no. 654027 recorded on 7 February 2023 between 01:56:44 hrs and 02:02:09 hrs;

- 01:56:44 hrs - start of the train from the entrance semaphore to the Wrocław Brochów station; an increase in the speed to 26.46 km/h and a sudden decrease in the speed accompanied by activation of emergency braking
- 02:02:09 hrs - the train stops after covering 1,241 metres from the start time.
