**STATE COMMISSION ON RAILWAY ACCIDENTS INVESTIGATION**  
**Ministry of the Interior and Administration**

**REPORT No. PKBWK 02/2022 from investigation of railway accident that occurred on 26 February 2021 0532 hrs at Grodzisko Dolne station, on second railway track, at km 163.654 of railway line No. 68 Lublin - Przeworsk, railway management infrastructure of PKP PLK S.A., Rzeszów Railway Department.**

**WARSAW, 9<sup>th</sup> of March 2022**

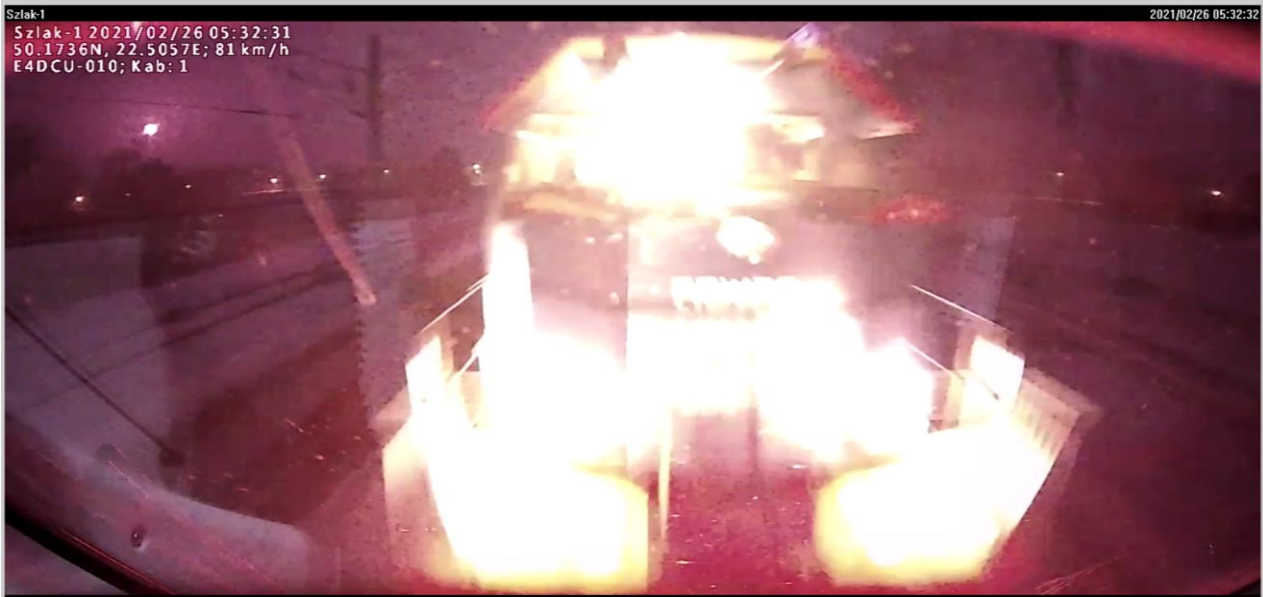
**Casual factor:** Omission of semaphore D<sup>2</sup> showing signal Sr1 "Stop", ripping the crossover of turnout no. 6 and entry of locomotive 6Dg-140 onto main track two directly in front of train MPE38100.

**Photo 1 - shows the situation 1 second before the collision (recorded by the PKP Intercity S.A. locomotive camera).**

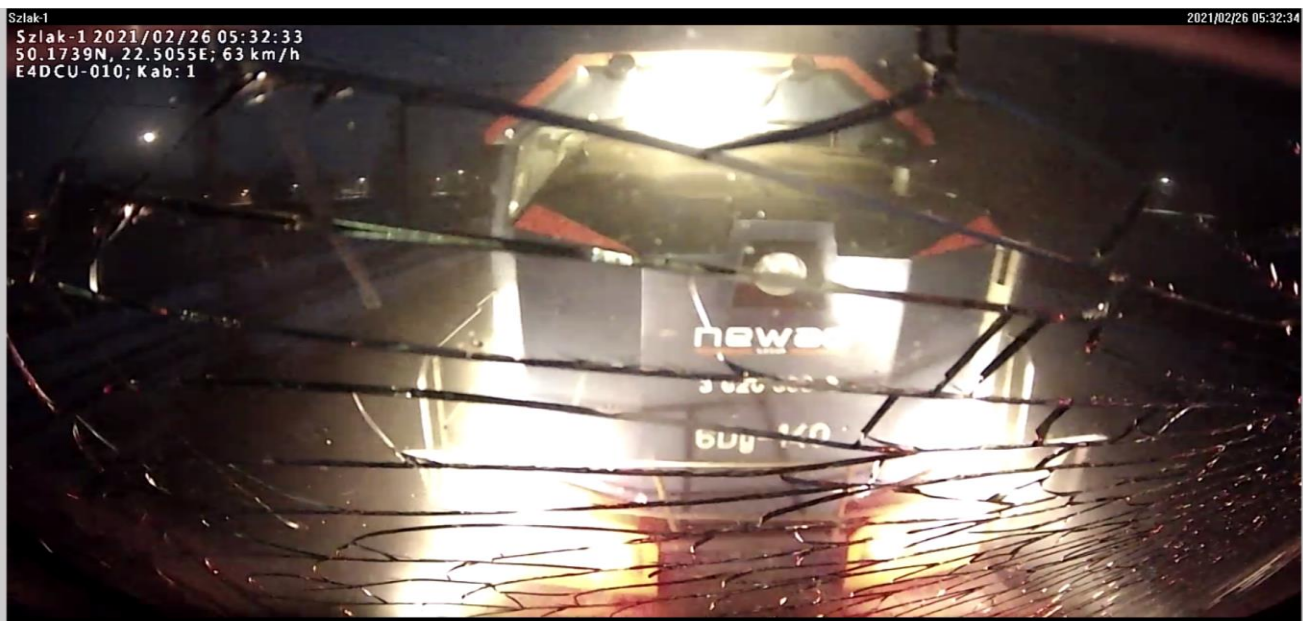
**Photo 2 - view of the site and consequences of the accident (own material of the PKBWK)**

Damaged locomotives 6Dg-140 and EU160-010, damaged first 3 wagons behind the locomotive of passenger train MPE38100: nos. 50512978054-8, 50513978045-4 and 50512978062-1. Damaged drive system of crossover no. 6. No damage to the environment.

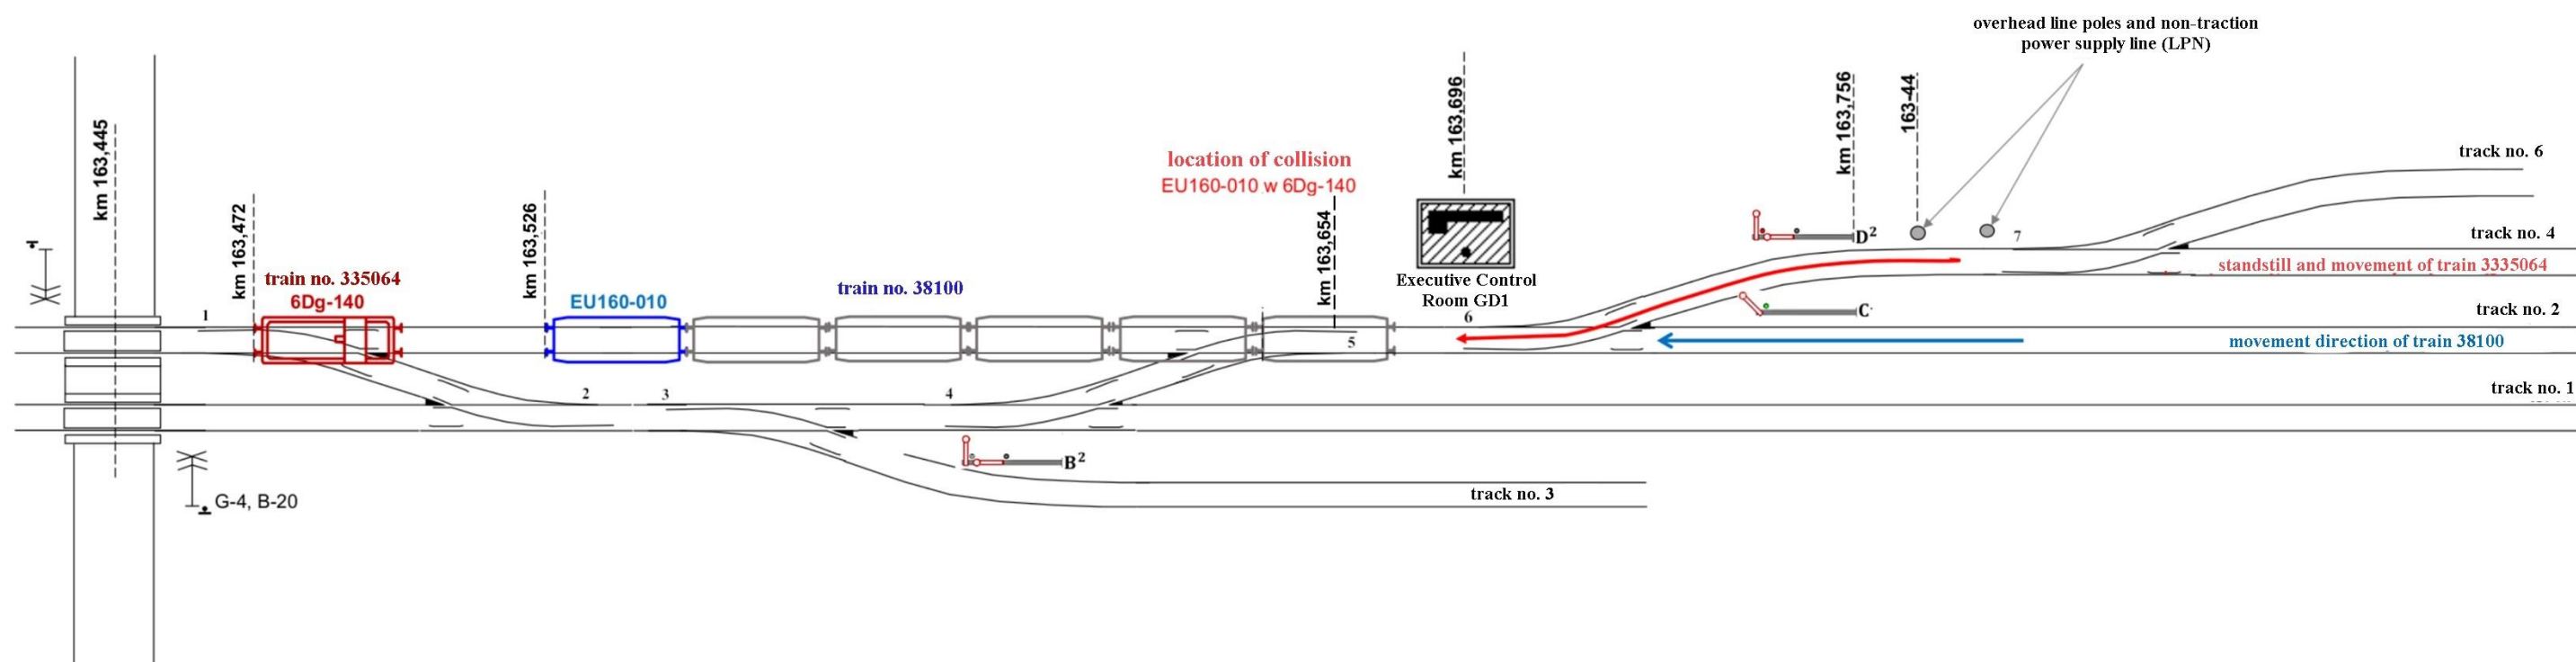
Figure 2 - Sketch of the accident (by PKBWK)

From additional main track no. 4, using not prepared way, without required permission, with D<sup>2</sup> semaphore showing "stop", the train LSS335064 (loose locomotive 6Dg-140) entered the main track no. 2. The entering locomotive 6Dg-140 ripped the turnout no. 6 and entered onto main track no. 2 directly in front of the passenger train MPE38100, without automatically changing signal on semaphore C from "free way" to "stop", due to the type of equipment. The driver of this locomotive (series 6Dg-140) after realising that train MPE38100 is approaching from behind on the same track, started increasing the speed of the locomotive. On the other hand, the driver of passenger train MPE38100, seeing the locomotive in front of his/her train, implemented sudden braking. Despite the actions taken by both drivers, a collision occurred, that is the train of the carrier PKP INTERCITY S.A. MPE38100 collided with the rear of locomotive 6Dg-140 of the carrier LOTOS Kolej Sp. z o. o. The collision occurred on turnout no. 5, at km 163.654. After the collision, the front end of the locomotive EU160-010 stopped at km 163.526, that is after travelling 128 metres. The front end of locomotive 6Dg-140 stopped at km 163.472, that is, after travelling 182 metres after the collision.

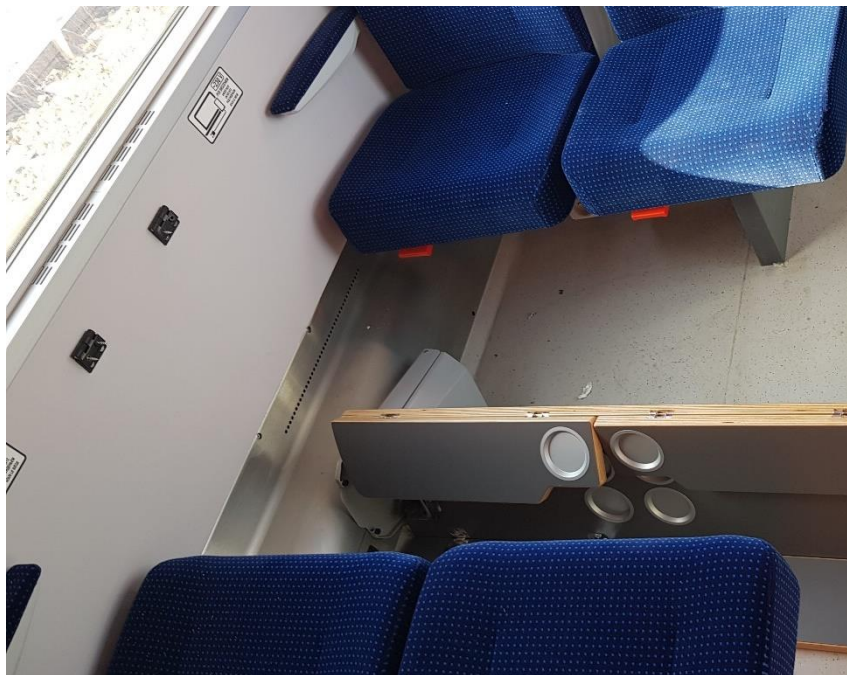
During the inspection of passenger coaches after the accident the investigating team has found the following damages: broken door windows, broken tables, damages of the carriage bodies. The photos below show broken tables in the non-compartment passenger coaches and the way of their fixing.

**Photo 3 – broken table in the passenger coach (photo by PKBWK)**

The fixing of the tables did not fulfil the task of preventing them from breaking off without the involvement of third persons and injuring passengers on the train, which poses a safety risk to travellers. The above photos show the tearing off of tables in the first and second coach behind the locomotive due to dynamic forces caused by the collision of trains, without the presence of passengers.

- 4) Railway undertakings will take measures to improve passenger safety on trains through the appropriate fitting of tables in the non-compartment passenger coaches, guaranteeing travellers' safety.

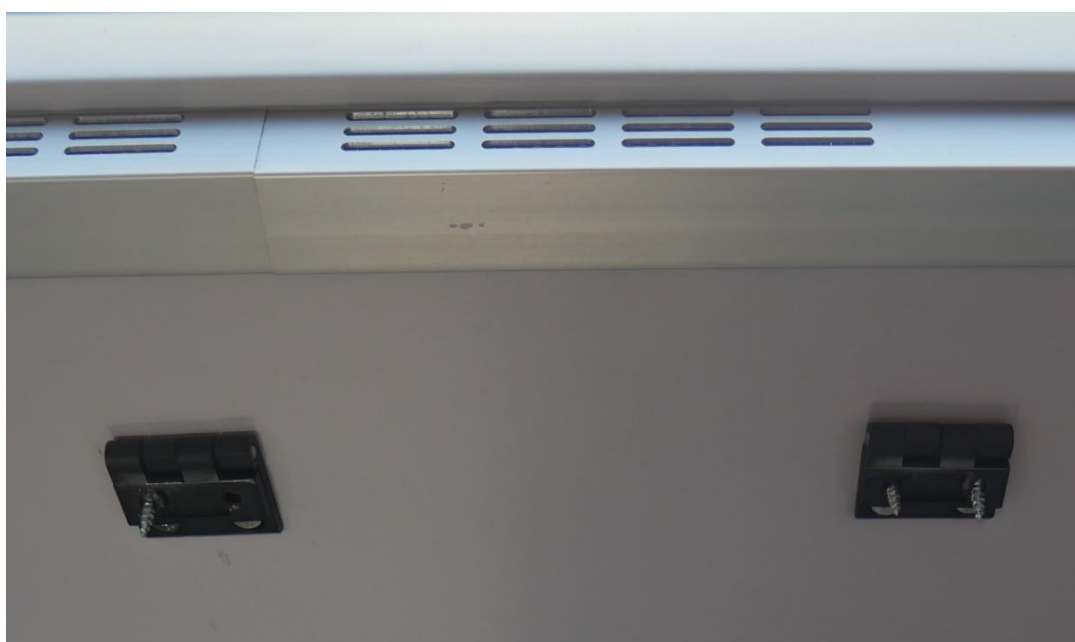
**Photo 4 – fixing system of the table (photo by PKBWK)**

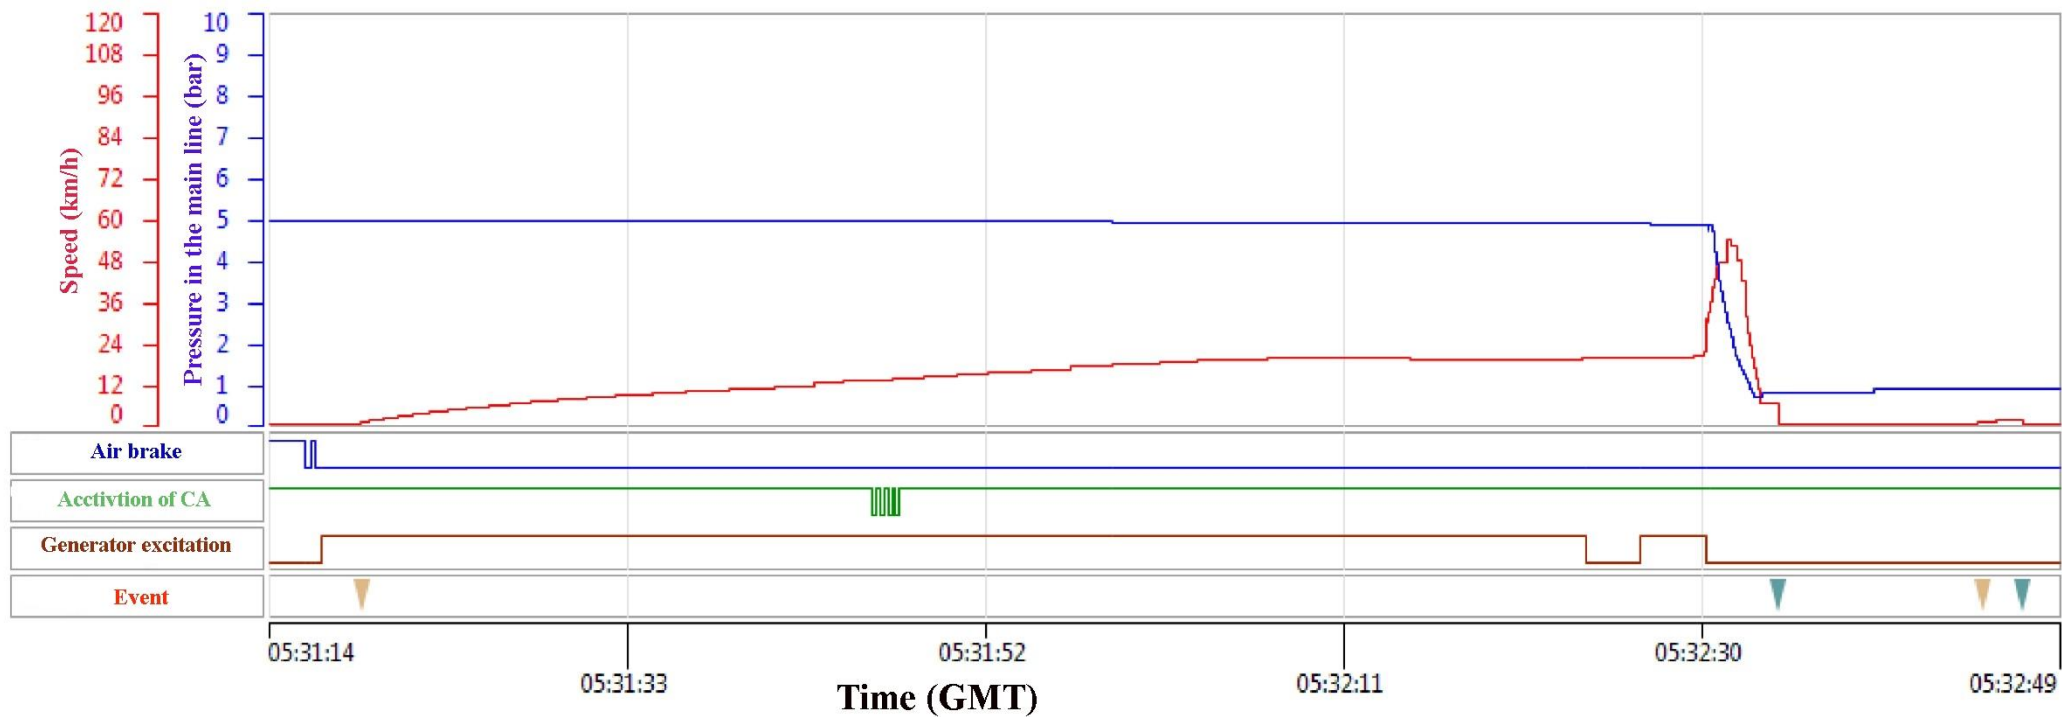
Figure 3 - Diagram of locomotive 6Dg-140 s running parameters as a function of time (prepared by the PKBWK)

The investigation team was not able to analyse the course of the accident on the basis of the monitoring system installed in the railway vehicle. The locomotive was not equipped with such a device.

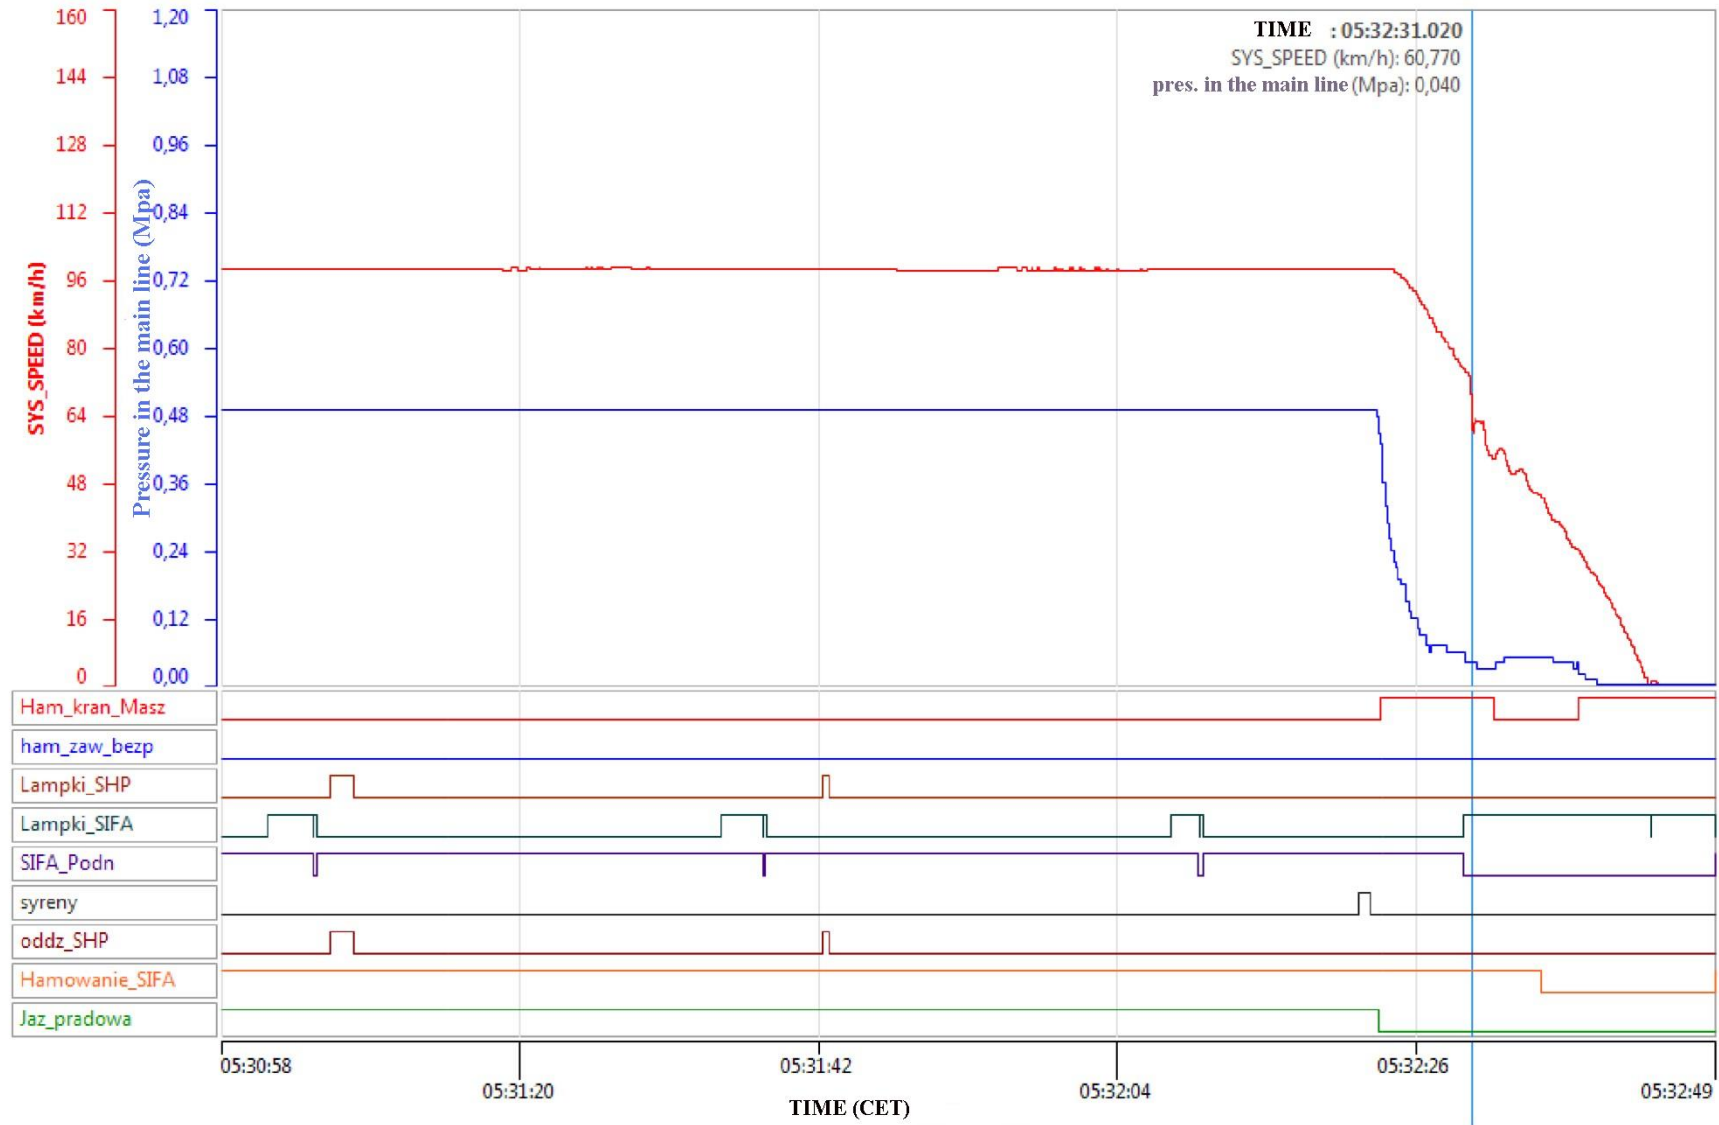
Figure 4 - Diagram of locomotive EU160-010 running parameters as a function of time (prepared by the PKBWK)

- at 05:32:36 the braking applied by SIFA was recorded,
- stopping the train at 05:32:44 after travelling 295 metres from the start of braking,
- the distance covered from the moment the attention signal was given to the start of braking was 45 metres, from the moment the brakes were applied to the impact was 163 metres.

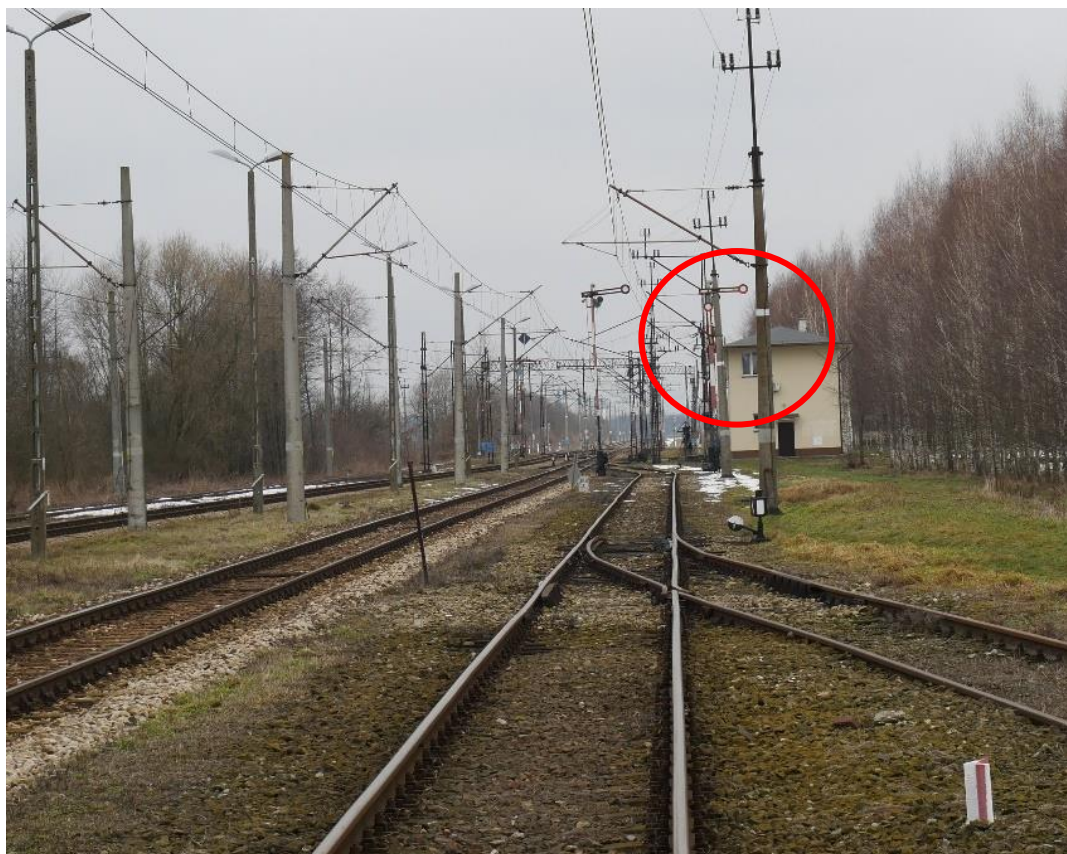
- Lack of uninterrupted visibility (at a distance of 100 metres) of the night signal Sr1 (Stop) given on semaphore D2 (exit from track 4) due to build up overhead line poles and non-traction power supply line (LPN).

Photo 5 – view of pole hiding the night signal of semaphore D (photo by PKBWK)

- 2) To ensure visibility of semaphore D at Grodzisko Dolne station of PKP PLK S.A., the Rzeszów Railway Department shall move the overhead traction line pole 163-44 located in the area of GD1 setting area.

- 3) Infrastructure managers shall perform exceptional checks on the visibility of semaphores, during day and night, in stations with overhead traction lines, both over the main and auxiliary tracks.

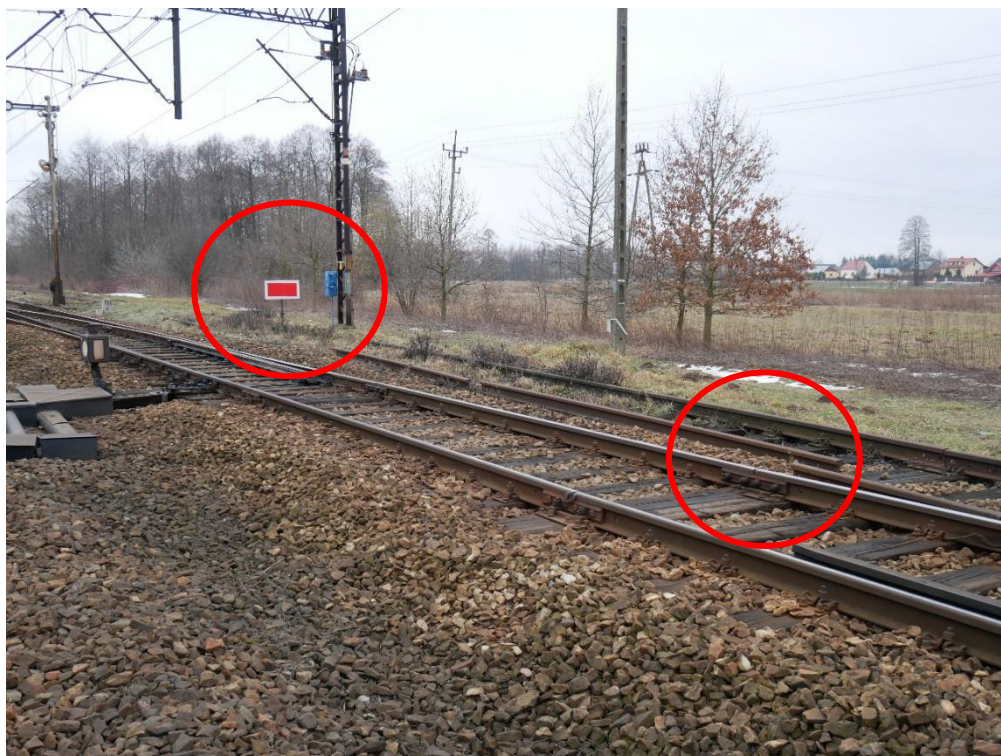
- Unfinished decommissioning of track three, partial decommissioning of turnout no. 3, devastated semaphore B, not removed lever of inoperative semaphore B.
- D1 disc set contrary to regulations.

**Photo 6 – closed track 3 and discontinuity of track 3 beyond the crossroad of turnout no. 3**

- 6) To ensure safety of train traffic on routes a<sup>1</sup><sub>1</sub> b<sub>2</sub> and a<sup>2</sup><sub>3</sub> PKP PLK S.A., Rzeszów Railway Department, shall restore the technical condition of infrastructure in Grodzisko Dolne station to the currently existing technical documentation.

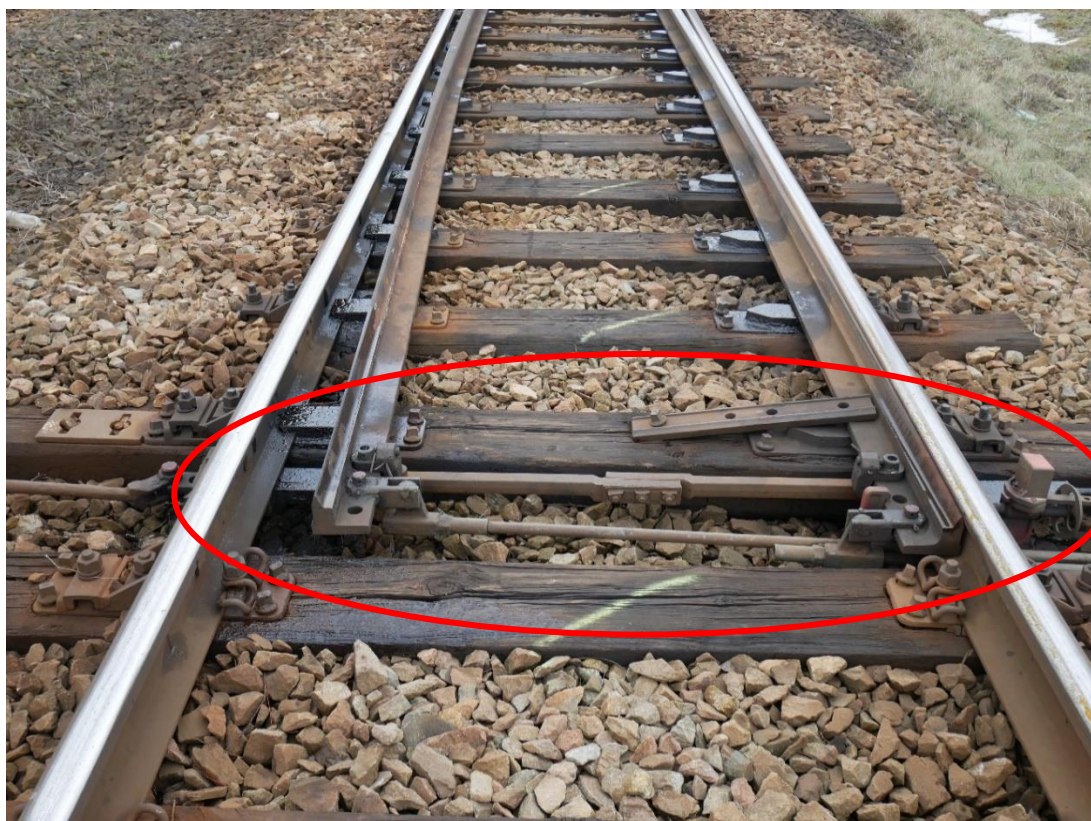
**Photo 7- Method of securing the crossover of turnout no. 3 (photo by GDPWK)**

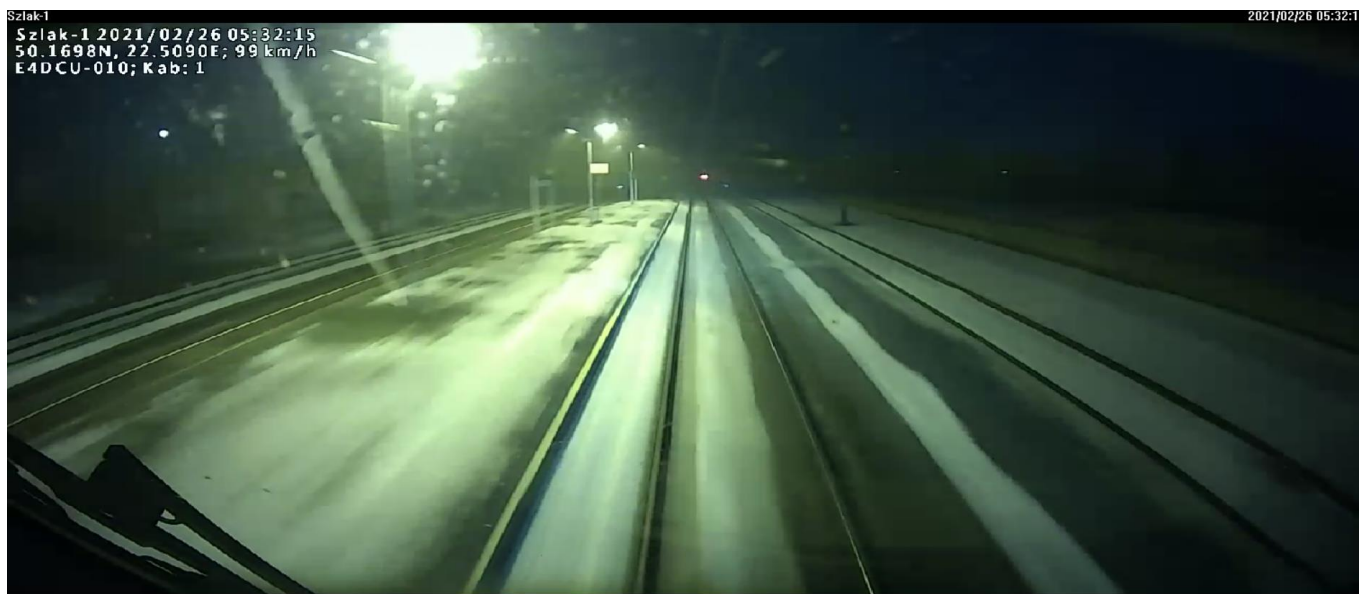
Photo 8 – view from the driver's cab of train MPE38100 travelling on track 2 when train LSS335064 was travelling on track 4 and was 20 metres in front of exit semaphore D.

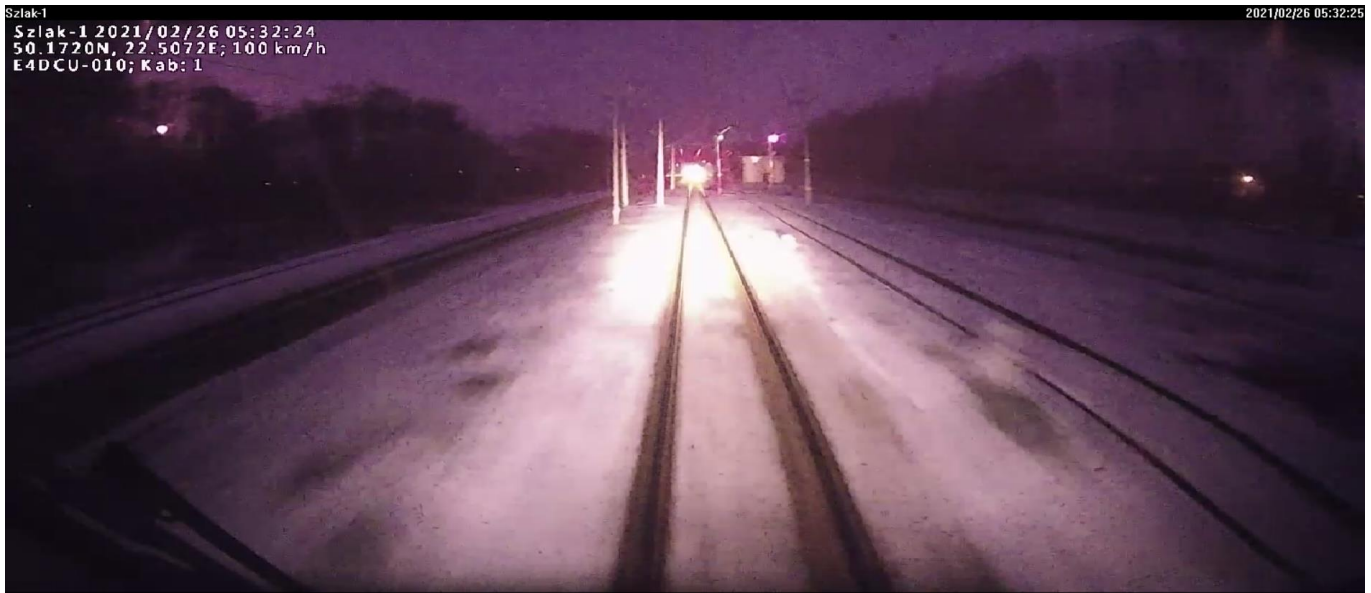
Photo 9 - view from the cab of a train travelling on track 2 at the time it implemented emergency braking as train LSS335064 entered its path, i.e. 99 metres ahead.
