STATE COMMISSION ON RAILWAY ACCIDENT INVESTIGATION
Ministry of the Interior and Administration.

REPORT No. PKBWK 04/2022

from the investigation of a railway accident that occurred on 29 July 2021 at 06:15 on the track Szczecin Gumieńce – Tantow, on track no. 1, at the railway crossing category C at 7.585 km of the railway line no. 409 Szczecin Gumieńce – State Border (Tantow) PKP PLK S.A. infrastructure manager area Zakład Linii Kolejowych [Railway Facility] in
Szczecin

Warsaw, 11 May 2022

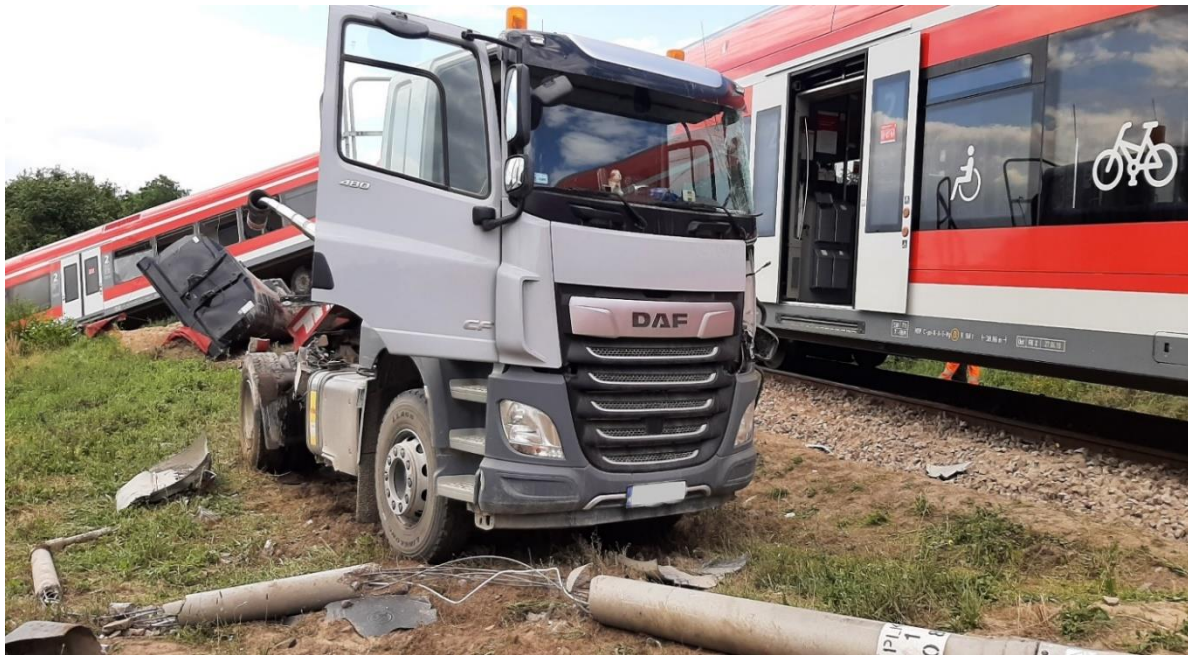
Photograph 1 – Consequences of the Incident (SCRAI own material)

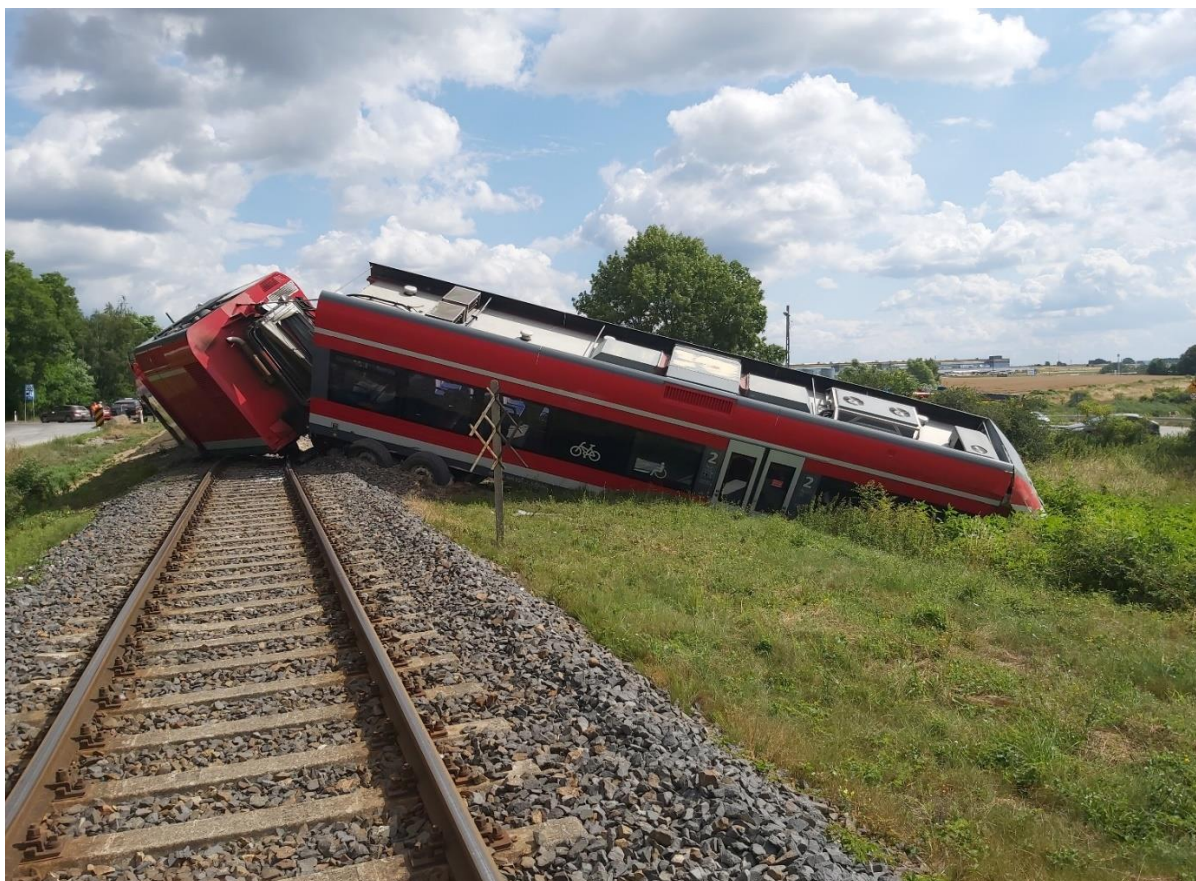
Photograph 2 – Consequences of the Incident (SCRAI own material)

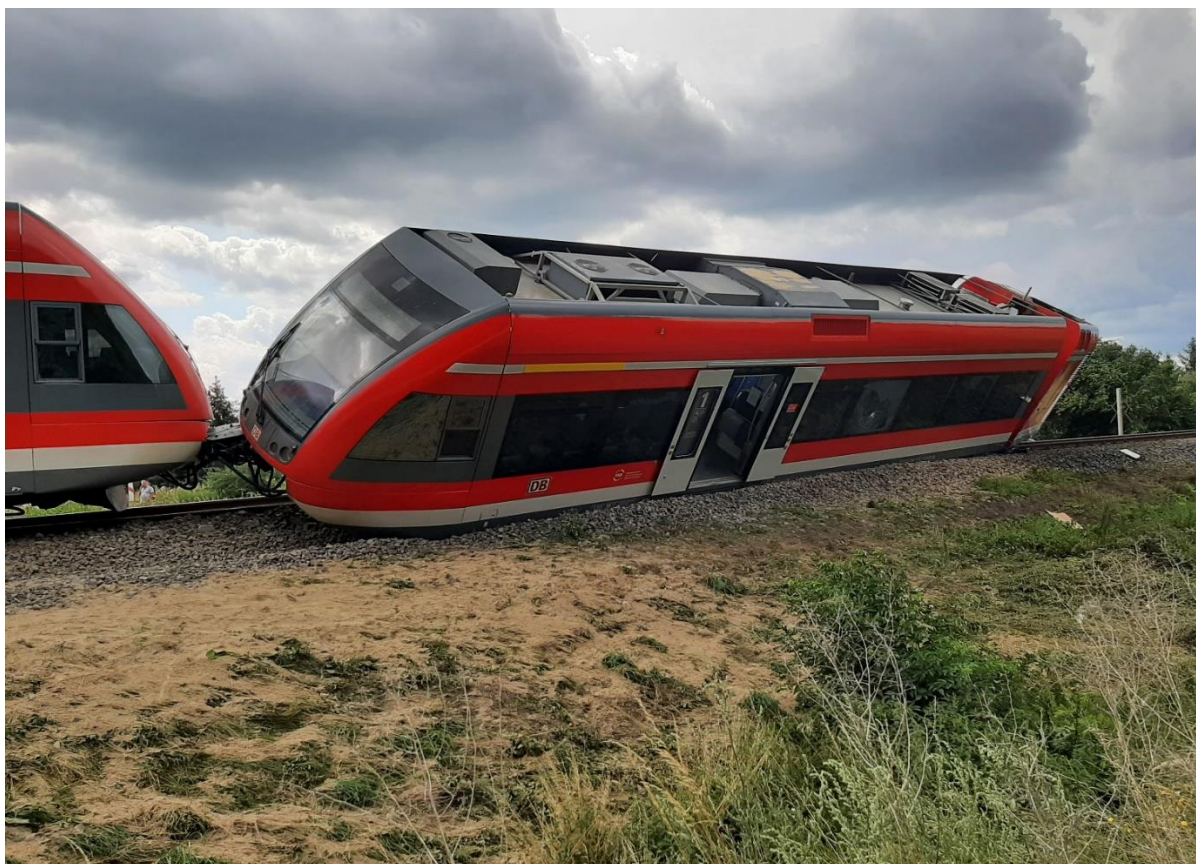
Photograph 3 – Consequences of the Incident (SCRAI own material)

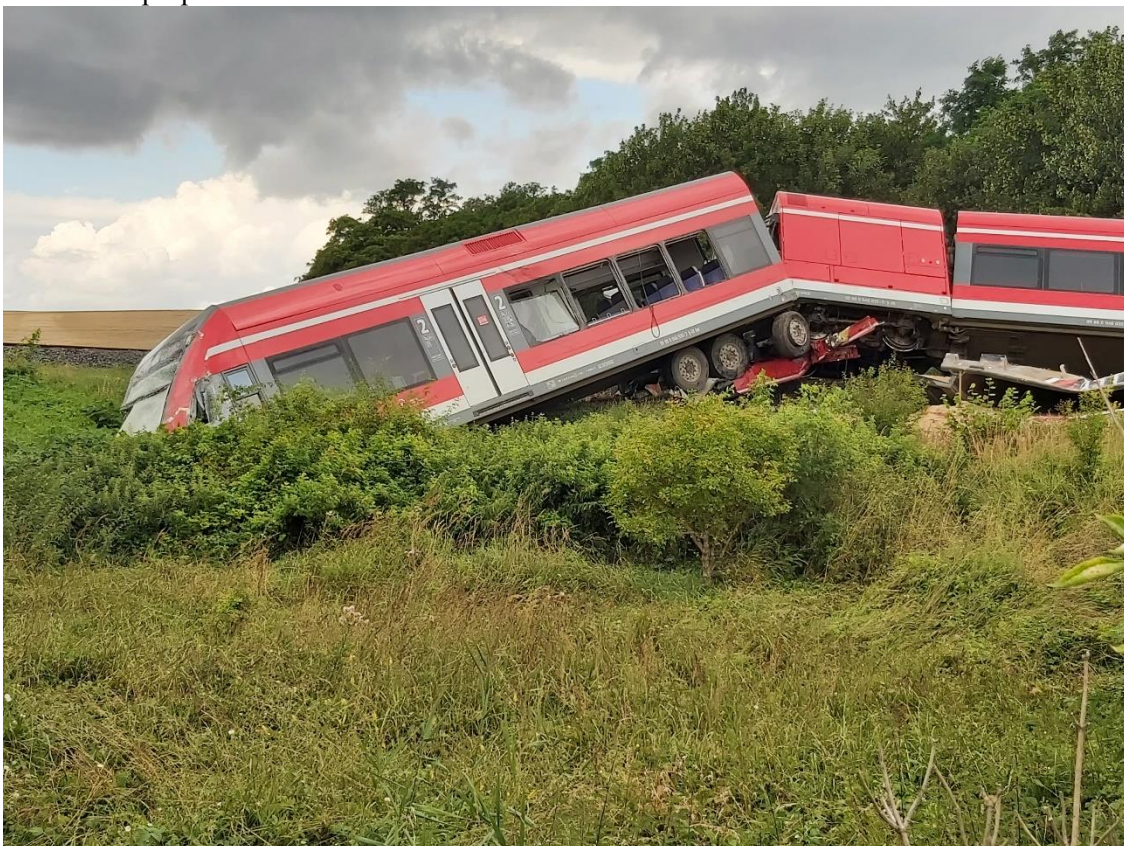
The collision caused the derailing of the first multiple units with all six wheelsets.

The bogies of multiple unit VT646 030 were severely damaged. The carriage frames and the superstructures were deformed as a result of the forces applied on them. The collision with the heavy goods vehicle caused a very serious deformation of the driver's cab.

The mechanical and electrical components connecting the individual parts of the rail bus were torn off. A large number of panes (windows/doors) were damaged.

Damage of the VT646-030 vehicle caused its inability to run on tracks.

Photograph 5 – View of the railway vehicle after the accident

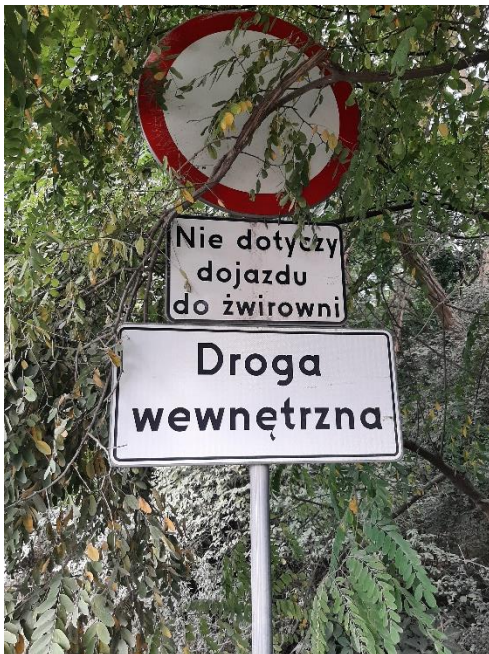
Directly in front of the crossing there is an exit from the district road, which is a connection of the district road with the road to the gravel pit and marked with a B1 sign with plates (photograph no. 6). The surface of the road to the gravel pit is bituminous at a length of approximately 200 m (counting from the junction with the district road). At a distance of 150 metres before the connection with the district road, there is a board with the information “*Attention! Railway crossing, take extra care.*” (photograph no. 7) The road to the gravel pit does not have an approved permanent traffic organisation.

Photograph 6 – Sign placed at the entrance to the gravel pit road

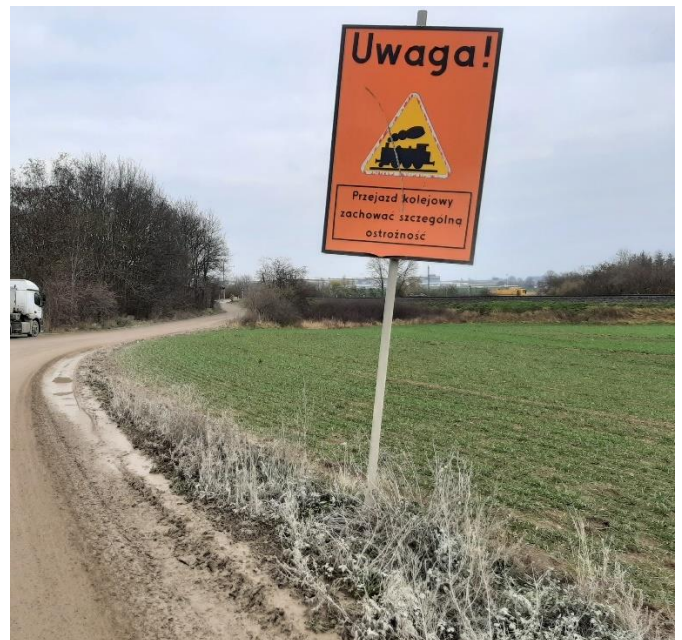
Photograph 7 – Information board placed by the road to the gravel pit

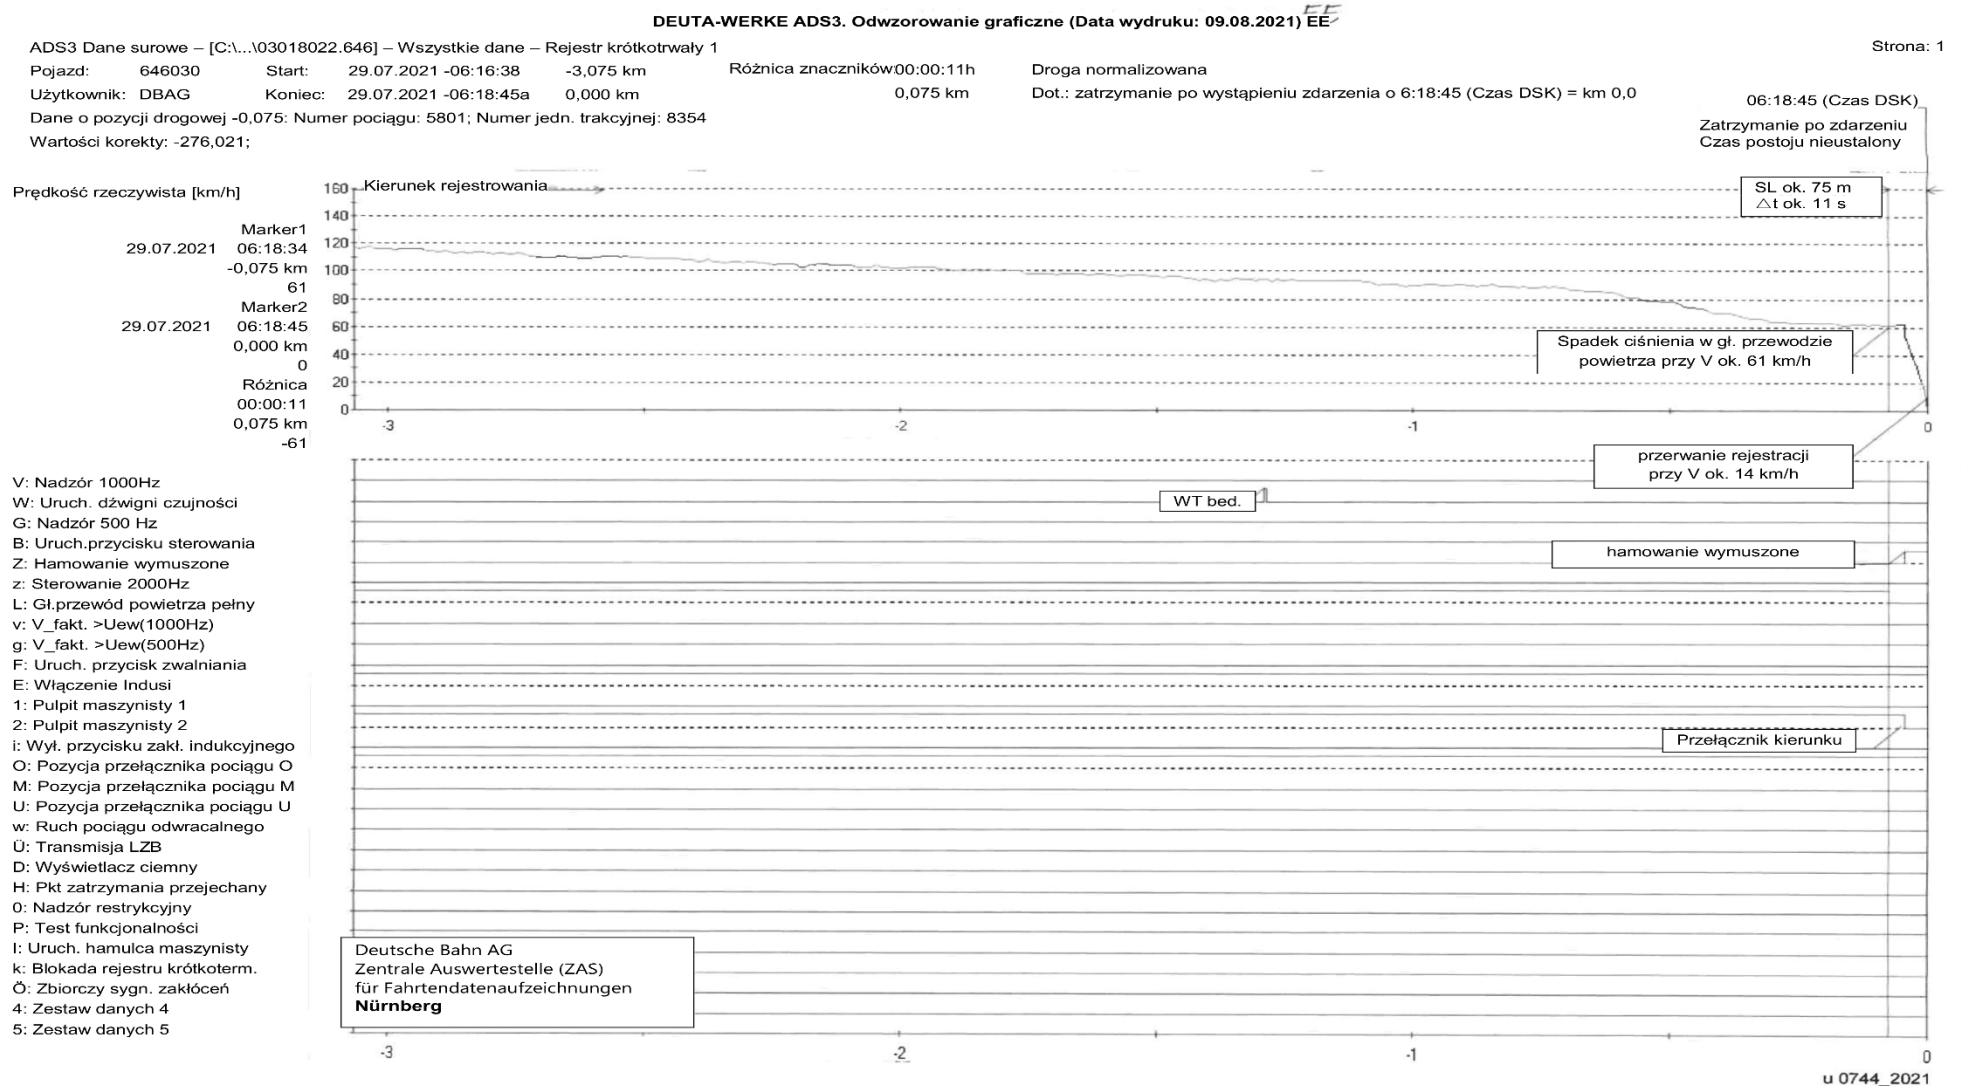
Figure 2 – Diagram of the driving parameters of the multiple unit VT646 as a function of time (developed by SCRAI)

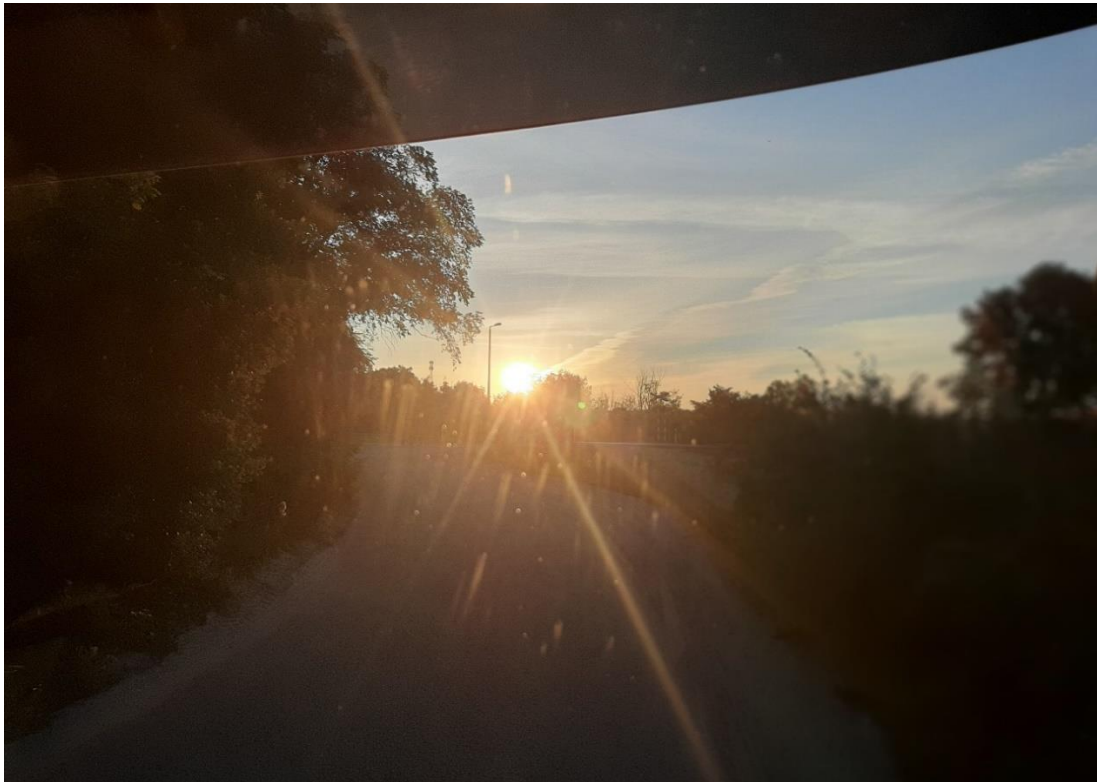
4. Sun glare (in the morning with a clear sky) on the user of the road to the gravel pit when accessing the district road and joining traffic (photograph no. 8).

Photograph 8– View from the road to the gravel pit during access to the district road and passage from the road vehicle
(source SCRAI)

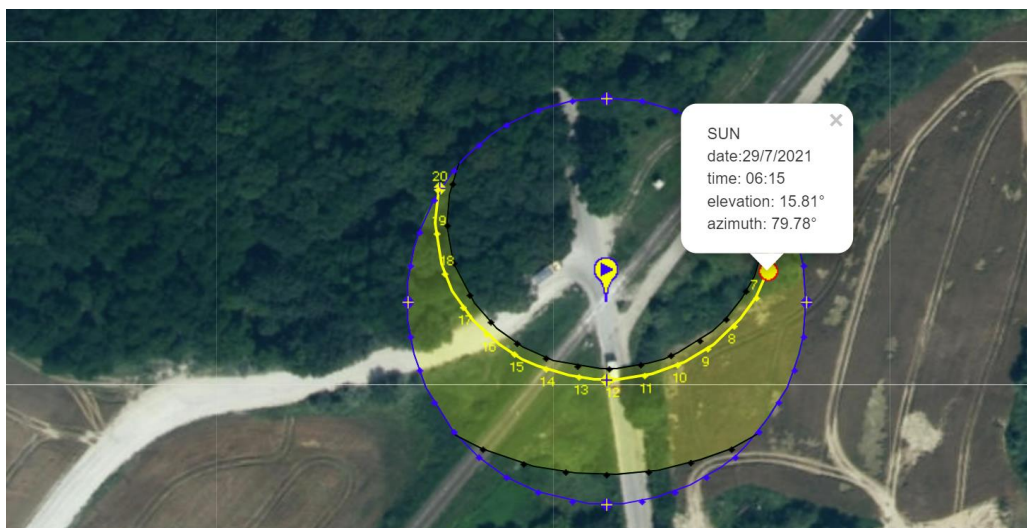
Photograph 9 – Sun position at the time of the accident (source: <https://www.sunearthtools.com>)

The positioning of the lenses of the traffic signal number S3 causes the phenomenon of blinding the users of the road to the gravel pit in the morning in sunny weather, making it very difficult to identify the signals transmitted by this sign.

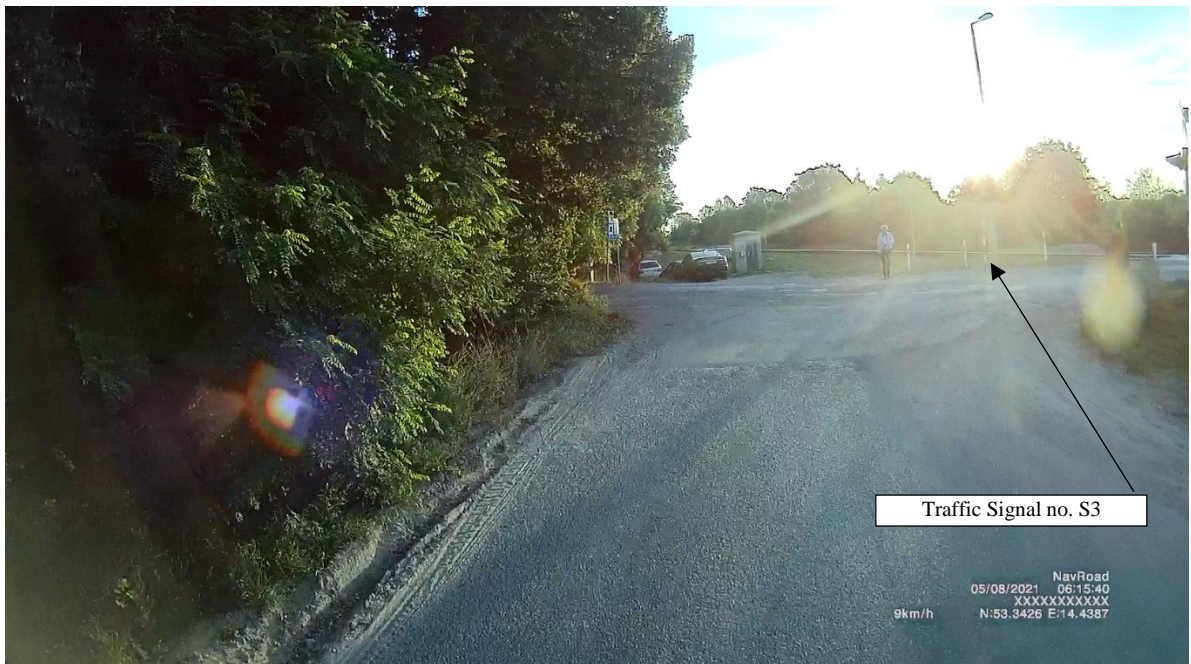
On 05.08.2021 (7 days after the incident) an experiment was conducted to determine the field of vision of the truck driver when approaching the district road and crossing. The experiment involved representatives of the infrastructure manager, the road carrier whose vehicle was involved in the incident and members of the Investigation Team. The experiment was conducted under conditions similar to those in which the event occurred. A road vehicle of the same type as the vehicle involved in the incident (a heavy goods vehicle with a semi-trailer loaded with gravel) was used for the experiment. The weather conditions were similar to those on the day of the accident (sunny, temperature +15°C, no rain or fog). The automatic crossing system equipment was activated by train no. RMM 80681/5801 (in accordance with the timetable at the same time as on the day of the accident). The road vehicle journey was carried out in a manner similar to the technique and driving of the vehicle involved in the accident. A video recorder was installed in the road vehicle at the driver's eye level. During the experiment, it was found that the driver of a road vehicle is blinded by sunlight coming directly from above the traffic signal box no. S3 when approaching the district road. When joining the traffic and entering the district road, the driver of the road vehicle is forced to take the left side of the road to the gravel pit and make a sharp right turn (90-degree angle) also occupying the left lane of the district road while driving over a steep climb. During this manoeuvre, the sun blinds the driver at all times and at some point, during the journey, the signals transmitted by signal box S3 are not visible. The road mirror intended to improve visibility onto the district road when joining traffic from the road to the gravel pit is not performing its function job as it is also located the height of the sunlight (photographs 10 and 11).

Photograph 10 – A frame from the driving recorder during the experiment (source SCRAI)

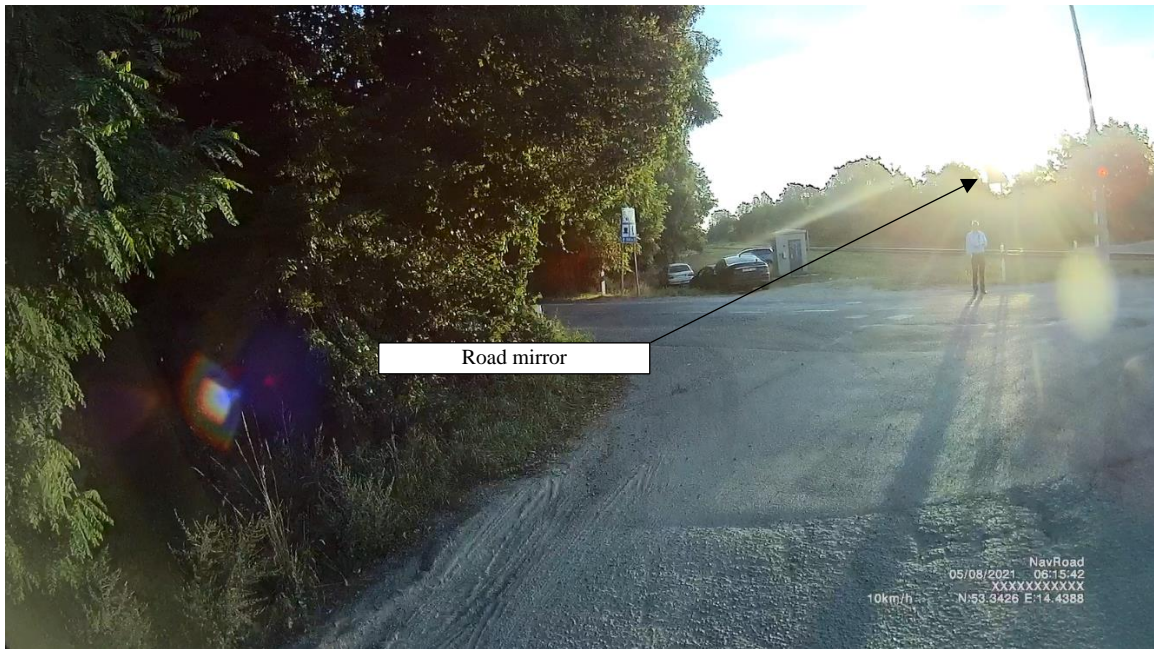
Photograph 11 – Another frame from the driving recorder during the experiment (source SCRAI)
