STATE COMMISSION ON RAILWAY ACCIDENT
Ministry of the Interior and Administration

REPORT No. PKBWK 01/2022

**from the procedure in case of serious train accident on 04 April 2021 at 09:10 on route from
Oborniki Wielkopolskie - Rogoźno Wielkopolskie, on track no. 1, railway-road crossing
category D at km 30.453 of railway line no. 354 Poznań Główny POD – Piła Główna**

WARSAW, 23.02.2022 r.

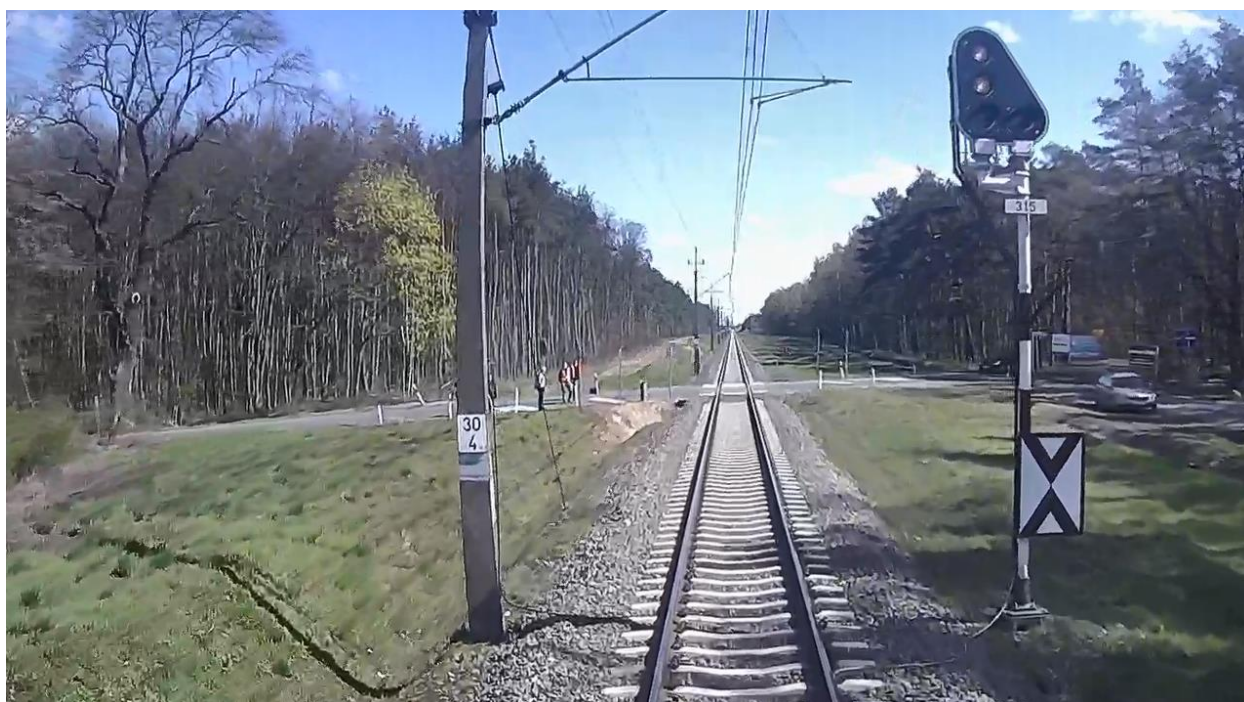
Photo 3. View of a level crossing from the cab of a railway vehicle from the direction of train travel (source: GDPWK)

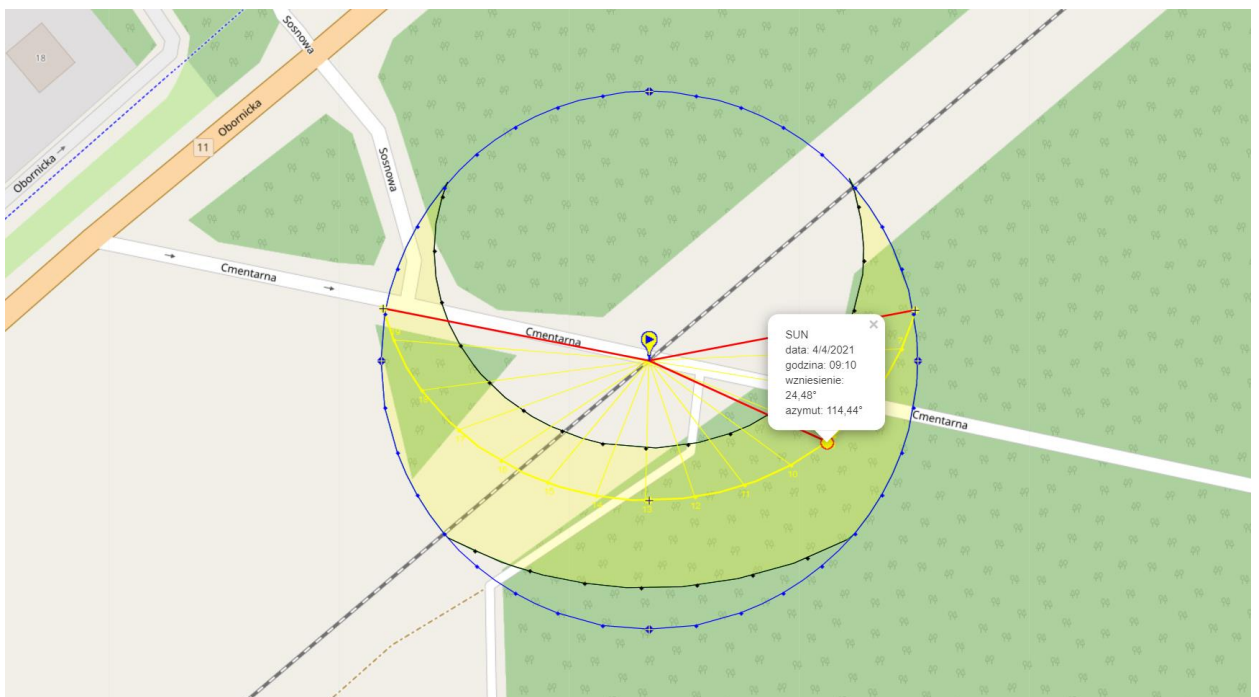
Photo 5. The position of the sun at the time of the event (source: Sunearthtools.com)

The incident took place in good weather conditions, without rain or fog. It was early morning, the sky was cloudless, sunny, the sun was low above the horizon, the direction of the sun's rays was along the road towards the oncoming car, the temperature was about 5° C. Within the railway-road crossing at the time of the incident there were no other road users likely to absorb the attention of the driver of the road vehicle. No work was carried out in the area of the rail-road crossing.

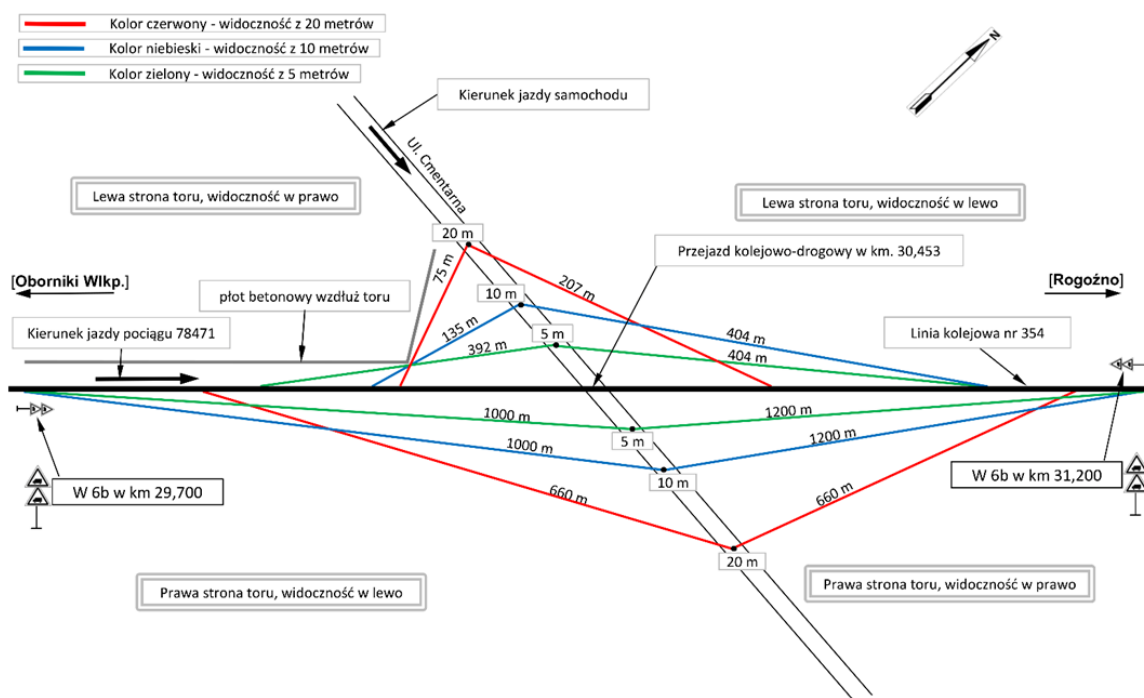
Figure 2 - Triangles of visibility of the train front from the road measured by the Study Team (developed by GDPWK)

The investigation team found that the visibility parameters for the train front from the access road as stated in the level crossing metric were not consistent with the facts. On the day of the accident, a train speed of up to 120 km/h was in force at the level crossing. The visibility values given in the rail-road crossing metric allowed train speeds of up to 100 km/h. Taking into account the non-conformities found, the Chairman of the GDPRC issued a recommendation to measure the visibility of the train front from the approach road using a railway vehicle of the same type as in the incident. The results of the measurements are entered in Table 2 and plotted in Figure 2.

Analysing the collected material, the Investigation Team found that the visibility conditions had not changed since the date of the entry of the visibility measurements in the metric of the level crossing, i.e. 20.08.2020. The visibility of the train front was mainly limited by a concrete fence and concrete traction poles (Photo 6). From the measurements made by the Research Team, it is clear that with a train head visibility of 392 metres from 5 metres, the speed of trains within the railway-road crossing should not exceed 70 km/h. In the opinion of the Investigation Team, the data contained in the rail-road crossing metric regarding the visibility of the train front did not reflect the actual situation. The actual conditions of visibility of the train front from the road indicated that the speed of the trains had to be reduced.

- 3) Infrastructure managers shall take measures to improve the quality and depth of inspections, diagnostic tests and the way the visibility triangle of level crossings is measured. When measuring visibility triangles account must be taken of the fact that the visibility of the train head from 5 metres from the outermost rail must be continuous (not obscured by any objects as the train approaches the level crossing) and must include the front end signal lanterns. If this condition is not complied with, the speed of trains in the area of level crossings shall be reduced in accordance with the legislation in force.

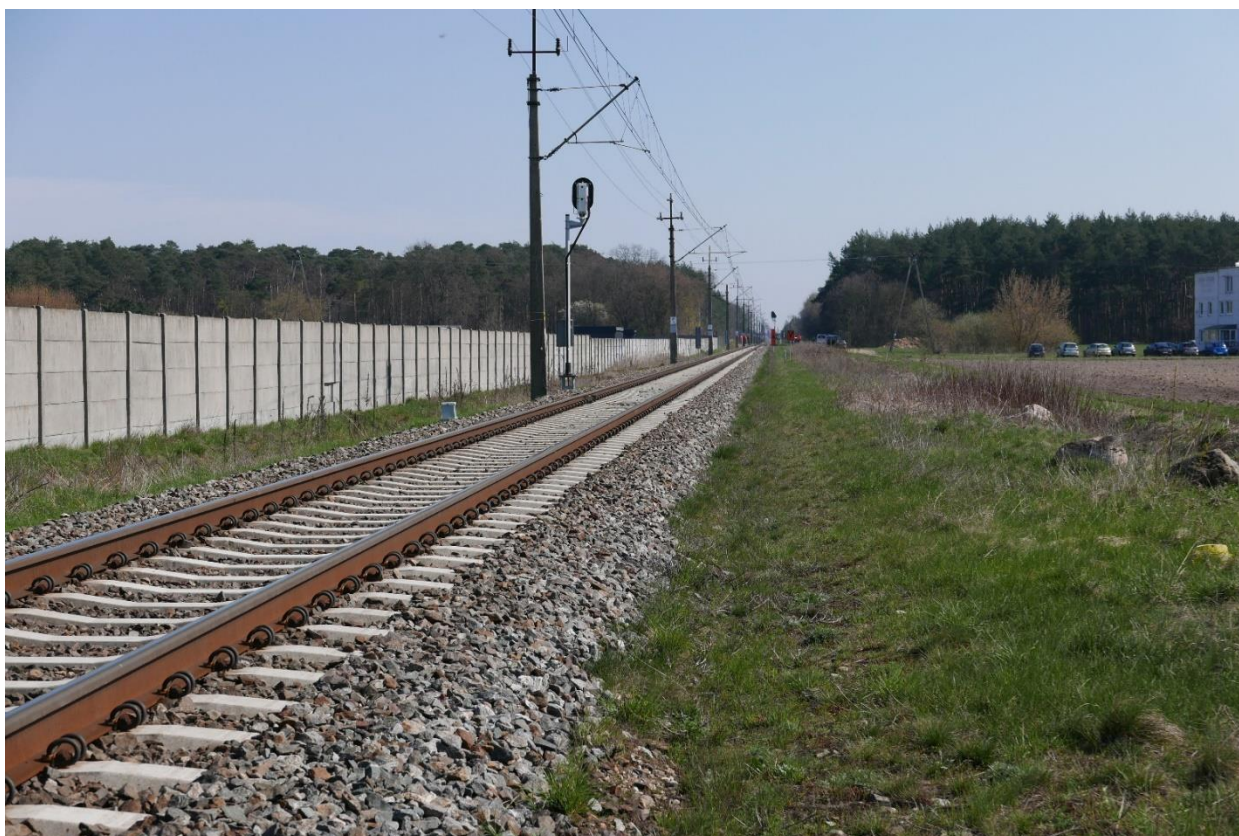
There was a 375 m long fence made of prefabricated concrete elements on the left side of the track before the level crossing from the Oborniki Wlkp station. The height of the fence was 2.0 - 2.5 m, the distance from the rail from 5.0 m to 7.5 m. The fence ends approximately 50m before the level crossing and restricts visibility for drivers of railway and road vehicles.

On the same side of the track as the fence there are concrete catenary poles also limiting the field of vision.

Photo 7. Fence and traction poles restricting visibility (source: GDPWK)

The committee requested that the built-up concrete fence near the rail-road crossing be surveyed and replaced with an openwork fence by the property owners.

During the course of the investigation, the concrete fence was altered and part of it replaced with an openwork fence in order to improve the visibility of the front of the train and the approaching road vehicle.

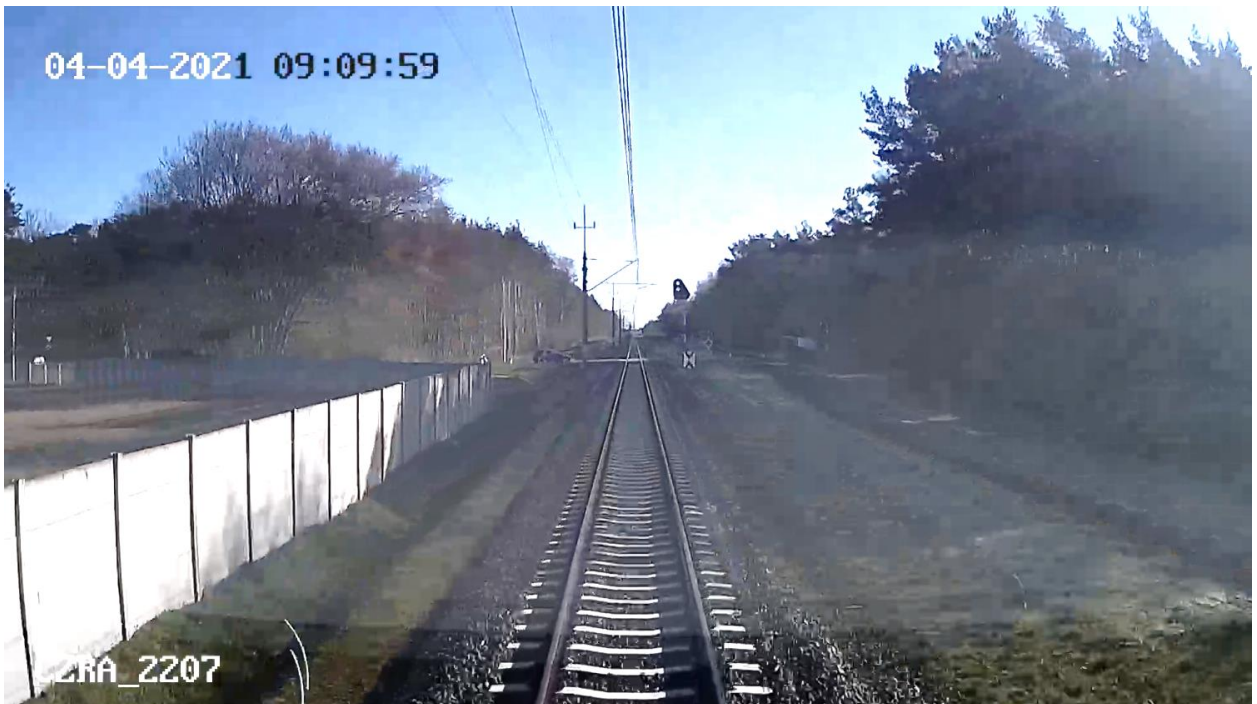
Photo 8. View from the driver's cab just before the collision - about 100m to the level crossing, 09:09:59 (source: GDPWK)

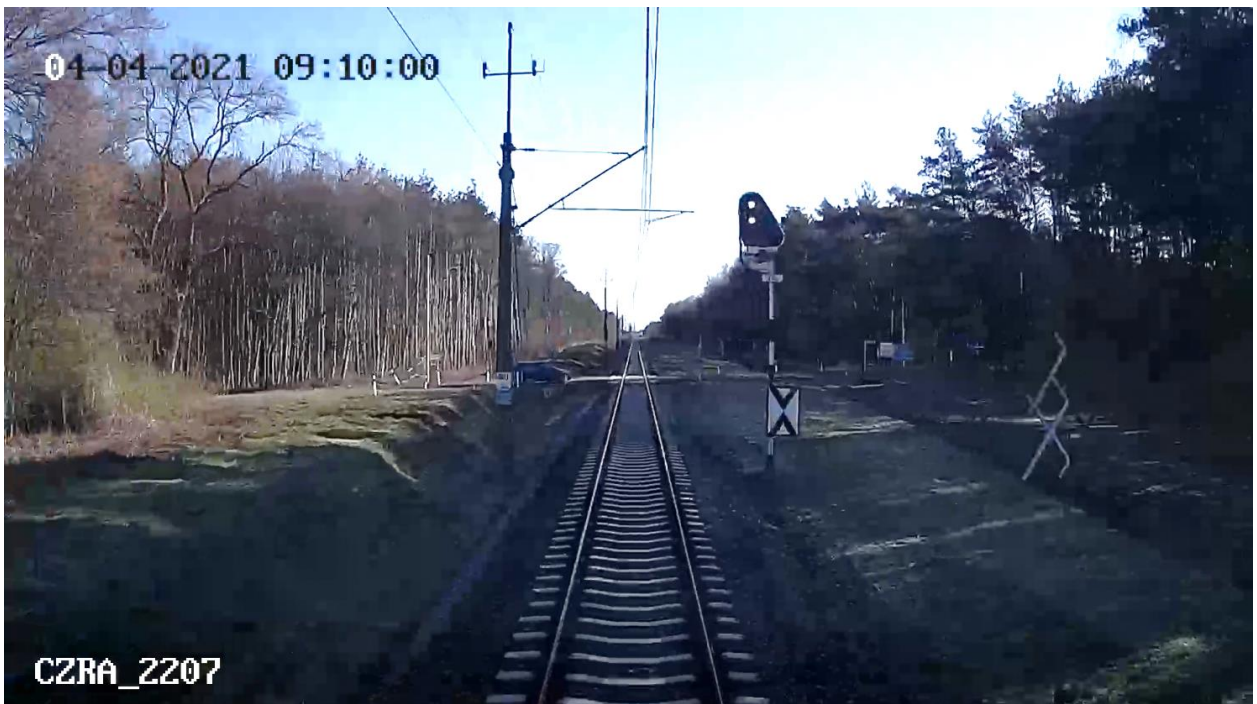
Photo 9. View from the driver's cab just before the crash - about 64m to the rail-road crossing, 09:10:00 (source: GDPWK)

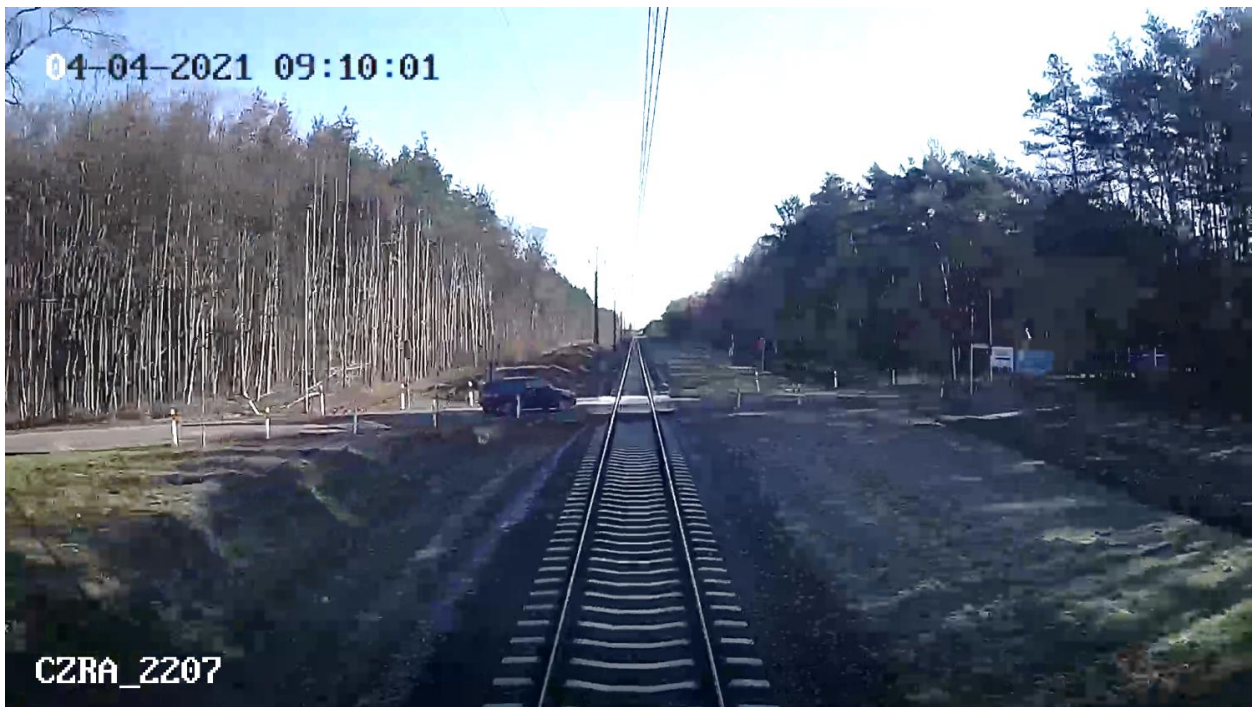
Photo 10. View from the driver's cab just before the crash - approximately 39m to the level crossing, 09:10:01 (source: GDPWK)

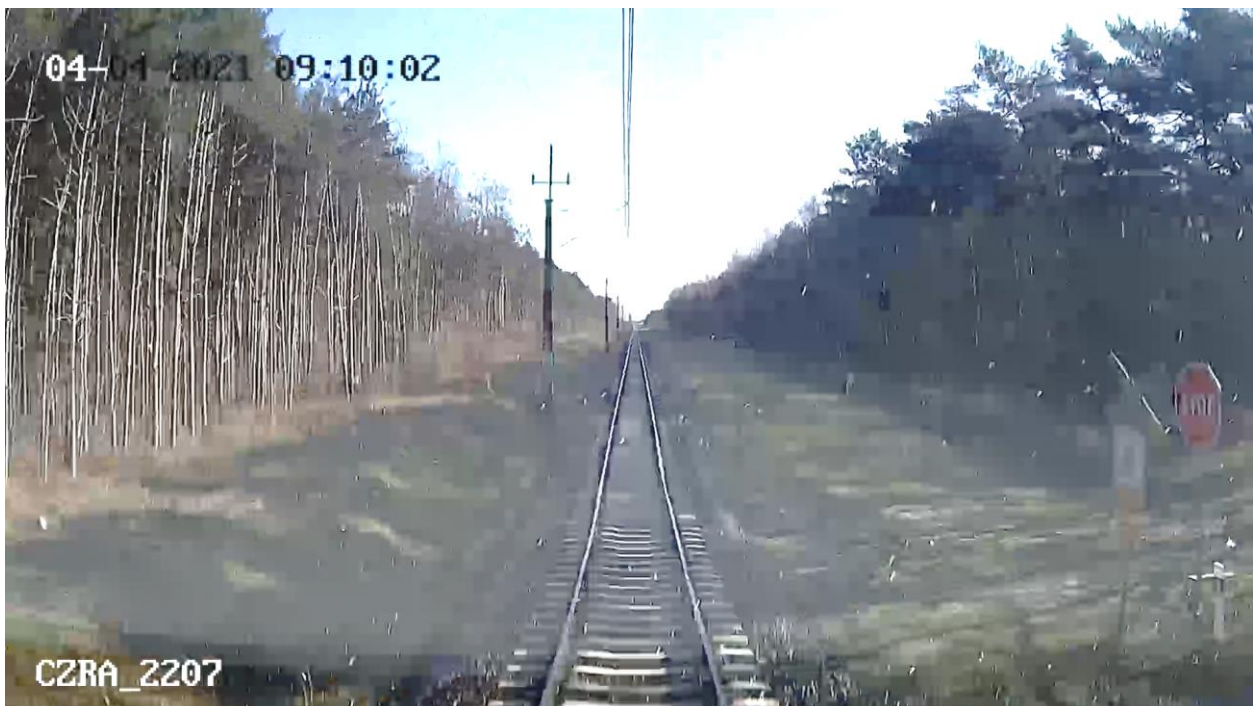
Photo 11. View from the driver's cab at the time of the crash - 09:10:02 (source: GDPWK)

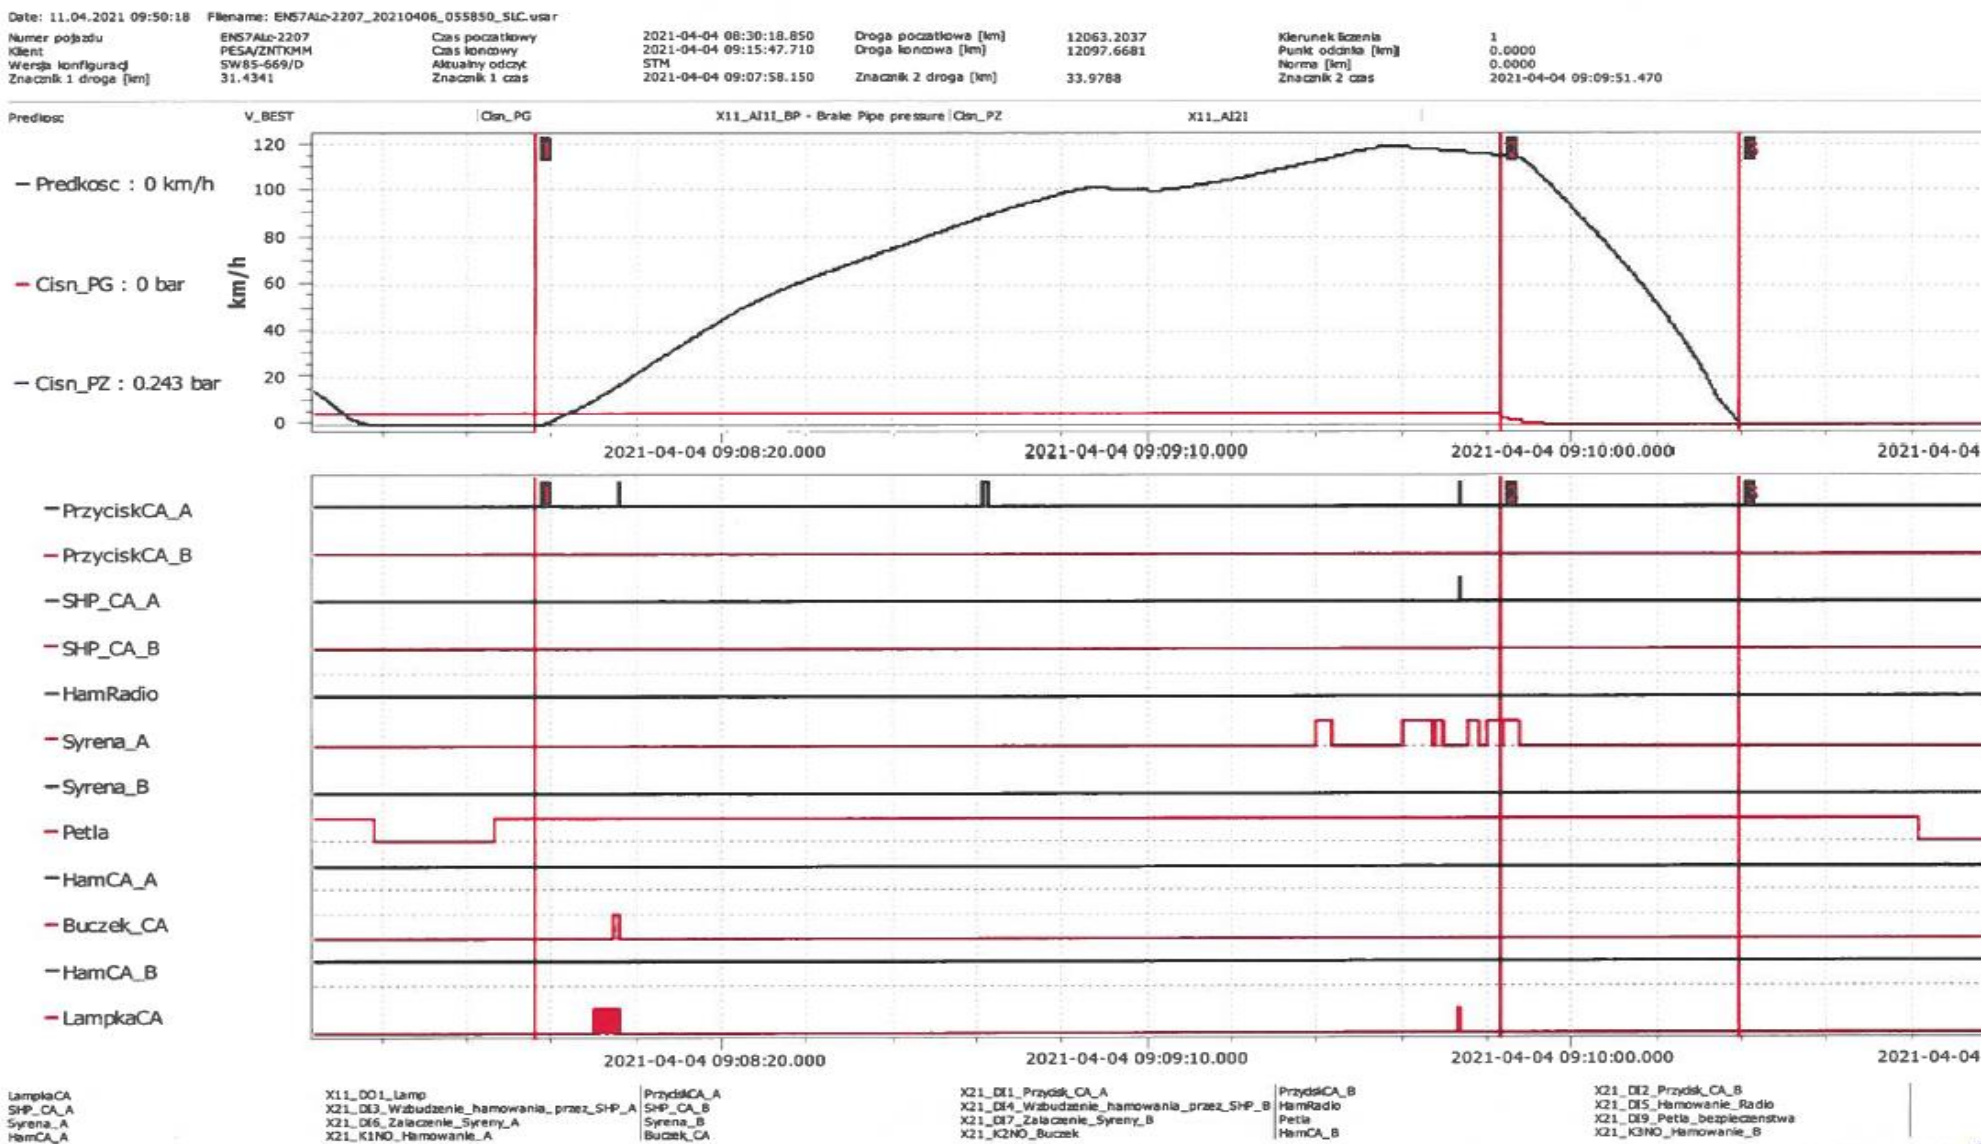
Figure 3 - Graph of EN57ALc-2207 driving parameters as a function of time (developed by GDPWK)

The above diagram shows, inter alia, the following running parameters of train ROJ 78471:

1. speed,
2. pressure in the main line,
3. pressure in the air reservoir,
4. use of the active standby button,
5. use of the SHP button,
6. use of an audible signal,
7. cab identification - control from cab B.
