# FINAL REPORT

## ACCIDENT

**Occurrence No.: 466/07**

**Aircraft: B737-800, EC-HBM**

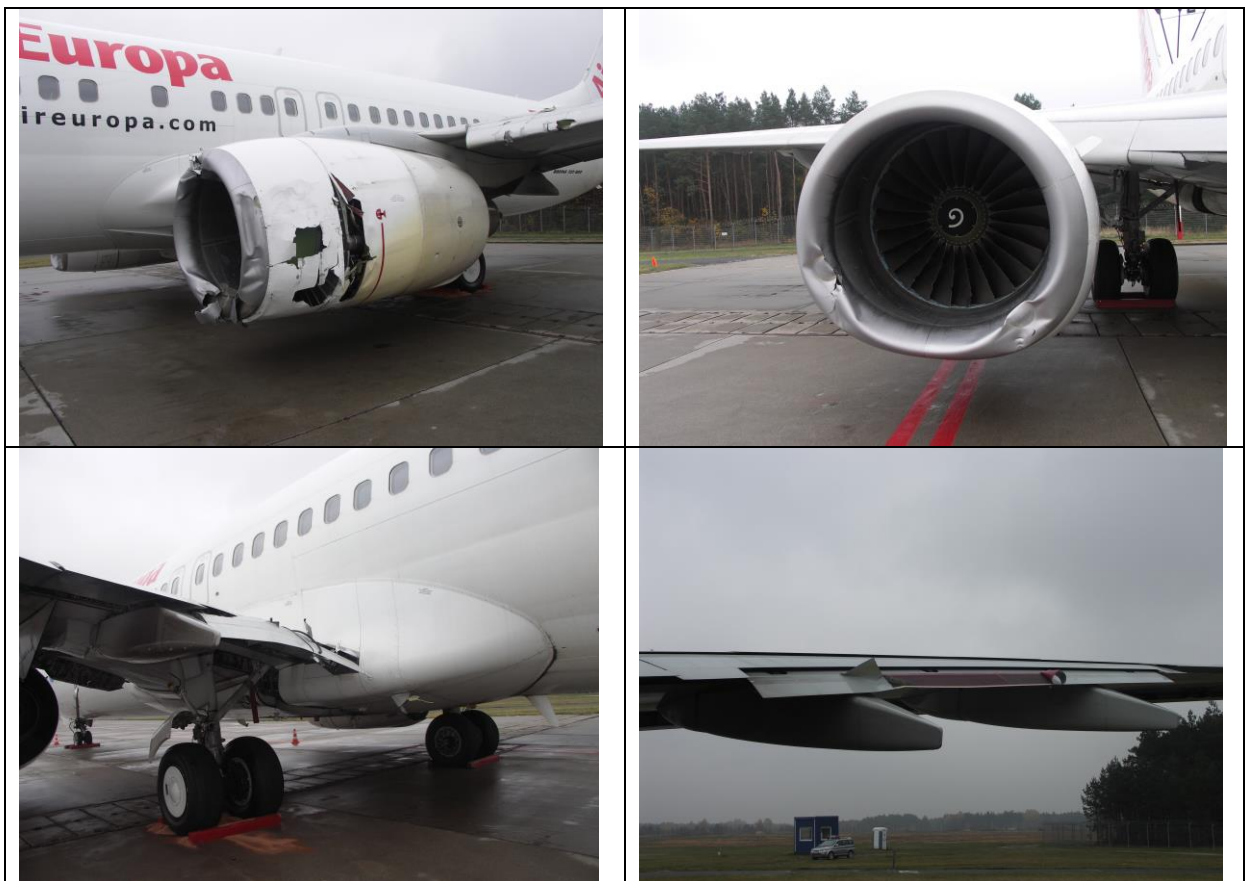
As a result of the occurrence the aircraft sustained substantial damage to both wings skin, flaps, engines and the landing gear hydraulic system. Boeing survey report sent to the SCAA I contained 123 items.

Fig. 3-6. Damage to the EC-HBM airplane

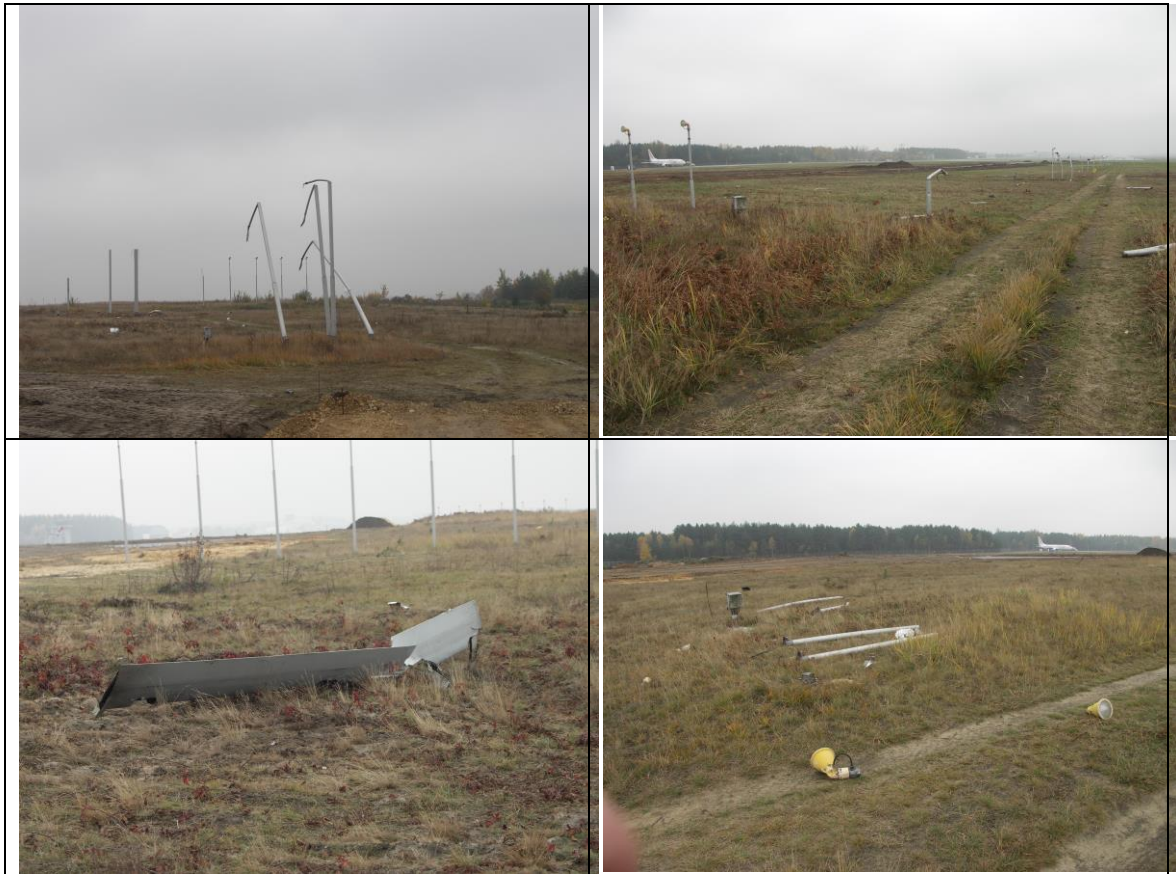
Damage to the system of approach lights (66 approach lights, 20 flashing lights and other elements of the lighting system).

Fig. 7-10. Damage to the approach lights on EPKT

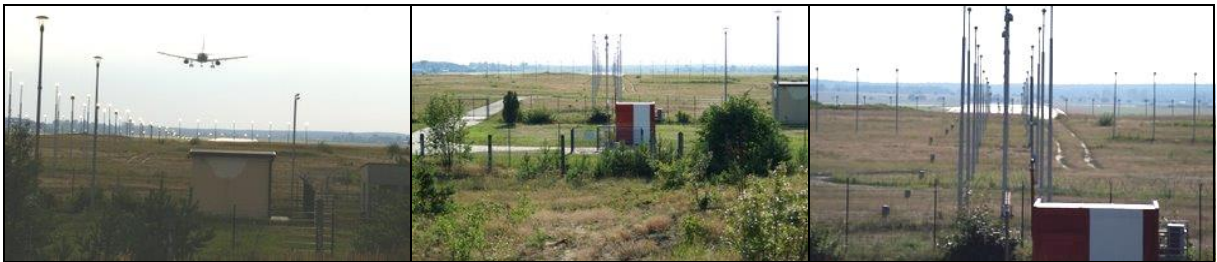
6, 7, 8 – Approach lights situated ahead of EPKT RWY27 – condition prior to the accident  
[photo: internet site publicly available]

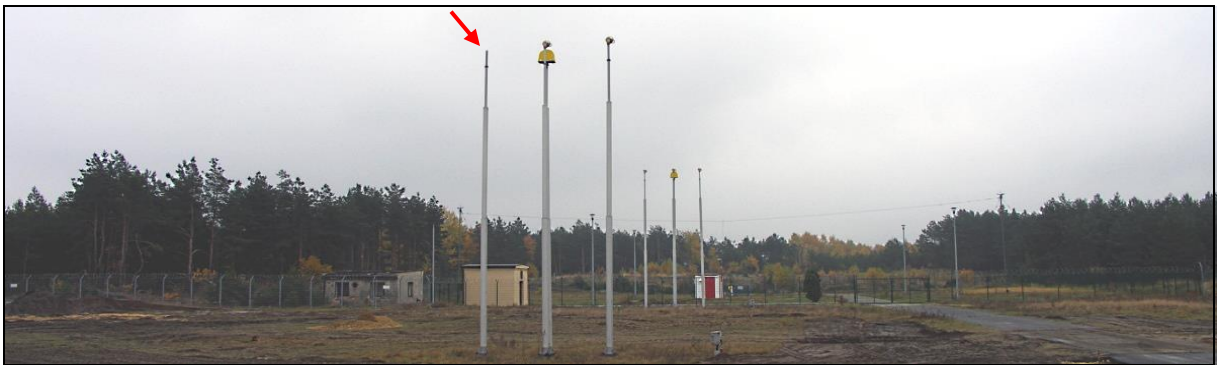
9 – Beginning of the approach lights system ahead of EPKT RWY27 threshold after the accident

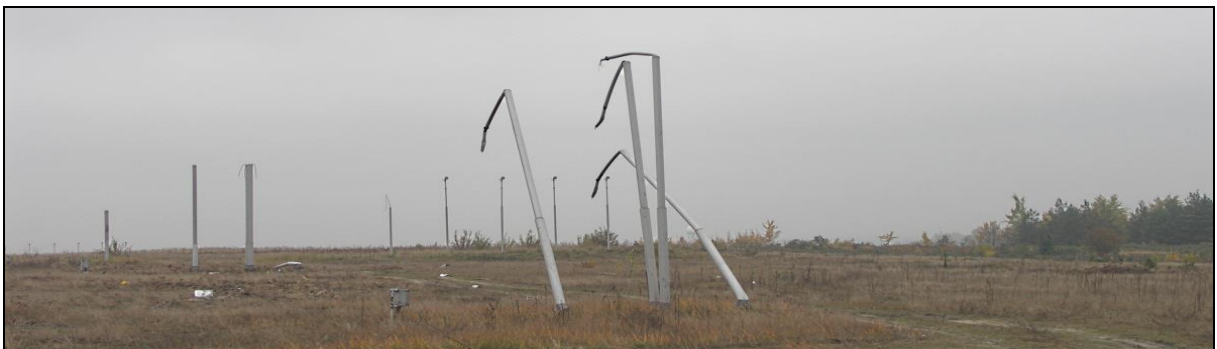
10 – Damage to the approach lights system ahead of EPKT RWY27 threshold after the accident

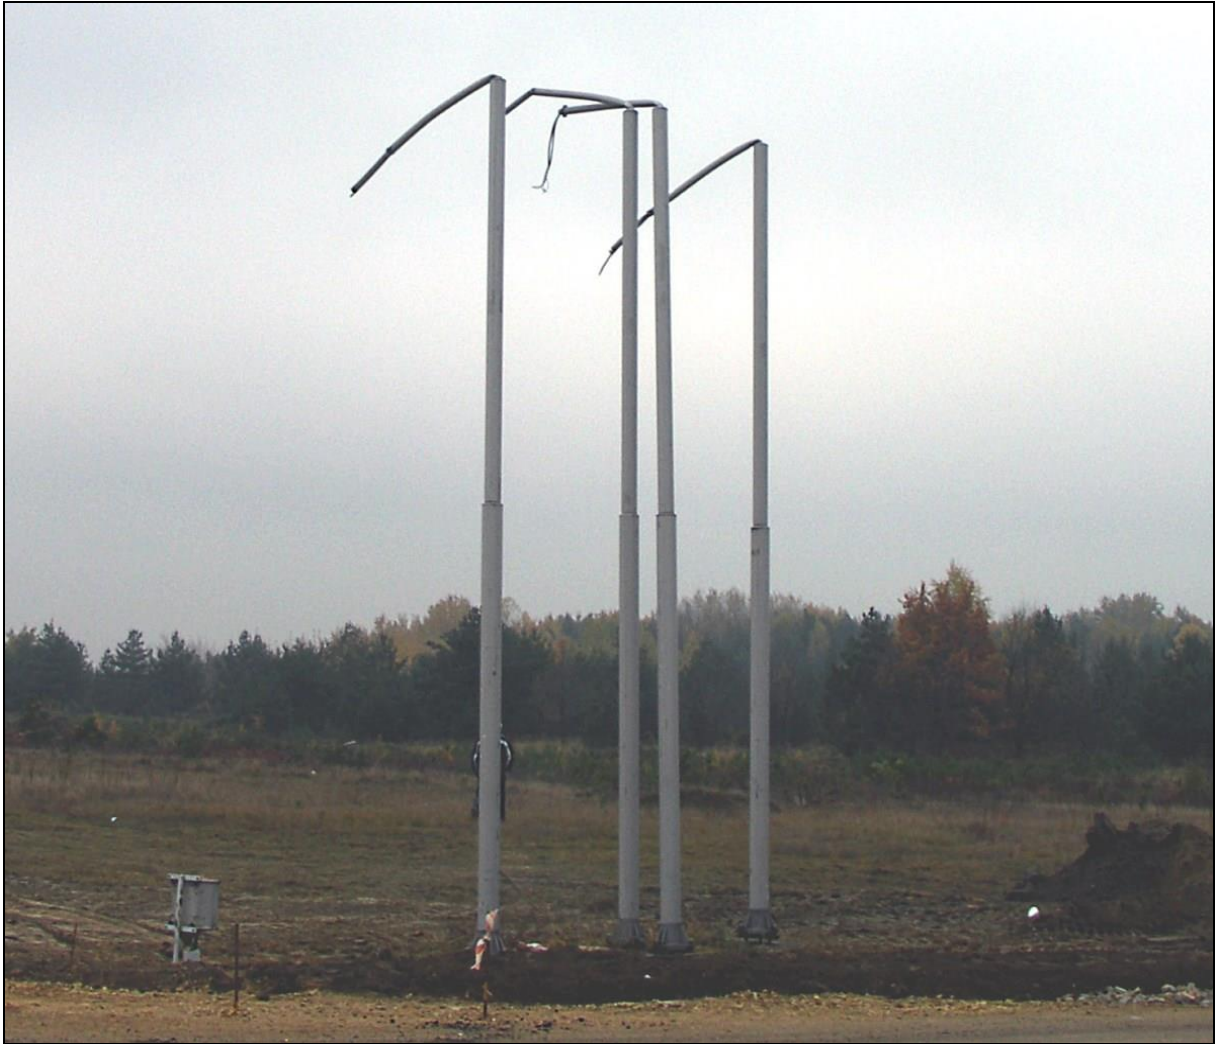
**11 – Damage to the approach lights system ahead of EPKT RWY27 threshold after the accident**

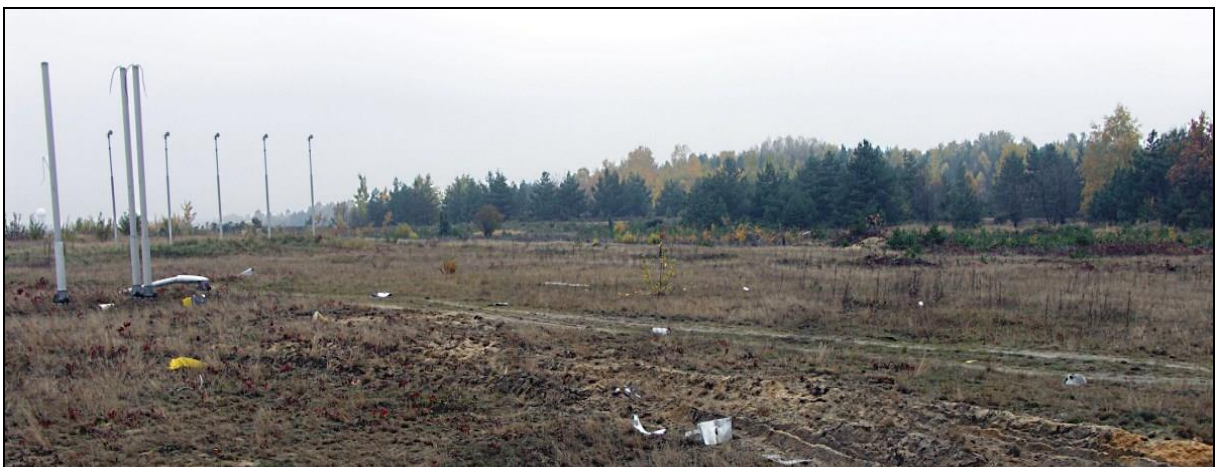
**12 – Damage to the approach lights system ahead of EPKT RWY27 threshold after the accident**

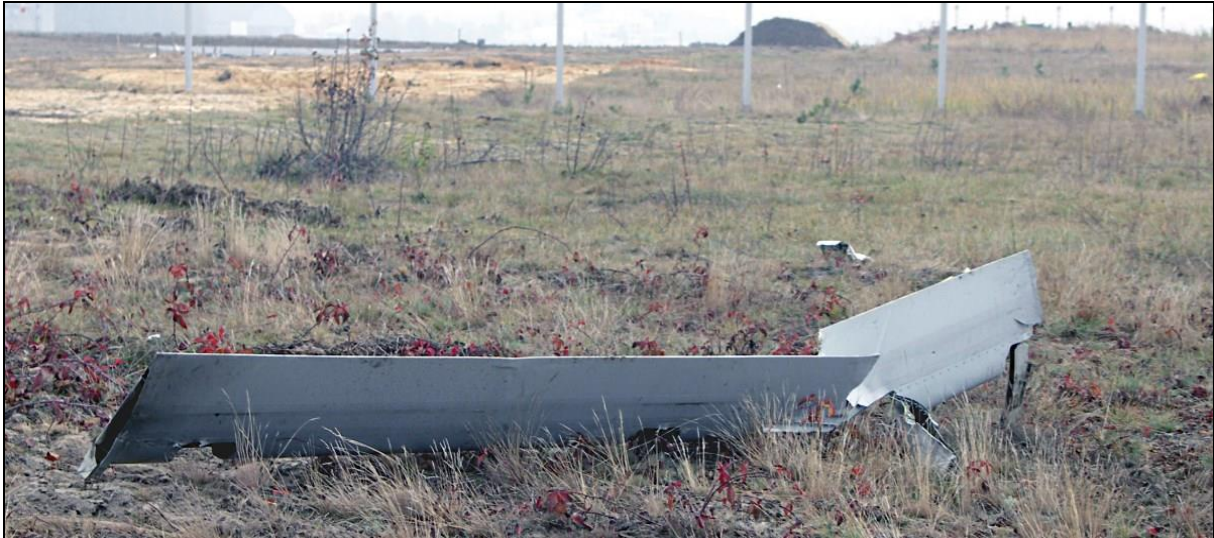
**13 – Trailing part of the left outboard flap separated from the airplane**

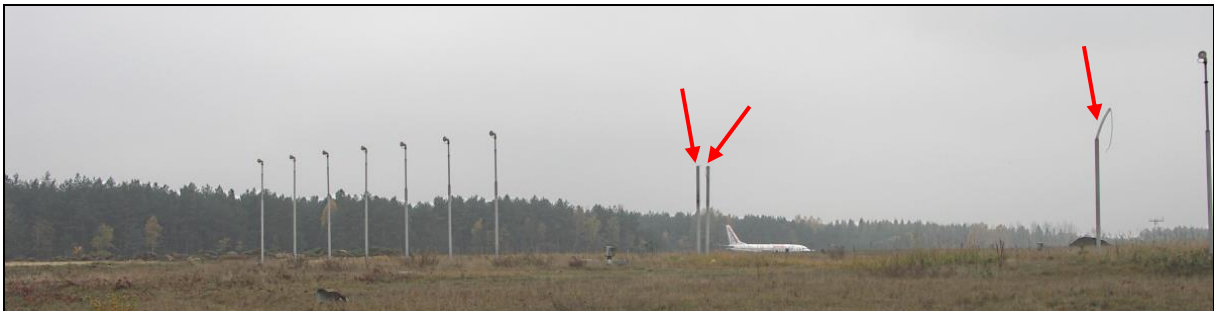
16 – Damage to the approach lights system ahead of EPKT RWY27 threshold after the accident

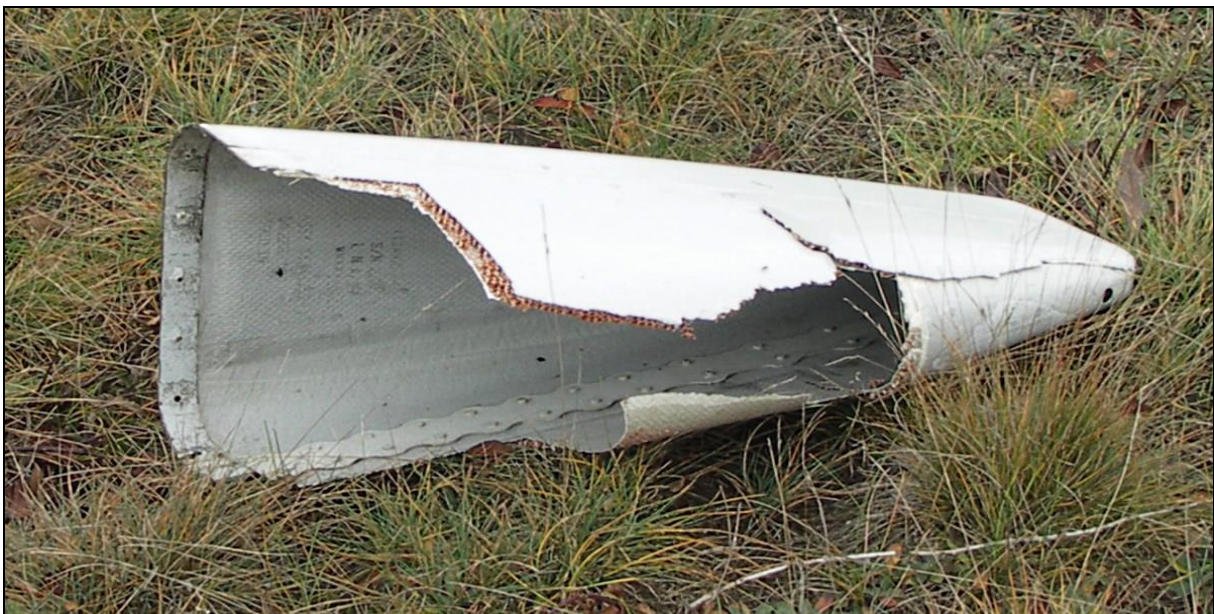
17 – Separated part of a flap track fairing from the left wing

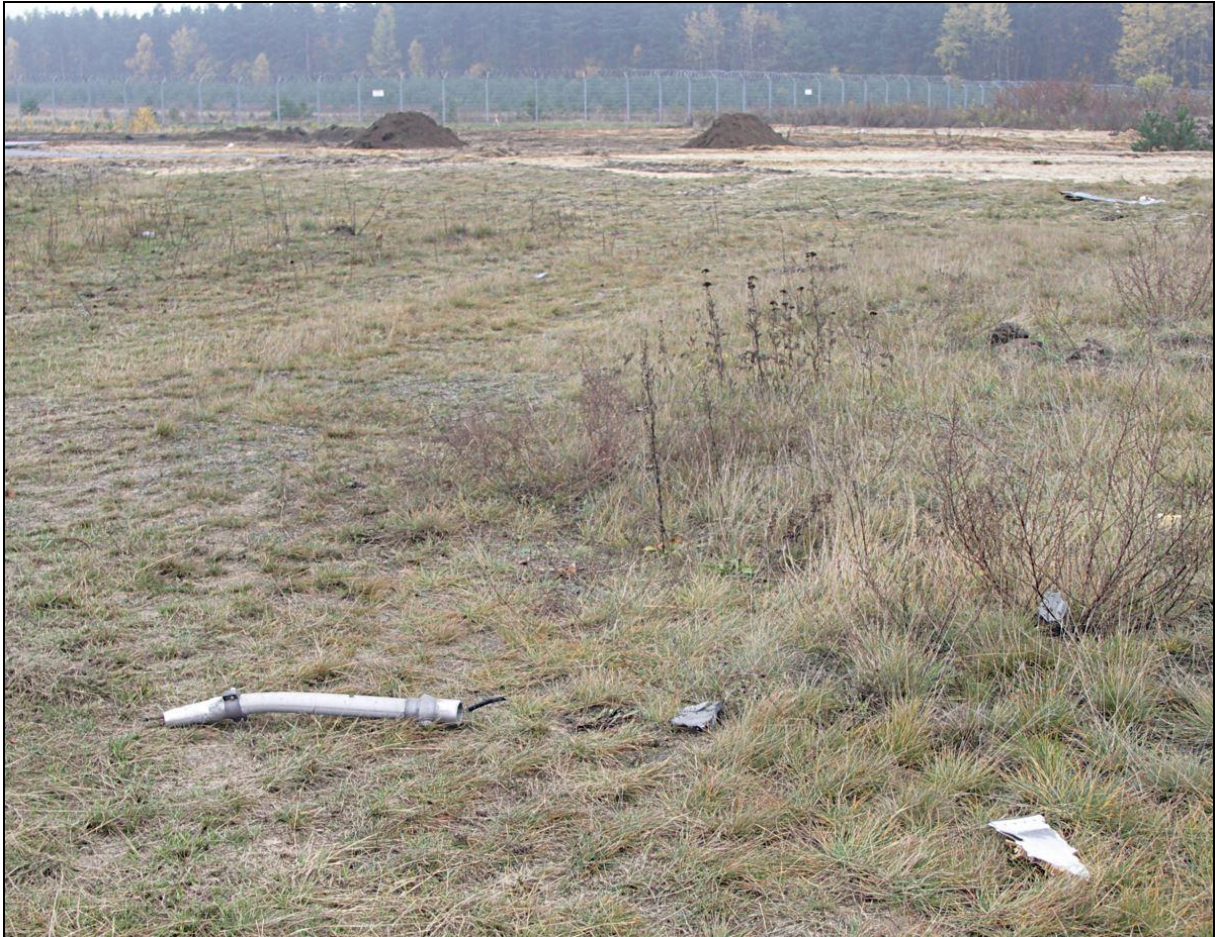
**18 – Pieces of damaged lights and small pieces of the airplane skin**

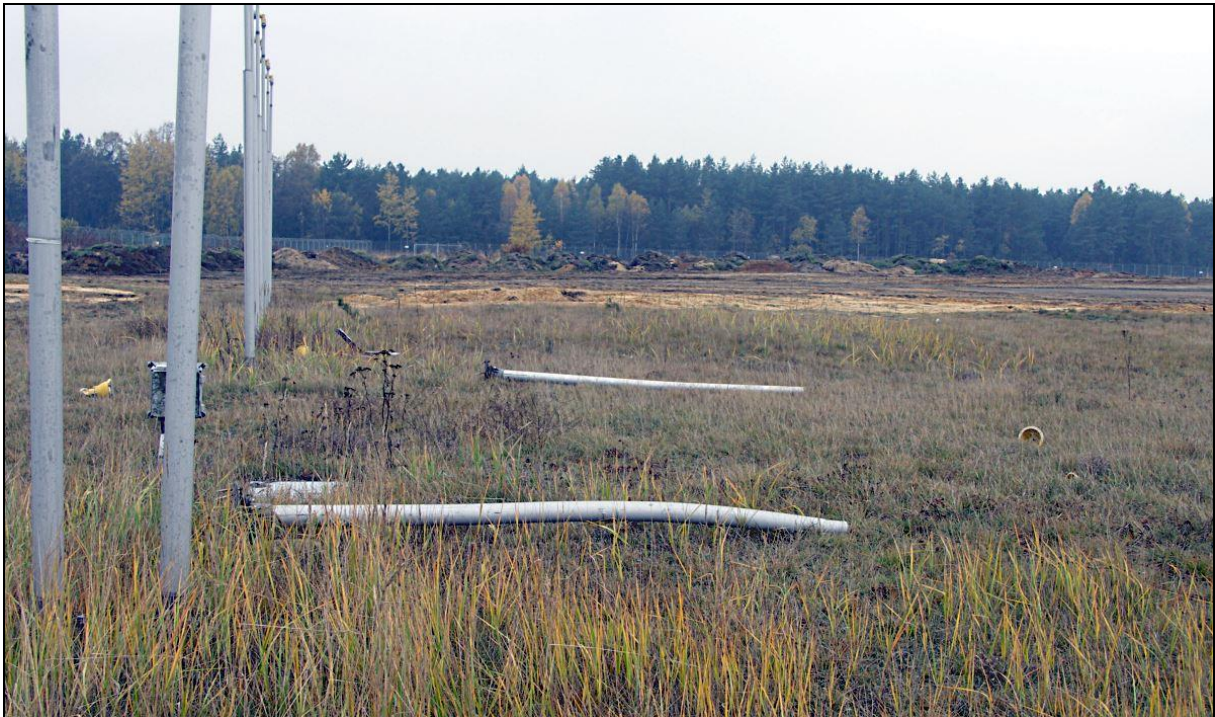
**19 – Damage to the approach lights system ahead of EPKT RWY27 threshold after the accident**

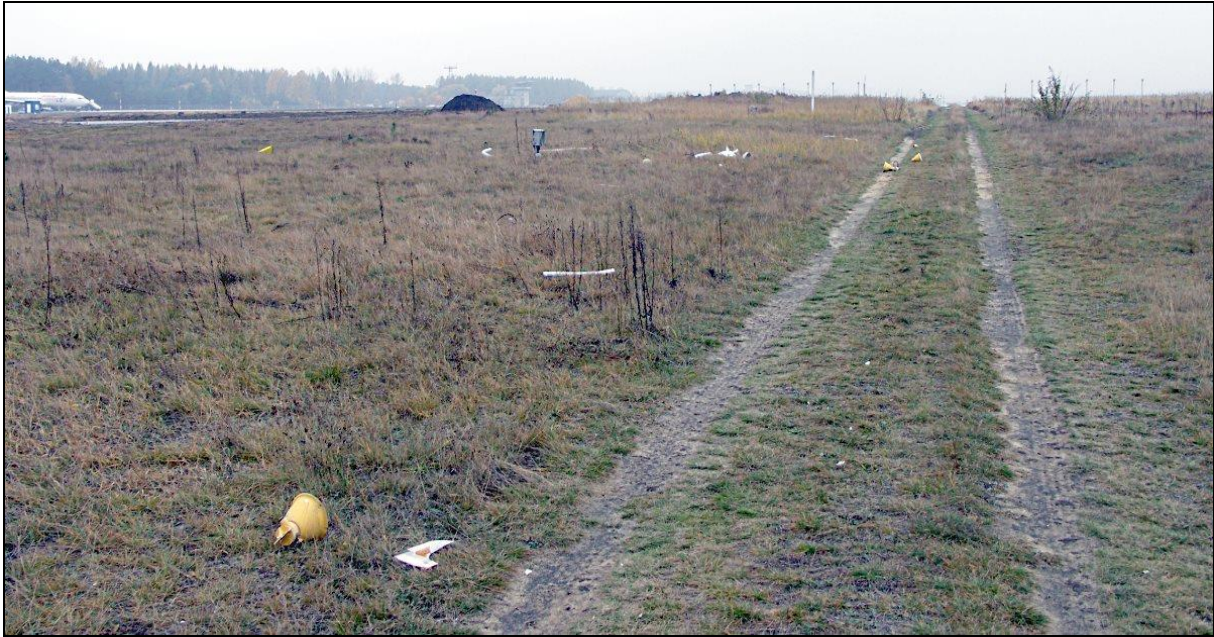
**20 – Pieces of damaged lights and small pieces of the airplane skin**

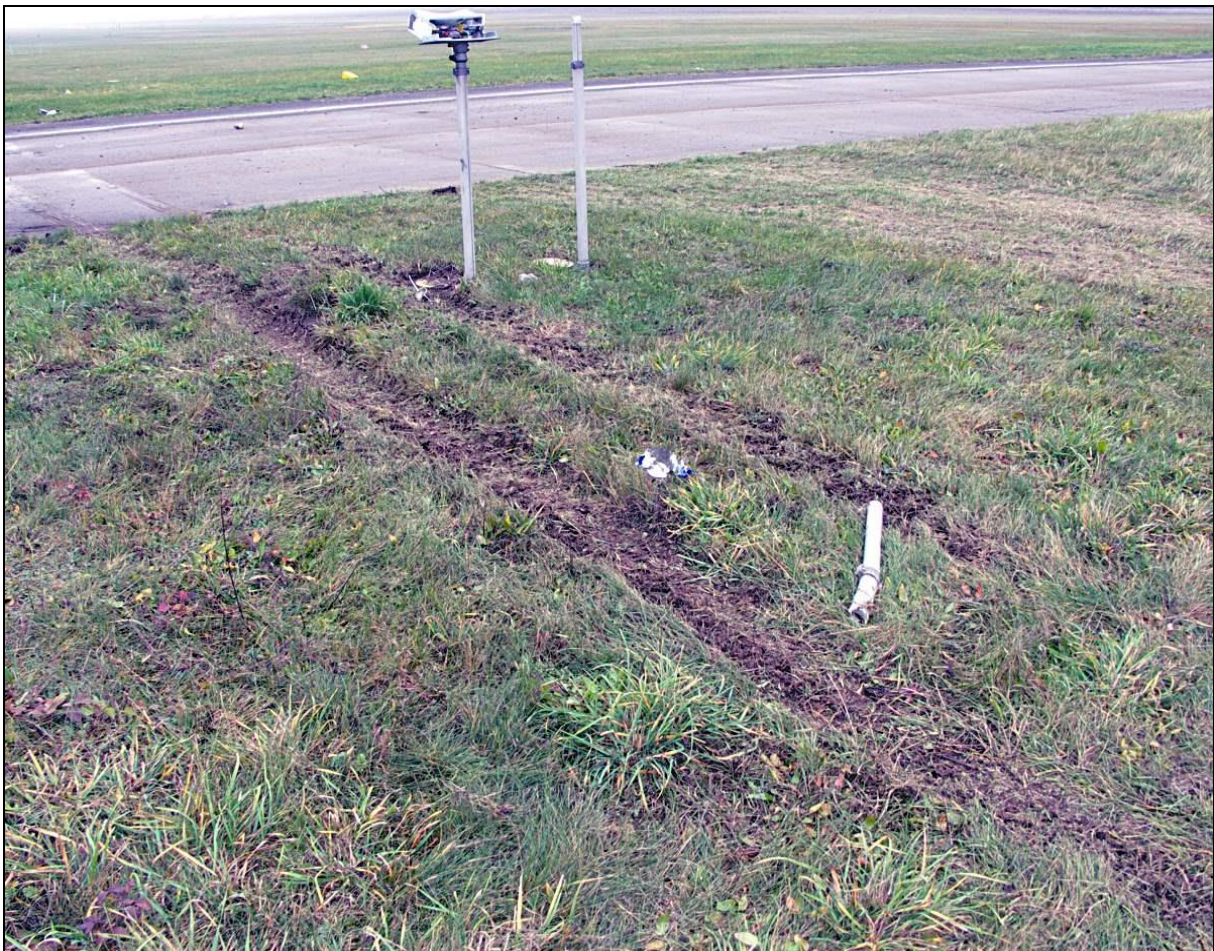
**21 – Tracks of the left main landing gear wheels near transversal taxiway ahead of EPKT RWY27 threshold**

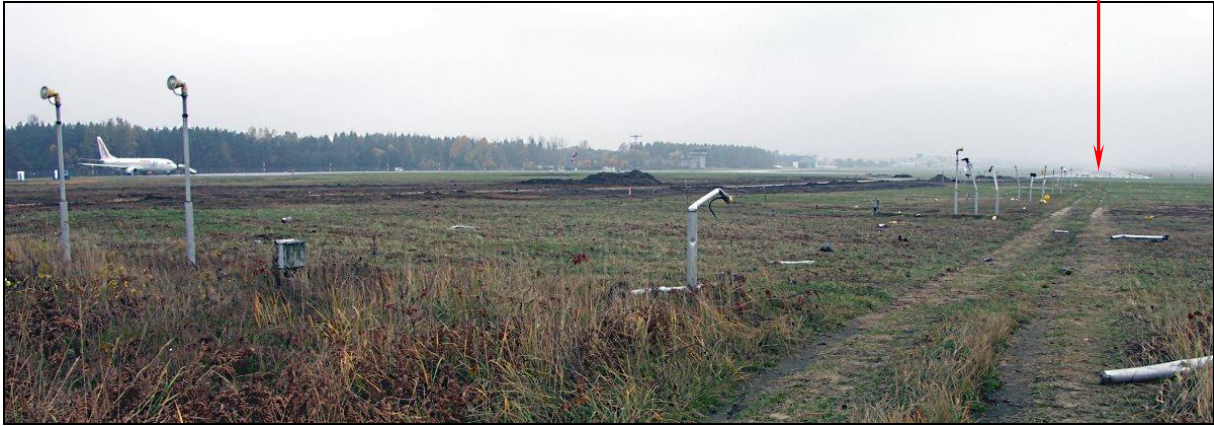
22 – Damage to the approach lights system ahead of EPKT RWY27 threshold after the accident. Visible RWY27 threshold

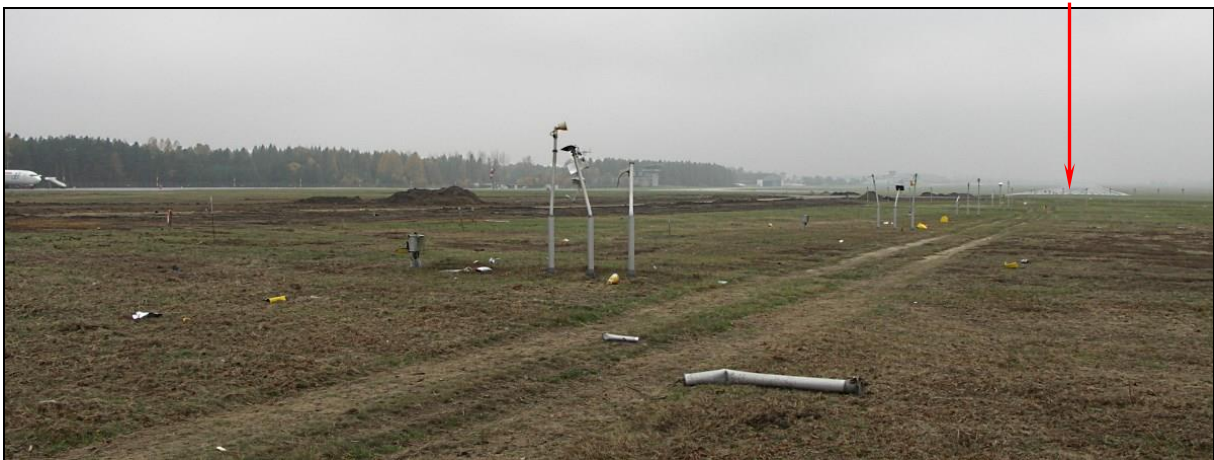
23 – Damage to the approach lights system and small pieces of the airplane skin. Visible RWY27 threshold

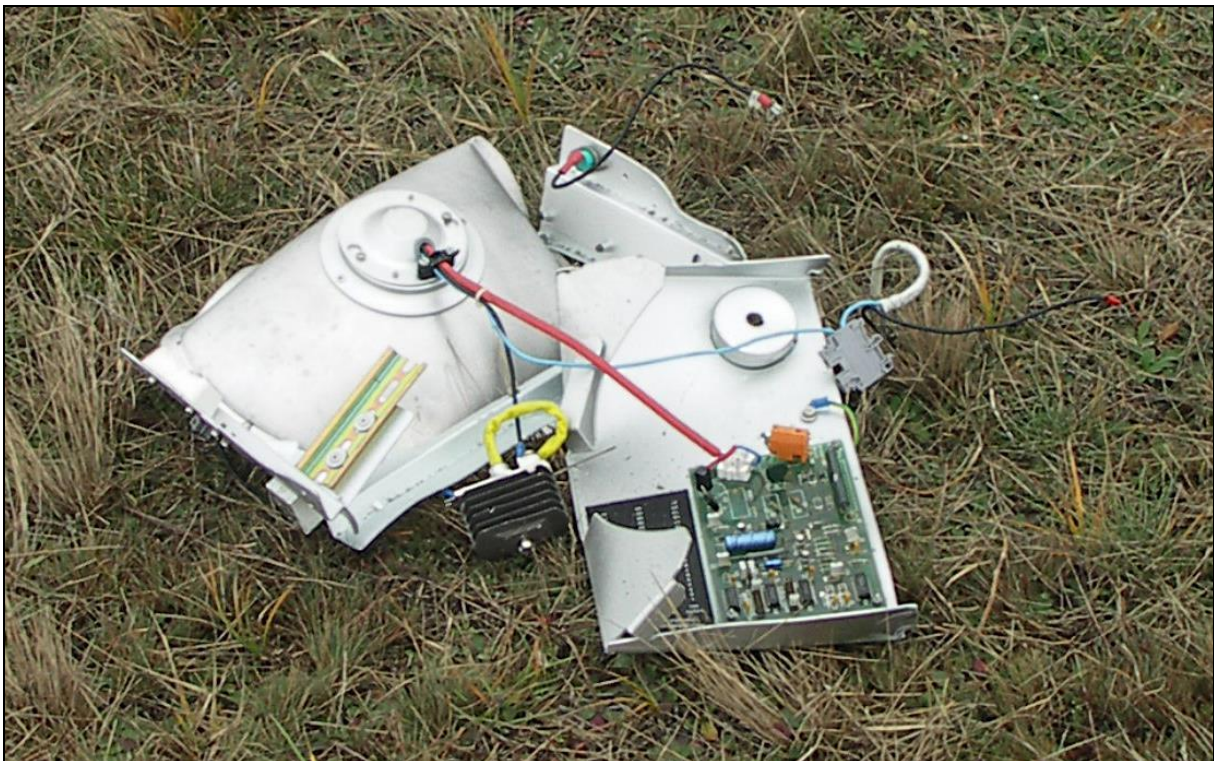
24 – Wreckage of one of the approach system lights

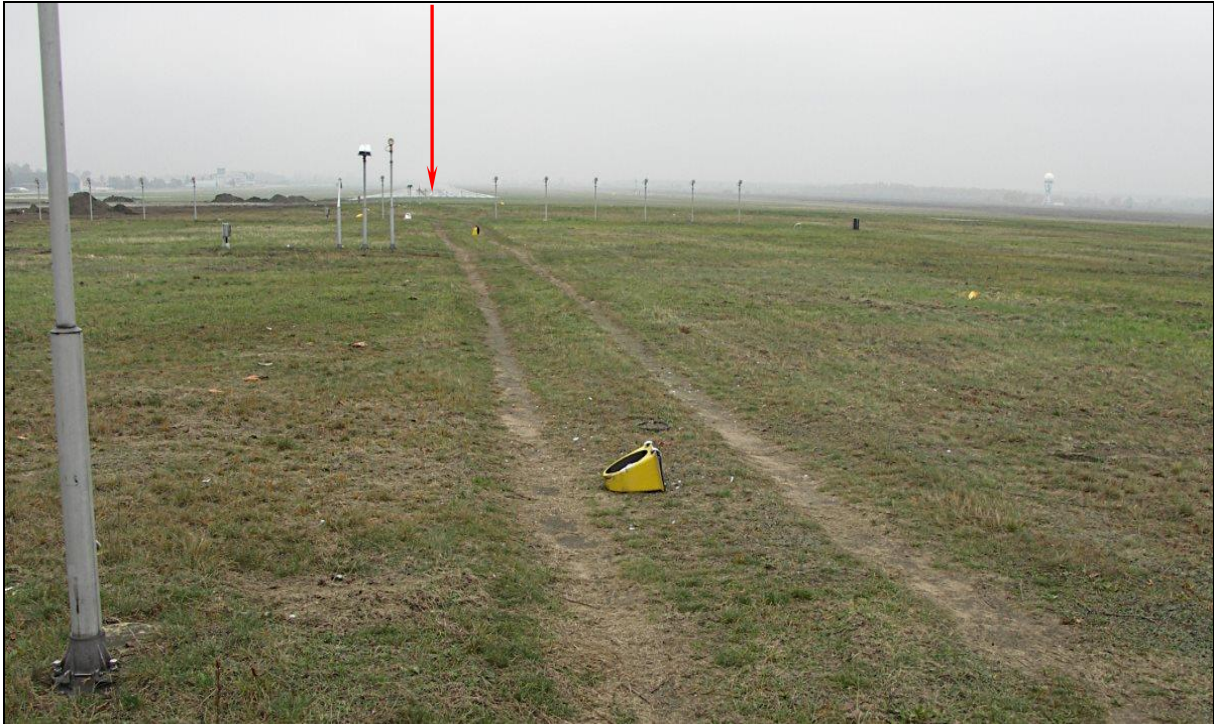
25 – Damage to the approach lights system and small pieces of the airplane skin. Visible RWY27 threshold

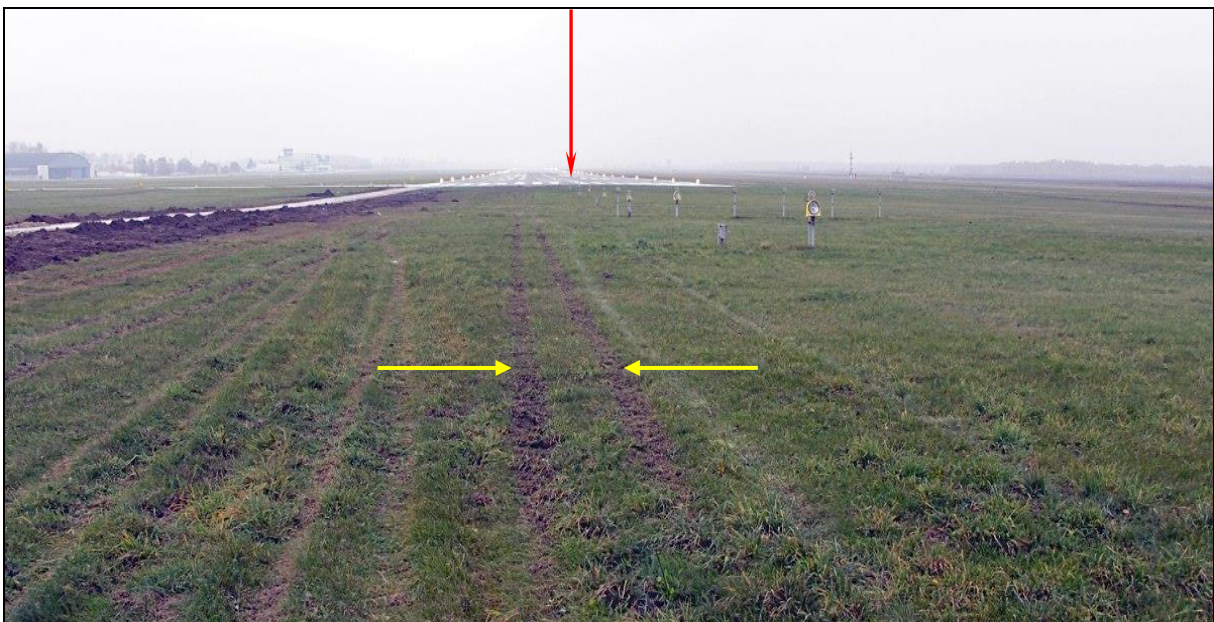
26 – Tracks of the left main landing gear wheels just ahead of EPKT RWY27 threshold

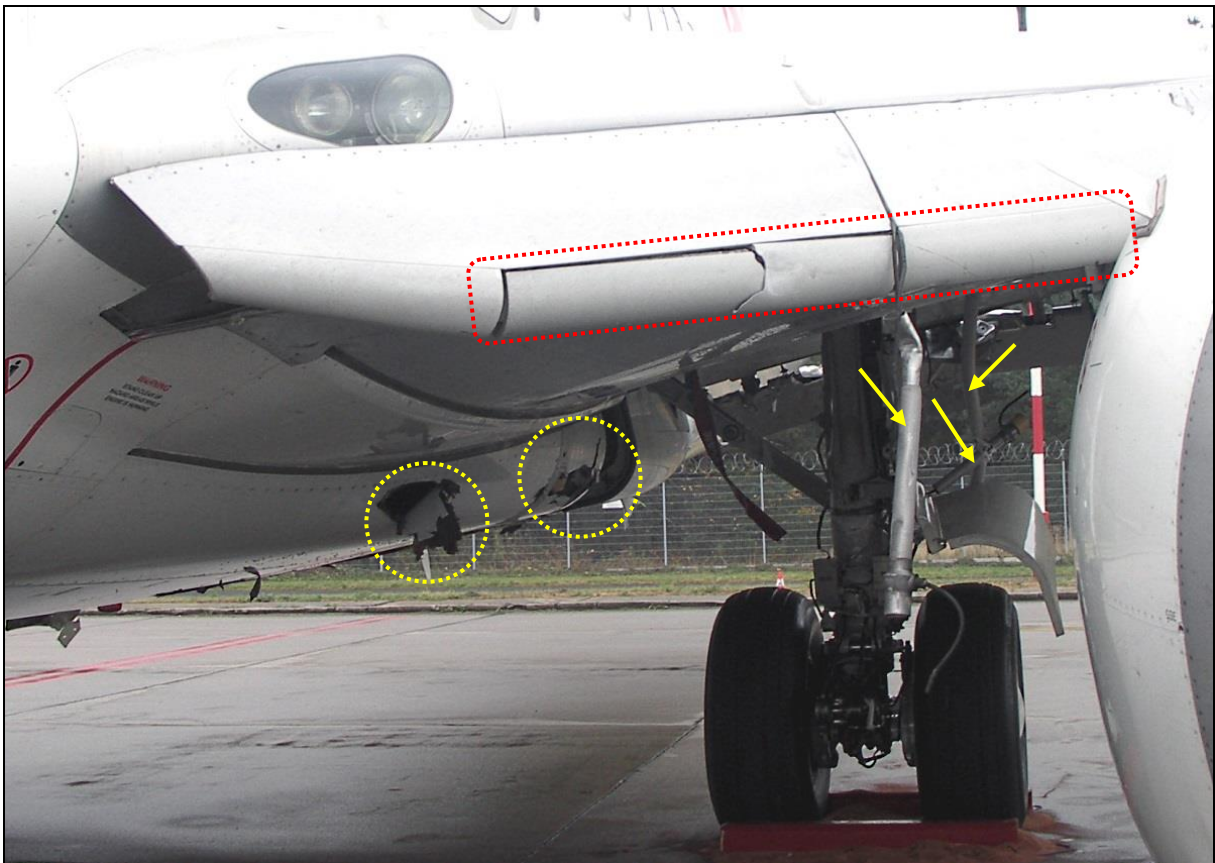
48 – Left wing front view – inboard section, damage marked. Arrows show the lights pieces stuck in the airplane structure

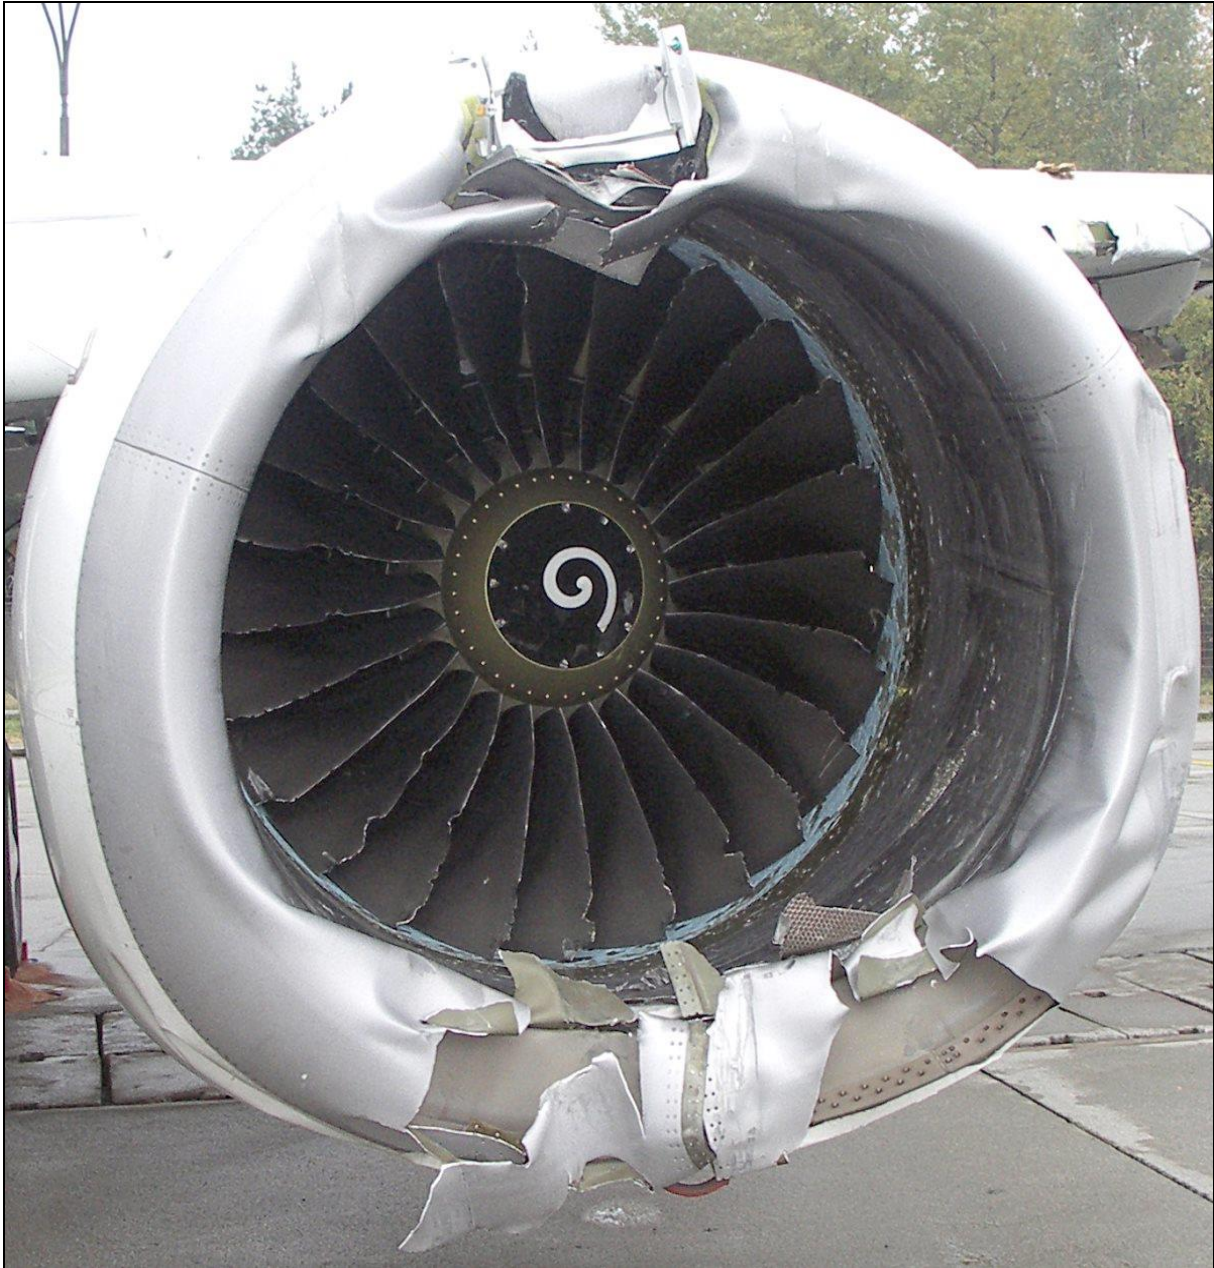
**49 – Left engine inlet – visible damage**

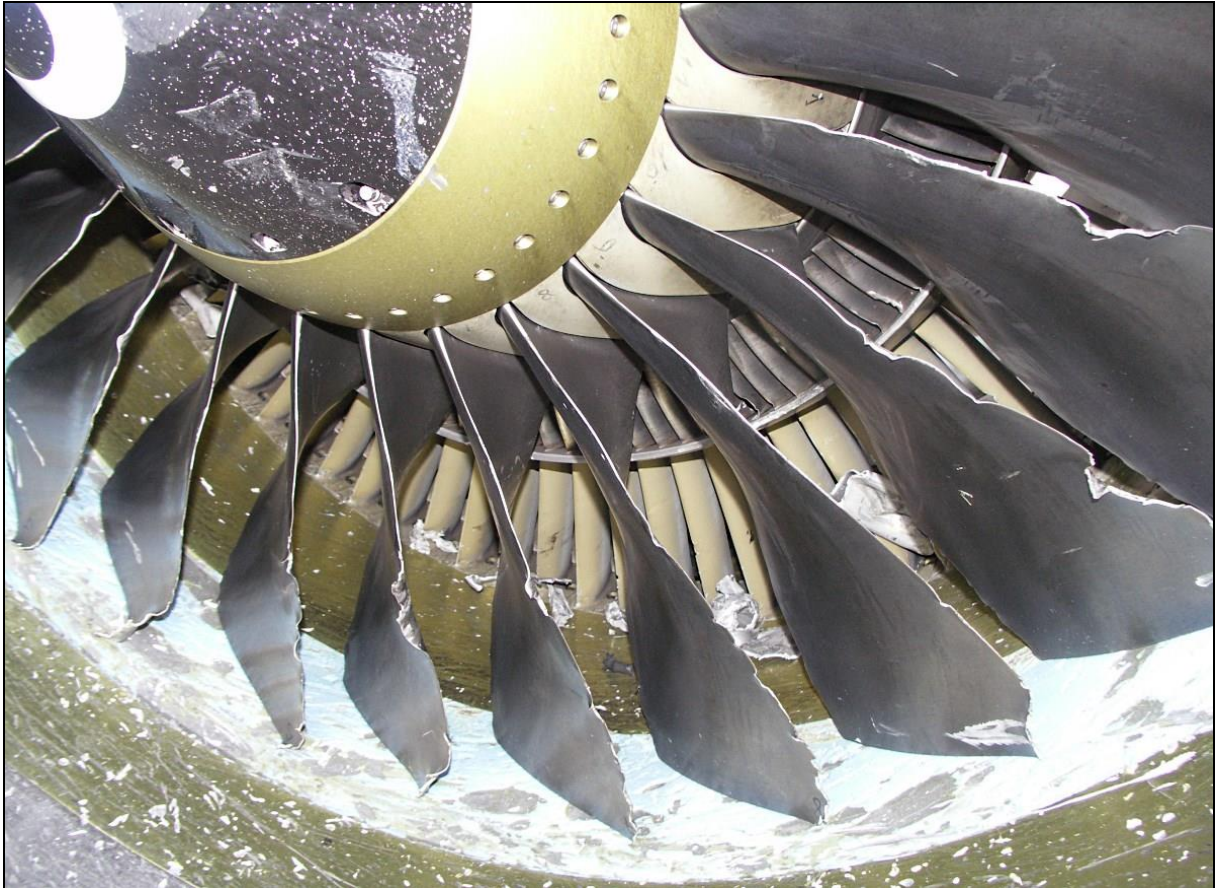
50 – Damage to the left engine fan – close-up

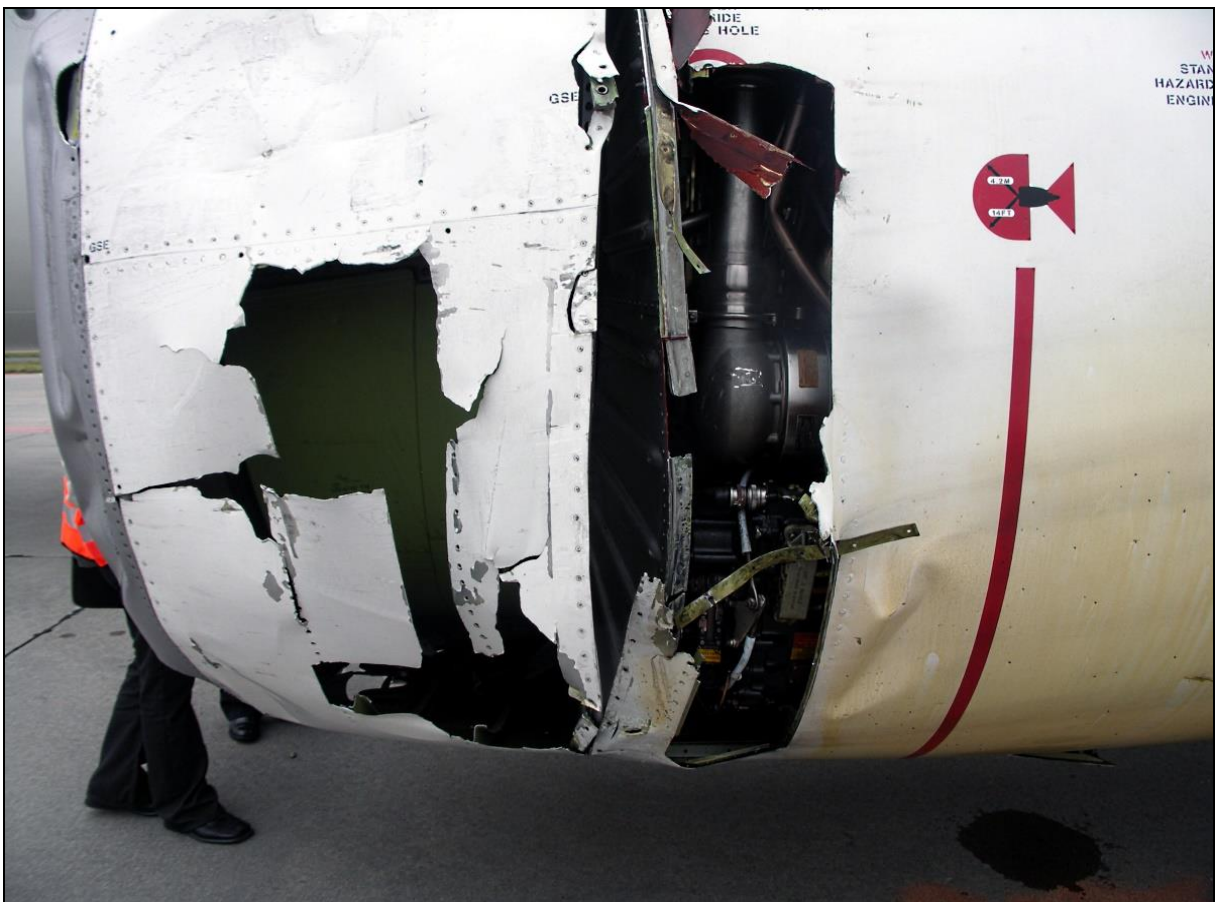
51 – Damage to the left side of the left engine nacelle

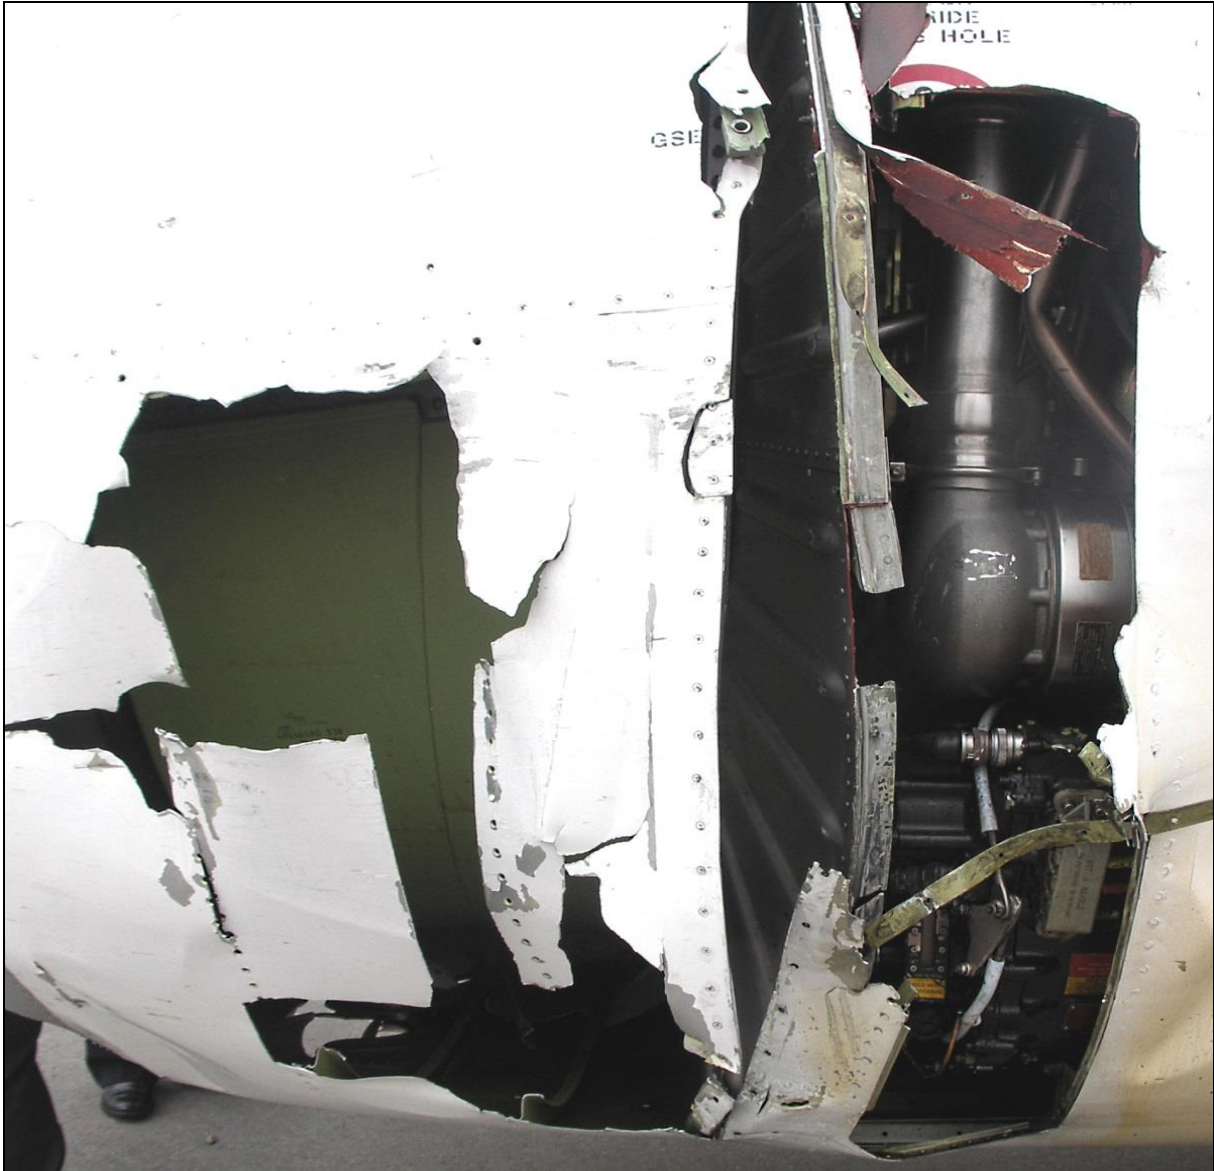
52 – Damage to the left side of the left engine nacelle – close-up

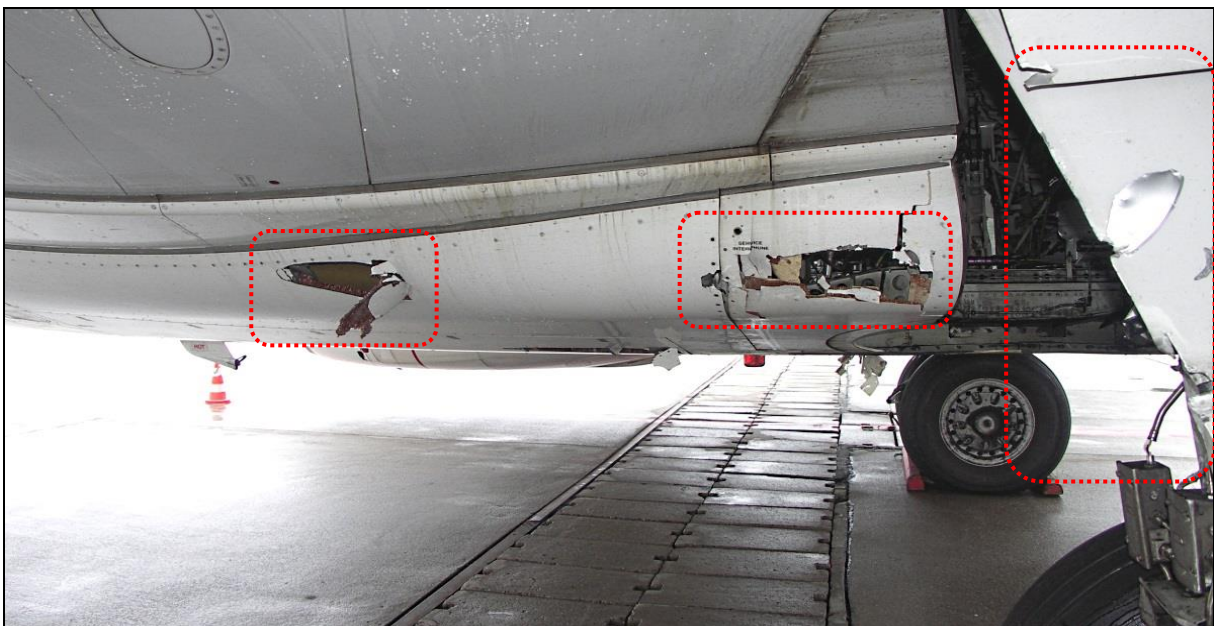
53 – Damage to the left side of belly fairing and the left main landing gear door

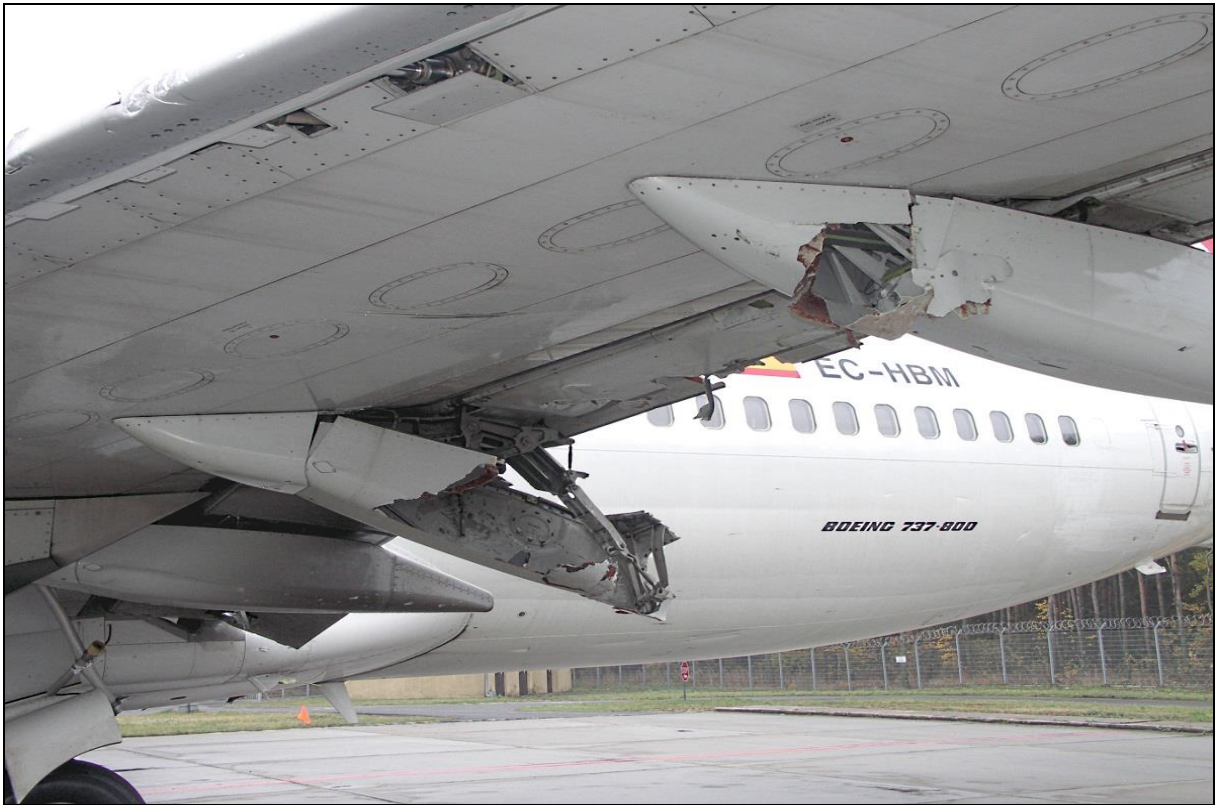
54 – Damage to the flap and flap track fairing of the left wing
