# FINAL REPORT

## ACCIDENT

**Occurrence No.: 466/07**

**Aircraft: B737-800, EC-HBM**

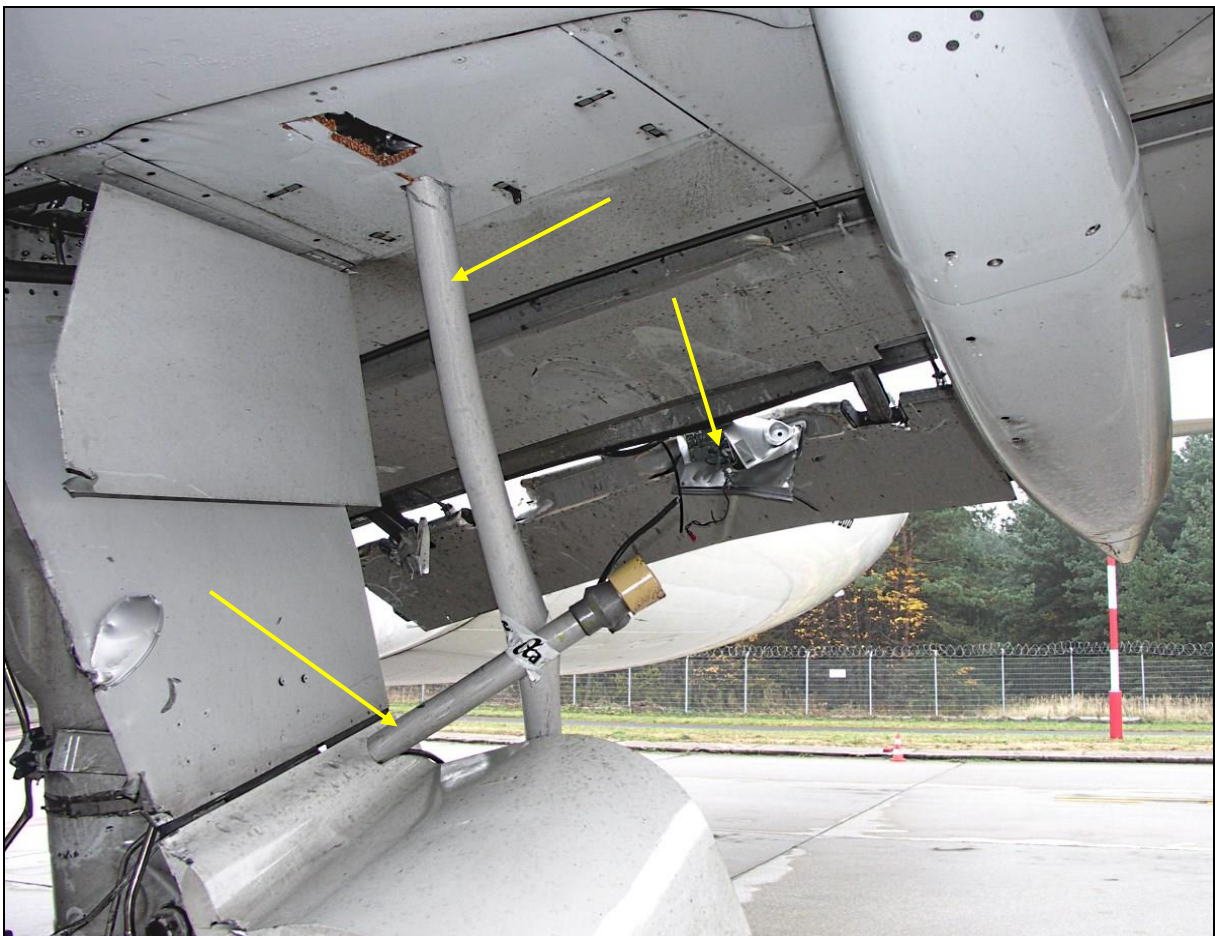
55 – Damage to the bottom of the left inboard flap. Arrows show the lights pieces stuck in the airplane structure

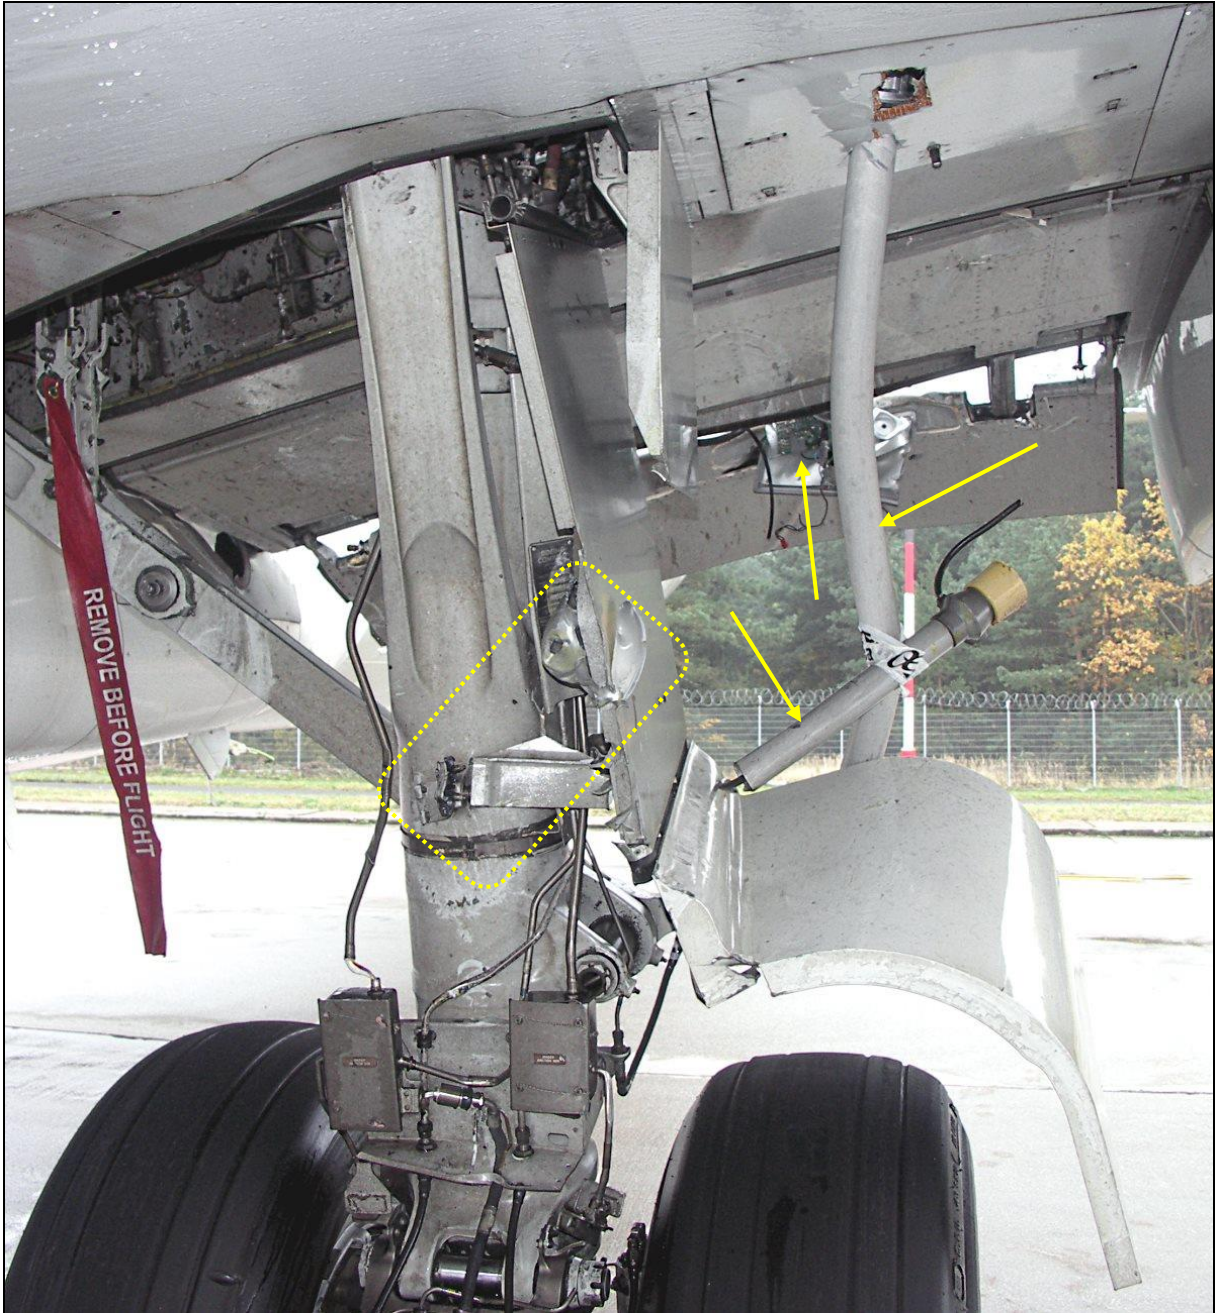
56 – Damage to the door of the left main landing gear and the bottom of the left inboard flap. Arrows show the lights pieces stuck in the airplane structure

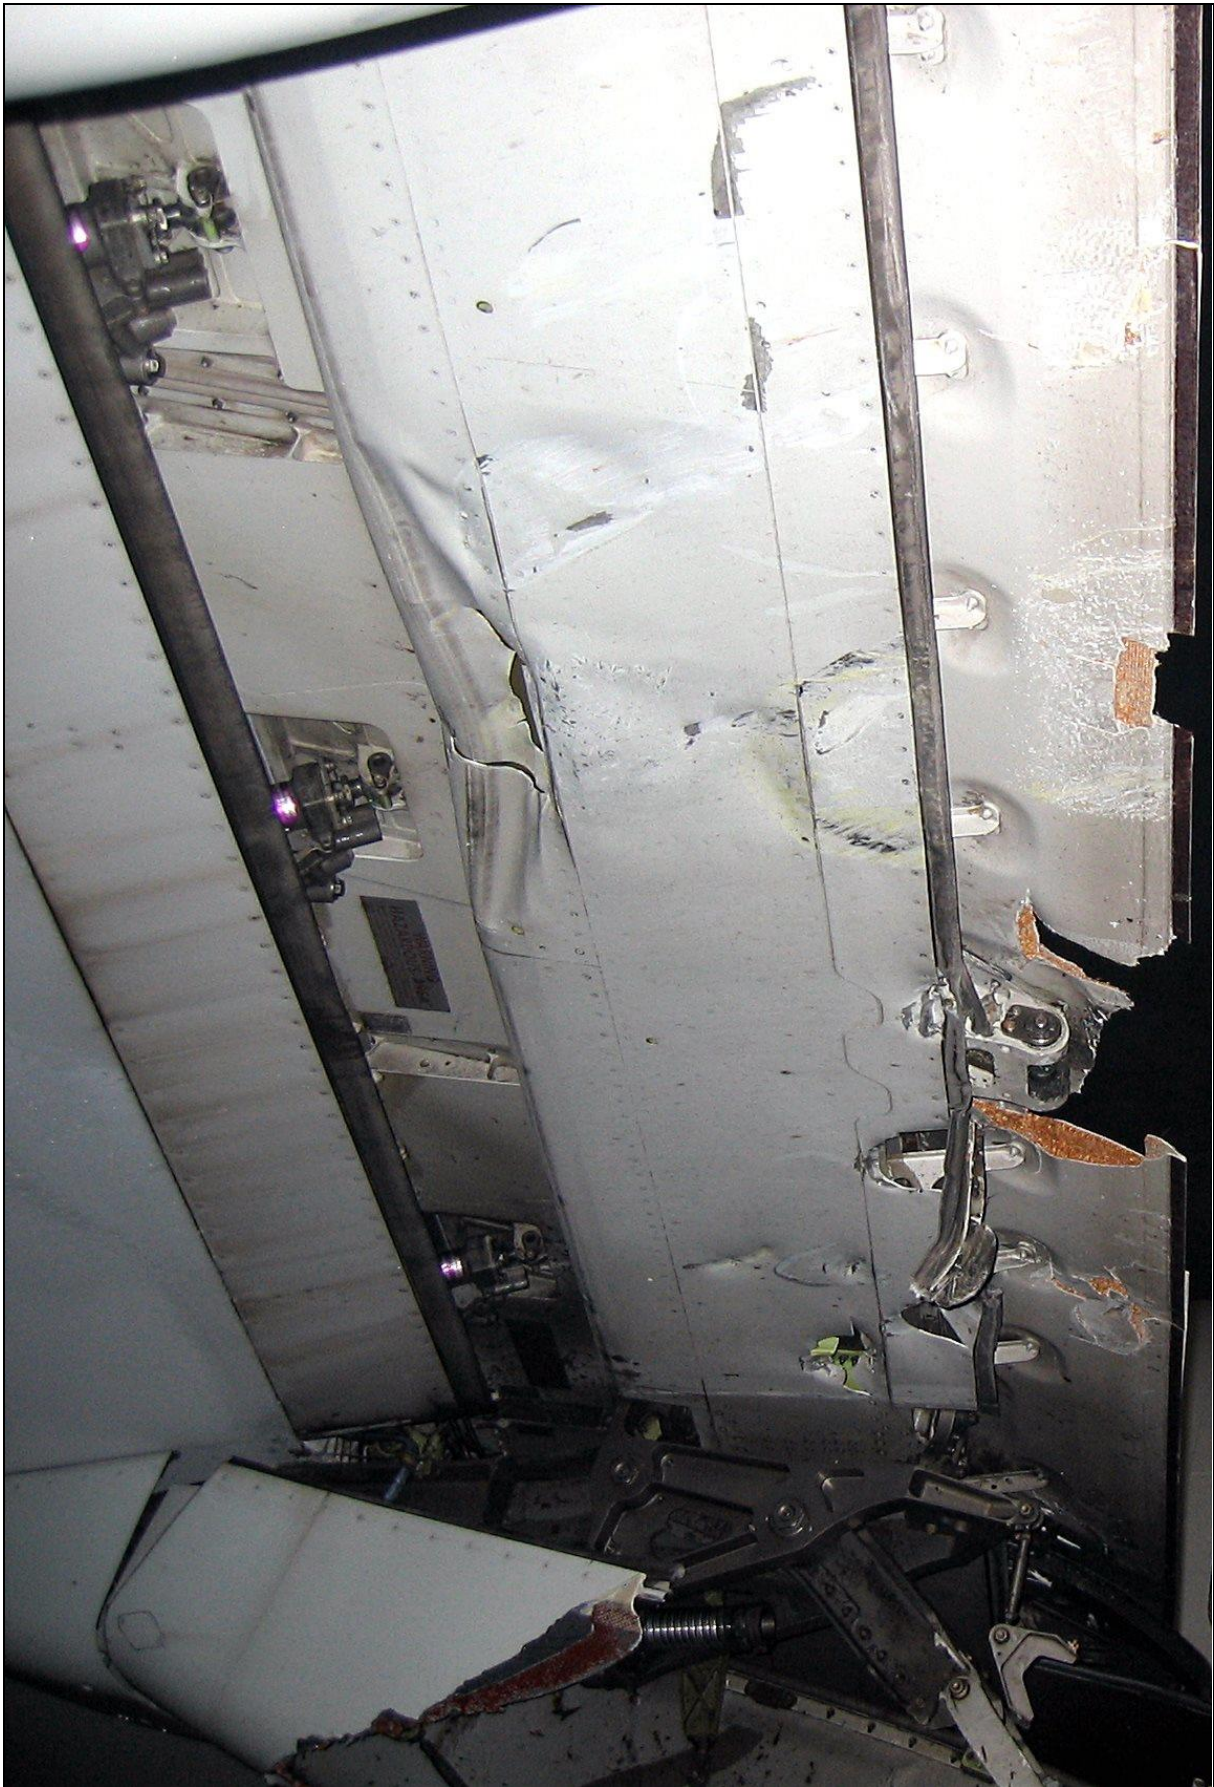
57 – Damage to the bottom of the left outboard flap – close-up [photo: airplane crew]

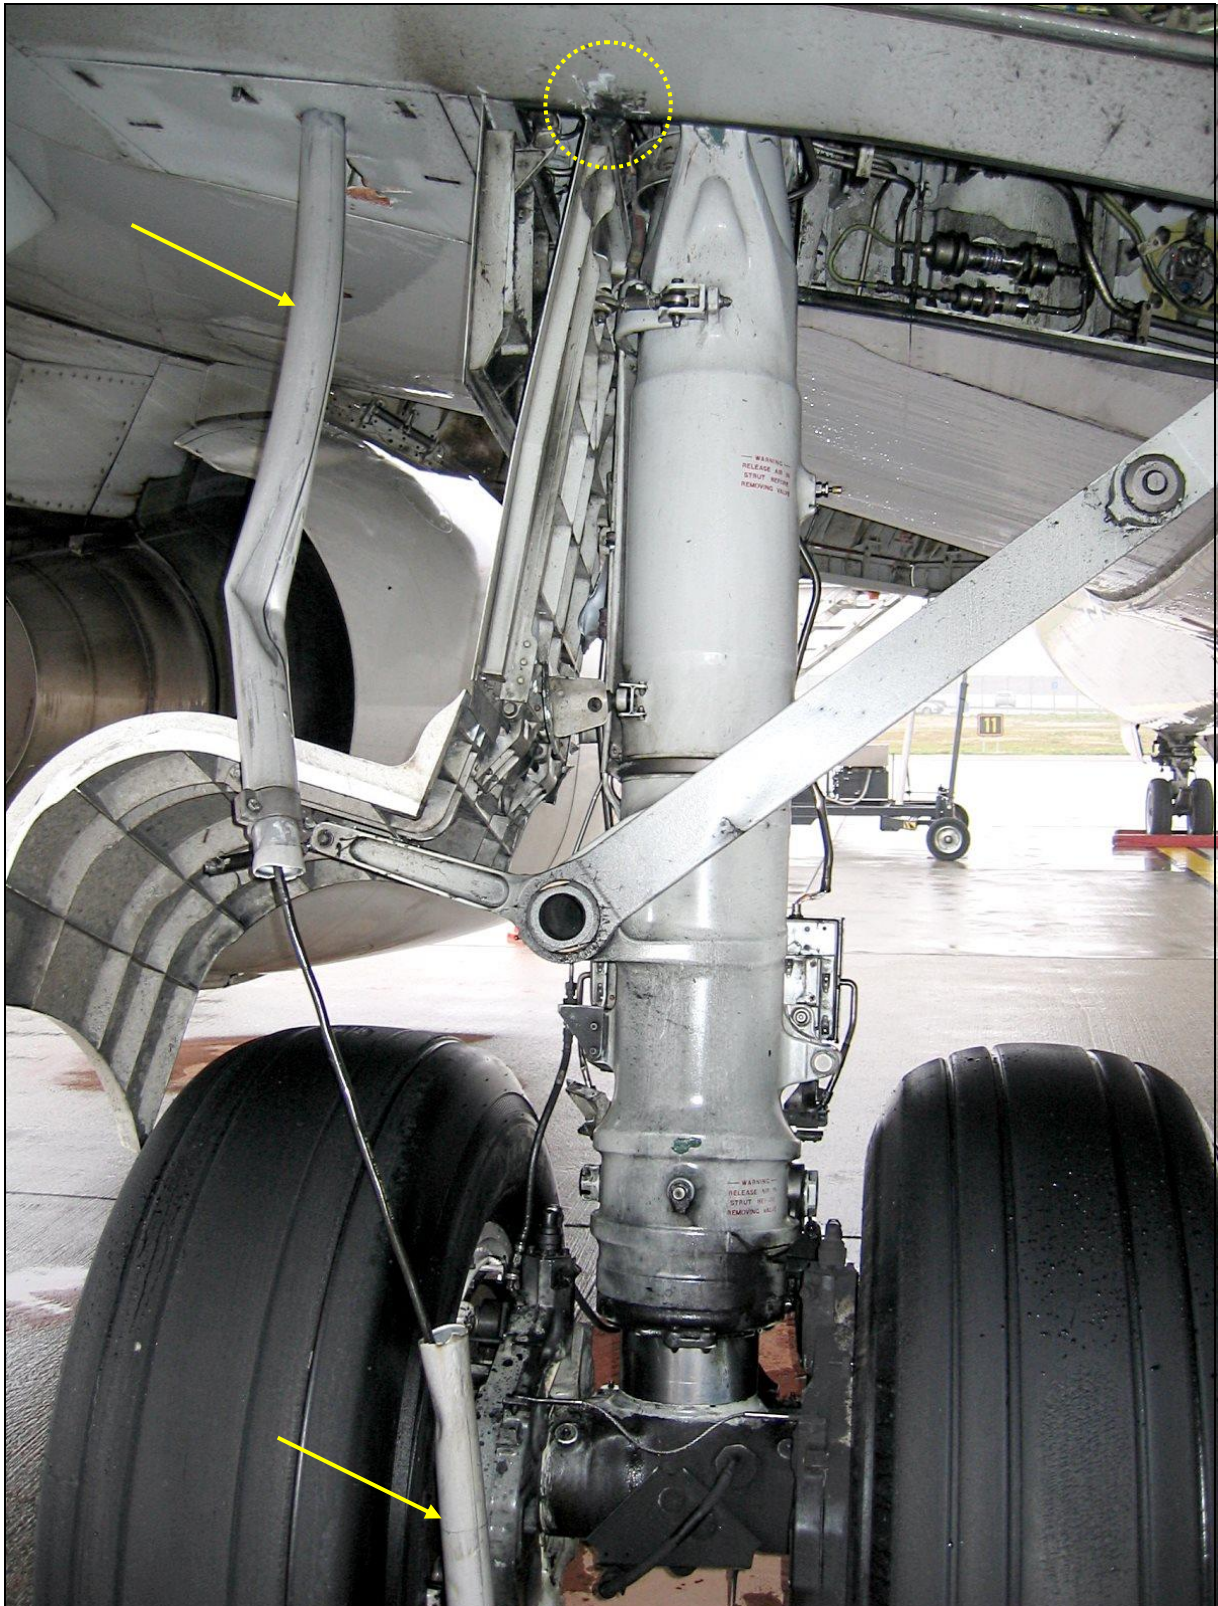
58 – Damage to the rear section of the left main landing gear door. Arrows show the lights pieces stuck in the airplane structure [photo: airplane crew]

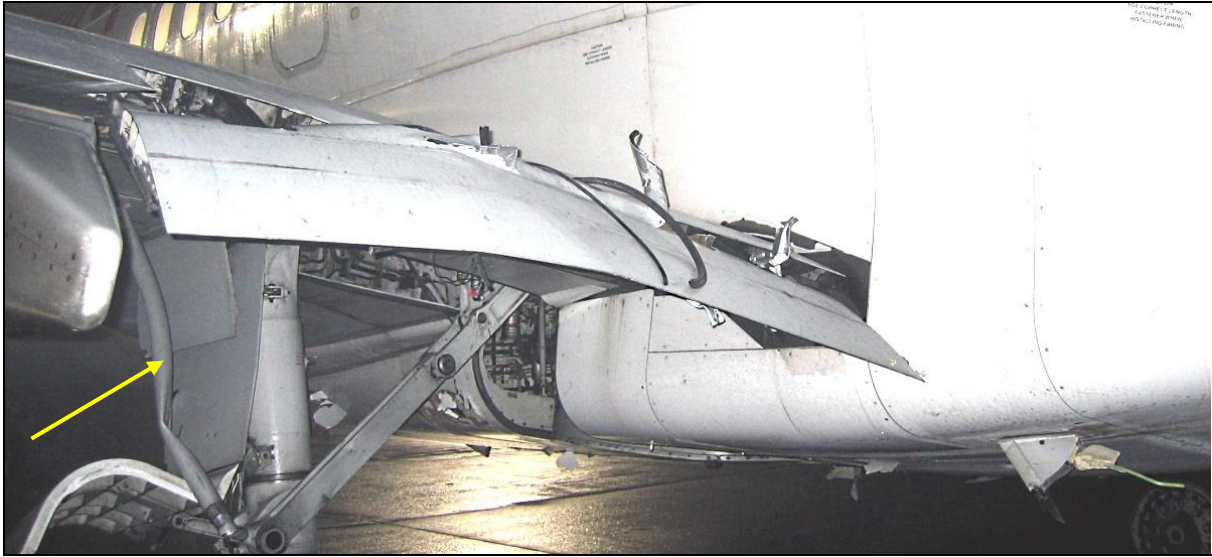
**59 – Damage to the left main landing gear door and the left inboard flap. Arrows show the lights pieces stuck in the airplane structure [photo: airplane crew]**

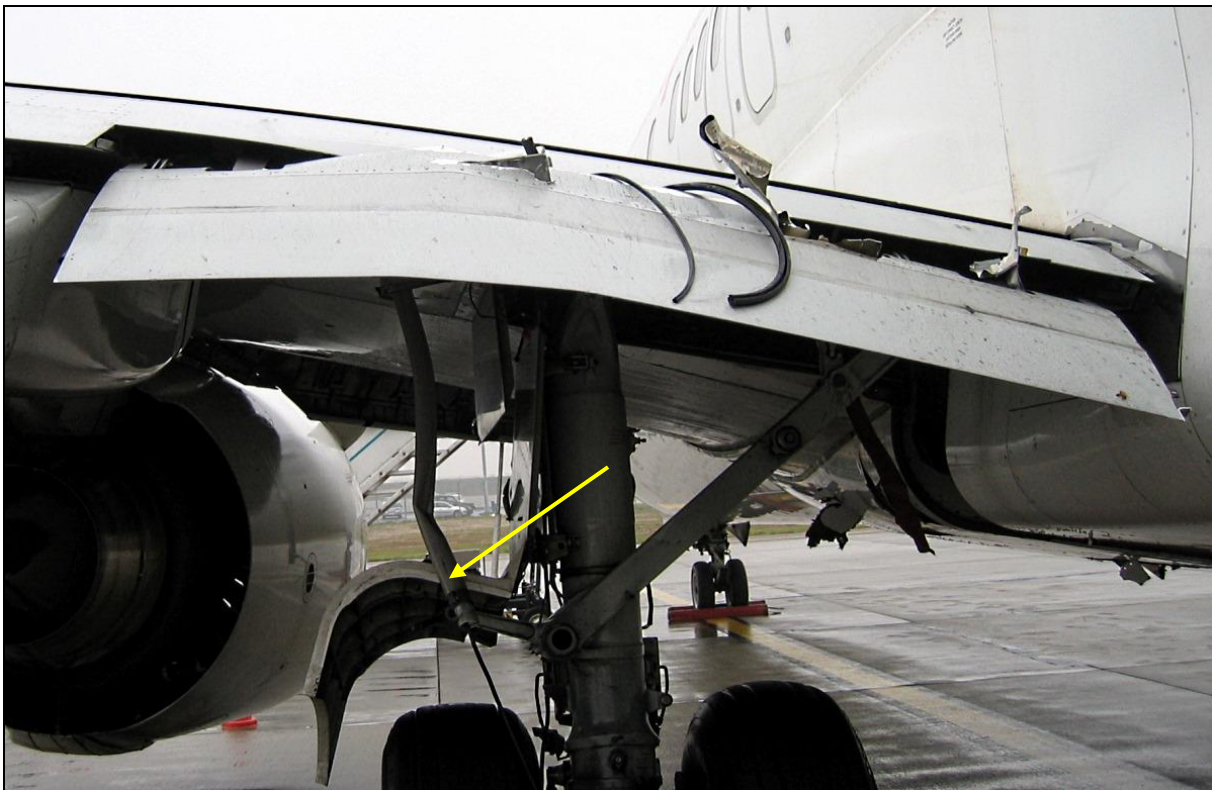
**60 – Damage to the rear section of the left inboard flap – close-up. Arrows show the lights pieces stuck in the airplane structure [photo: airplane crew]**

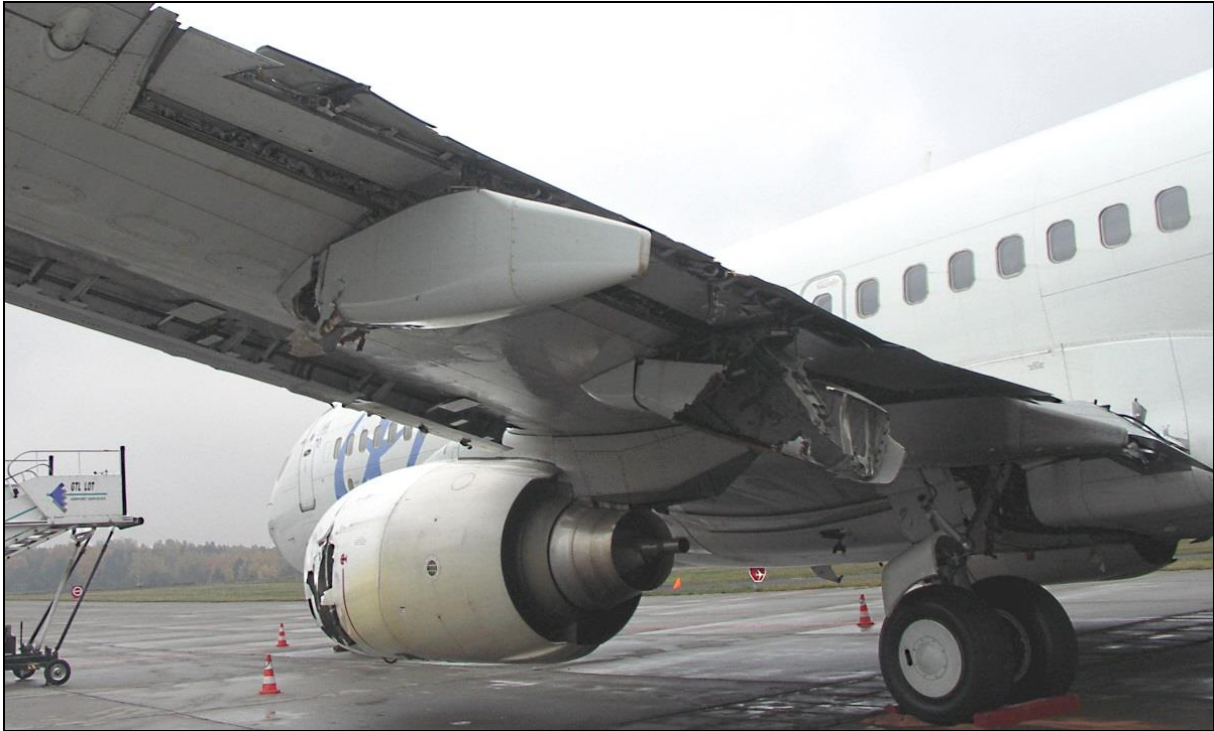
**61 – Damage to the rear section of the left outboard flap and the flap track fairing – close-up**

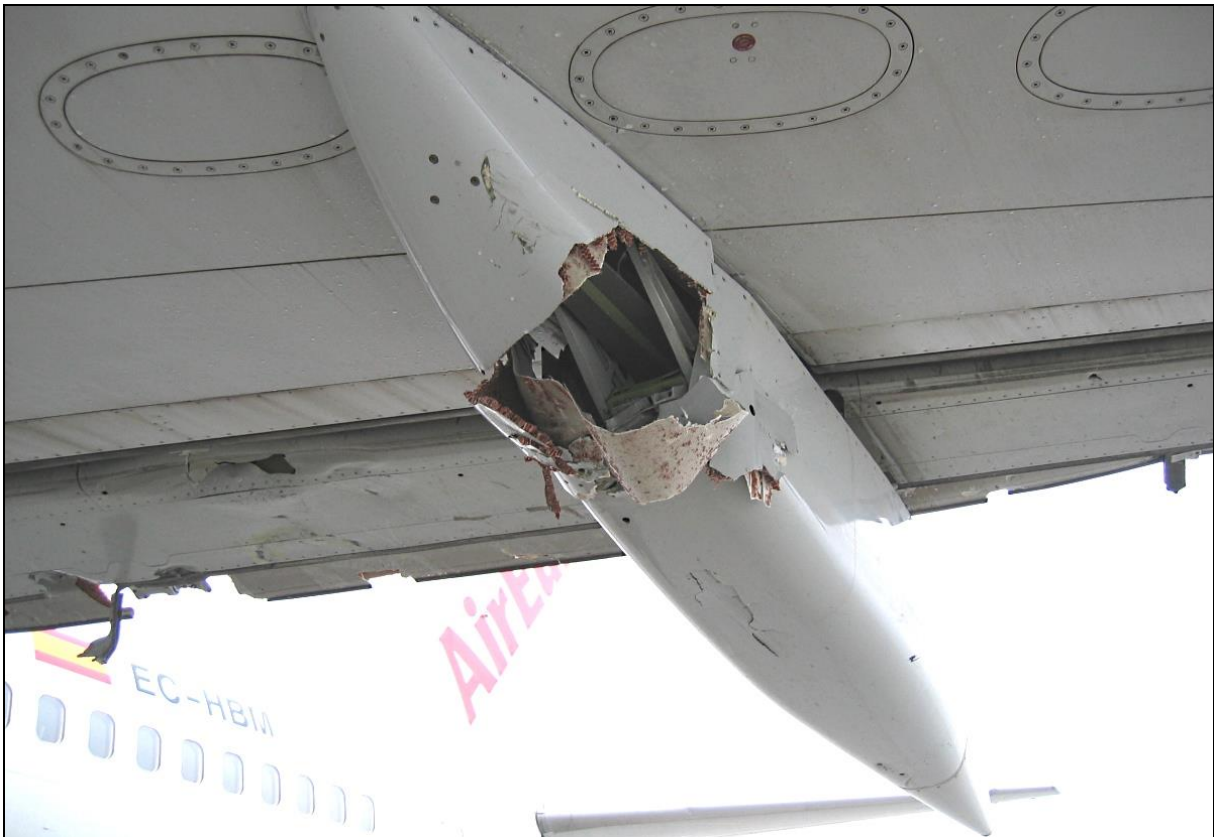
**62 – Damage to the track fairing of the left outboard flap; visible damage to the flap [photo: airplane crew]**

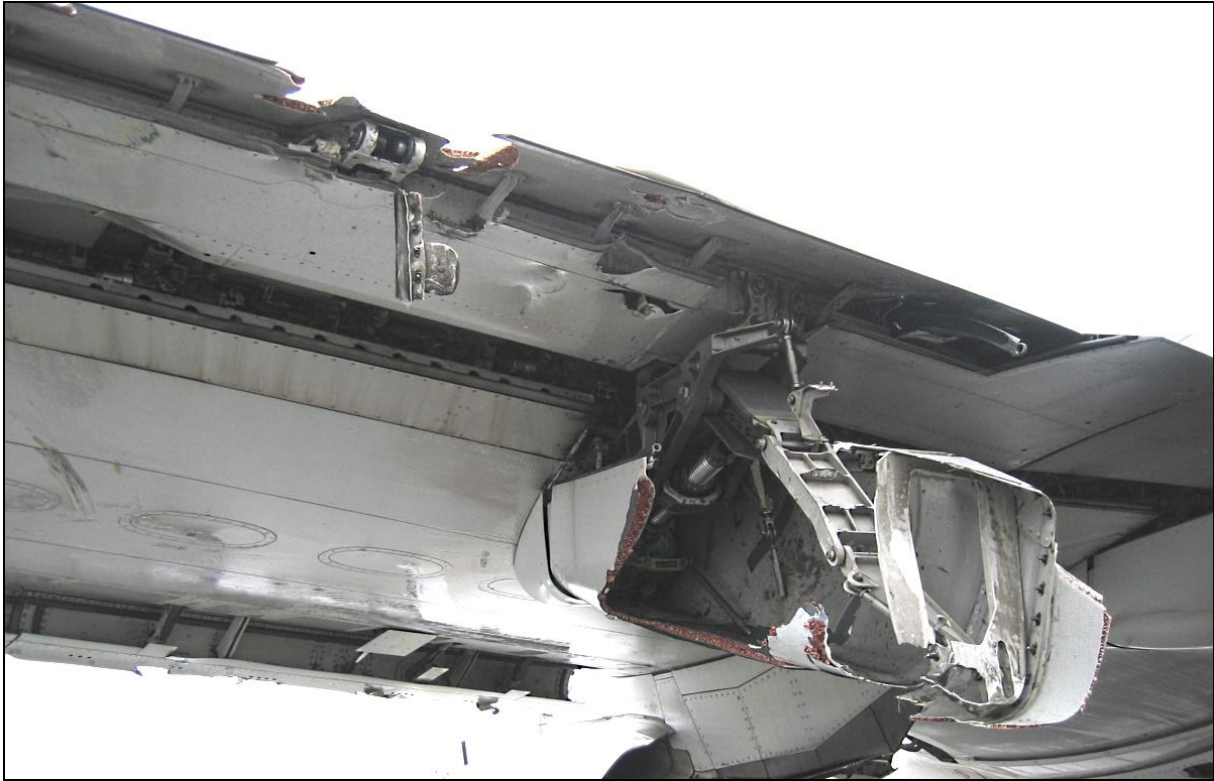
**63 – Damage to the track fairing of the left outboard flap; visible damage to the flap [photo: airplane crew]**

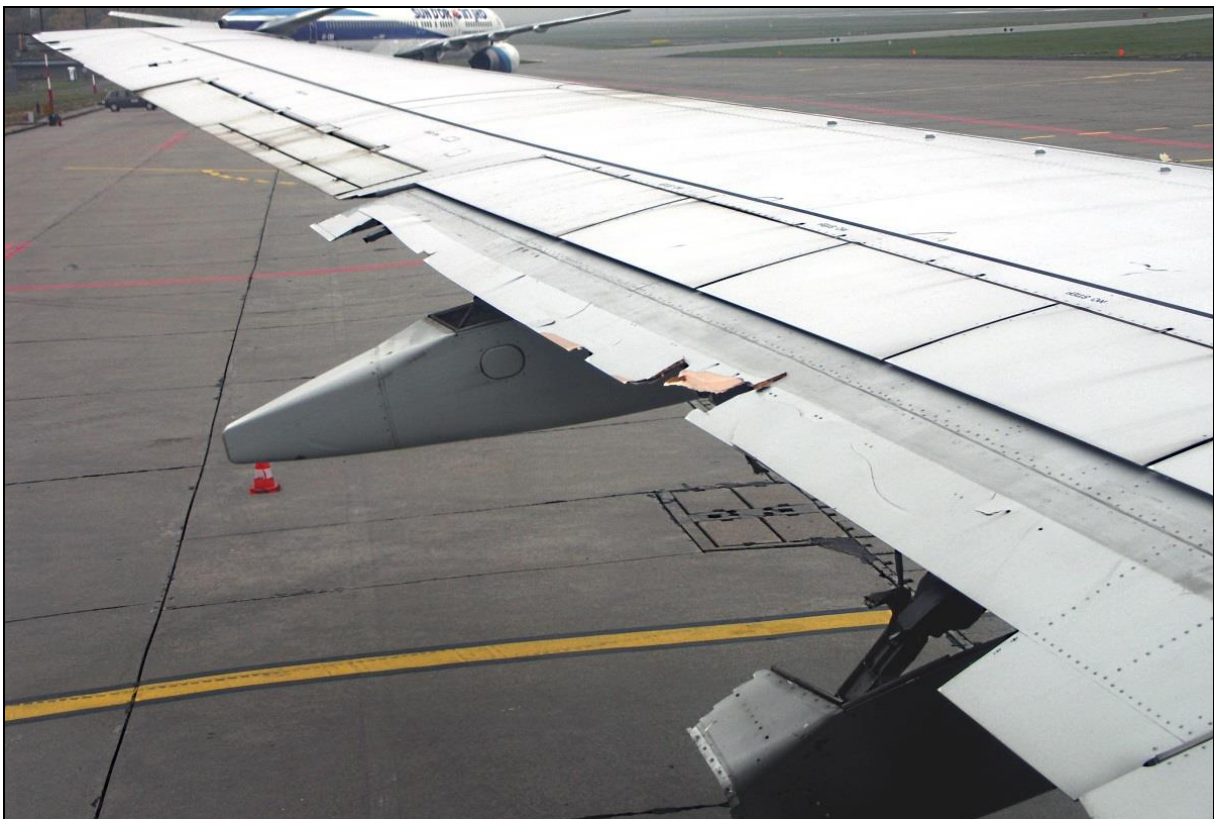
**64 – Top view on the damaged left outboard flap. Visible part of the damaged track fairing**

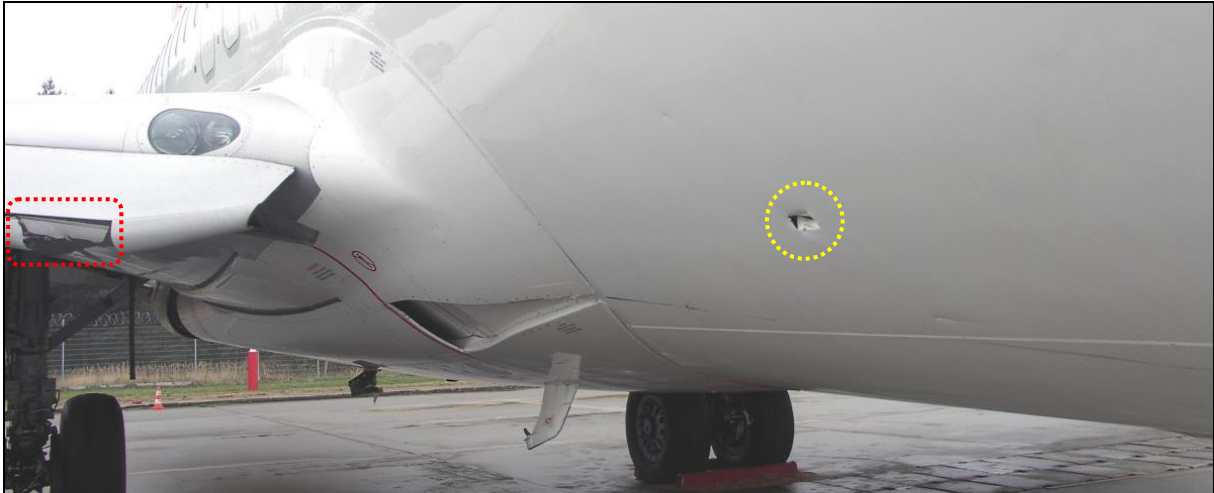
66 – Root area of the right wing – visible damage to the Krüger flap and fuselage puncture

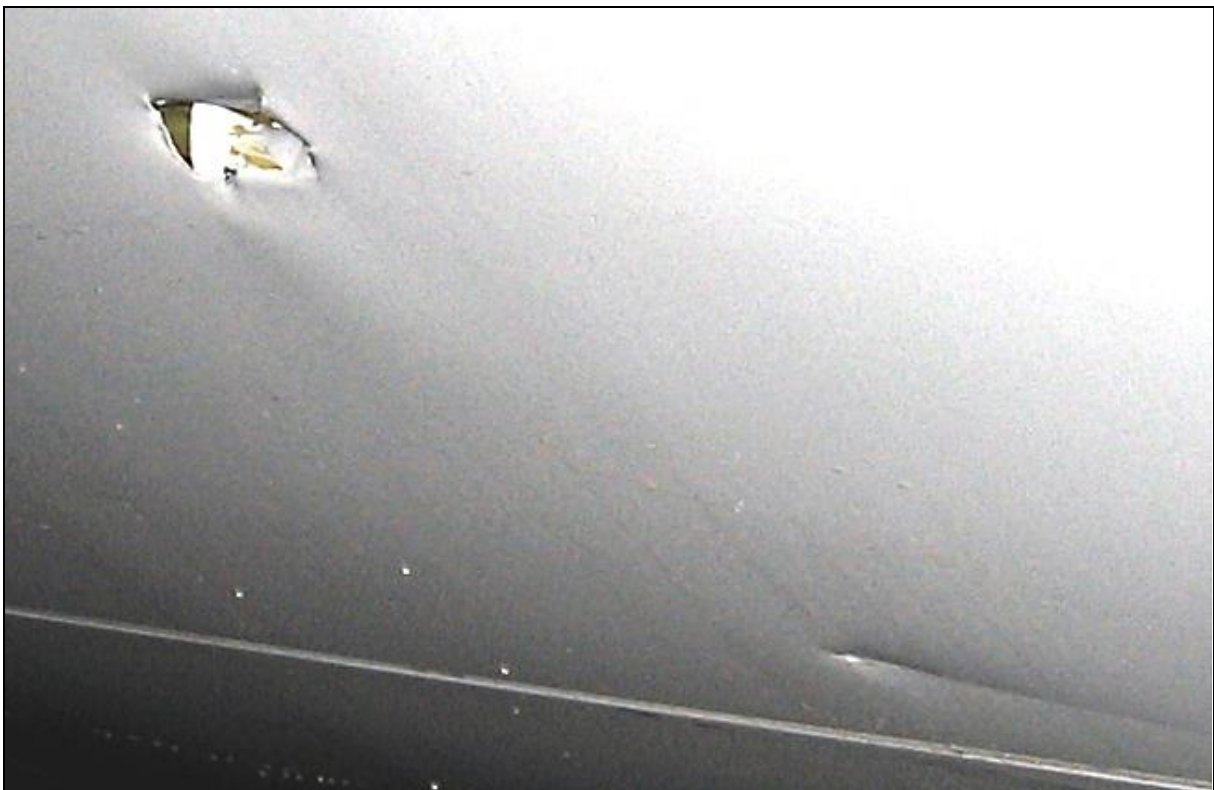
67 – Puncture and scratch of the fuselage – close-up [photo: airplane crew]

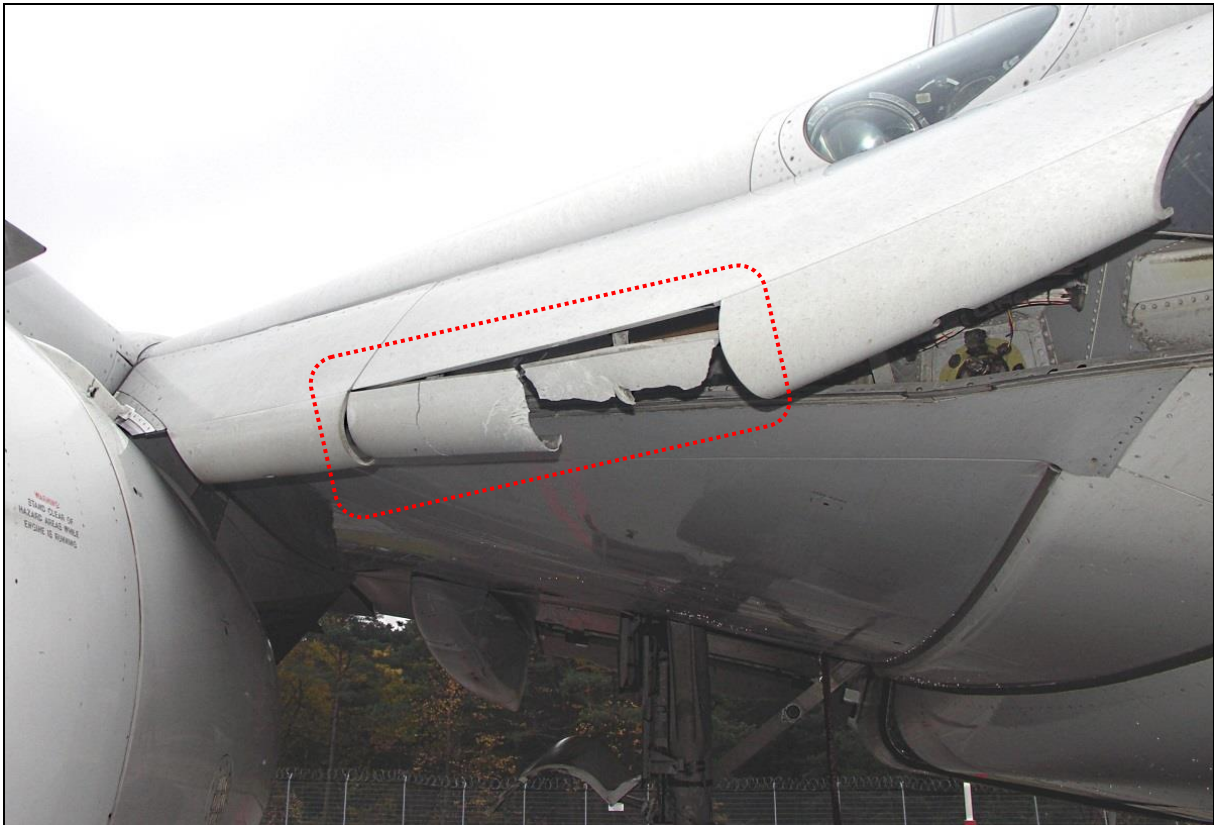
68 – Damage to the right Krüger flap

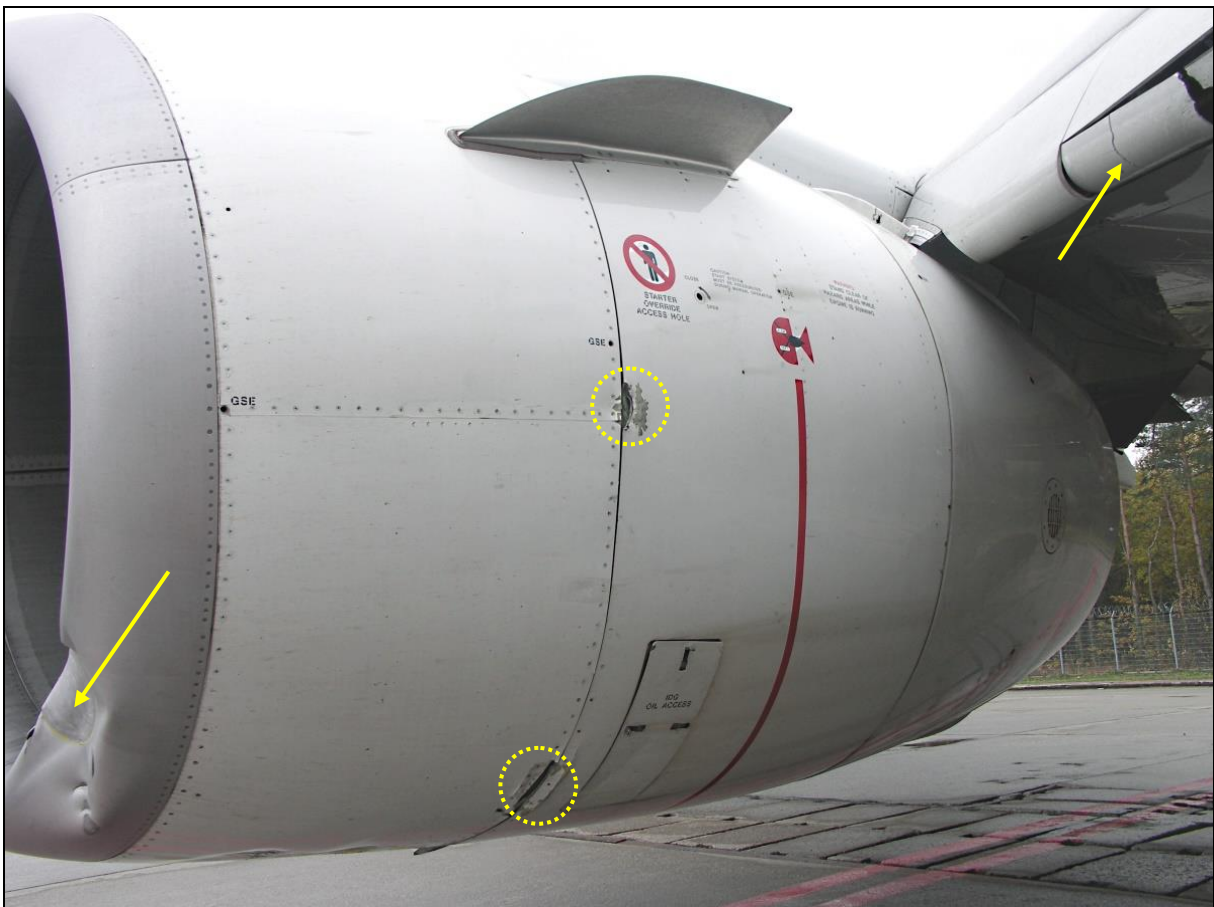
69 – Damage to the left side of the right engine nacelle. Marked damage resulting from a collision with a light and damage to the Krüger flap

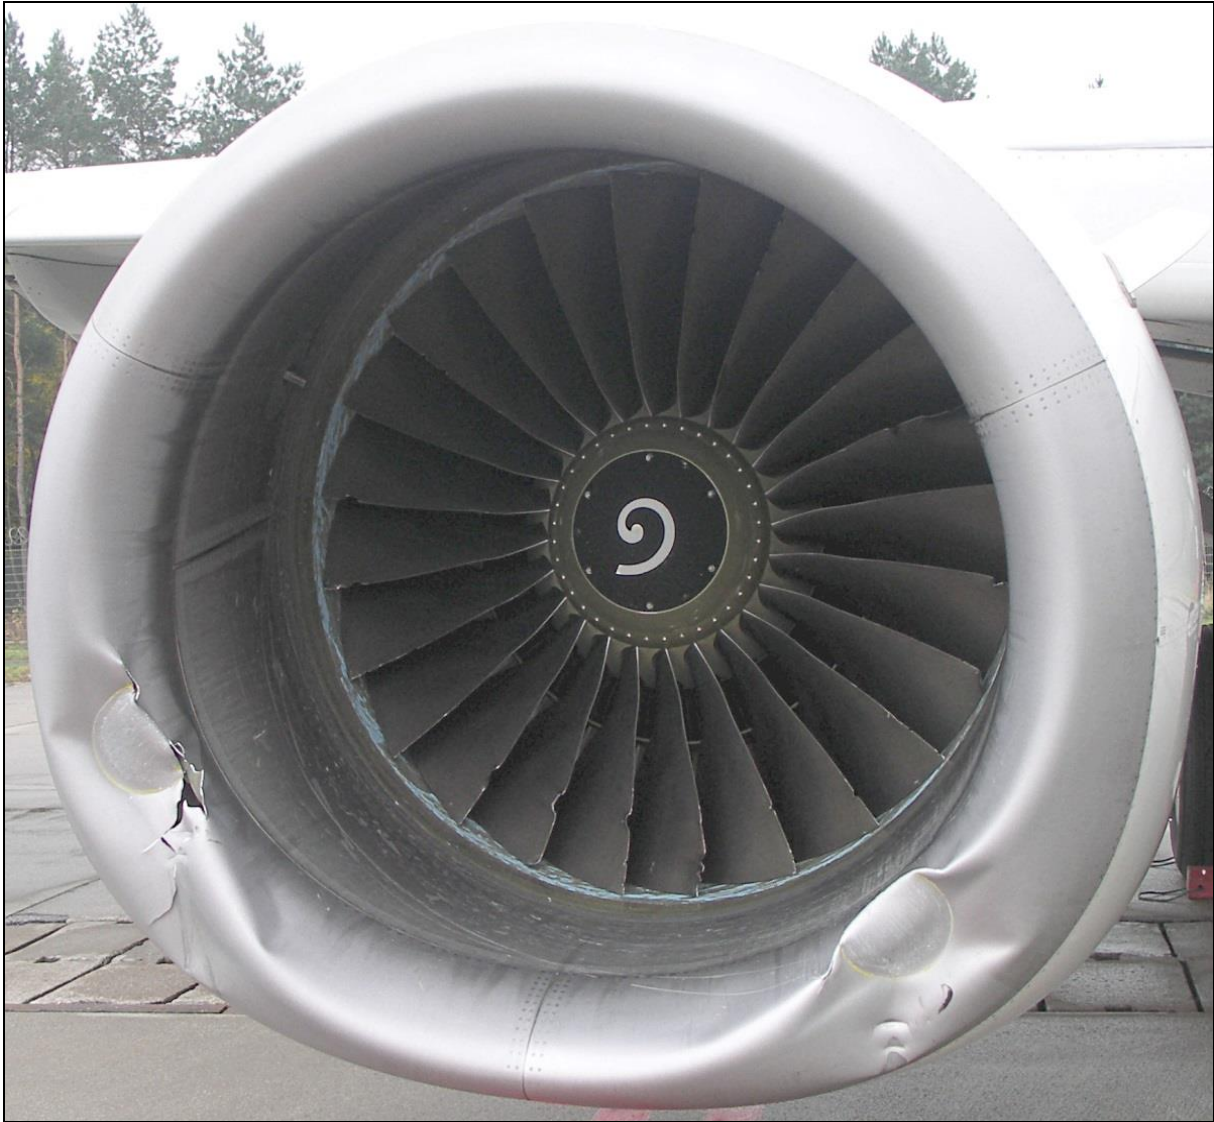
**70 – Damage to the right engine inlet**

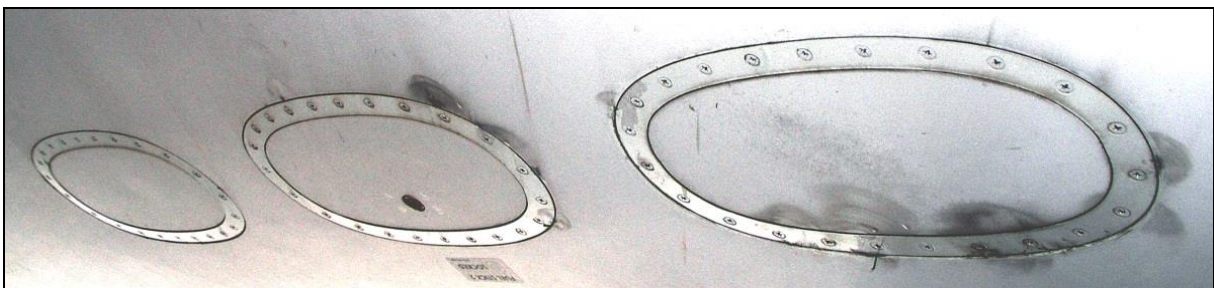
**71 – Signs of unsealing of the integral tank in the area of the right wing root**

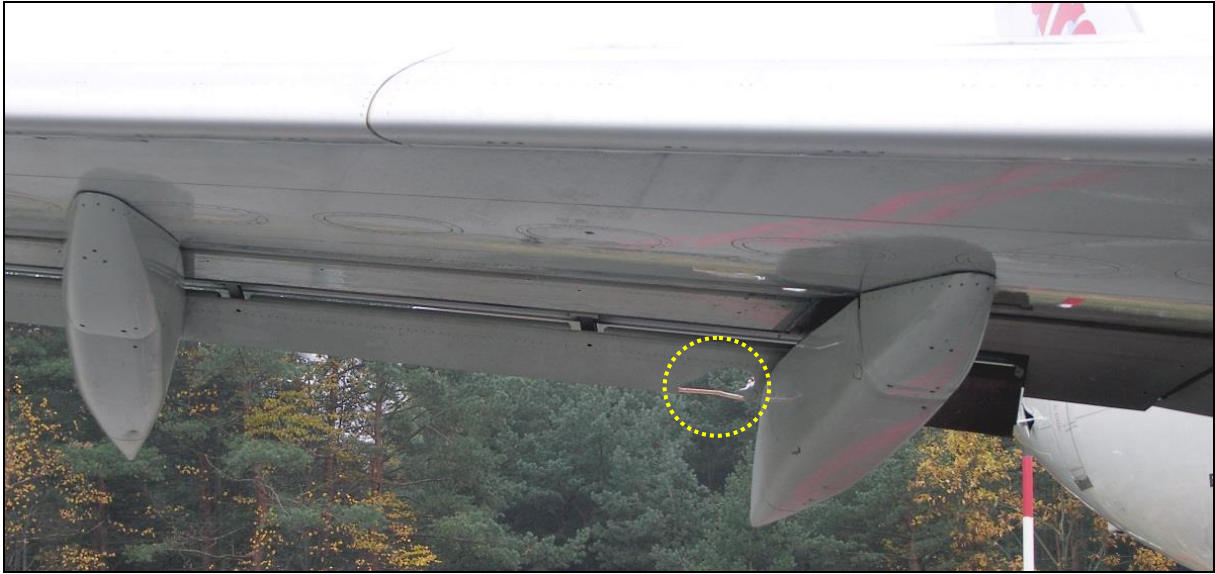
**72 – Damage to the right outboard flap, bottom view**

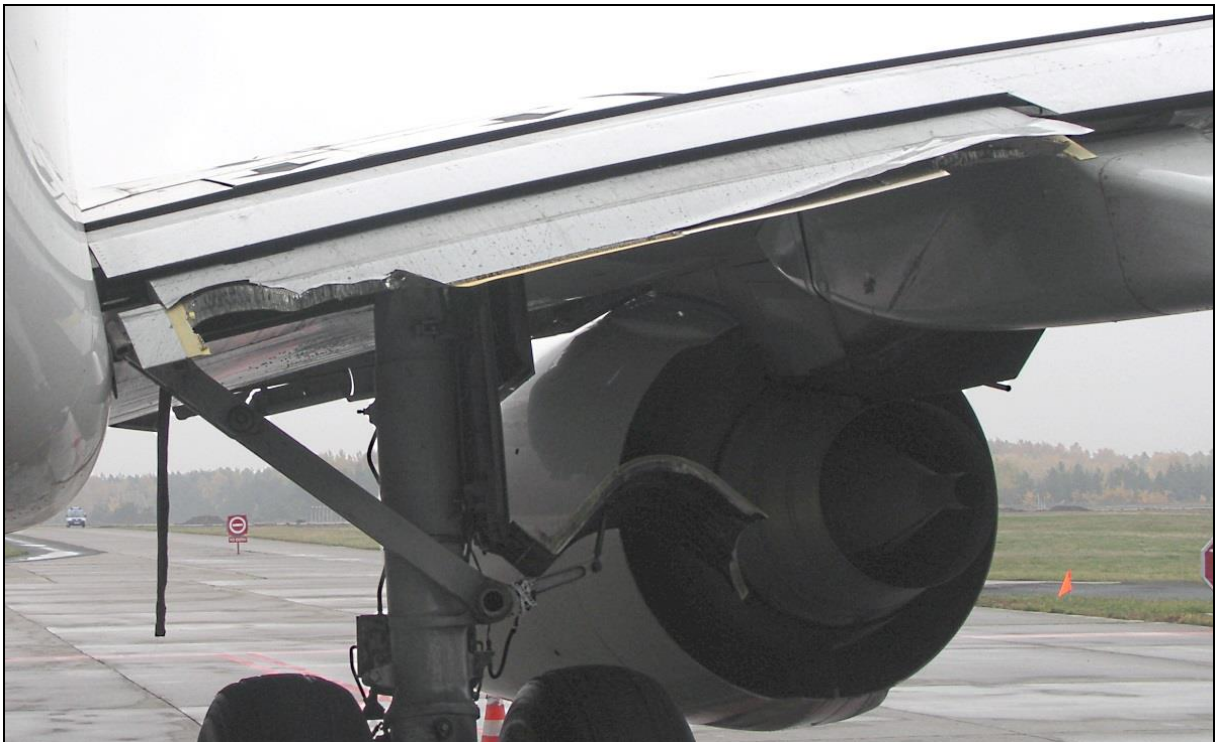
**73 – Damage to the left inboard flap, rear view**

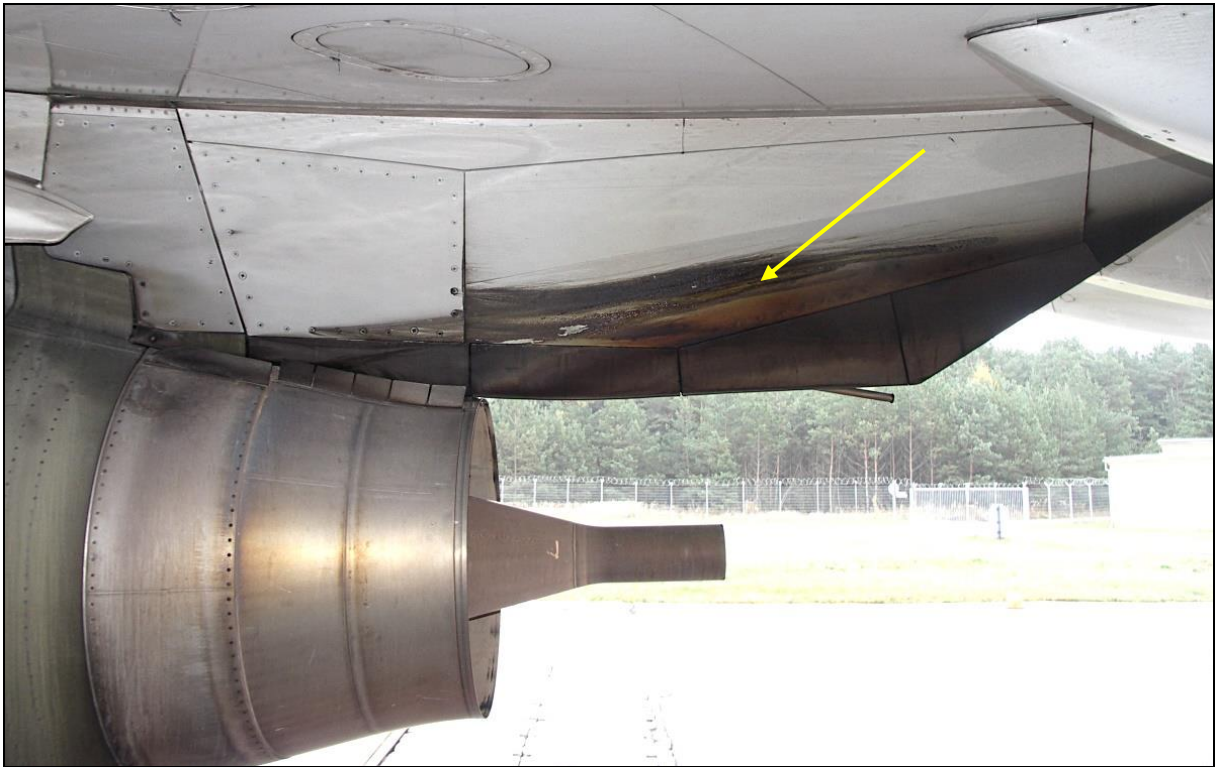
**74 – Abnormal signs on the right engine pylon**

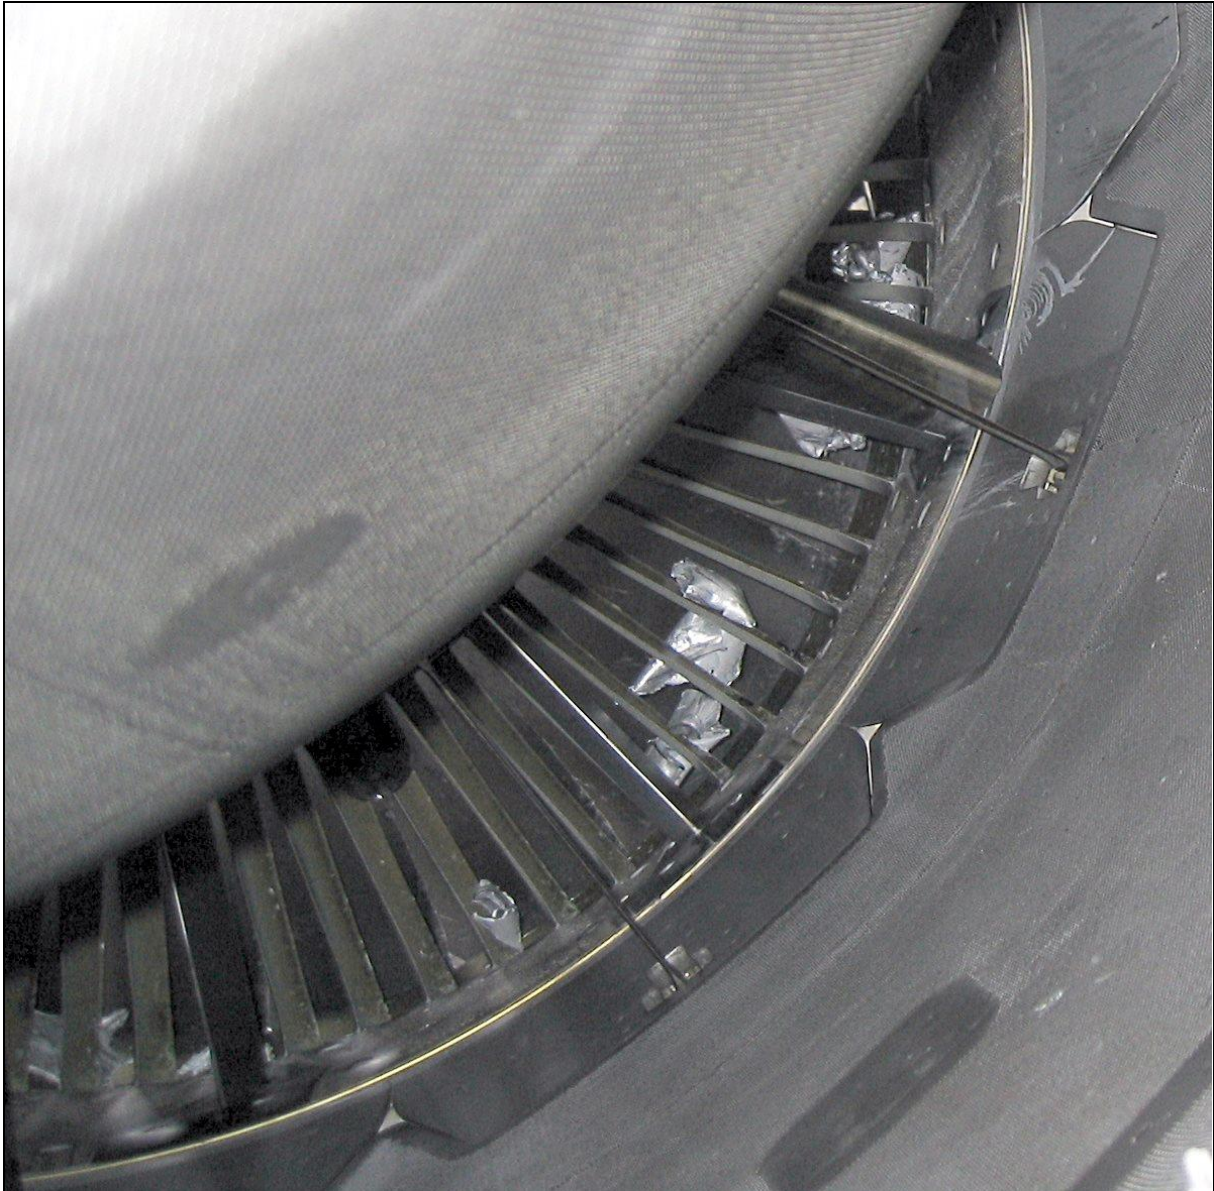
**76 – Lights pieces, which went through the outer flow of the engine [photo: airplane crew]**

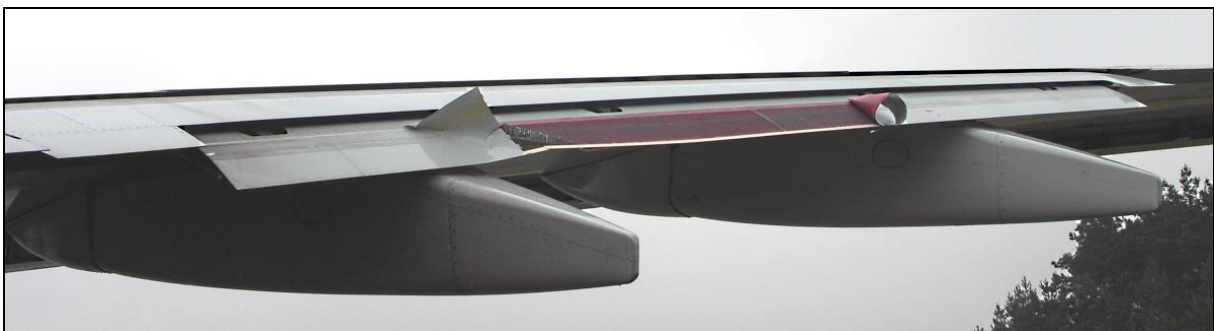
**77 – Damage to the right outboard flap – rear view**
