# FINAL REPORT

## ACCIDENT

**Occurrence No.: 466/07**

**Aircraft: B737-800, EC-HBM**

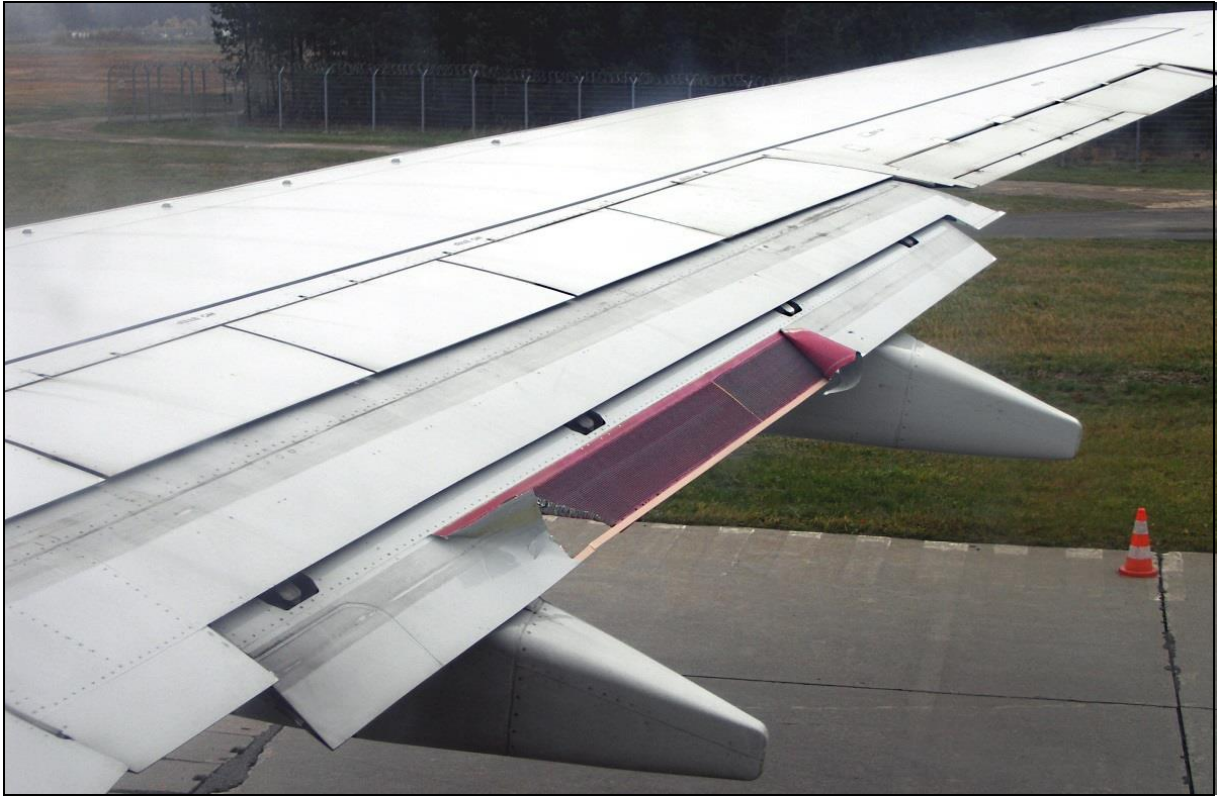
**78 – Damage to the right outboard flap – top view**

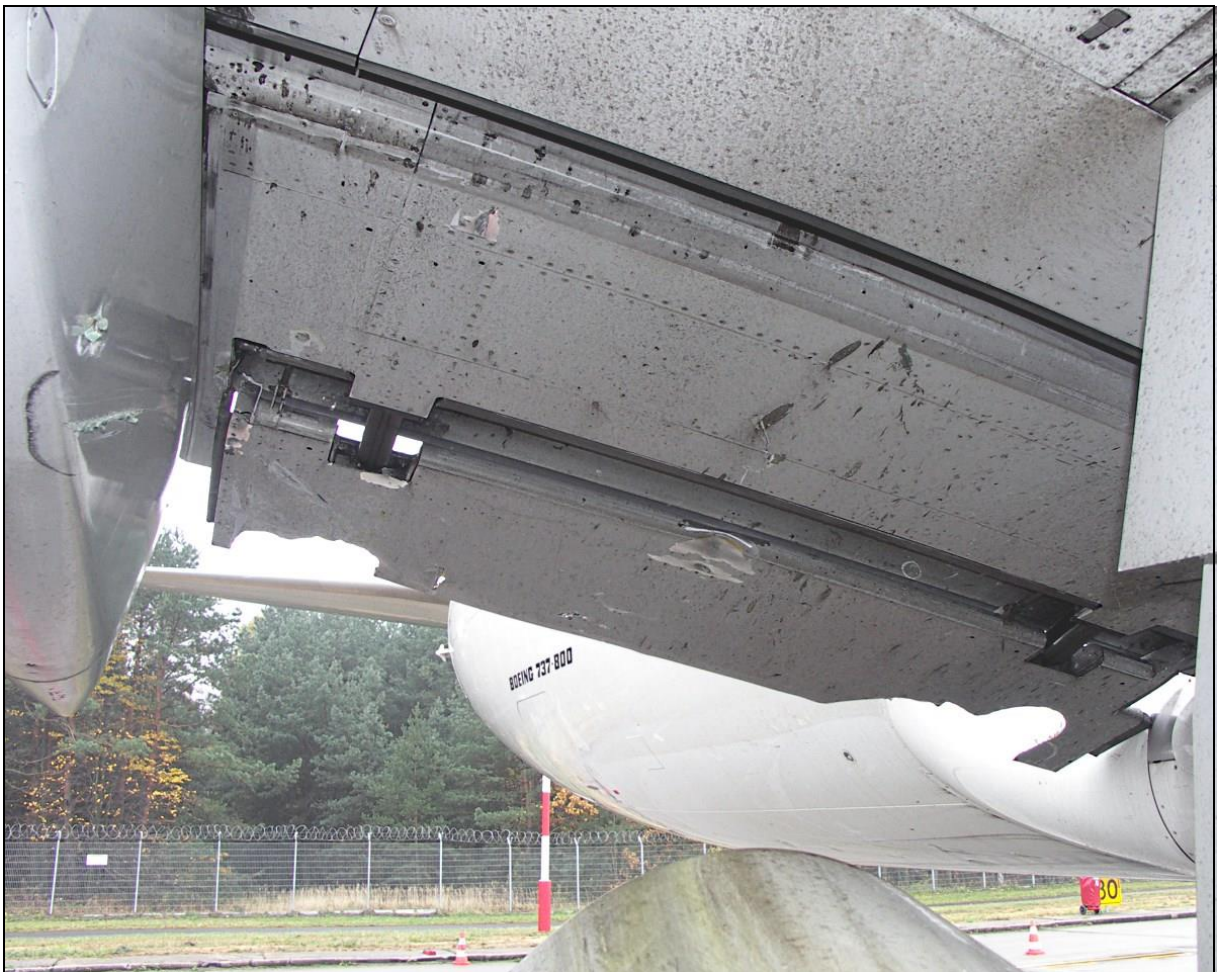
**79 – Damage to the right inboard flap – bottom view**

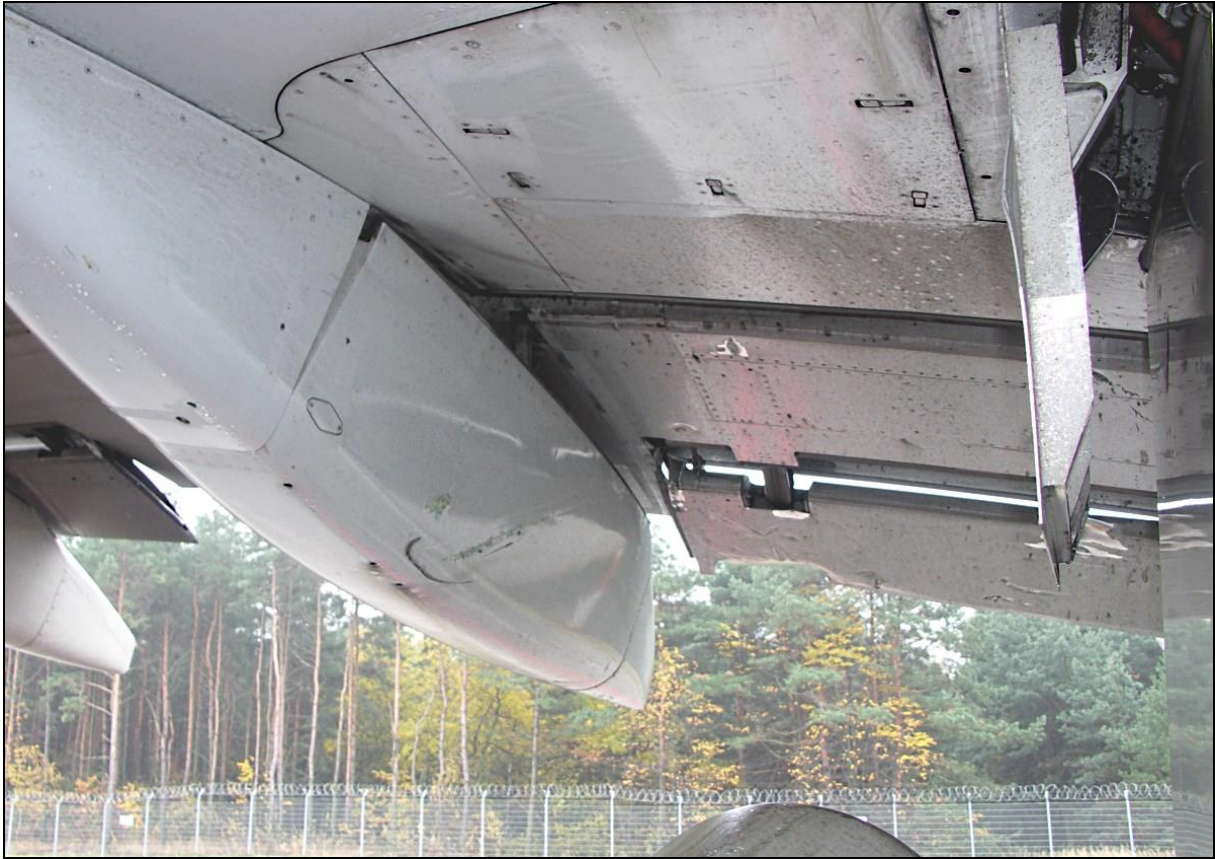
**80 – Damage to the right inboard flap – bottom view**

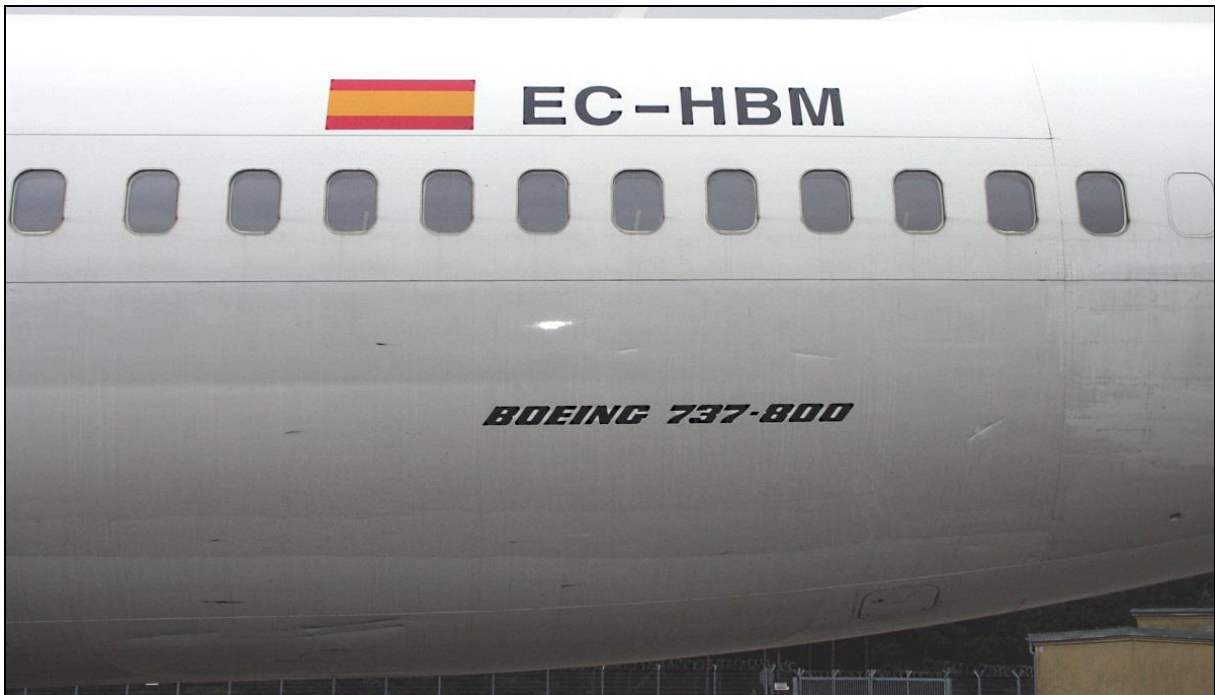
**81 – Scratches and abrasions of the left rear part of the fuselage skin**

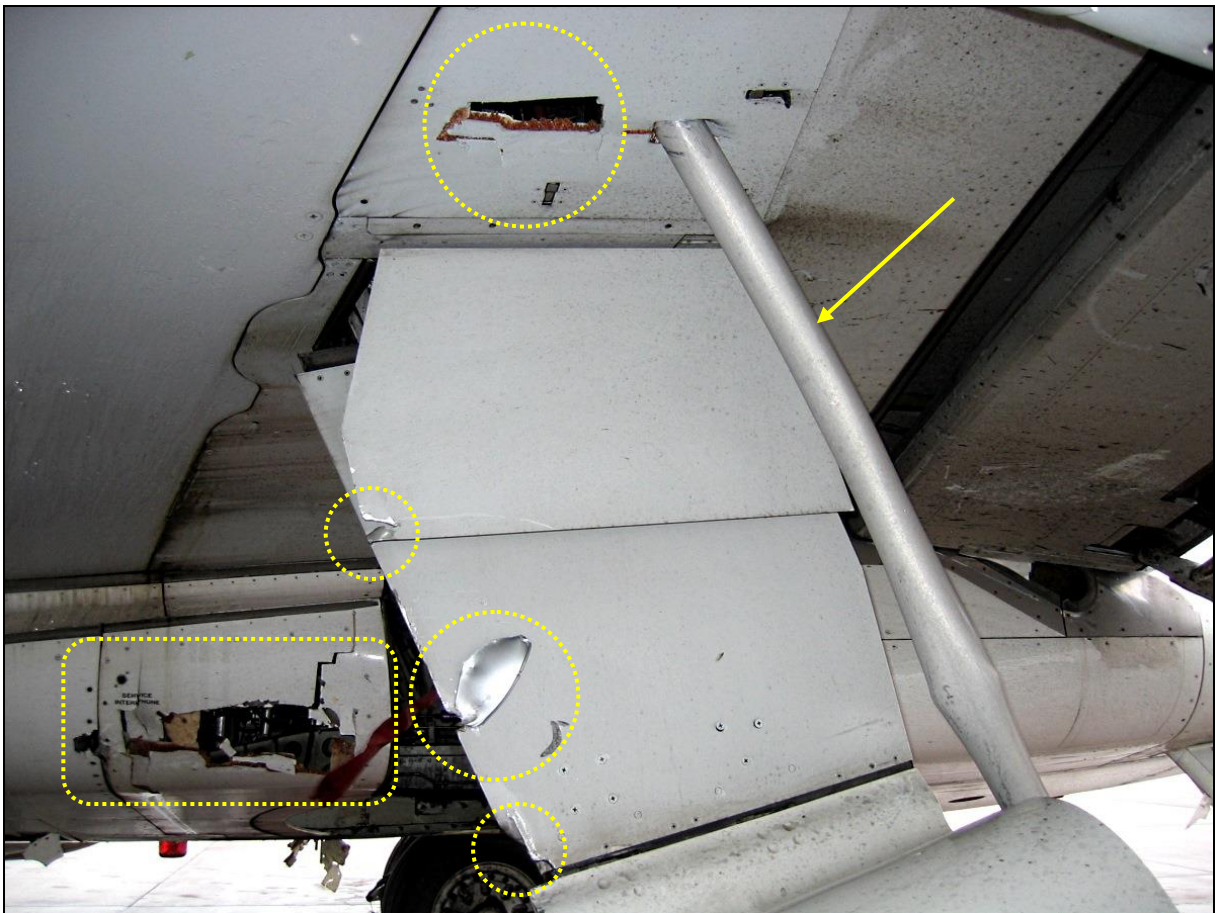
**83 – Damage to the left main landing gear door and belly fairing. Arrow shows a light piece stuck in the airplane structure [photo: airplane crew]**

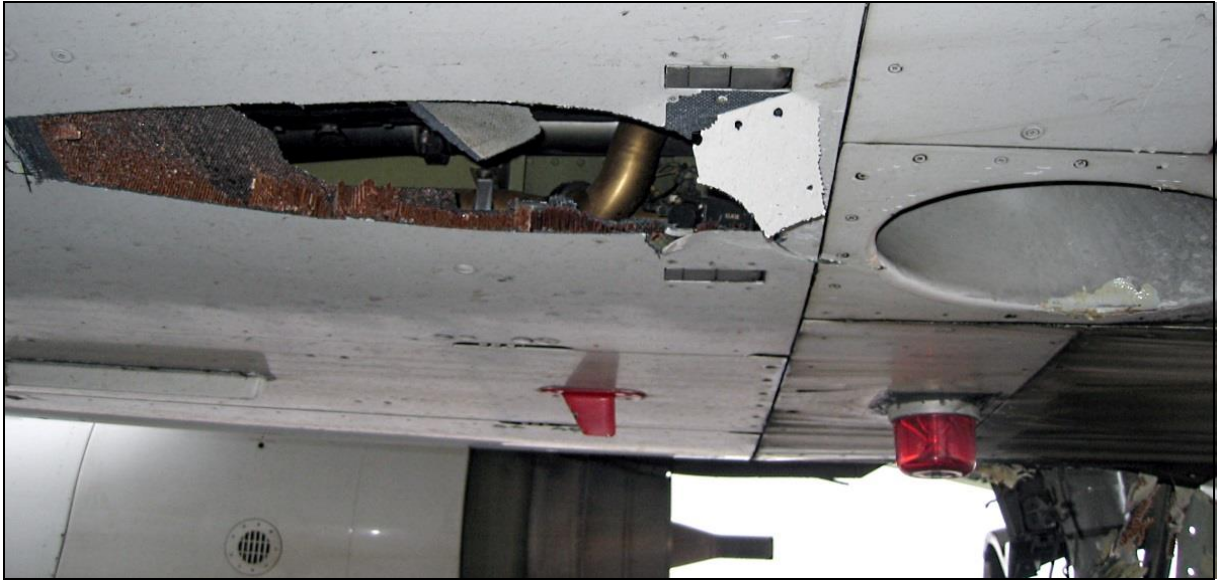
**84 – Damage to the belly fairing – close-up [photo: airplane crew]**

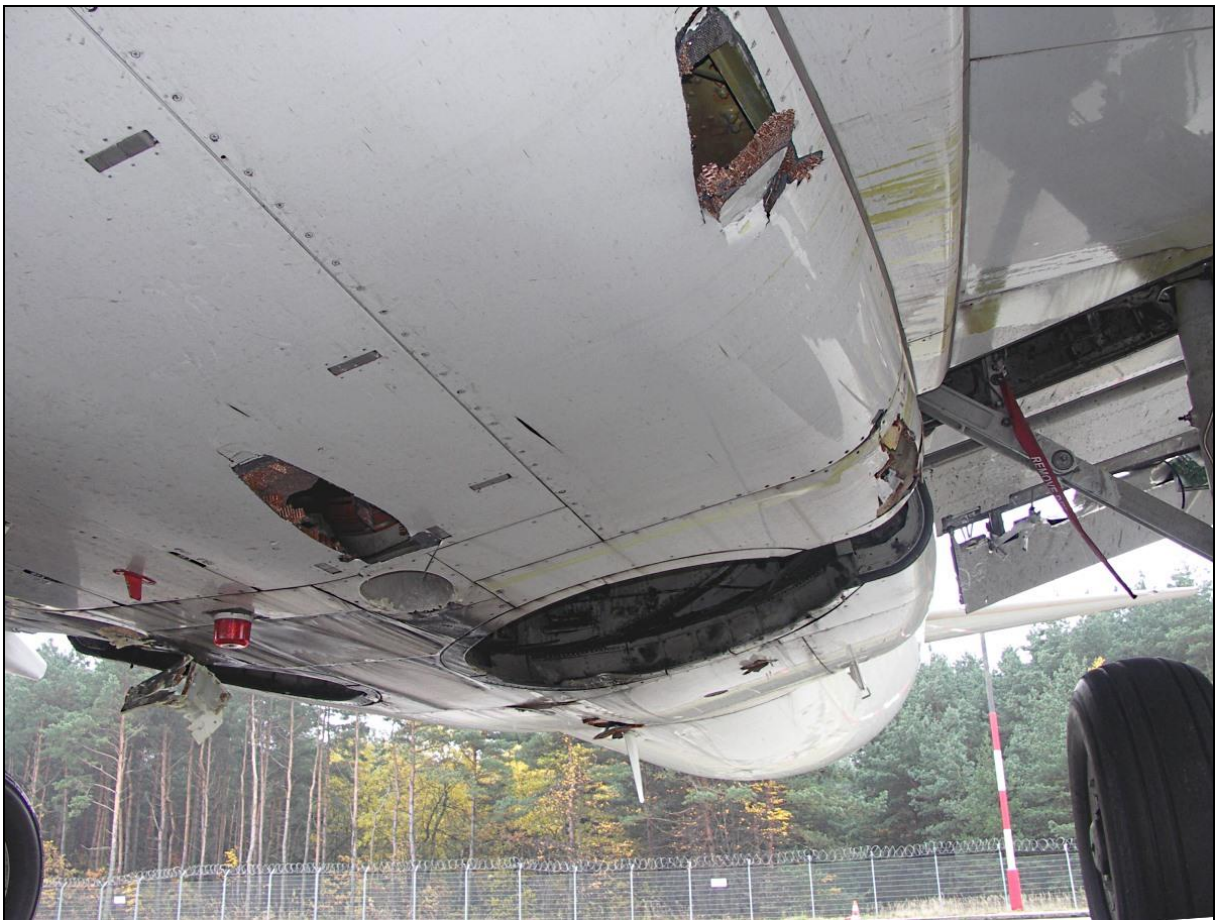
**85 – Damage to the belly fairing – close-up [photo: airplane crew]**

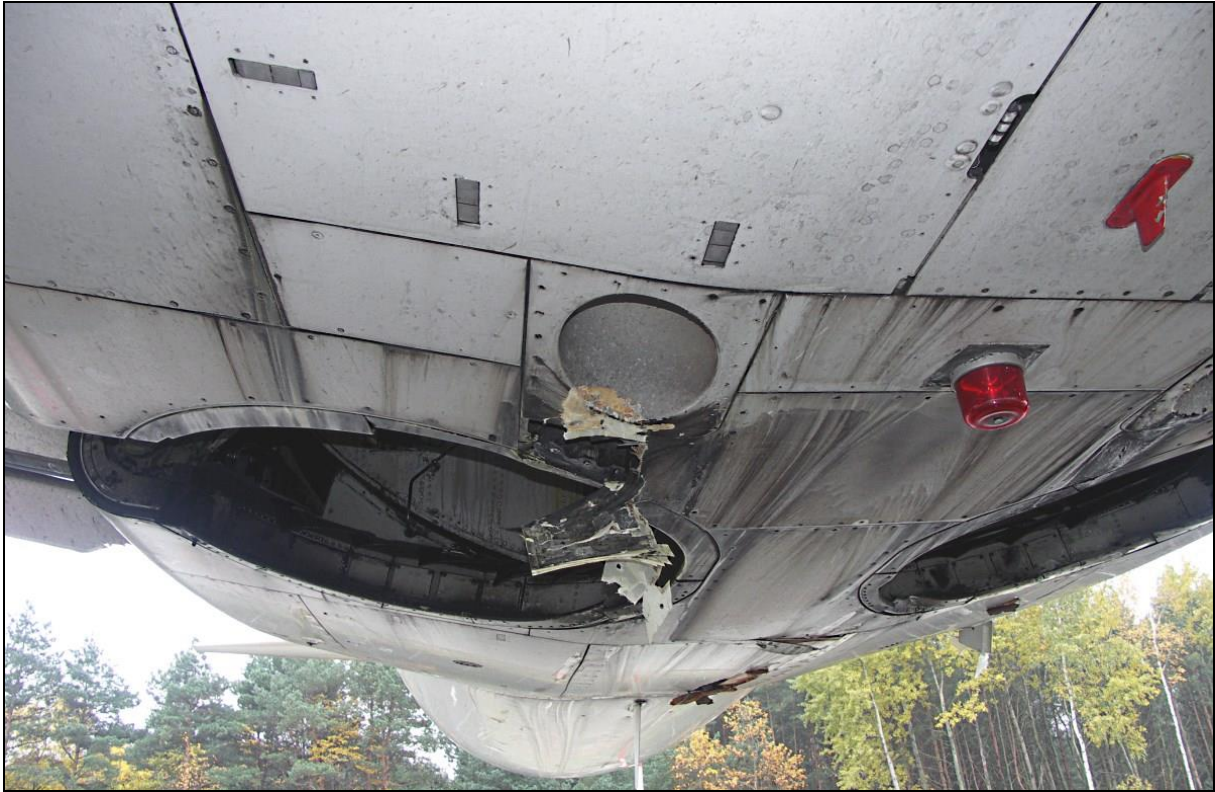
**86 – Damage to the belly fairing – close-up**

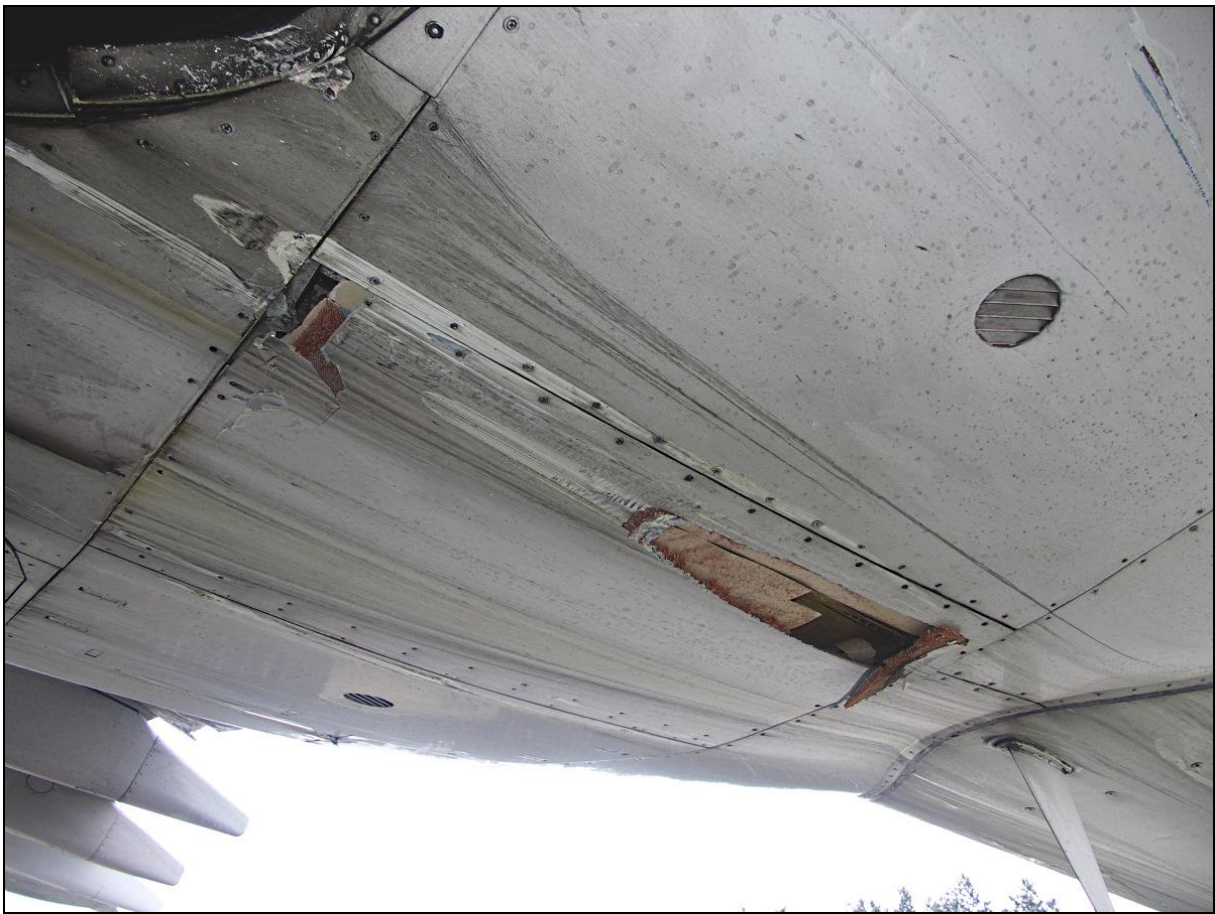
**87 – Damage to the belly fairing – close-up**

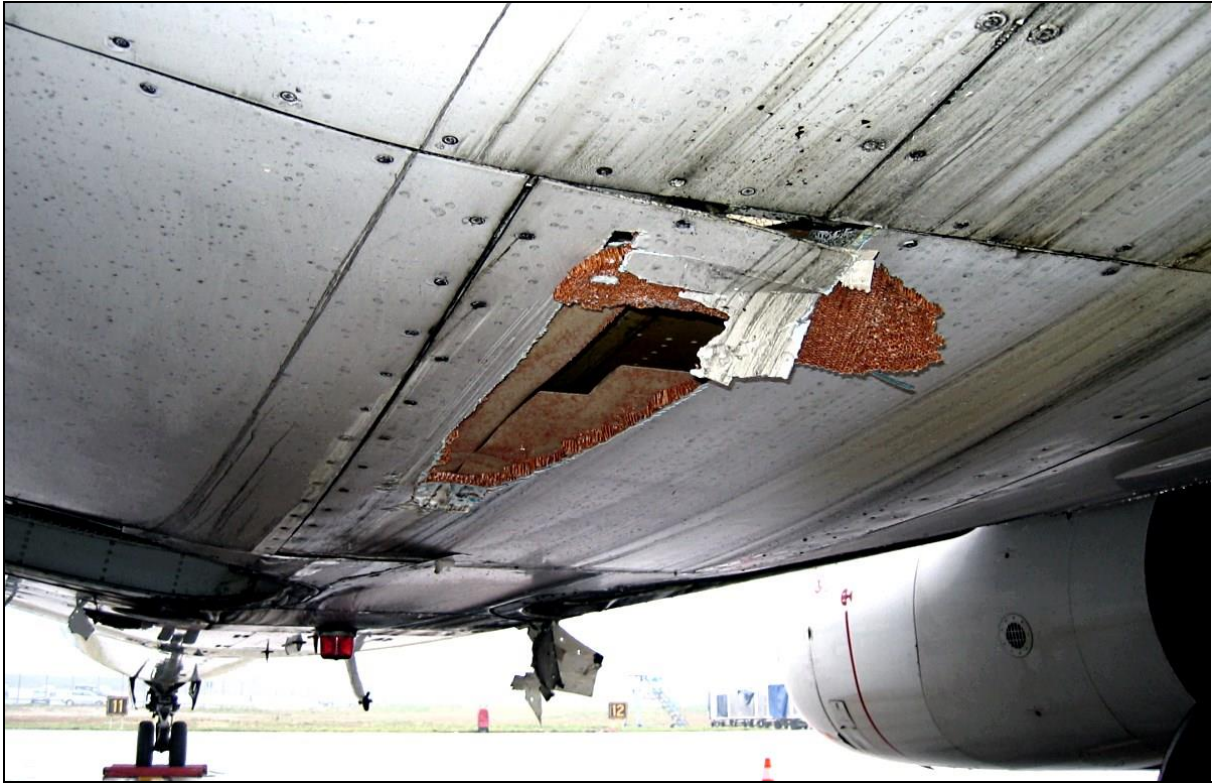
88 – Damage to the belly fairing – close-up [photo: airplane crew]

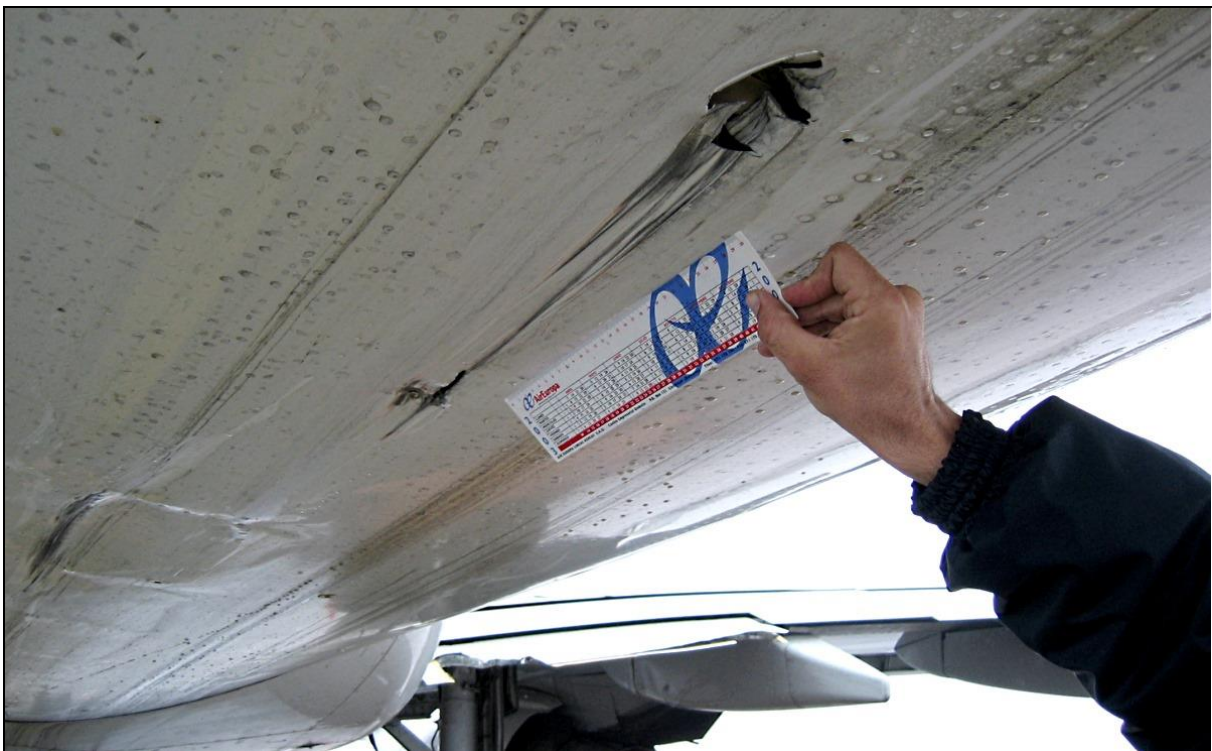
89 – Damage to the bottom part of the fuselage skin – close-up [photo: airplane crew]

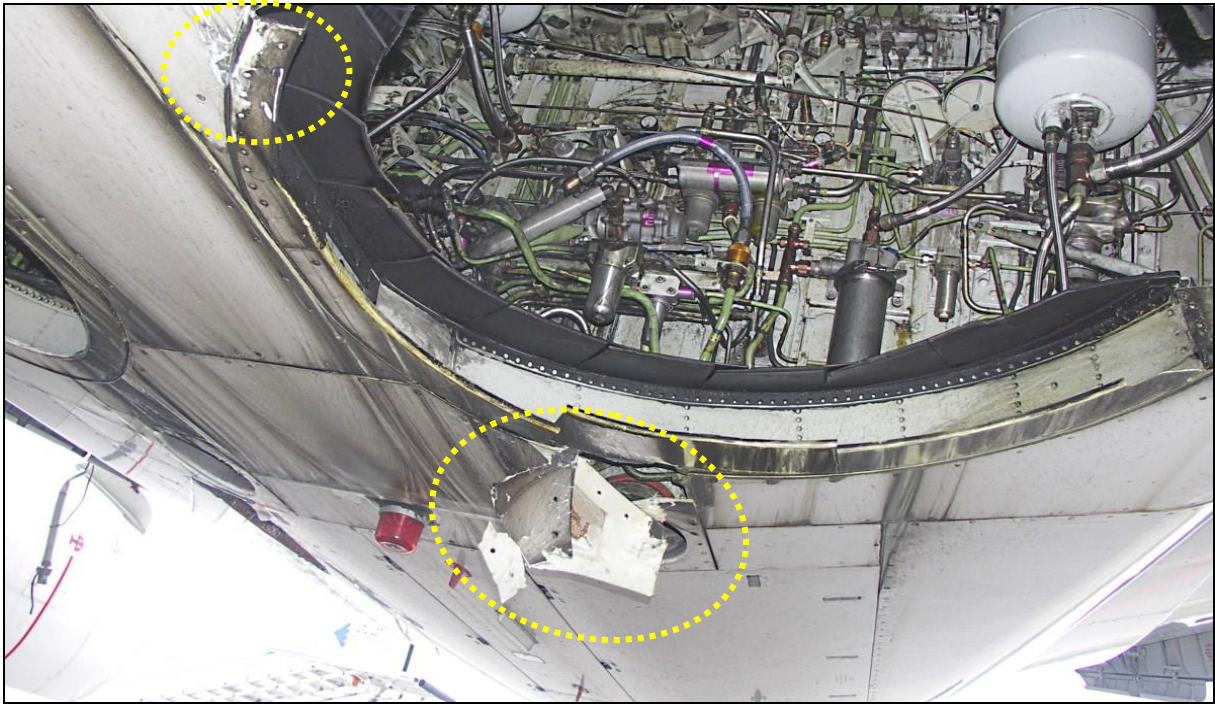
90 – Damage to the belly fairing in the area of the right main landing gear well – close-up

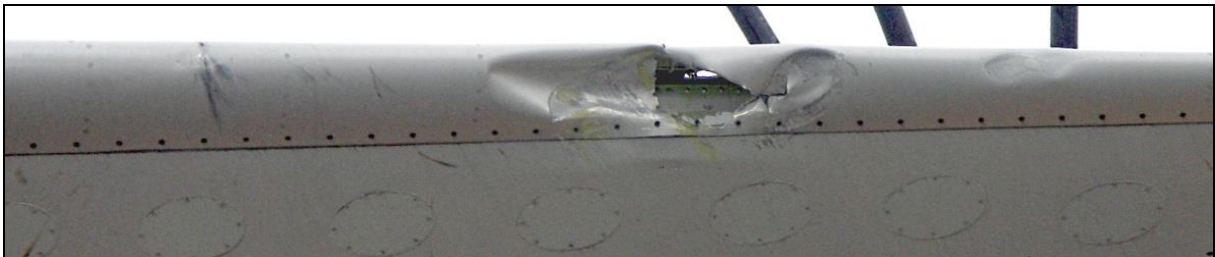
91 – Damage to the left horizontal stabilizer leading edge – close-up

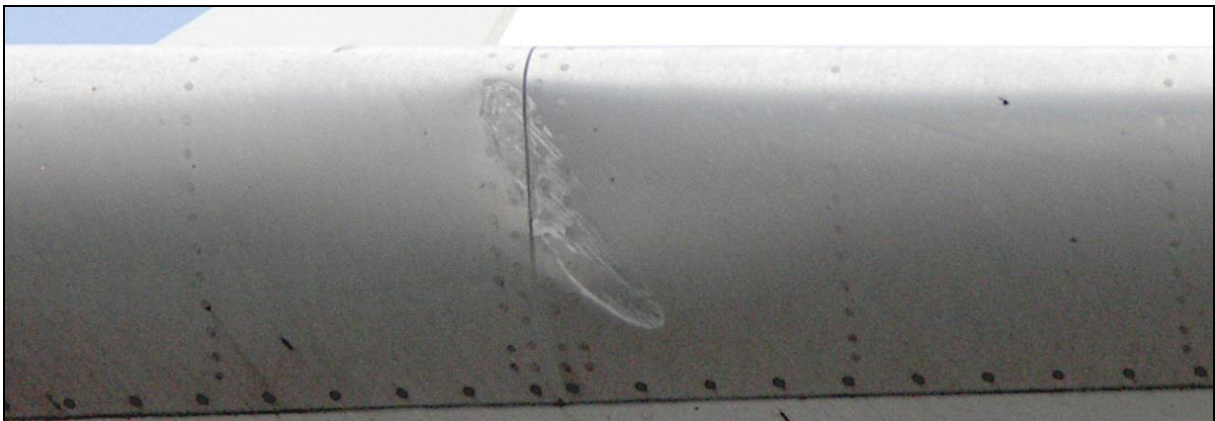
92 – Damage to the left horizontal stabilizer leading edge – close-up

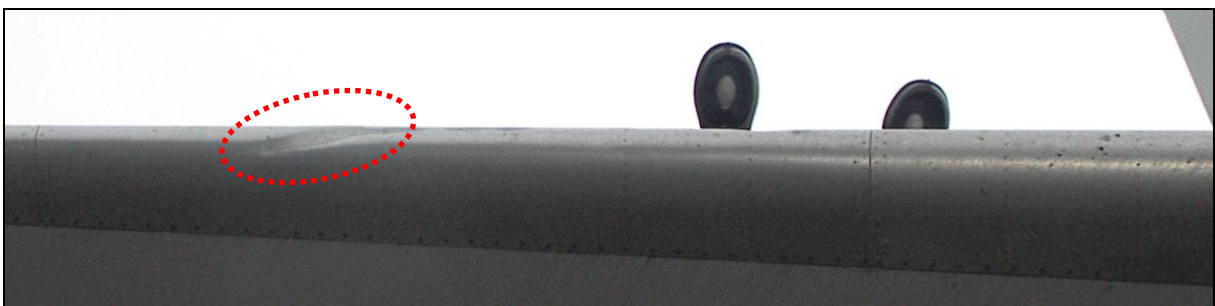
93 – Damage to the right horizontal stabilizer leading edge – close-up

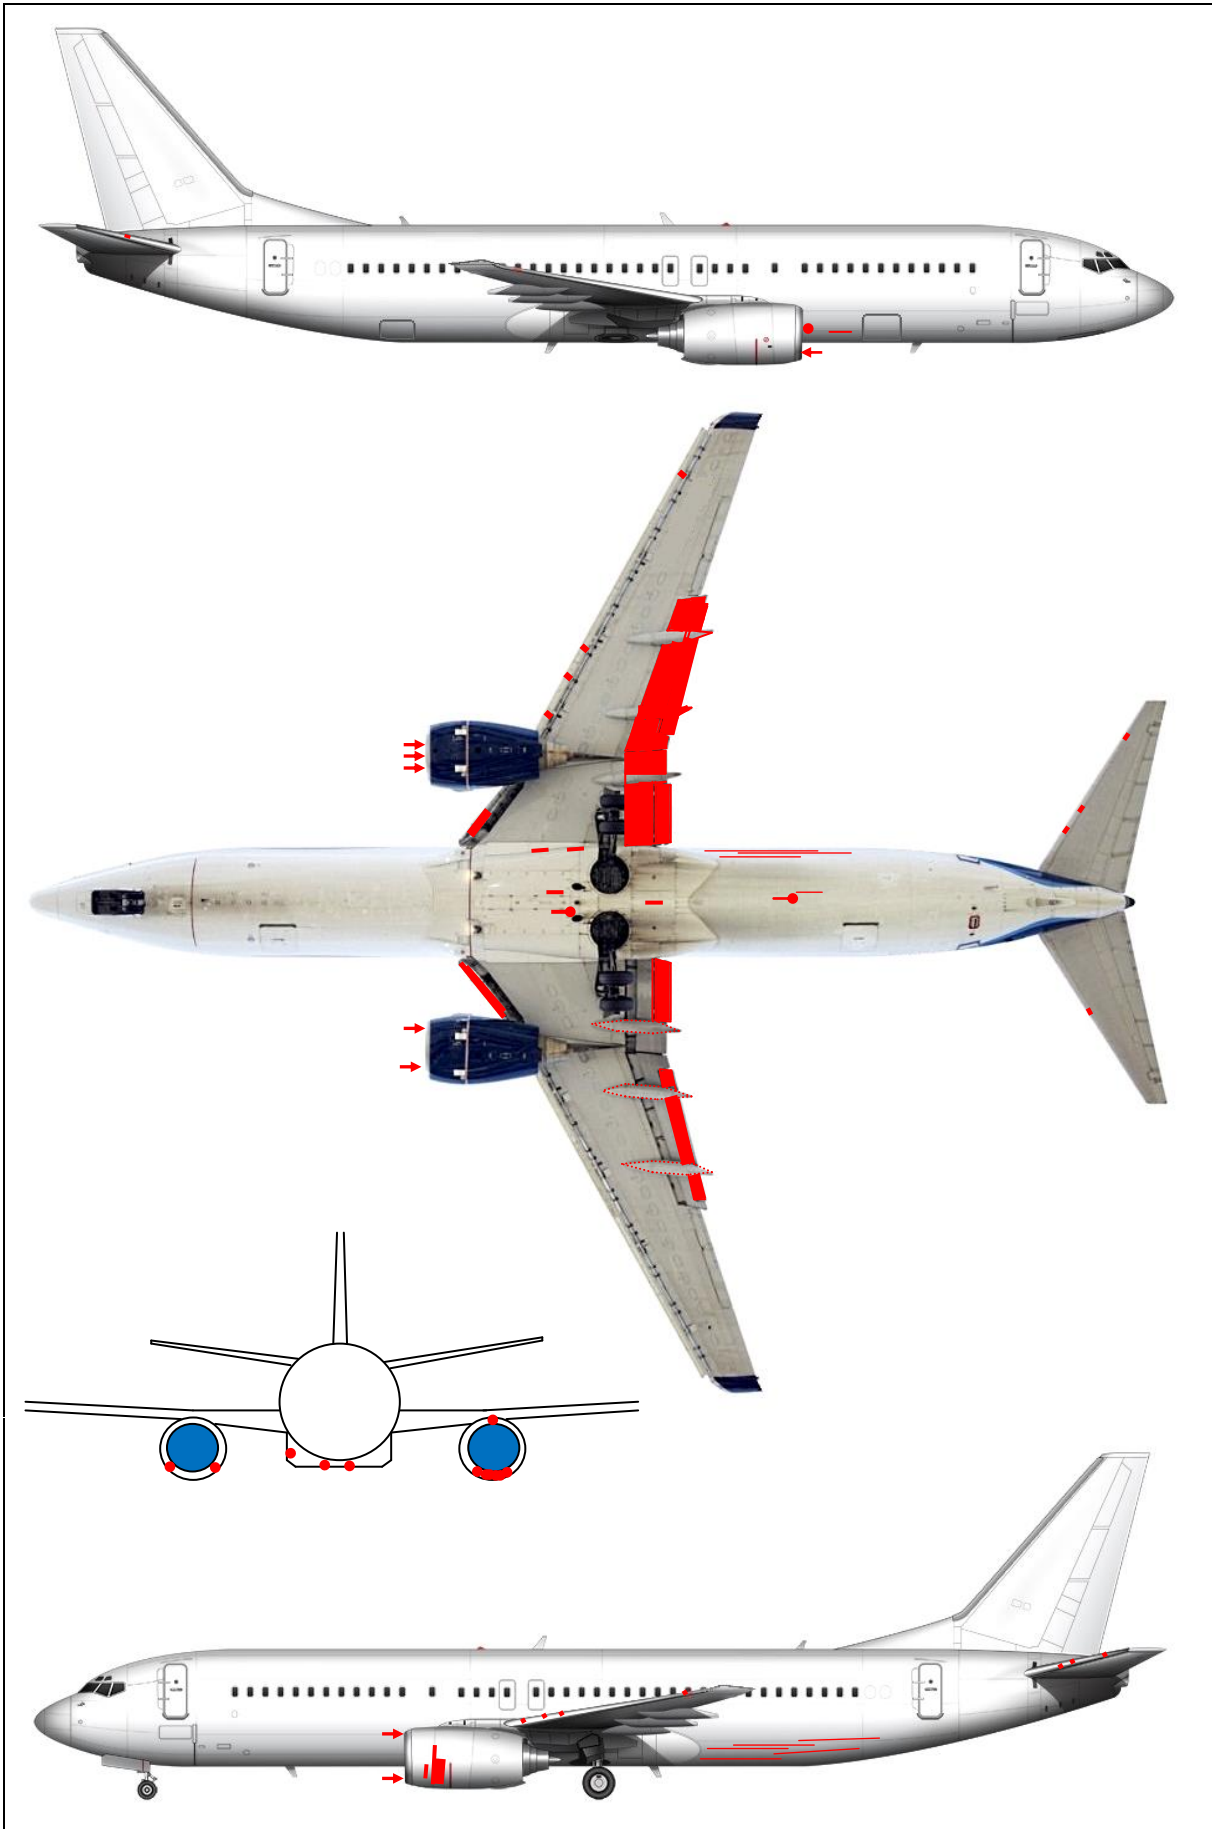
94 – Damage to the airplane parts marked in red
