**MINISTRY OF TRANSPORT, CONSTRUCTION AND MARITIME ECONOMY  
STATE COMMISSION ON AIRCRAFT ACCIDENT INVESTIGATION**

**1318/2011**

## **FINAL REPORT**

### **on investigation of an air occurrence to aircraft of a maximum take off weight equal to or below 2 250 kg \***

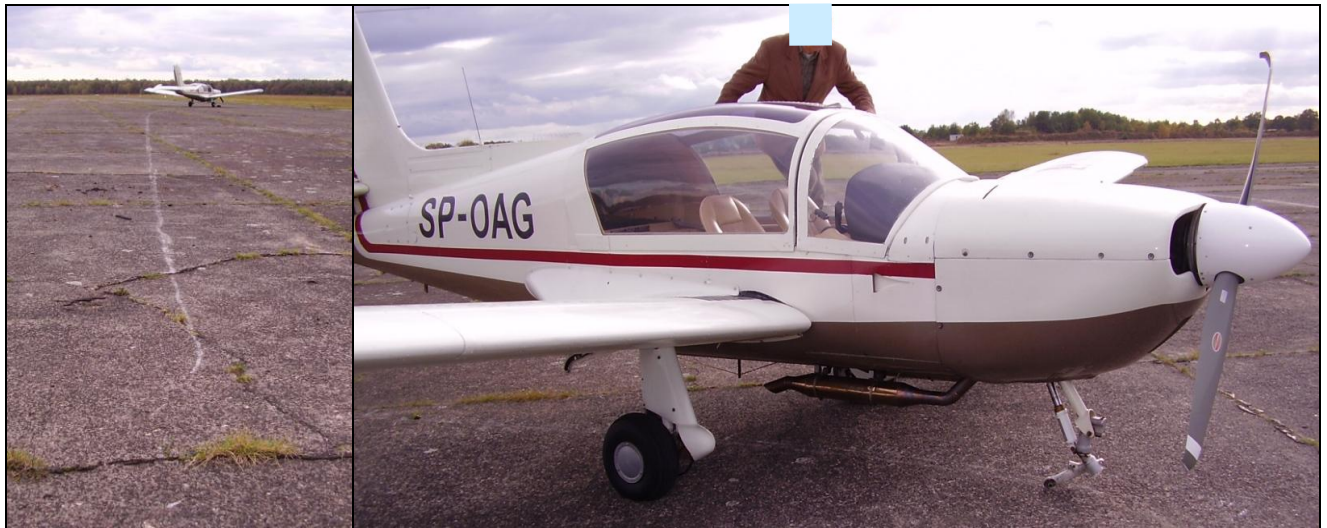
**1, 2 – Landing track on a concrete and the airplane after coming to rest - attention is drawn to the lack of the nose landing gear wheel and damaged propeller. Photo T. Dunajski.**

The landing roll was completed on the leg of the nose landing gear within the runway limits with the loss of direction by about 30°. When the airplane came to rest the pilot shutdown the engine. The nose landing gear wheel separated as a result of breaking of its axle. This caused further damage to the leg of the nose landing gear and the propeller blades.

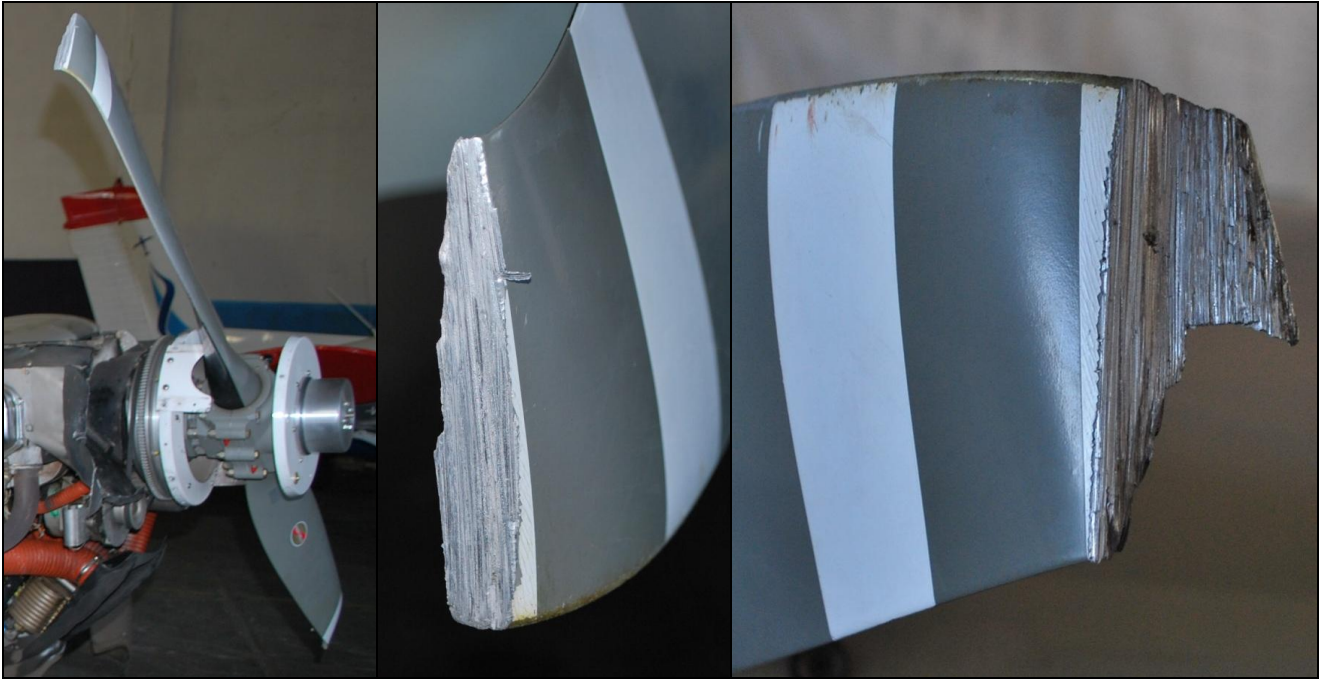
3, 4, 5 – Damages to the propeller blades . Photo SCAAI.

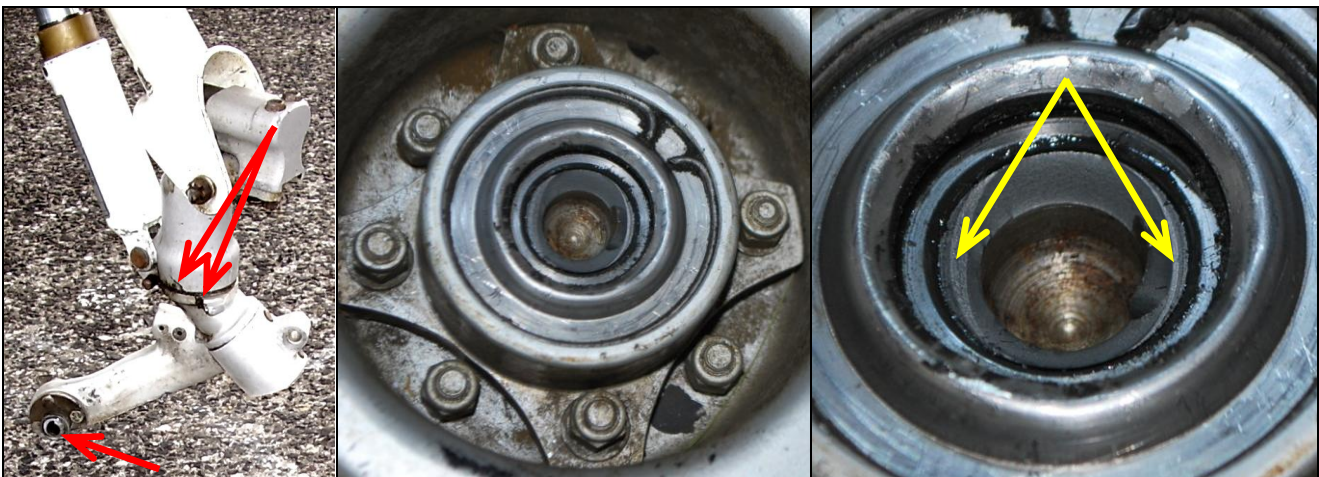
The fracture of the nose wheel axle showed a typical fatigue nature. Comparison of the geometry and dimensions of the damaged axle with the dimensions shown in the engineering drawing of the manufacturer led to the conclusion that the radius of the curvature (of R1 dimension) between the inner bearing track ( $\text{Ø}20\text{g}6$ ) and cylindrical surface ( $\text{Ø}26^{-0.1}/\text{Ø}27^{-0.2}$ ) extending to the flange, which is fixed by four pins to the nose landing gear fork, was practically eliminated, which created a notch.

6, 7, 8 – Nose landing gear fork with marked damages (red arrows) and wheel hub with the broken axle inside (yellow arrows indicate the areas of fatigue crack initiation). Photo SCAAI.

The elimination of the curvature radius was a result of systematic "tightening" of the main nut on the wheel axle in order to eliminate the bearing clearance (according to the aircraft Maintenance Manual). After a sufficiently large number of cycles of such "tightening" one of the elements of the inner bearing housing (i.e. closer to the axle flange) came into contact with

the axle surface exactly in the location of R1 curvature. The resulting friction between the two elements caused gradual destruction of such a transition curvature and formation of a notch.

A notch formed in a critical place, combined with the phenomena caused by the friction heat, led to the local accelerated material fatigue.

in consultation/cooperation with the aircraft manufacturer or by itself: consider introduction of an airworthiness directive for users of Morane-Saulnier/SOCATA Rallye aircraft (and, if necessary, PZL-110 Koliber and other aircraft with identical technical design) specifying with the safe margin:

- service life of the axle of the nose landing gear wheel (expressed as number of landings - cycles) including the permissible number of "tightenings" of the main nut on the wheel axle in order to eliminate the bearing clearance  
or
- the number of landings (cycles), beyond which intervals between technical inspections of the axle of the nose landing gear wheel should be shortened and setting the new intervals, with particular attention to be paid to the dimension of clearance between the flange and the inner bearing.

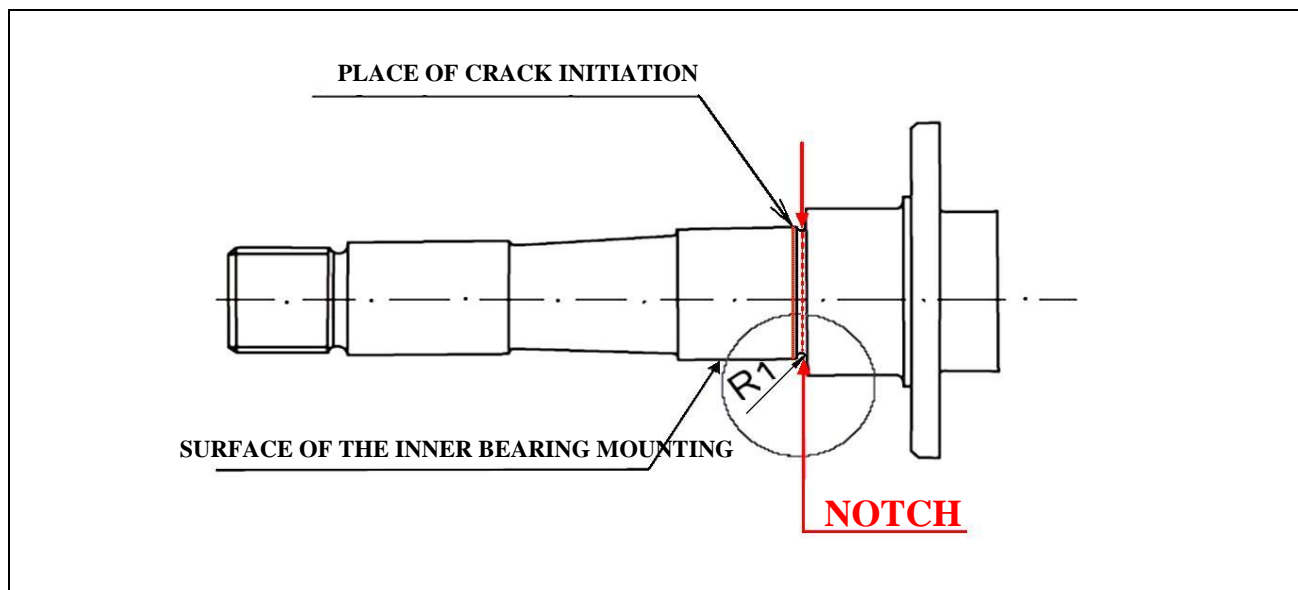
9 - Sketch of the axle of the nose landing gear with the crack place and its geometrical features.

- the surface of the fracture has a shape resembling a cone with the top angle of about 45°.
- the radius of curvature (of R1 dimension) between the inner bearing track (Ø20g6) and cylindrical surface (Ø26<sup>-0.1</sup>/Ø27<sup>-0.2</sup>) extending to the flange, which is fixed by four pins to the nose landing gear fork, was practically eliminated, which created a notch initiating fatigue phenomena in the material. In these circumstances, cumulation of bending and tensile stresses combined with increased temperature, created favorable conditions for the fatigue crack formation and growth.

- elimination of the curvature radius is a result of systematic "tightenings" of the main nut on the wheel axle in order to eliminate the bearing clearance (according to the aircraft Maintenance Manual).

- after a sufficiently large number of cycles of such "tightening" one of the elements of the inner bearing housing (i.e. closer to the axle flange) came into contact with the axle surface

exactly in the location of R1 curvature. The resulting friction between the two elements caused gradual destruction of such a transition curvature and formation of a notch.

**Fatigue crack of the axle of the nose landing gear wheel, caused by its local mechanical wear resulting from the design and maintenance features.**
