### STATE COMMISSION ON AIRCRAFT ACCIDENT INVESTIGATION

# FINAL REPORT

## Serious Incident No: 404/07

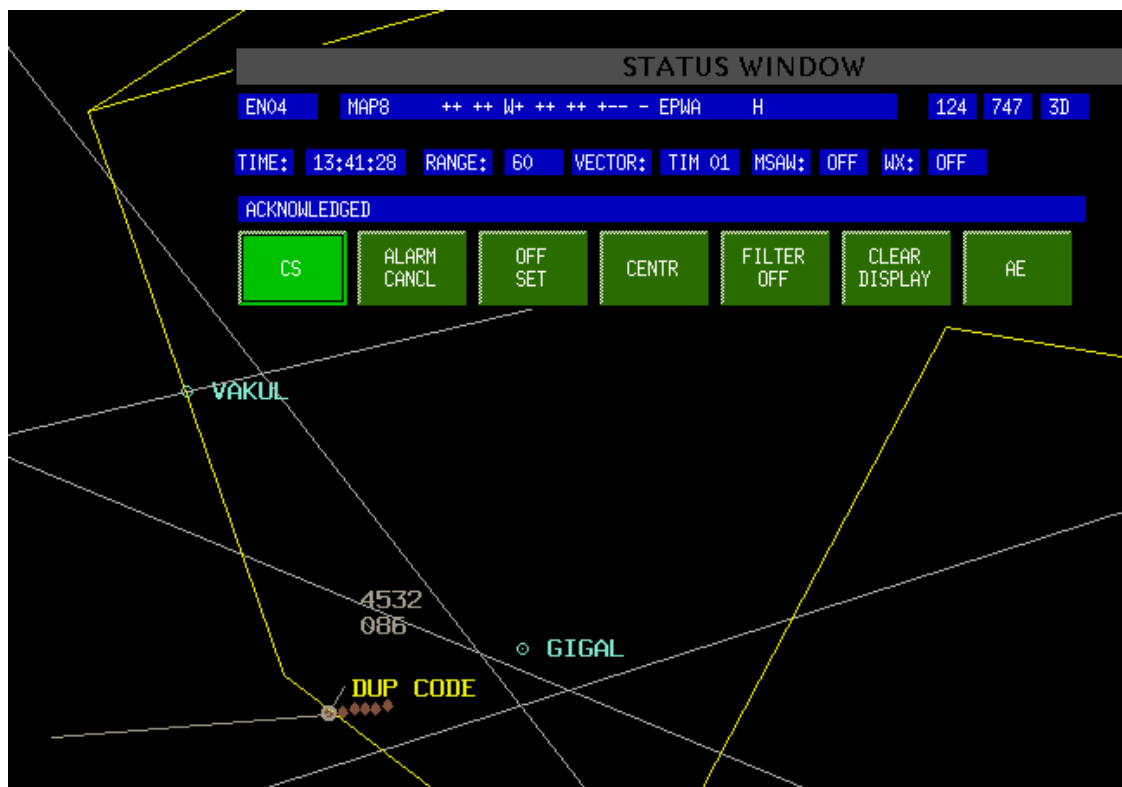
traffic control clearance issued at 13:31:10 UTC. The clearance did not contain any conditions related to the flight level at the time of crossing TMA boundary. DLH3UV continued climbing according to the received clearance directly to the UVSOV navigation point and crossed FL86 exactly at TMA boundary.

DLH3UV airplane was flying for 40 seconds in the airspace class „G” (from passing TMA boundary to crossing FL100 - re-entry into the controlled airspace class "C") and within this time limits, at 13:41:35, the flight crew reported very dangerous proximity to another aircraft.

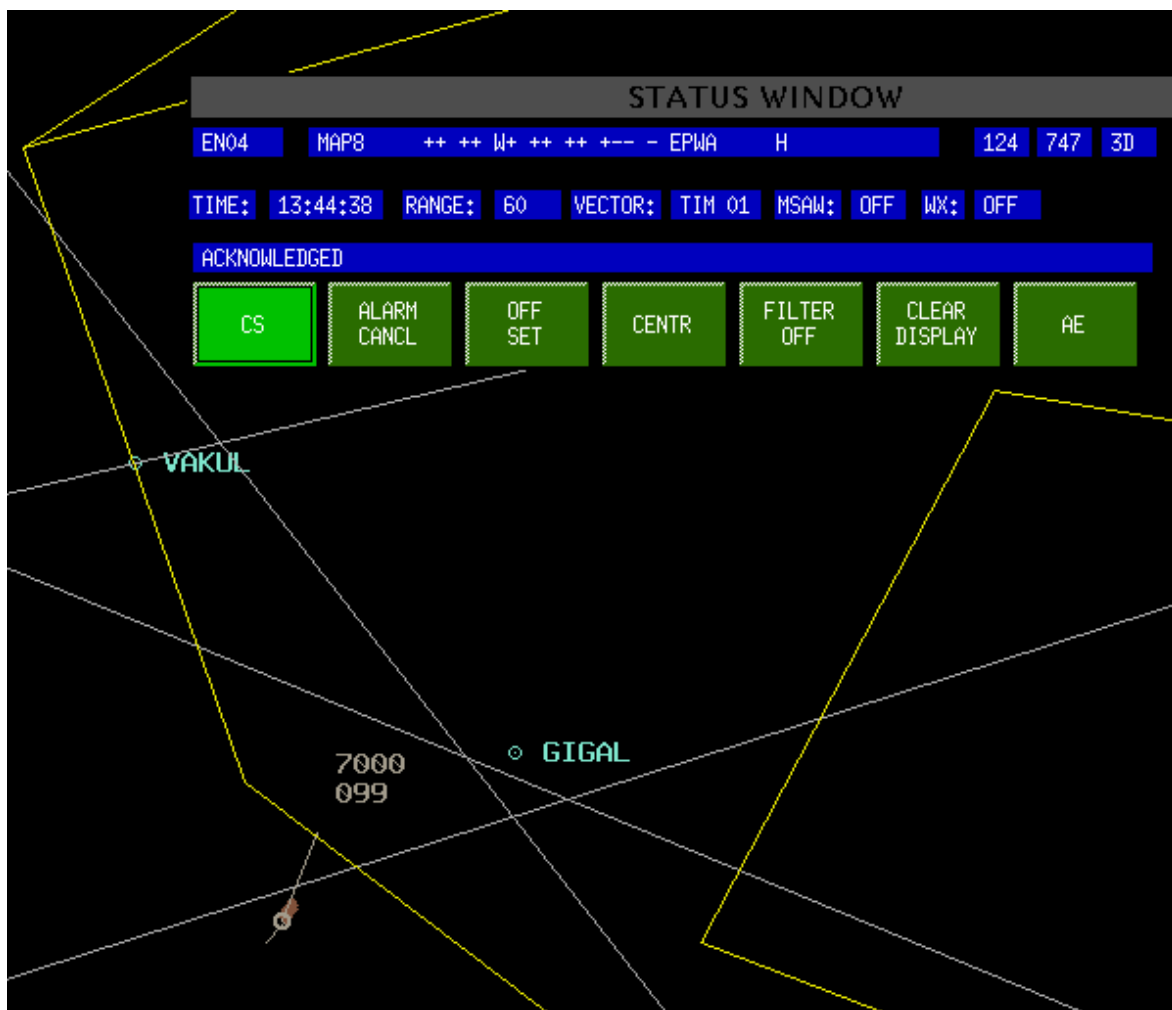
The helicopter involved in the incident with DLH3UV was identified as F-GECM only after the flight crew turned on the transponder code 7000 (radar screen below) at 13:44:10 UTC. The helicopter pilot established communication with FIS Poznań at 13:46:36 UTC. No Flight Plan was submitted prior to the helicopter flight in question.

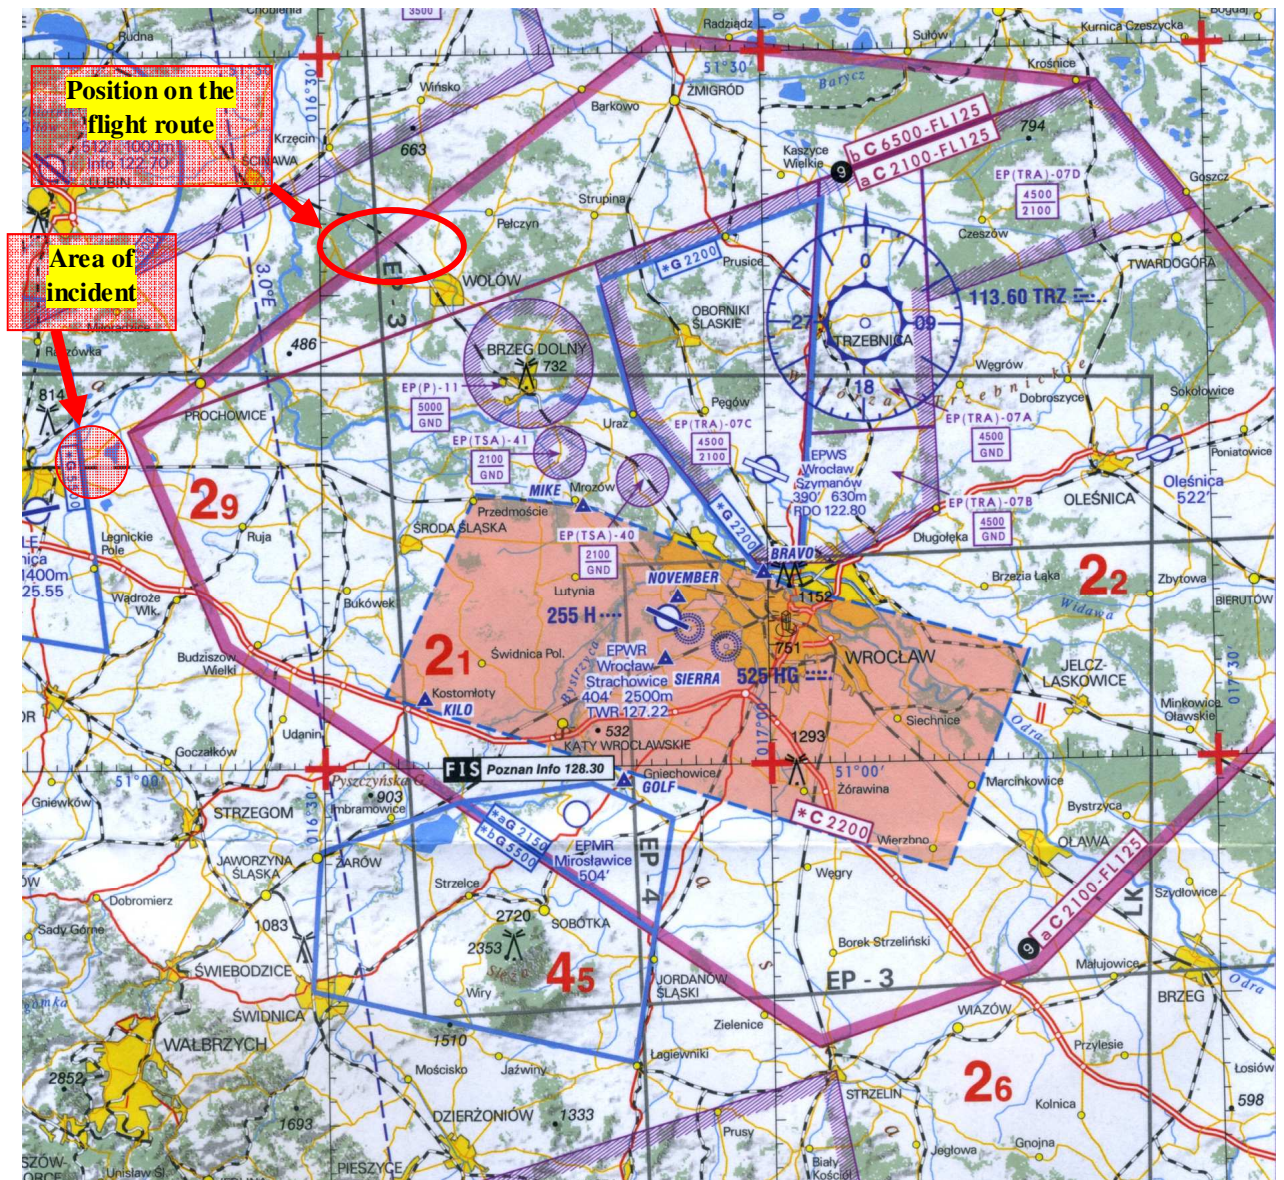
### ***EPWR TMA (Jeppesen)***

Secondly, the pilot planned to fly over Wołów town, which was within the upper sector ("b") of EPWR TMA (from 6500ft AMSL to FL125), and about 50 meters from the boundary of the lower sector ("a") of EPWR TMA (from 2100 ft AMSL to FL125). In spite of the obligation under VFR, the pilot performing flight in close proximity of controlled airspace did not establish communication with EPWR air traffic control unit to set altimeter.
