MINISTRY OF INFRASTRUCTURE
STATE COMMISSION ON AIRCRAFT ACCIDENT INVESTIGATION

FINAL REPORT

Serious Incident No: 450/07

**Approach abandoned by the flight crew of
Embraer 145 airplane, registration marks: SP-LGG
resulting from runway incursion by the flight crew of
Boeing 737-400 airplane, registration marks: TC-SKF
10 October 2007
Warszawa-Okęcie Aerodrome (EPWA)**

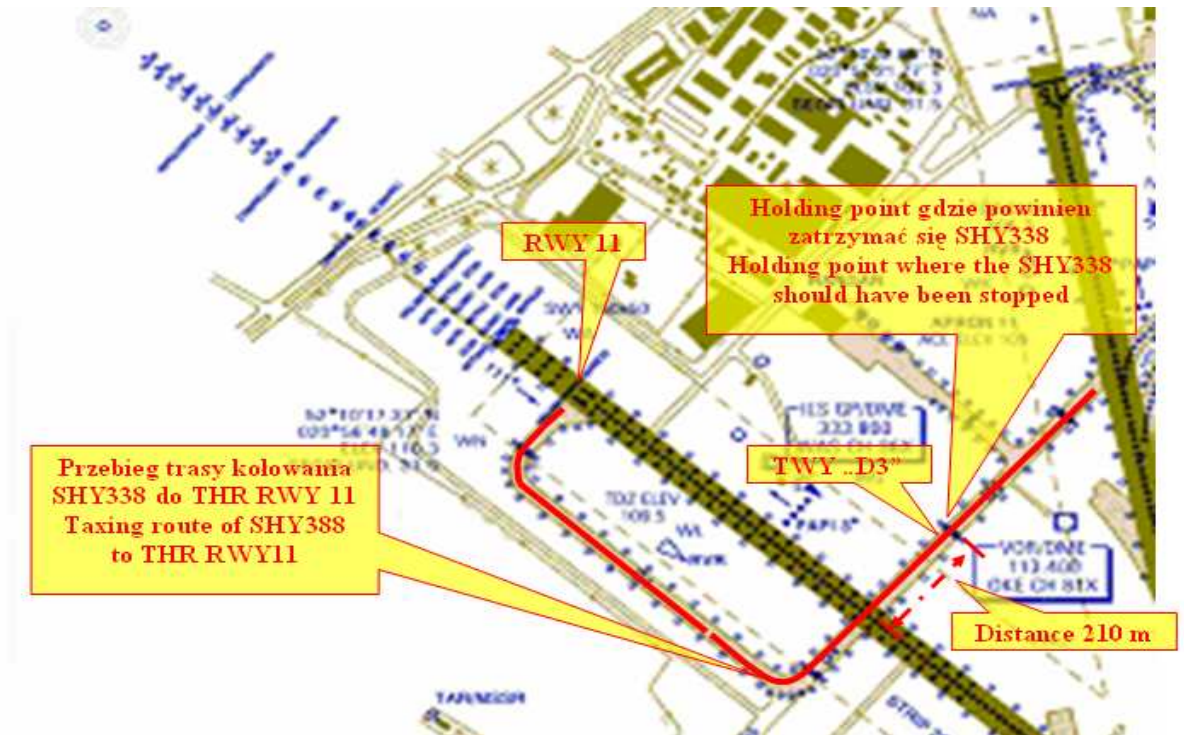
Taxi route of SHY338 leading to RWY11 threshold

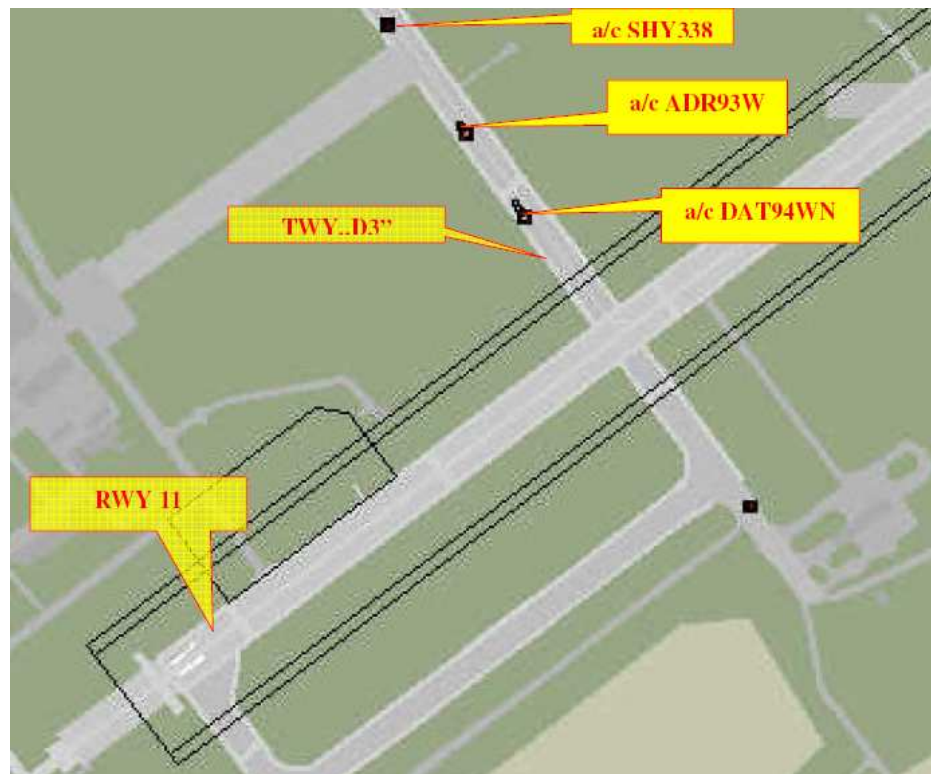
SMR display record: 3 aircraft short of RWY11

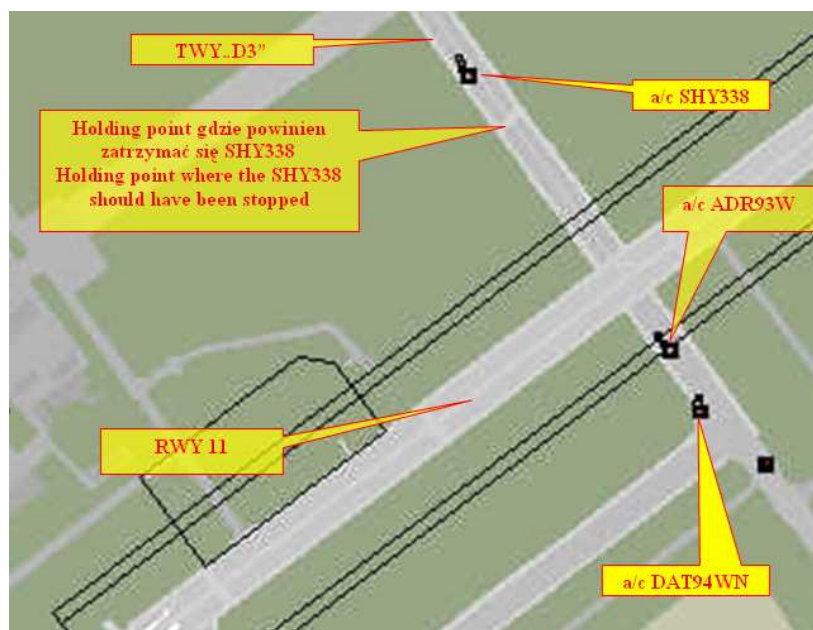
SMR display record: 2 aircraft after crossing RWY11 and SHY338 still on TWY D3 short of RWY11

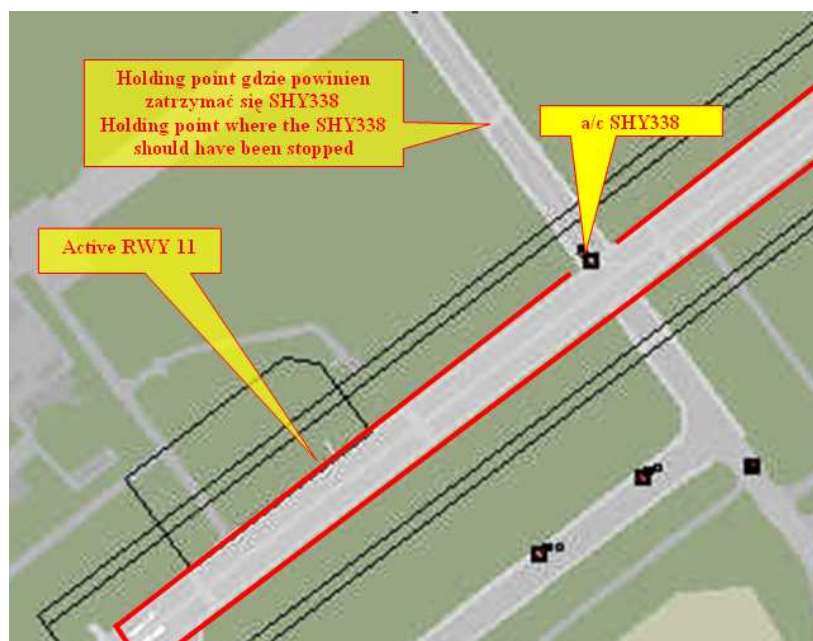
TWR controller noticed SHY338 coming fast to runway 11 and again ordered the flight crew to stop short of the runway. The SHY338 flight crew again failed to comply with the TWR controller order and taxied onto the active RWY 11, which was approached by LOT 270, located at that time approximately 1,5 NM (2,8 km) from the runway threshold.

SMR display record: SHY338 taxiing onto active RWY11

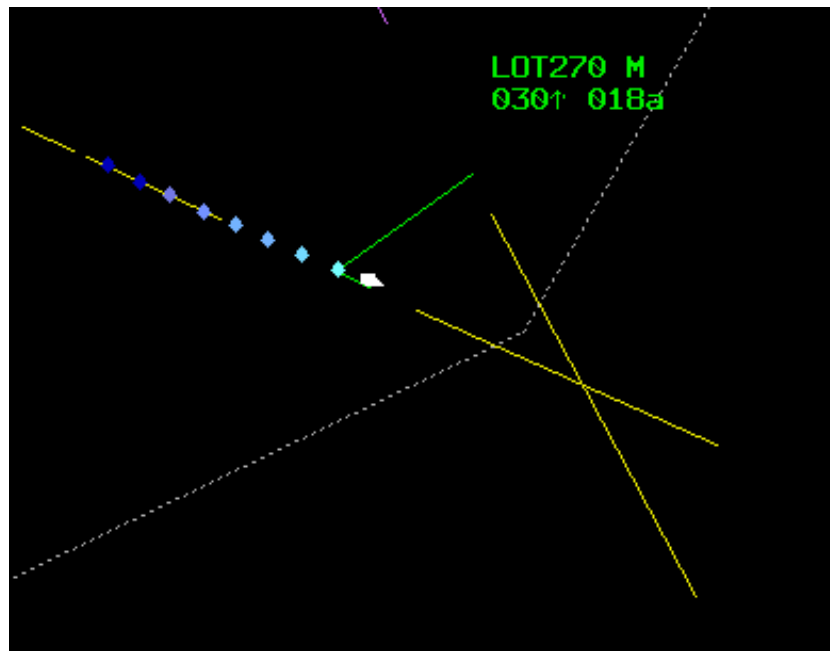
APP display record: beginning of go-around procedure by LOT270

As a result of the situation, the TWR controller instructed the flight crew of LOT270 to go-around. After the incident SHY338 vacated RWY 11, the flight crew apologized for incursion on the active runway and continued taxiing to take off for the destination.
