ALBUM ILUSTRACJI

Numer zdarzenia: 962/09

Rodzaj zdarzenia: poważny incydent

Statek powietrzny: samolot Boeing 737-800, 5B-DBV

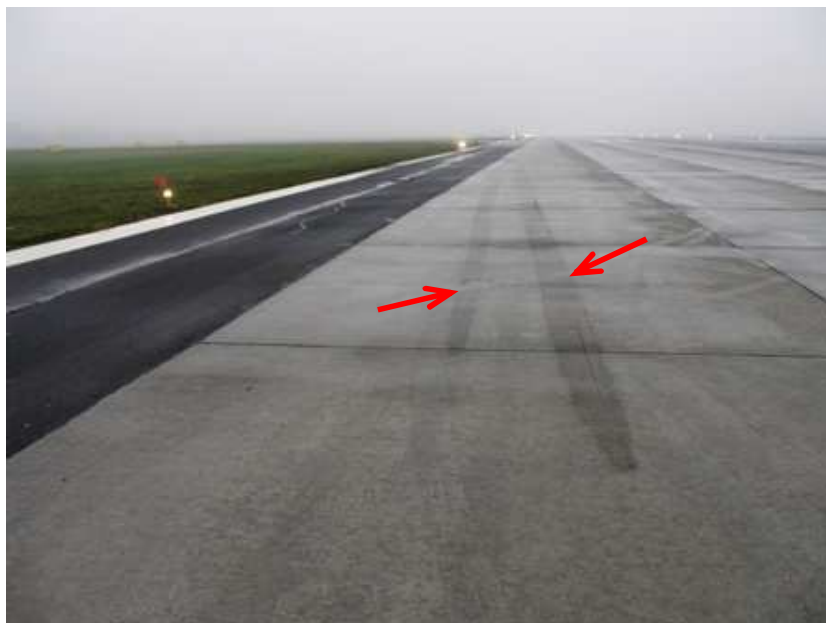
5. Ślady kół na drodze startowej po przyziemieniu samolotu wskazują na:
- niesymetryczne przyziemienie na prawe podwozie,
 - nierównoległe do osi drogi startowej lądowanie, co doprowadziło do wypadnięcia z drogi startowej.

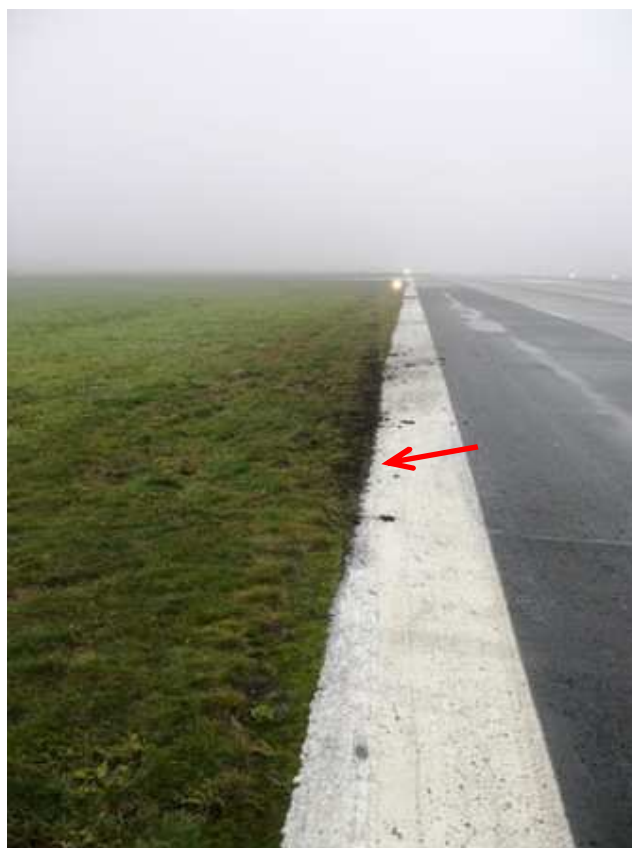
6. Strzałka wskazuje miejsce opuszczenia drogi startowej przez lewe podwozie główne.

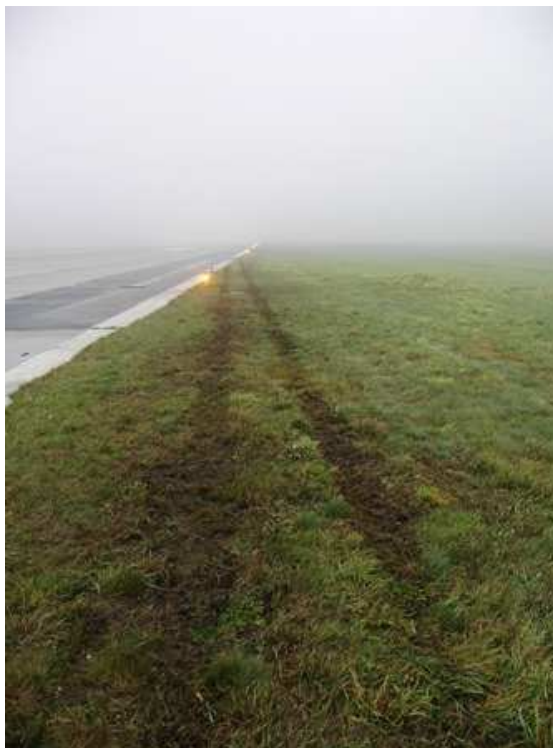
7. Ślady lewego podwozia głównego – zjazd samolotu z drogi startowej (kierunek wykonania zdjęcia – przeciwny do kierunku dobiegu).

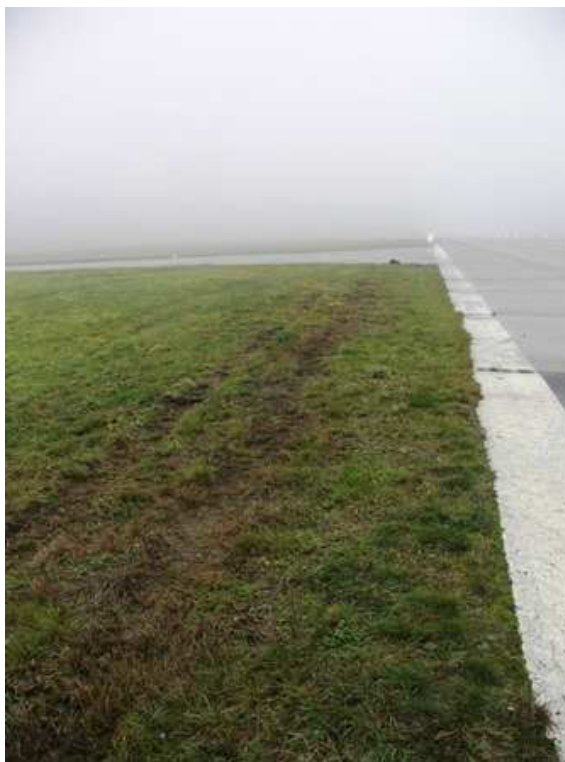
8. Ślad lewego podwozia głównego obok drogi startowej; w tym momencie koła podwozia przedniego były jeszcze na pasie.

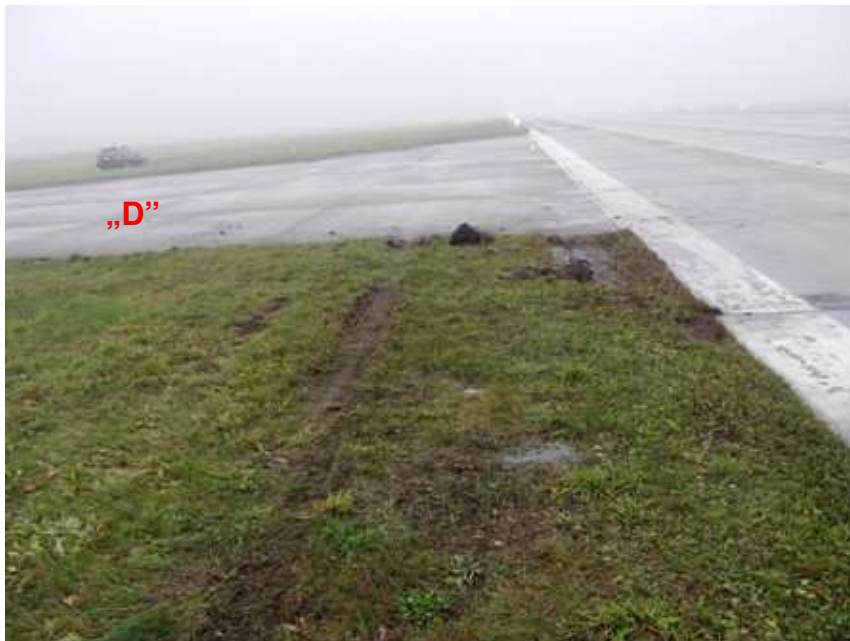
9. Ślad lewego podwozia głównego przed wjazdem na drogę kołowania D; w tym momencie koła podwozia przedniego były jeszcze na pasie.

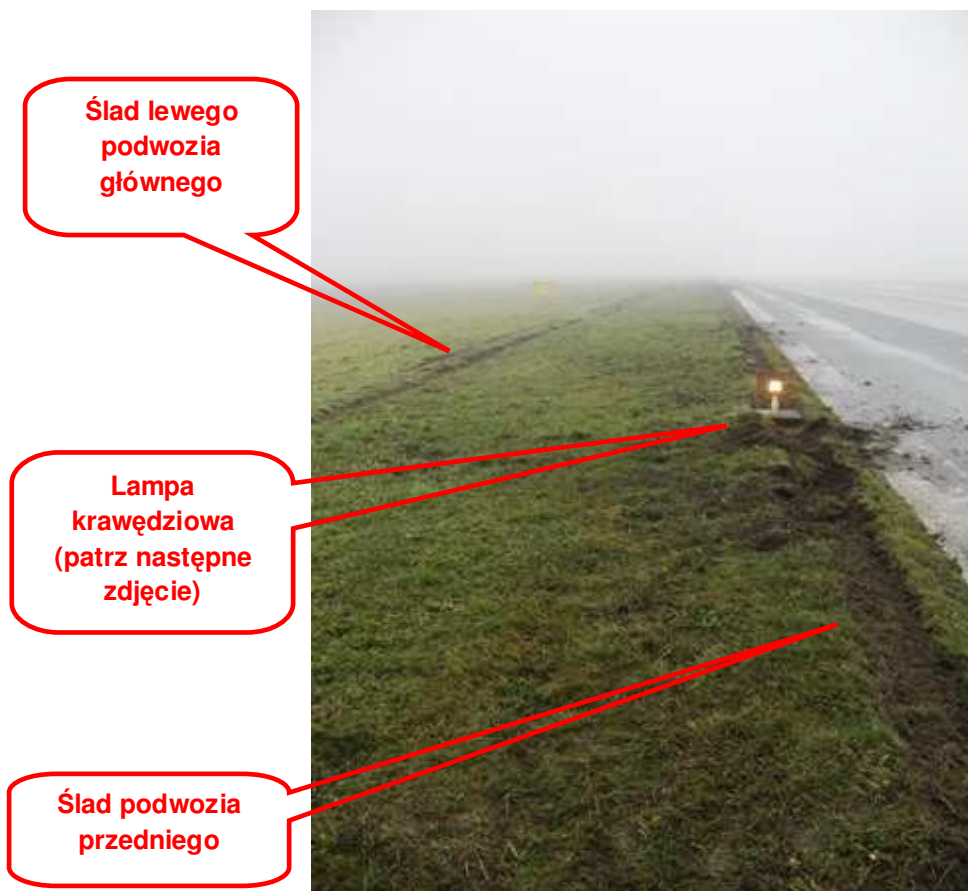
10. Ślady podwozia przedniego i lewego głównego na wysokości pierwszej zniszczonej przez samolot lampy.

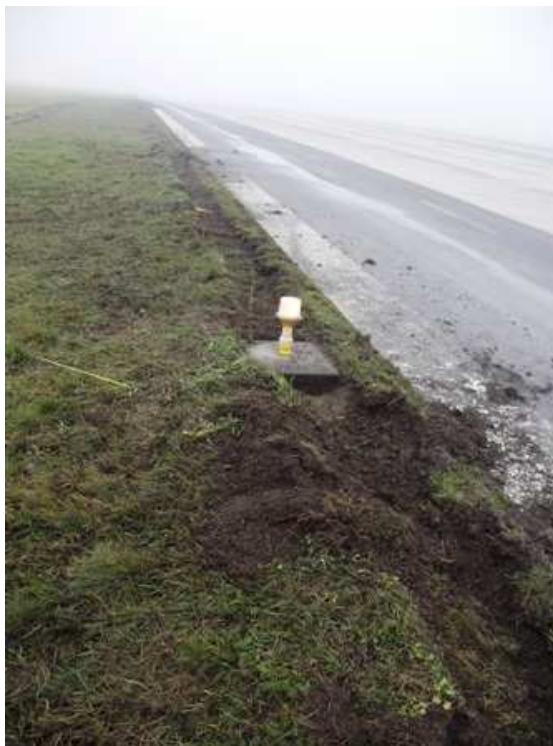
11. Lampa krawędziowa (na zdjęciu po naprawie) uszkodzona przez samolot; prawdopodobnie o fundament tej lampy została uszkodzona wewnętrzna krawędź felgi prawego koła podwozia przedniego.

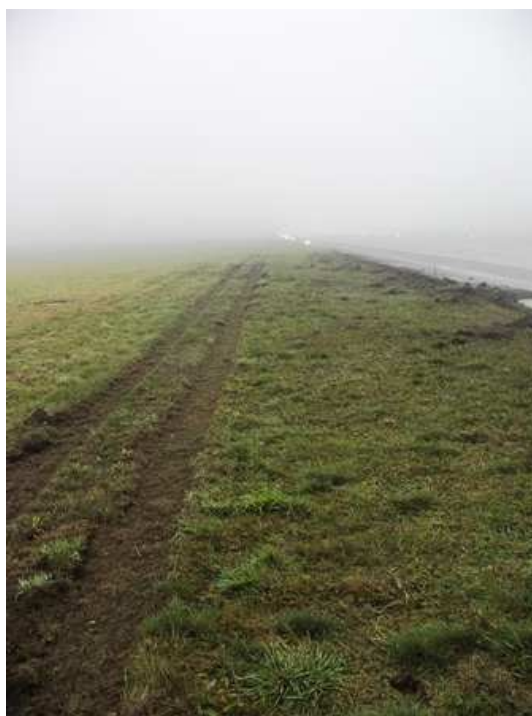
12. Ślad lewego podwozia głównego, na tym odcinku równoległy do drogi startowej.

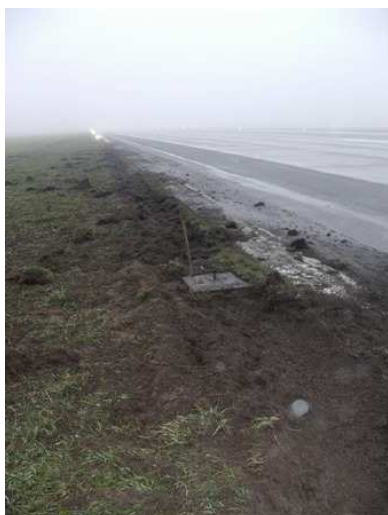
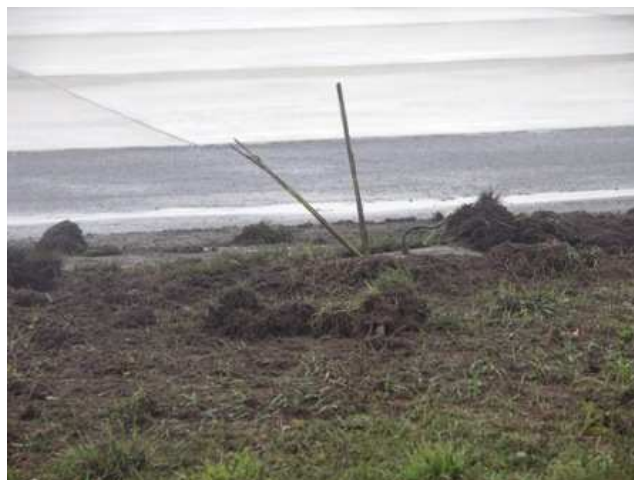
13a, b. Druga, zniszczona przez przednie podwozie, lampa krawędziowa.

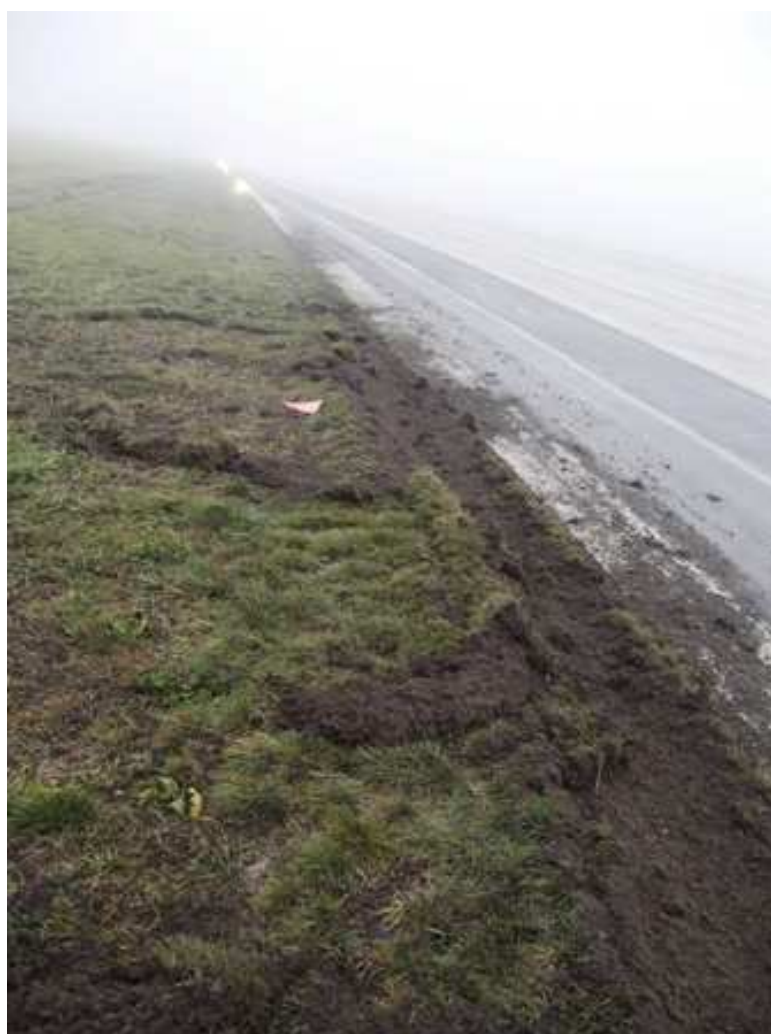
14. Ślad przedniego podwozia na krawędzi drogi startowej.

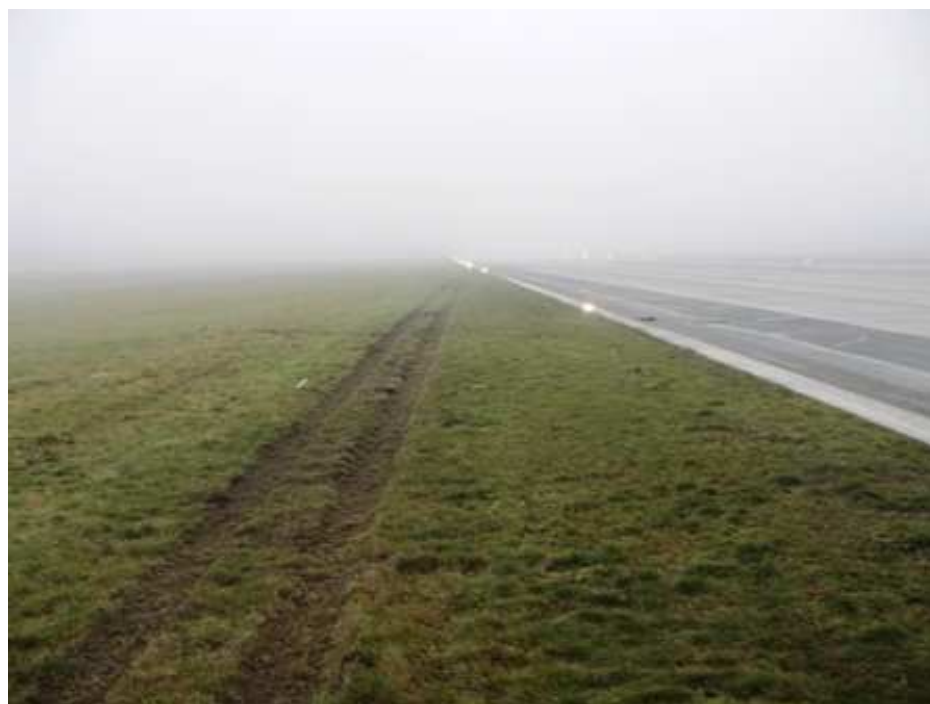
16. Ślad lewego podwozia głównego – powrót samolotu na drogę startową.

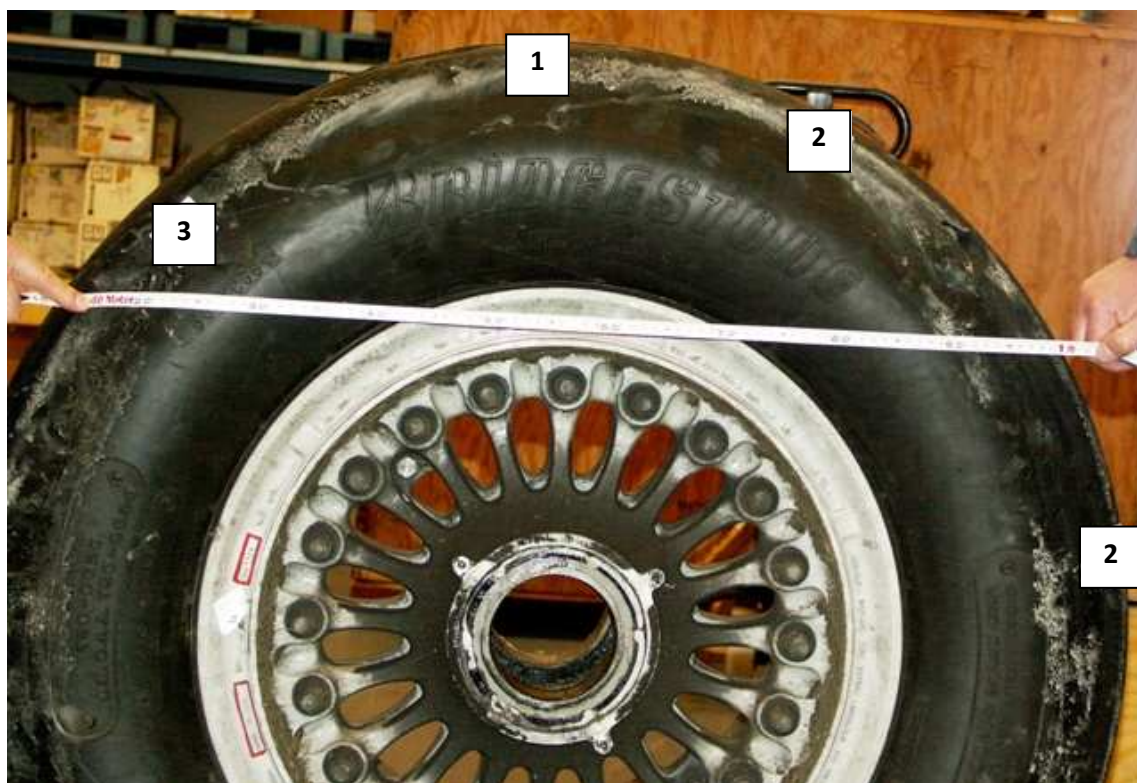
na każdej uszkodzonej oponie znajdują się uszkodzenia eliminujące ją z eksploatacji.

21. Umieszczenie uszkodzeń na MWA 3.

Item No.	ATA Chapter	A.D.D. No. Raised	A.D.D. No. Cleared	Signature	Signature	Signature	Signature	Signature
4E	32							
MAIN WHEEL TIRE				WHEEL HAS BEEN				
W/3 DROO CUT				REPLACED I.A.U. AMT				
WITH PART OF RUBBER				32-45-11				
HISSE NG

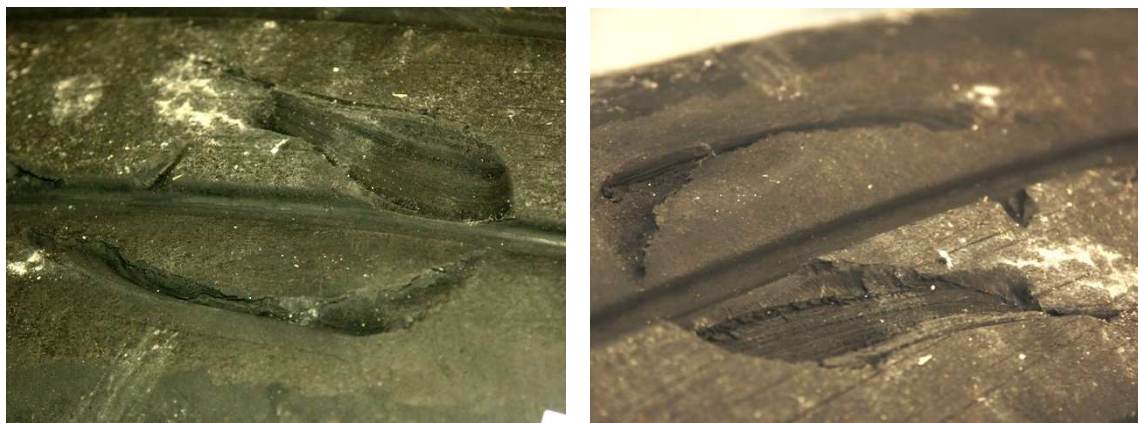
22a, b. Uszkodzenie oznacz. 1 na zdjęciu 21.

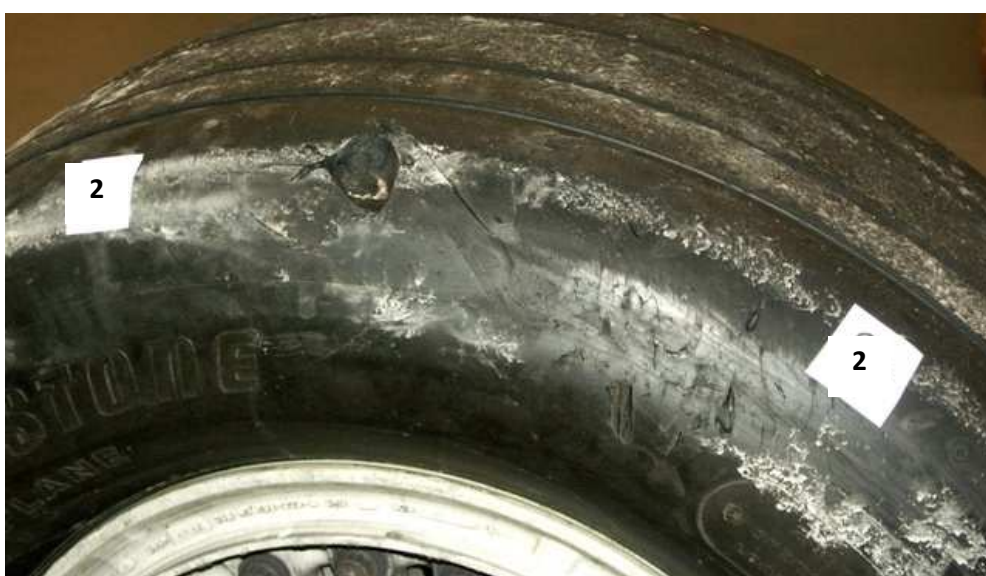
23. Seria uszkodzeń oznacz 2 (szczegóły – następne zdjęcie).

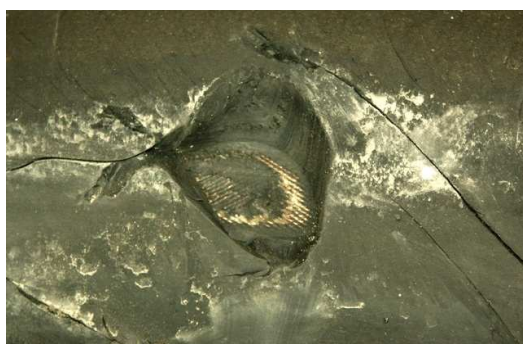
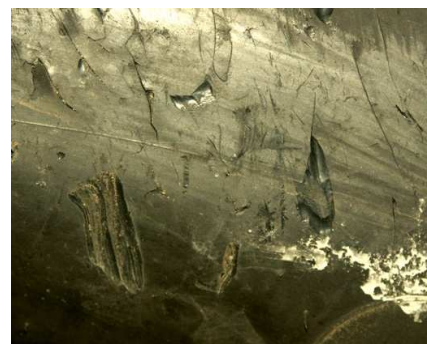
24a, b. Zbliżenie większych uszkodzeń z serii oznacz. 2.

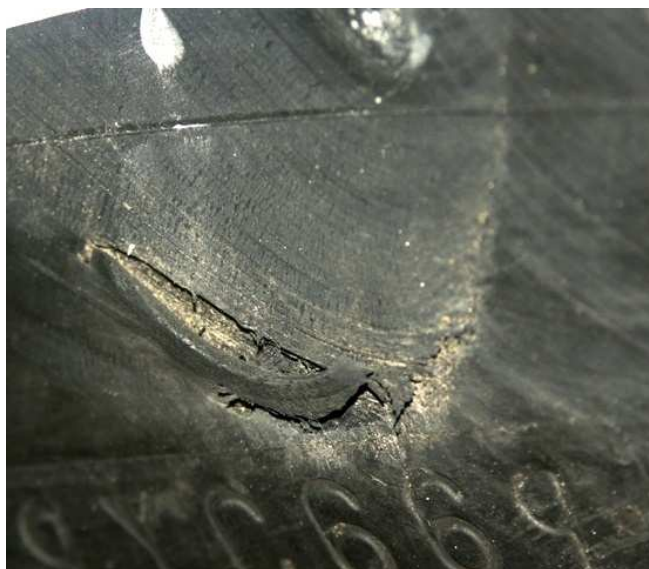
25. Zbliżenie uszkodzeń oznacz. 3.

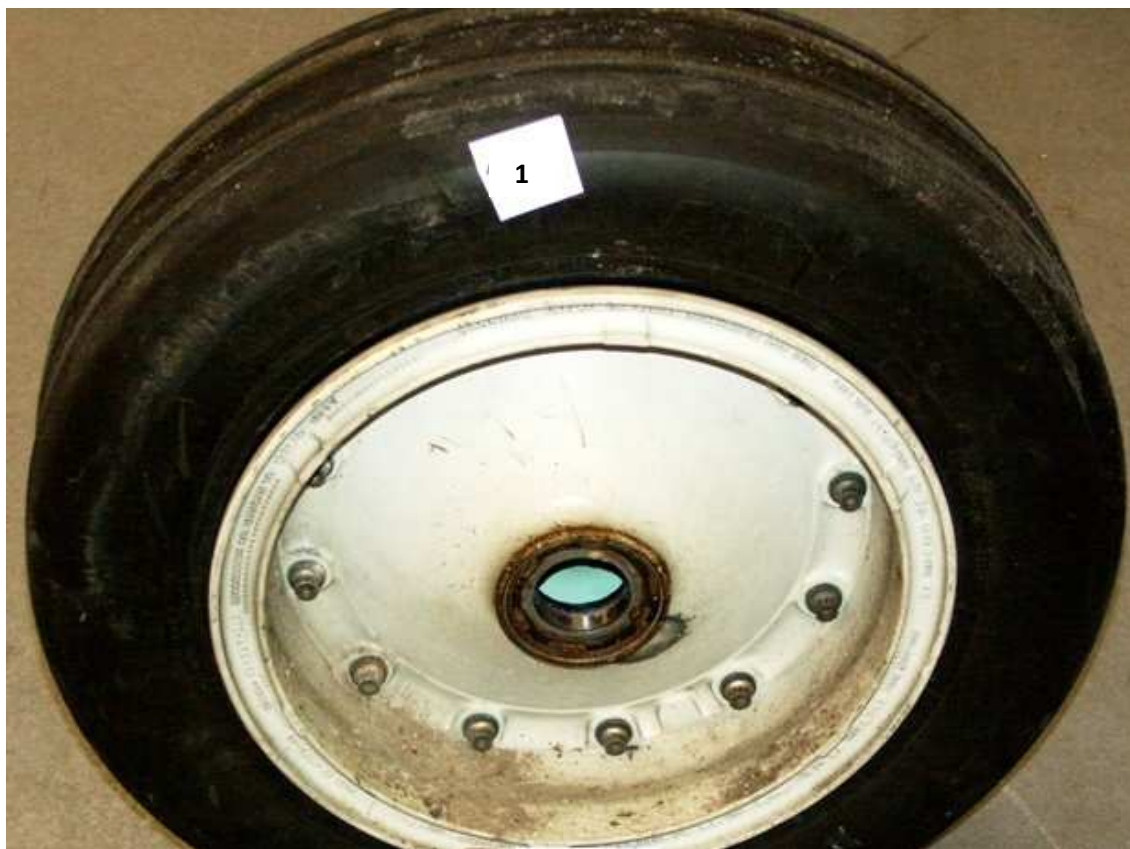
28. Umieszczenie uszkodzeń na NWA 1 (zdjęcie wykonane w hangarze).

Item No.	ATA Chapter	A.D.D. No. Raised	A.D.D. No. Cleared	Signature	Signature	Signature	Signature	Signature
3E	32							
NONE LIKEELS FOUND				LIMBERG HAS BEEN				
DROO CUTS WITH PART				REPLACED I.A.U. AMT				
OF RUBBER HISSE NG				32-45-21

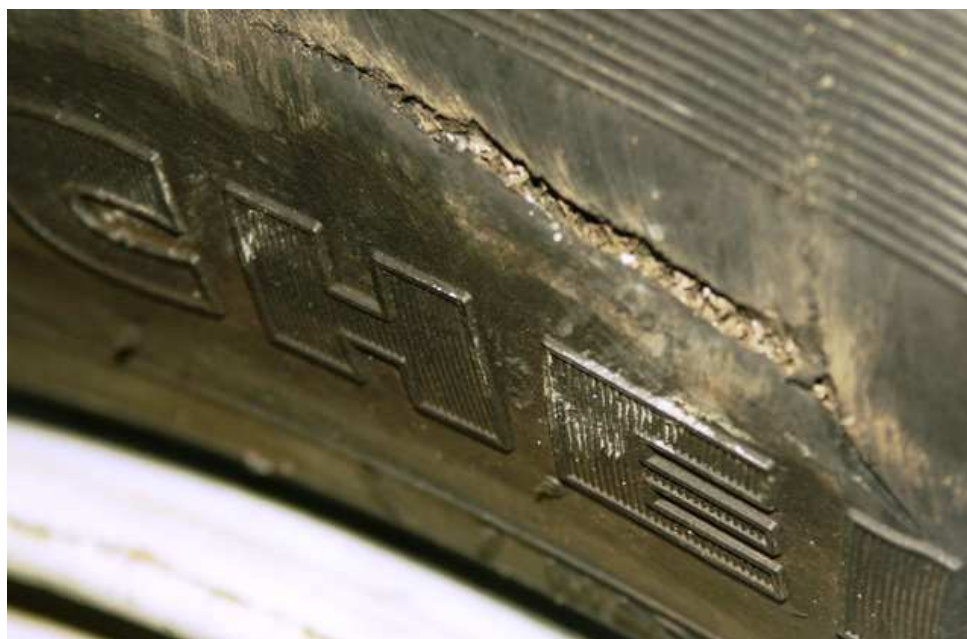
29. Zbliżenie uszkodzenia z oznacz. 1.

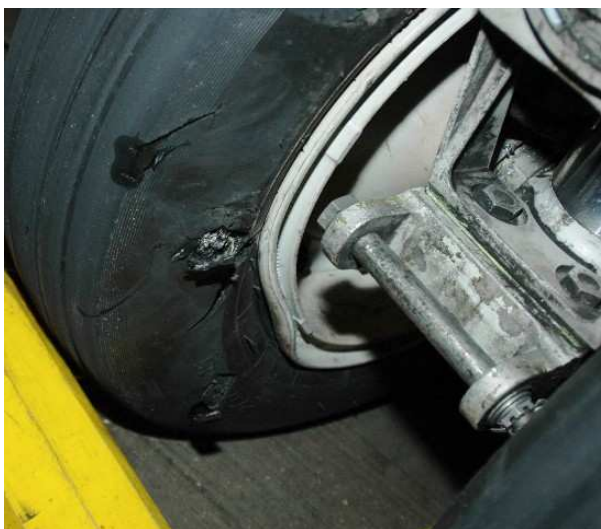
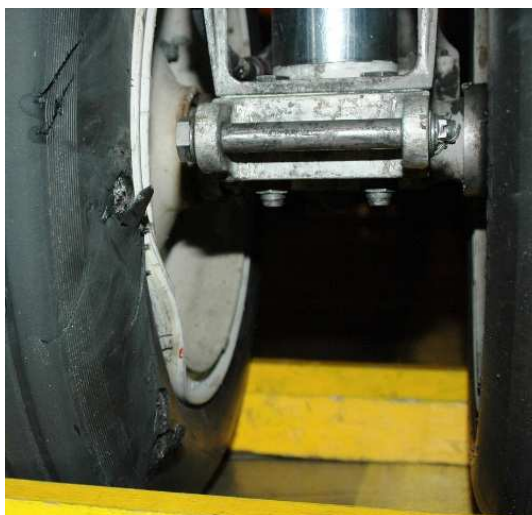
31a, b. Zdjęcie koła NWA 2 wykonane zamontowanego na samolocie. Wyraźnie widoczne uszkodzenia opony i felgi, których nie można nie zauważyć przy przedlotowym przeglądzie samolotu.

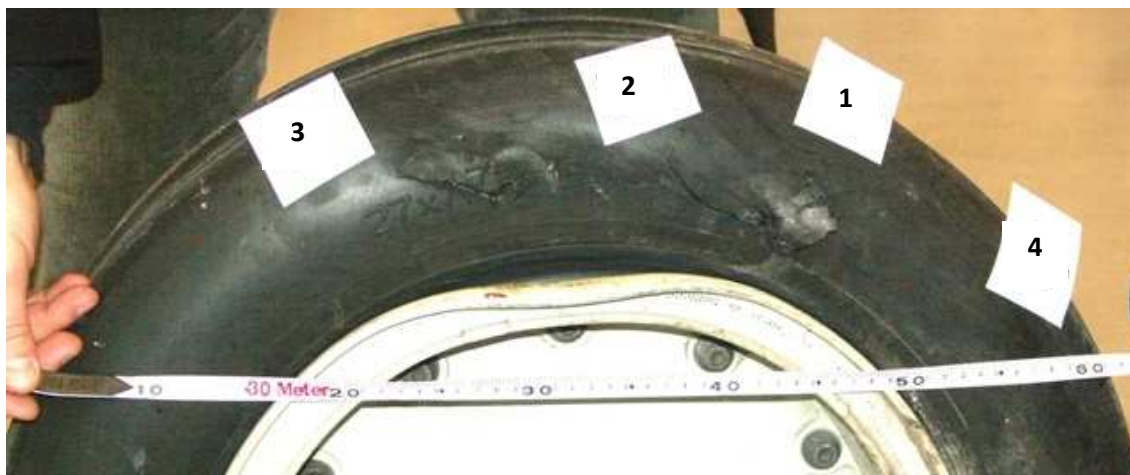
32. Umieszczenie uszkodzeń na NWA 2 (zdjęcie wykonane w hangarze).

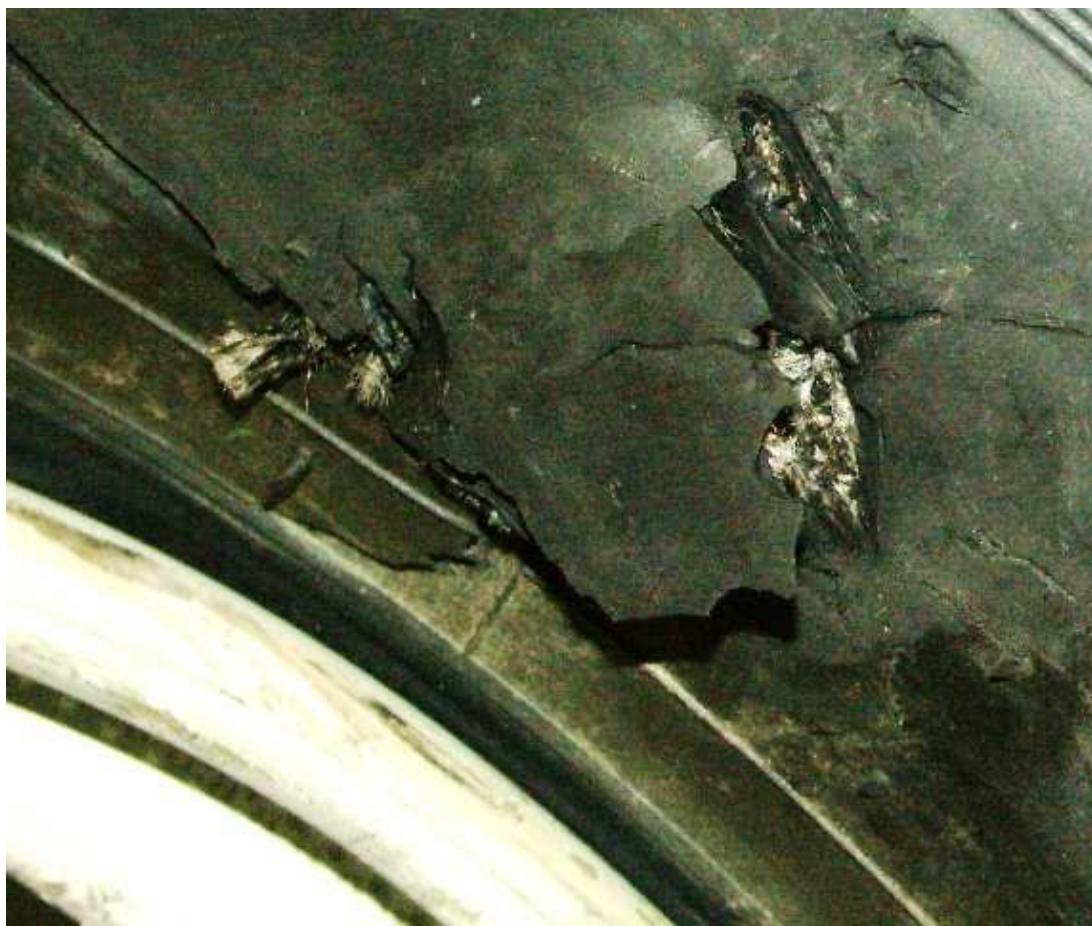
33. Zbliżenie uszkodzenia z oznacz. 1.

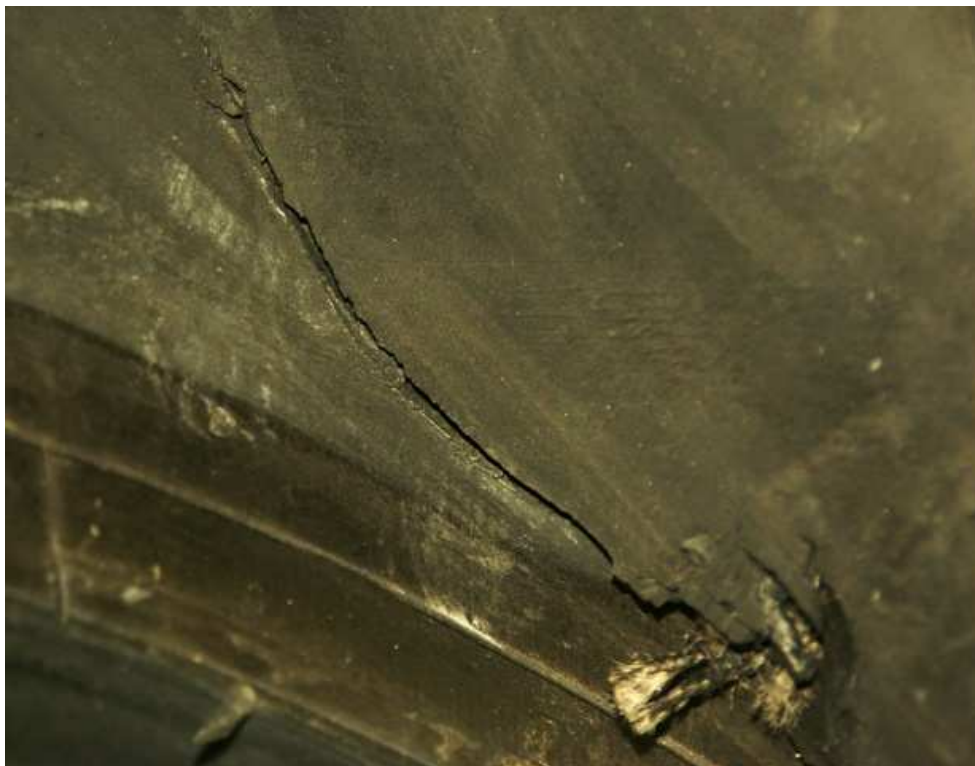
34. Zbliżenie uszkodzenia z oznacz. 2.

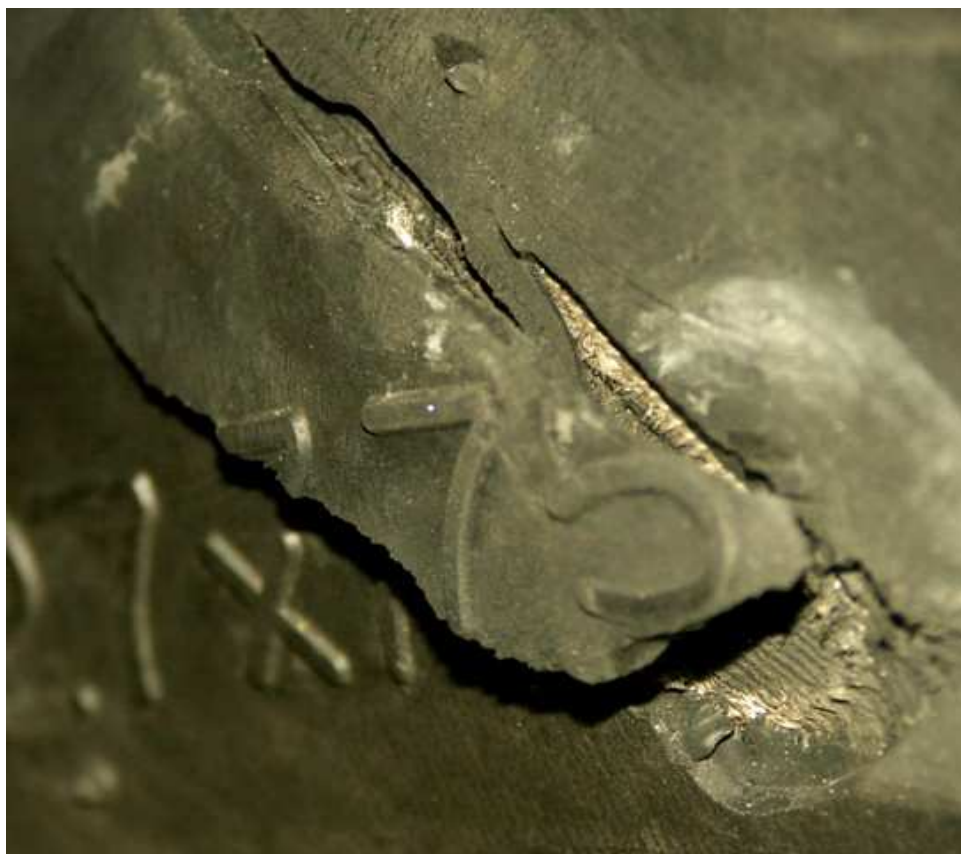
35. Zbliżenie uszkodzenia z oznacz. 3.

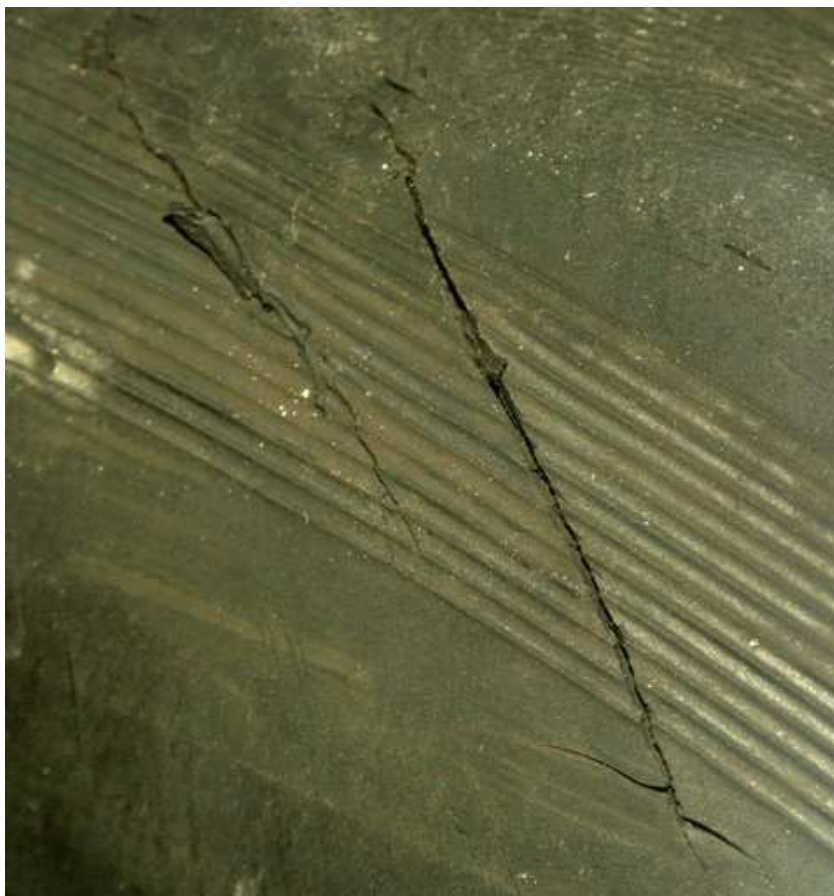
36. Zbliżenie uszkodzenia z oznacz. 4.

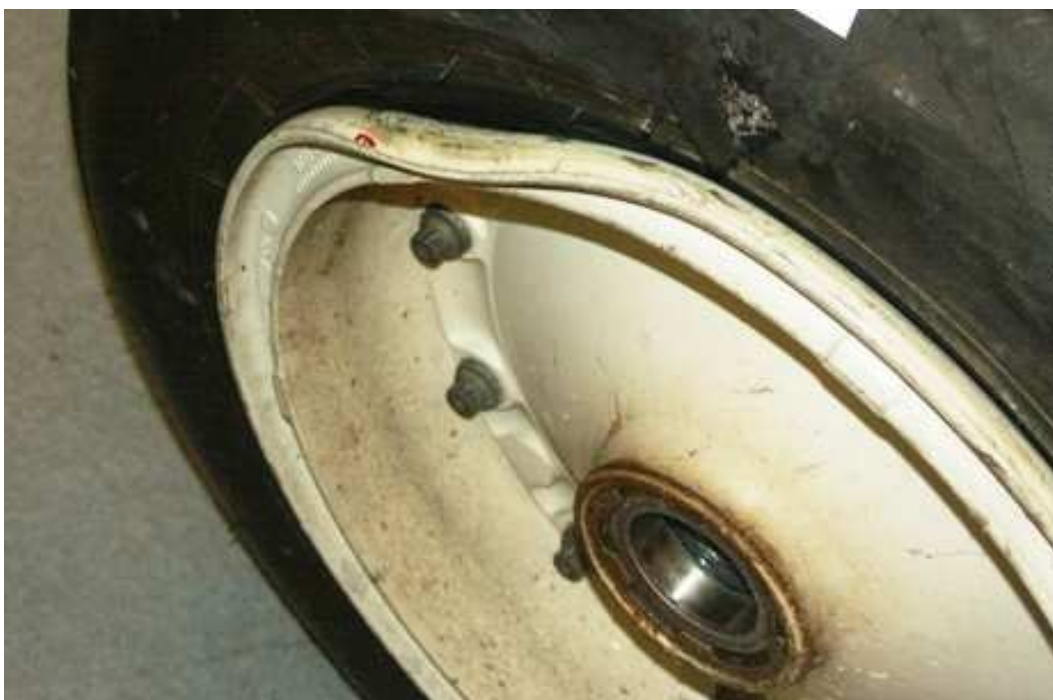
37. Zgięta felga NWA 2.

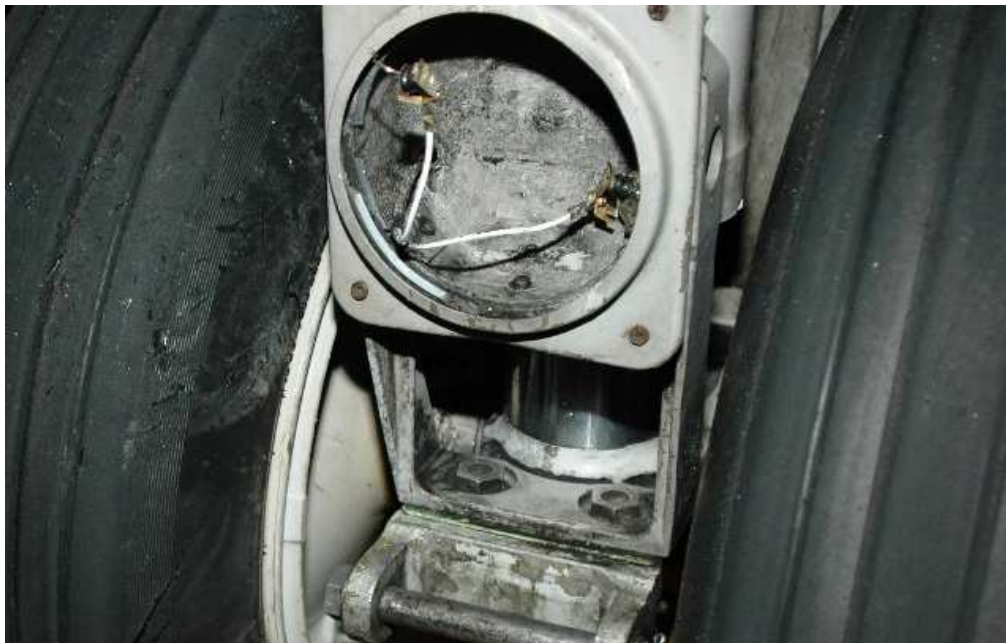
38. Zdjęcie reflektora kołowania wykonane na samolocie w po lądowaniu w WAW. Wyraźnie widoczne uszkodzenia, których nie można nie zauważyć przy przedlotowym przeglądzie samolotu.

Item No.	ATA Chapter	A.D.D. No. Raised	A.D.D. No. Cleared	Signature	Signature	Signature	Signature	Signature
6E	35							
NONE TAXI LIGHT				TAXI 3212 REPLACED				
FOUND BROKEN								
CERTIFICATE OF WORK (COW) - This form is to be completed by the maintenance personnel who performed the work specified on this form. It is to be used to certify that the aircraft is ready for flight. It is to be completed in accordance with the requirements of the applicable regulations.								
COMPONENT CHANGE DETAILS								
Defect Item No.	Position	Part Number	Serial No. OFF	Serial No. ON	Batch Number			
2E	1	2-1554	2096	2121	445 562			
4W	2	2-1554	2122	2226	445 562
