MINISTRY OF INFRASTRUCTURE
STATE COMMISSION ON AIRCRAFT ACCIDENT INVESTIGATION

FINAL REPORT

Occurrence No: 619/10

Aircraft: F-100, D-AGPH

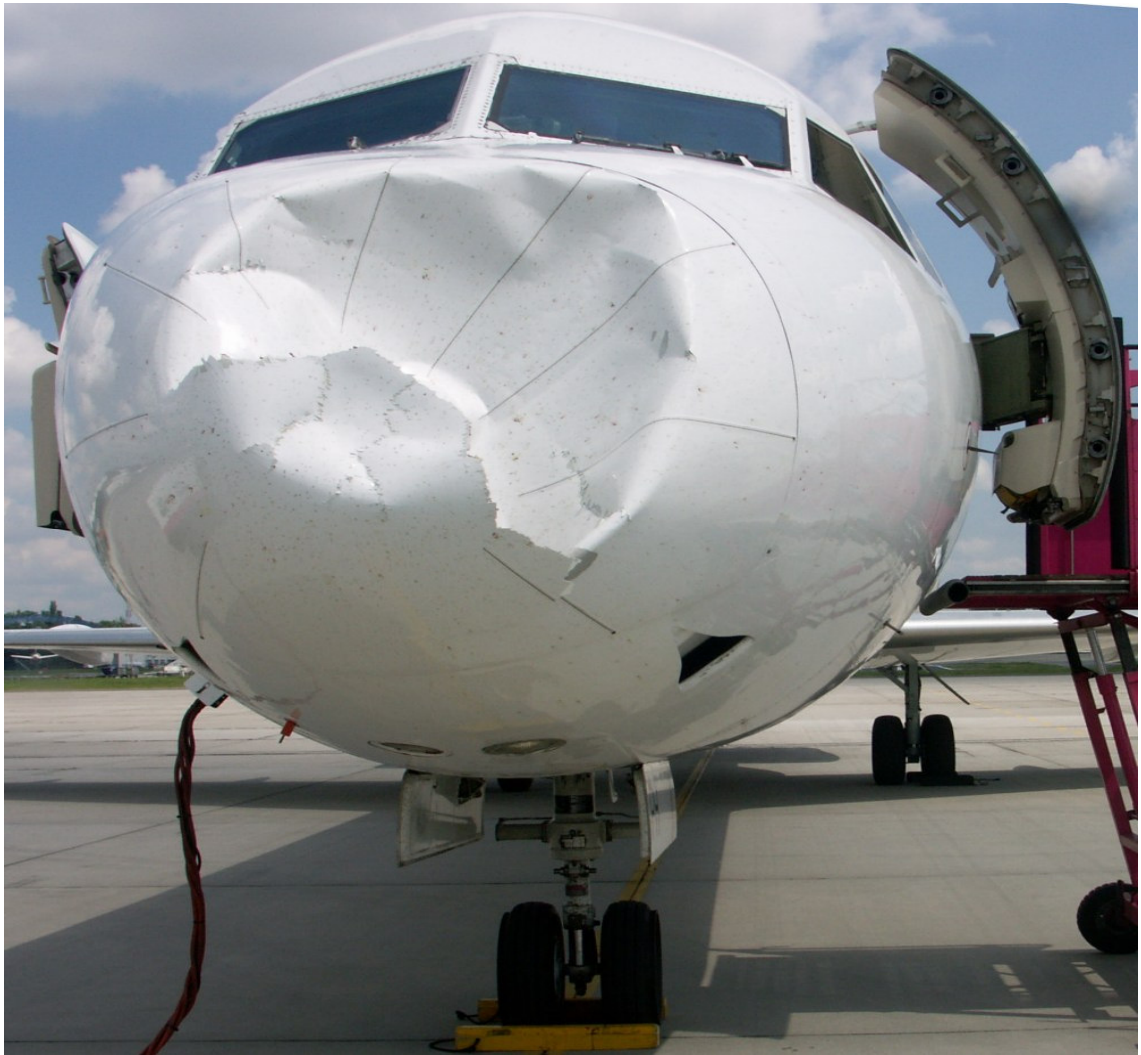
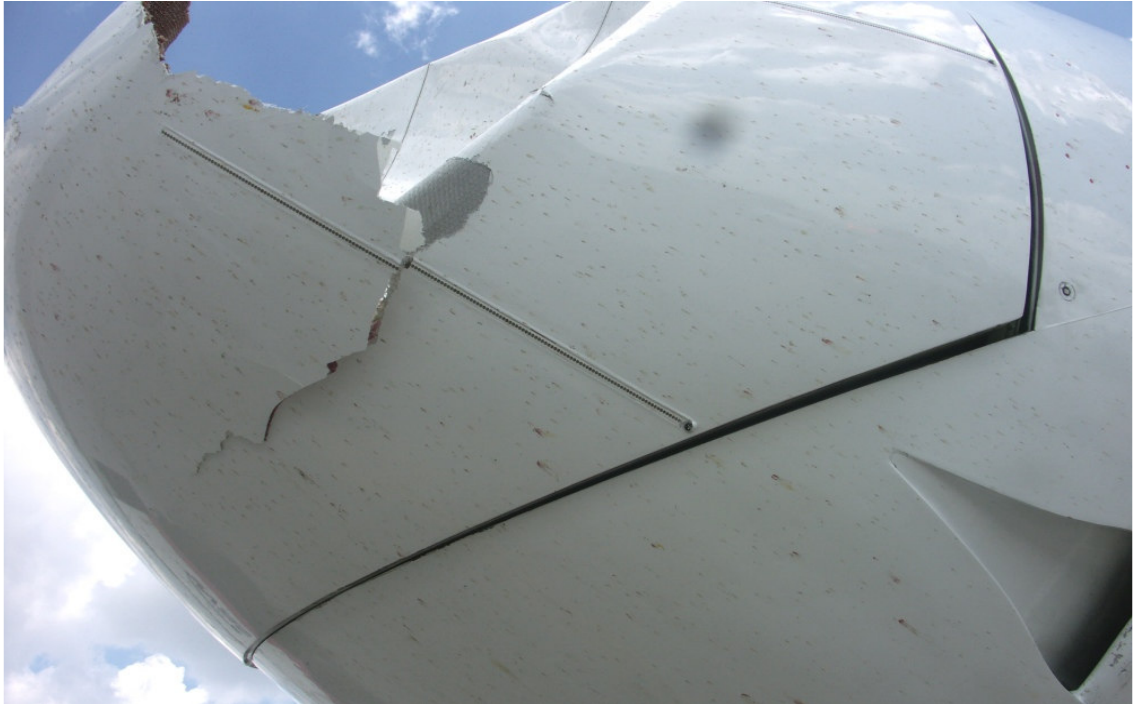
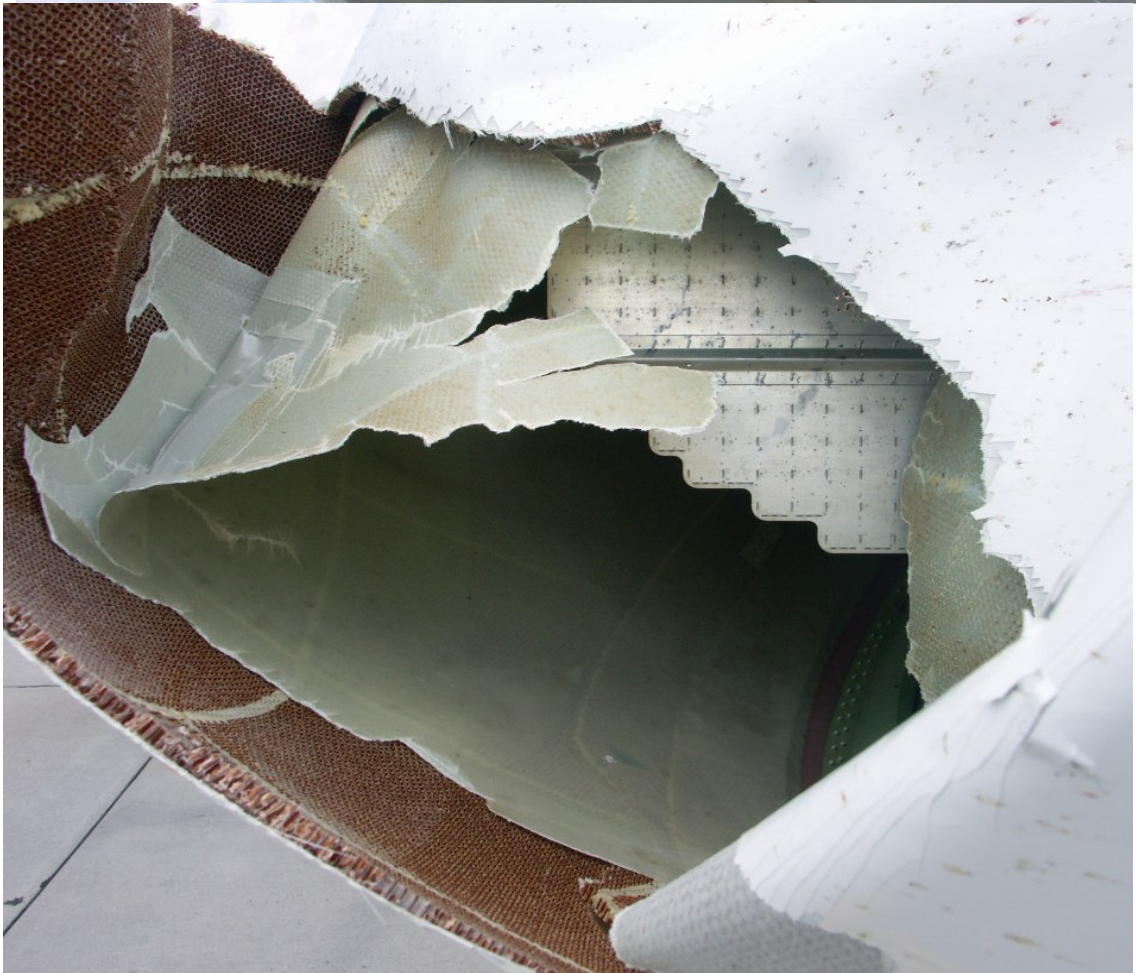
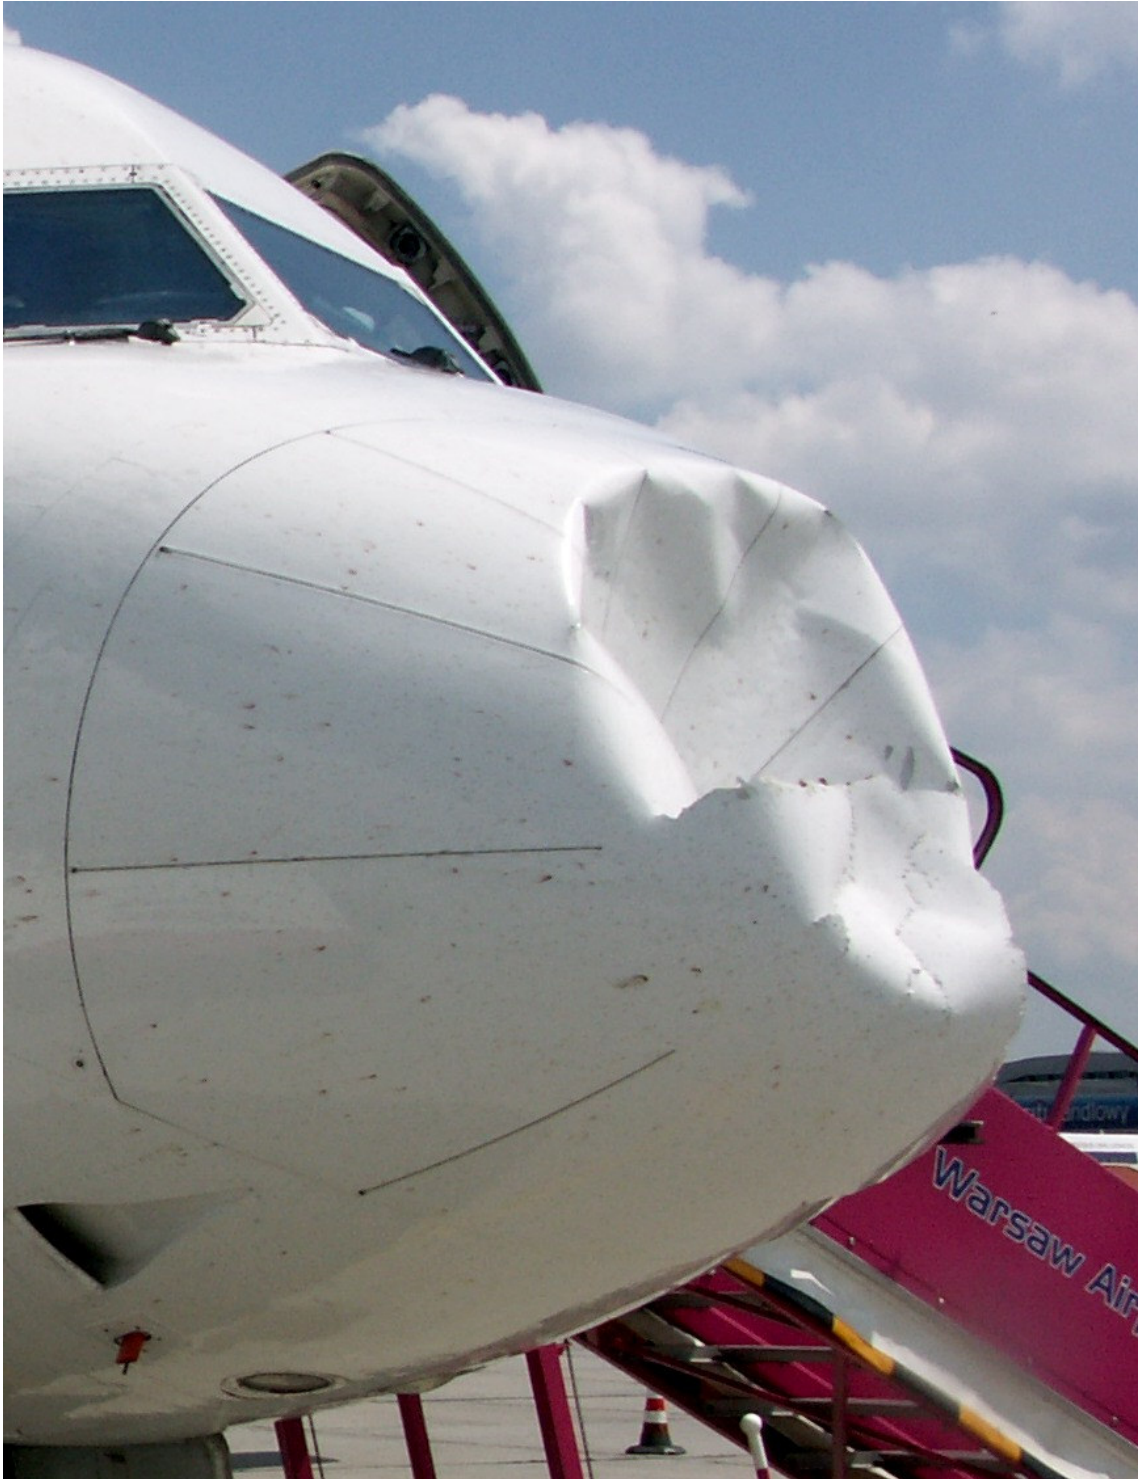
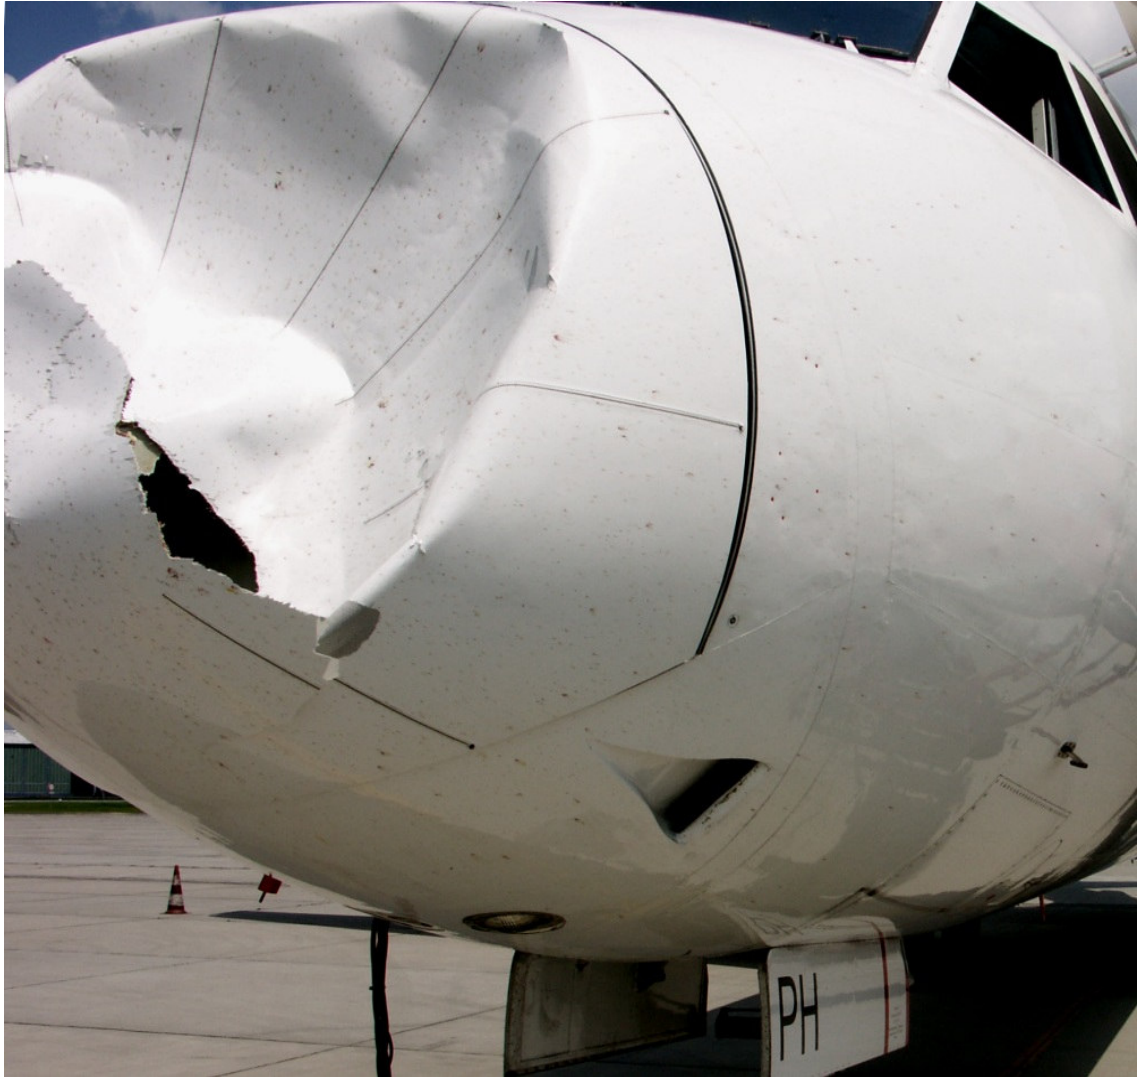
The radome in its central part was damaged and moved in the down left direction.

- *(...) no other structural damages except to the Radome, which was deformed and perforated;*
- *the inner layer of the material is delaminated of an area from 66-70% of the Radome;*
- *there are no signs of bird strike or other kind of impact traces;*
- *the mentioned IAS problems on L/H EFIS could not be reproduced on ground and were related to the turbulence caused by the damaged Radome;*
- *the WX antenna had slight chafing marks on the plate and three cables (...).*

The described damages are shown on the following photos made by the Commission members after their arrival at Warszawa - Okęcie aerodrome.

The described damages are typical of implosion.

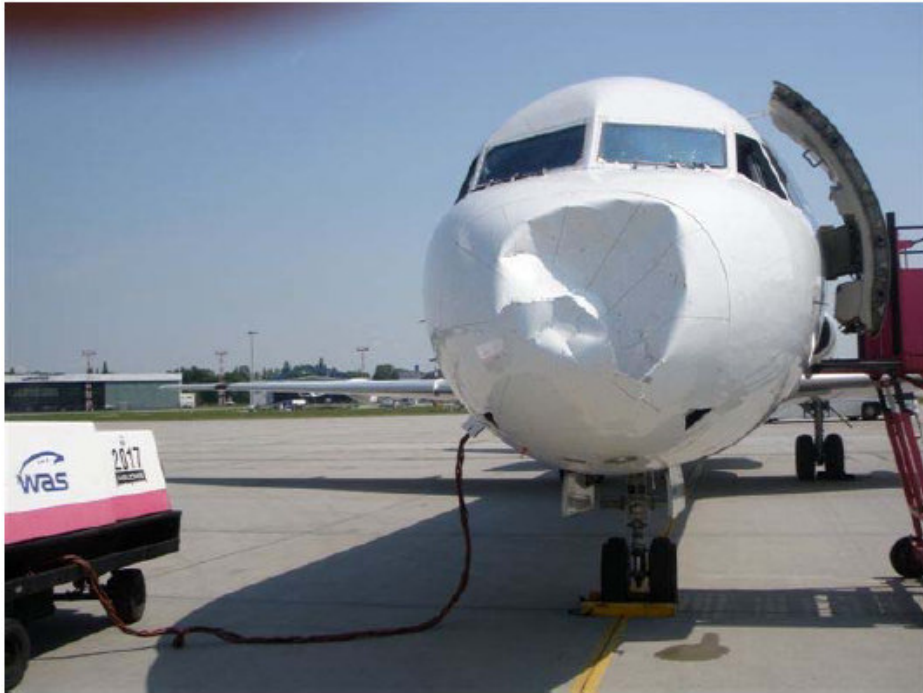
General view of the collapsed radome
Picture 1

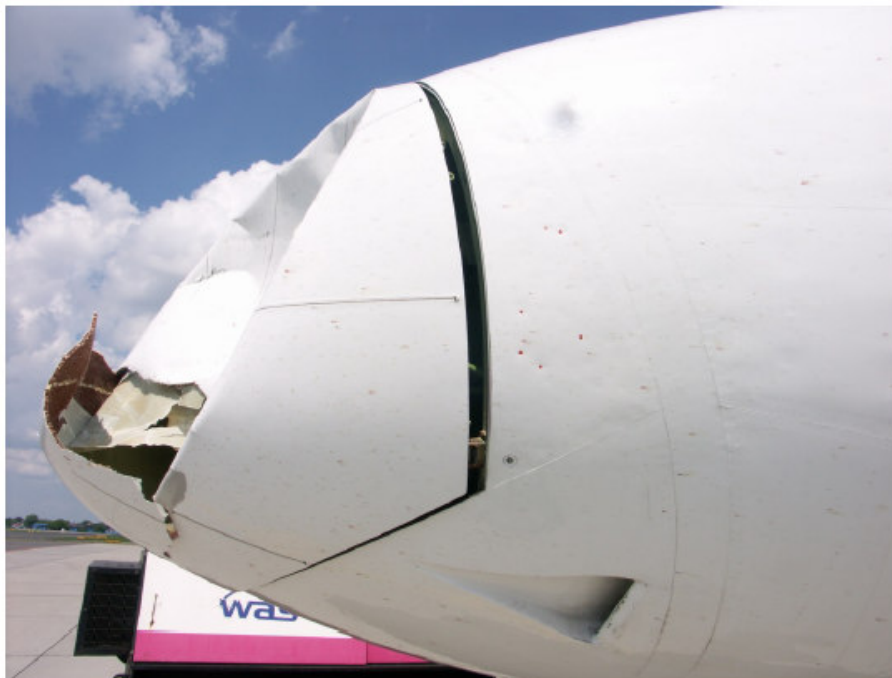
General view of the collapsed radome
Picture 2

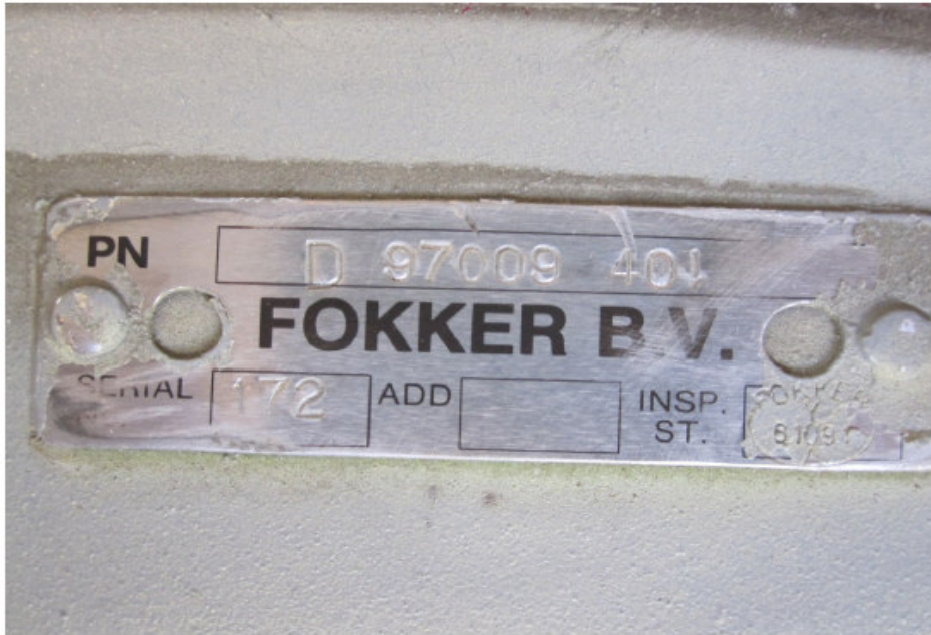
1. The radome has been identified by two different part numbers. One part number is located on a Fokker B.V. identification plate riveted on the radome frame and indicates D97009-401 and serial number 172. The other part number is applied by ink and indicates D97009-401P and serial number 1038AL repaired by NORDAM Texas on October 16, 2000.
Refer to pictures 3 and 4.
This part number is unknown to Fokker Services. A brief investigation of the repair data of the radome revealed that the radome was released after repair under part number D97009-401P (refer to chapter 6).

Fokker Identification Plate
Picture 3

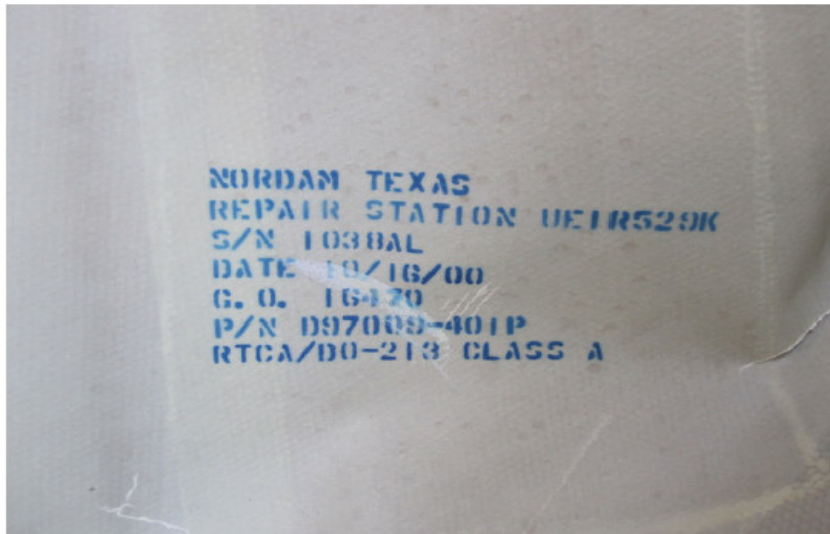
Nordam Identification Marking
Picture 4

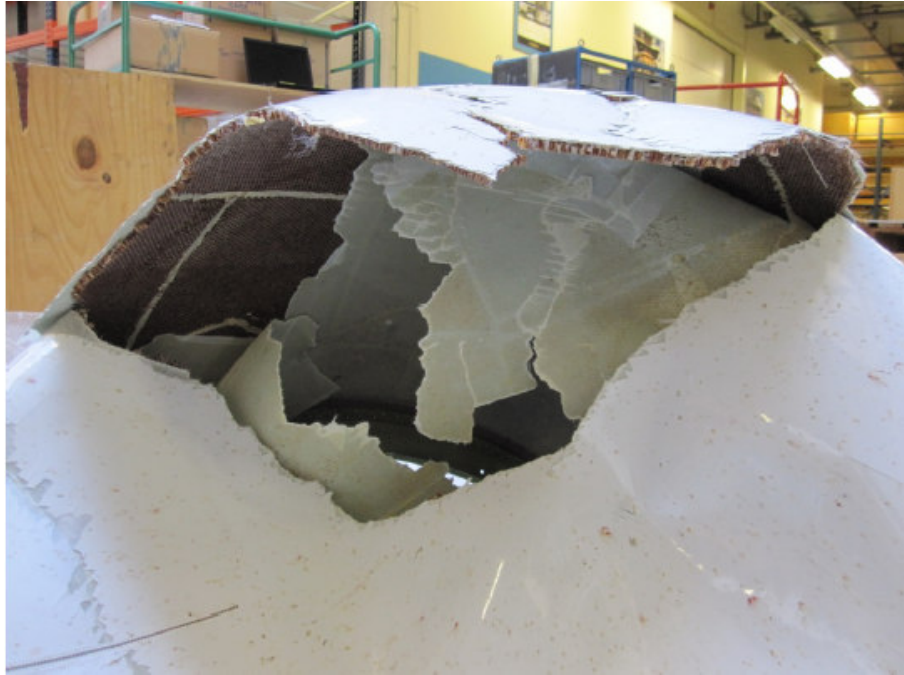
2. No signs of impact damage have been found (like e.g. birdstrike damage).
3. It appears that the core material (honeycomb) was still intact on the places where the glassfabric layers were attached found loose from to the honeycomb, hardly leaving showing any traces of bonding resin. Usually traces of bonding resin are an indication of good adhesion. So Fokker Services expected to see more traces or marks of the honeycomb in the resin attached to the disbanded glassfabric layers. Refer to pictures 5 and 6.

*Details honeycomb core and inner skin plies
Picture 5*

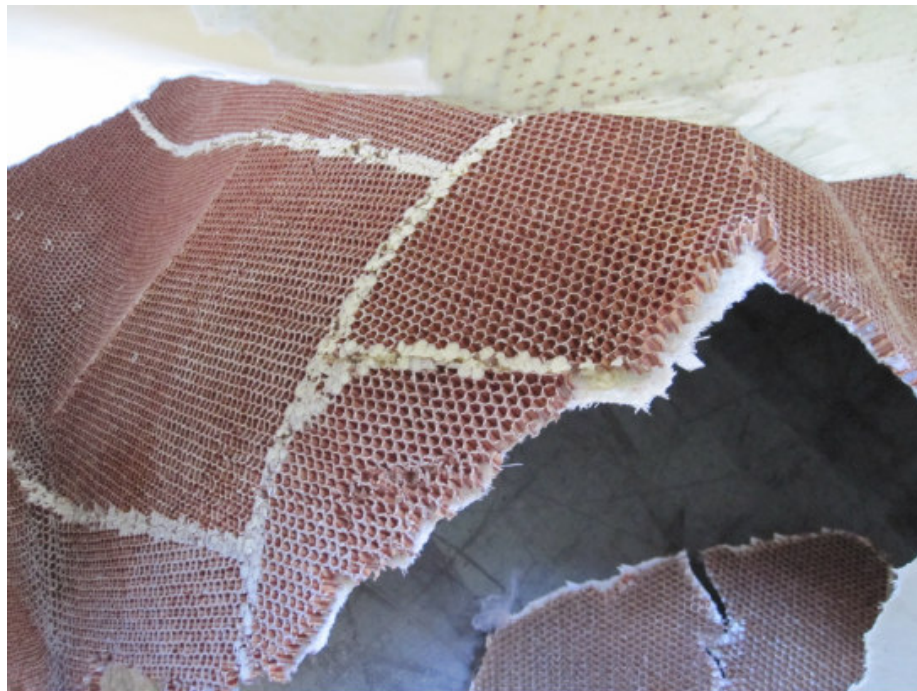
*Details honeycomb core and inner skin plies
Picture 6*

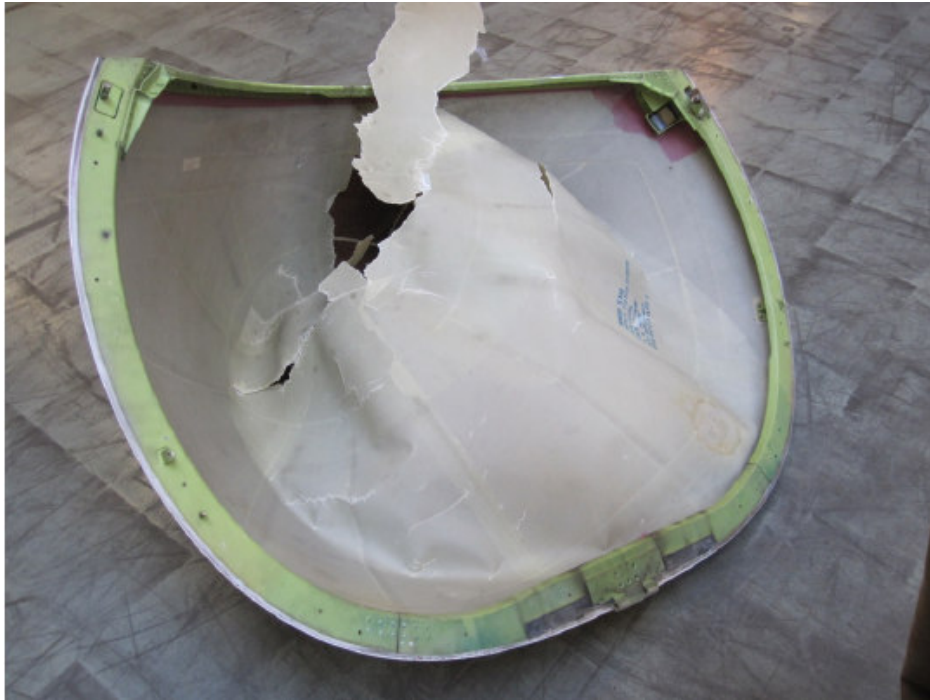
Delaminated inner plies
Picture 8 (picture number according to the original)

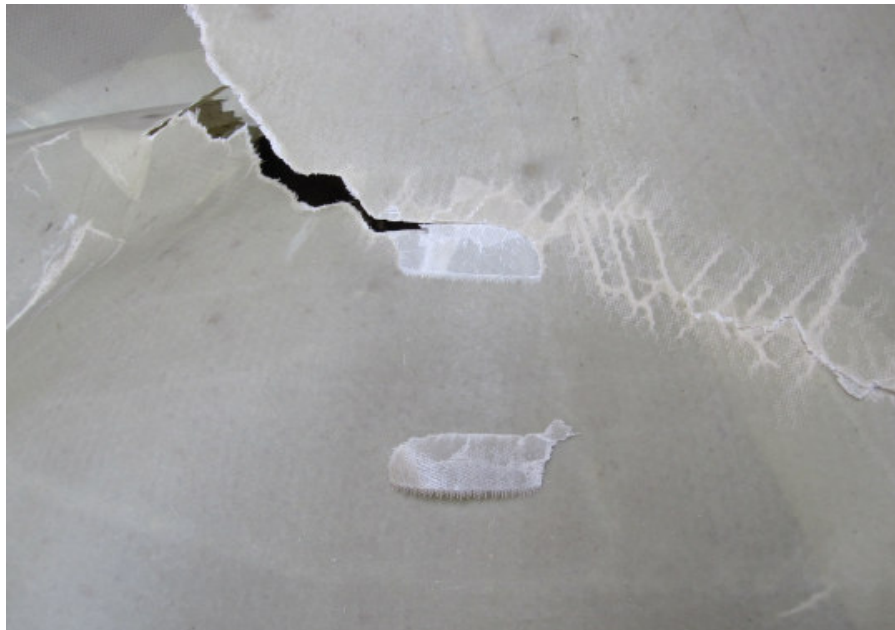
Delaminated inner plies
Picture 7 (picture number according to the original)

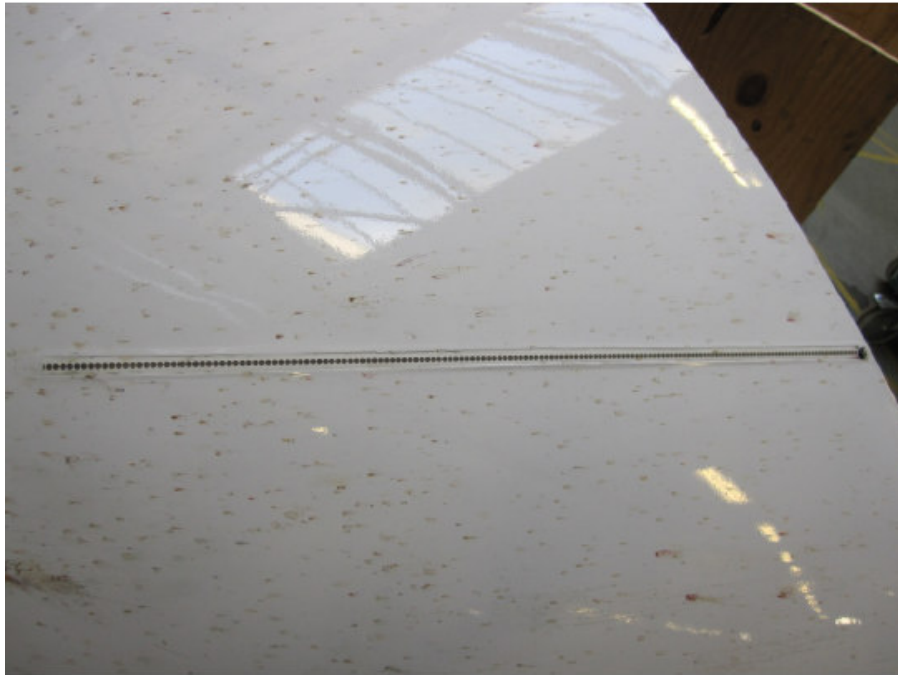
*Deviating lightning diverter strip
Picture 9*

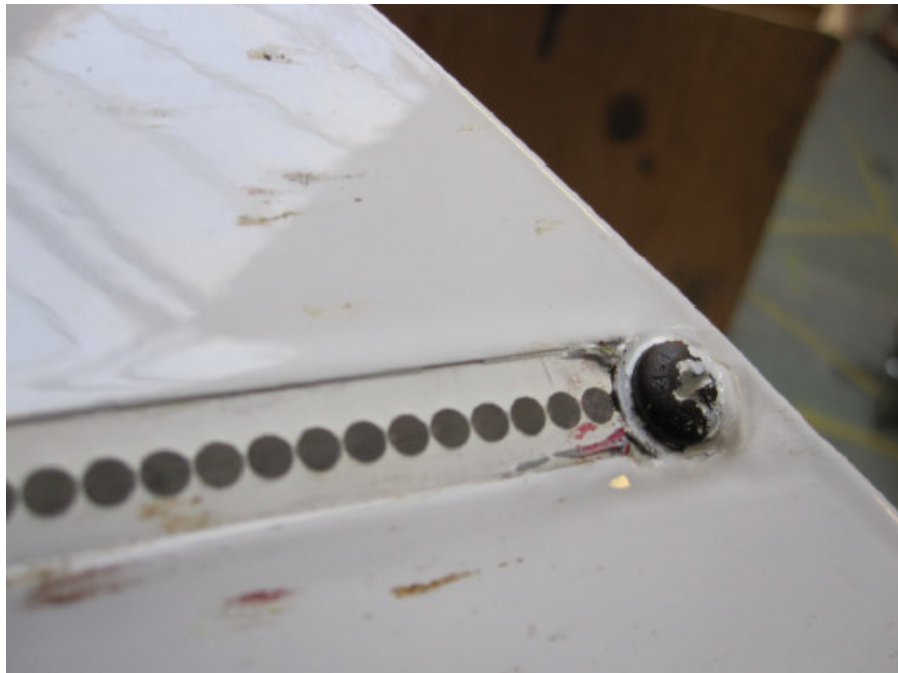
*Deviating lightning diverter strip grounding/bonding
Picture 10*

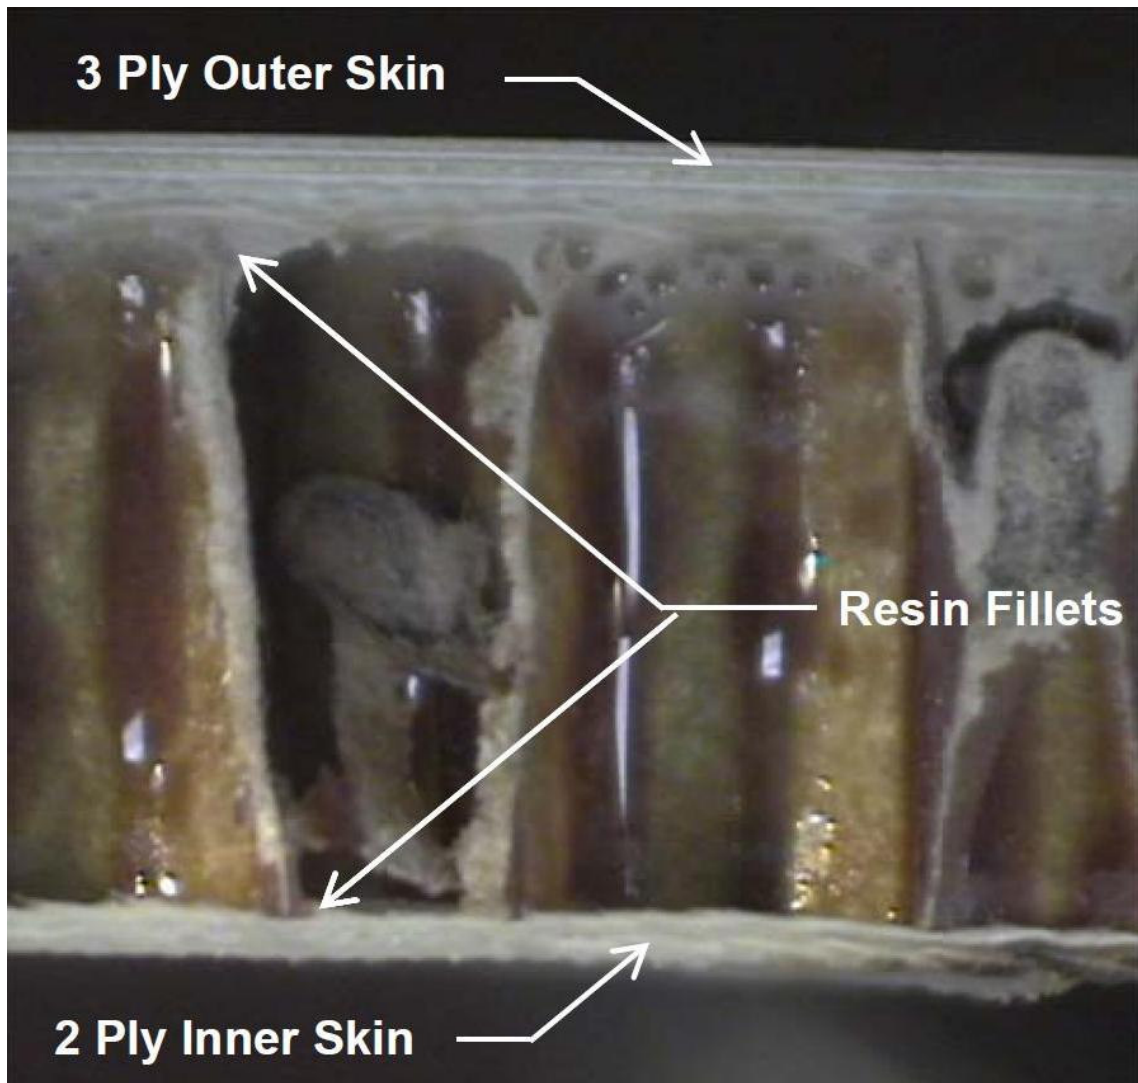
Figure 4

Contact Air Sample #2 Skin Resin Fillets to Core

Micro photographs were taken of the cross section from the Contact Air SN 172 Radome. This cross section shows the outer skin to core interface, inner skin to core interface and

the degree of resin fillets for both inner and outer skins. The image illustrates that bond pressure and resin fillets were adequate. The illustration does show that filleting was less on the inner skin than the outer skin however, the fillet size is typical for for a bonded structure of this type. Resin content is directly proportional to the number of plies in a composite layup. In this case the outer skin (in the area examined) contained three plies and the inner skin was constructed of two plies.

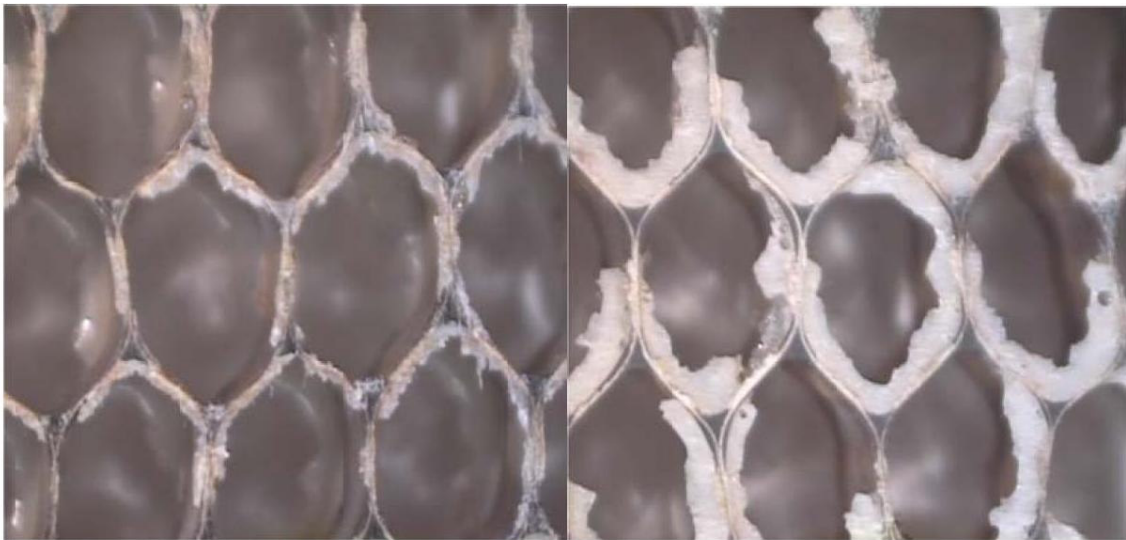
Inner Skin core cell edge with bonding resin

Outer Skin core cell edge with bonding resin

Figure 5 and 6 above show the resin residue remaining on the core cell edges. The residue is directly related to the resin fillets/prepreg plies present during the cure cycle of a bonded structure. The darker material in the classic honeycomb shape represents honeycomb core, the lighter material represents resin from the fiberglass/epoxy prepreg skin of the radome. The amount of resin deposited on both surfaces of the honeycomb cell edges are typical of what is expected with a sufficiently bonded honeycomb core to fiberglass/epoxy prepreg skin bond.

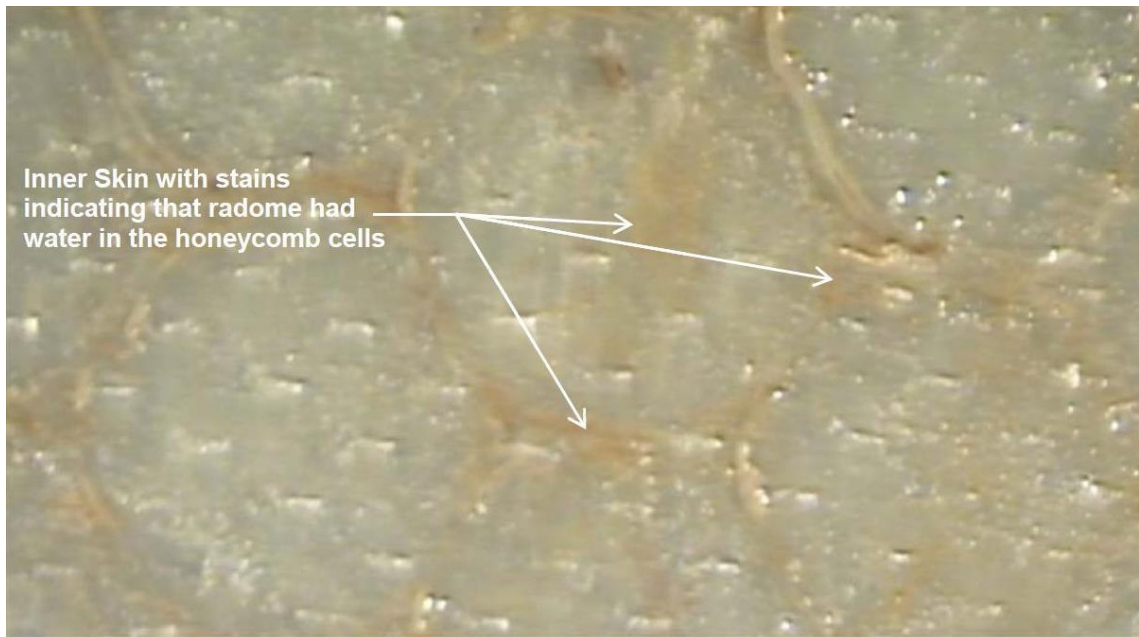
Figure 9
Contact Air Sample # 1, View Looking In
Nose Section (Failure Area)
Pattern Left by Honeycomb Material

The stained areas of the inner skin illustrated in Figure 9 shows evidence of moisture being present in the core cells. This is typical of most of the areas examined in the delaminated areas.

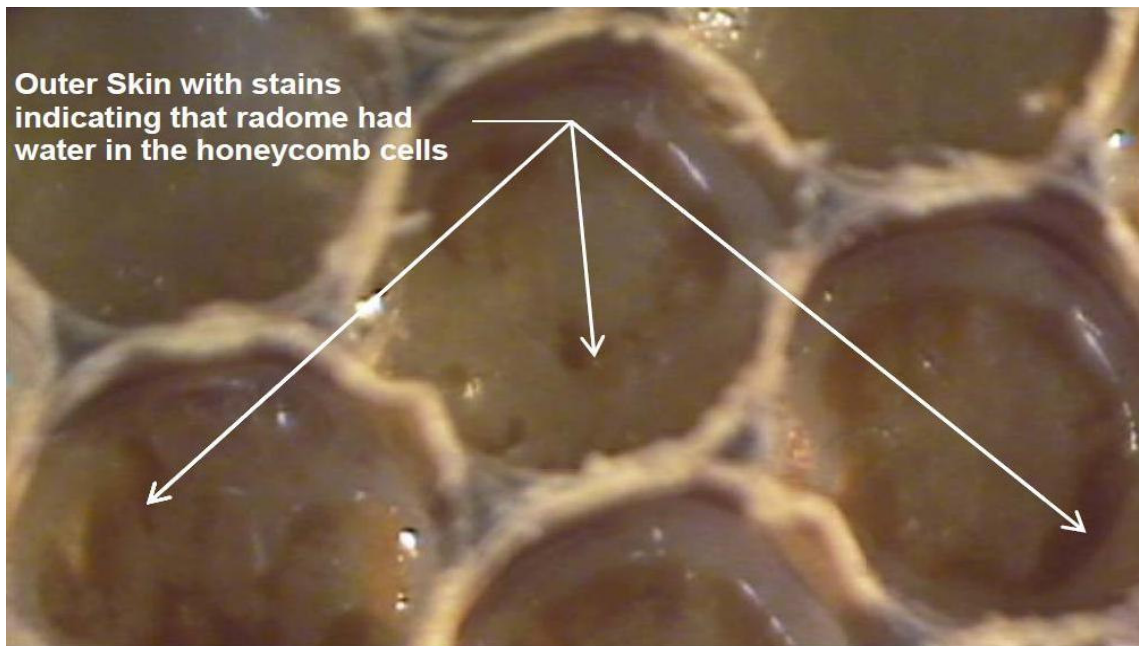
Figure 10
Contact Air Sample #3, View Looking out
Nose Section (Failure Area)
Stains Left by Moisture in the Radome

An area of the radome which appeared to be still bonded after the incident was removed for analysis. When the inner skin was removed from this sample water poured out of the honeycomb cells.

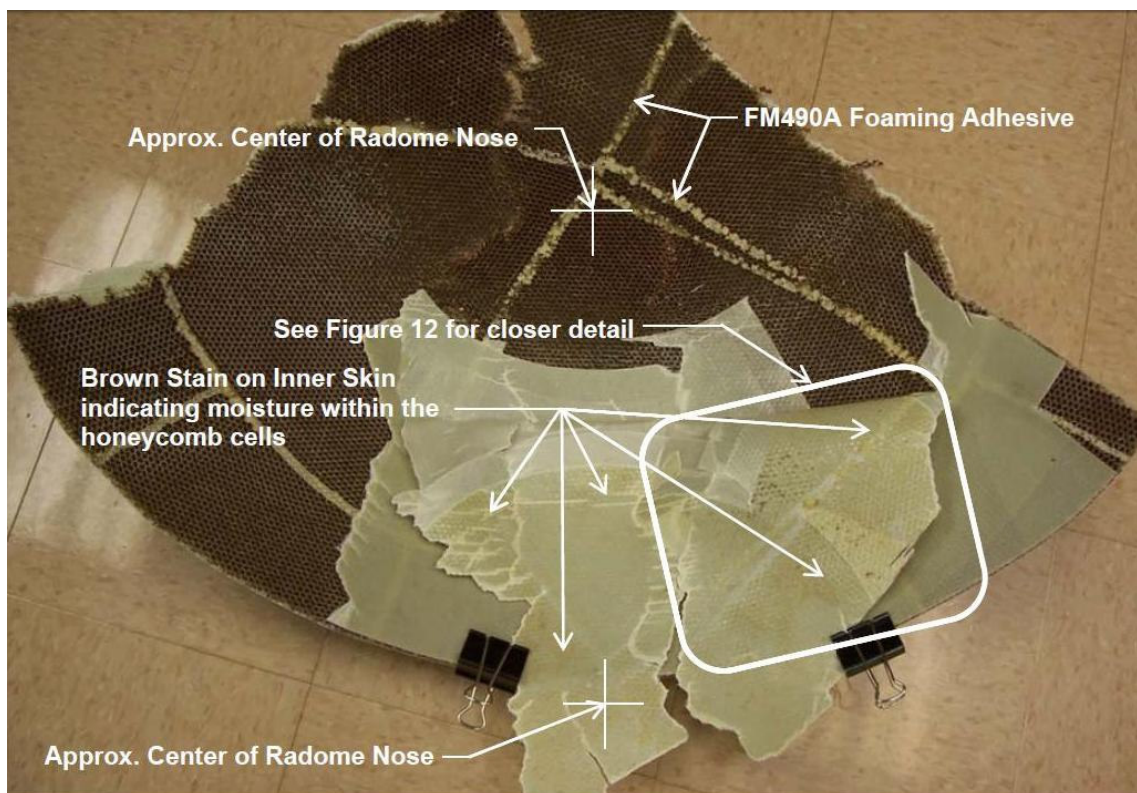
The initial failure area (Figure 11) shows the inner surface of the radome with the failed inner skin pulled back to reveal the honeycomb core. The inner skin exhibited residue that was left behind from trapped moisture. This evidence can be seen in three of the four quadrants as a light brown staining. The color of the staining is due to moisture washing off phenolic resin dust from the Nomex® honeycomb cell walls. Figure 12 is a closer view of the inner skin surface showing the light brown stain over a large area of the inner radome skin. The failure modes observed range from resin to skin; resin to core failure and in some cases core failure at the inner skin to honeycomb interface. These failures were likely caused by thermal cycling freeze/thaw of entrapped moisture inside the cells of the radome core causing the bonded structure to delaminate or become disbonded.

Figure 11
Contact Air Sample #1, View Looking Fwd
Nose Section (Failure Area)
Stains Left by Moisture in the Radome

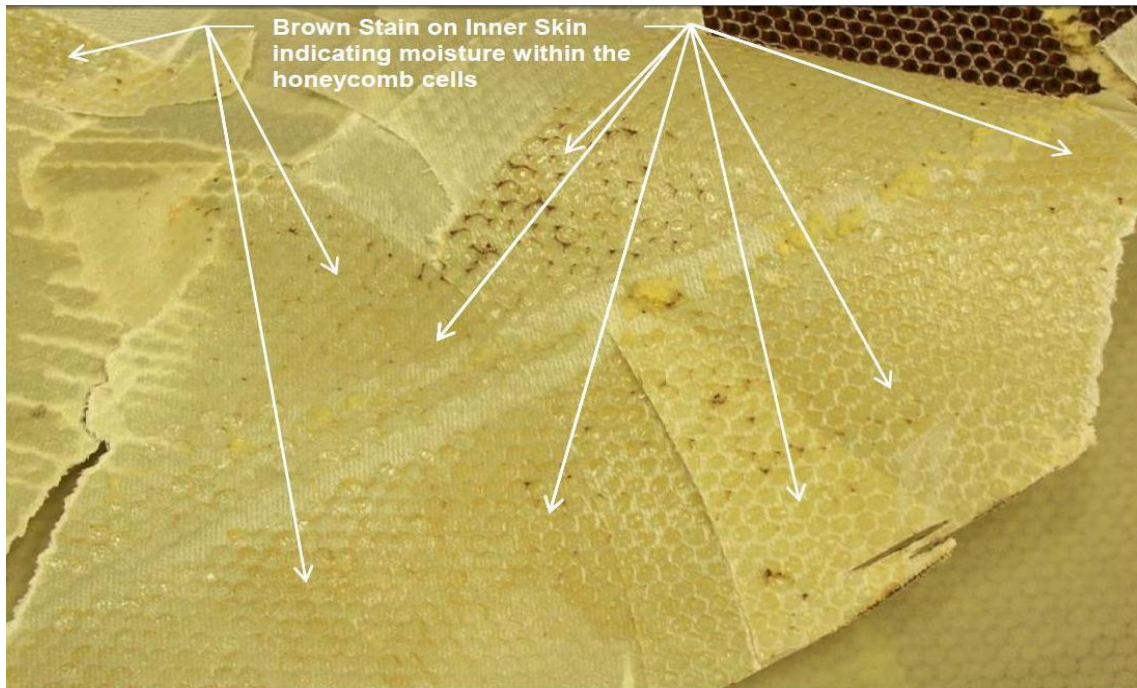
Figure 12
Contact Air Sample #1, View Looking Fwd
Nose Section (Failure Area)
Stains Left by Moisture in the Radome

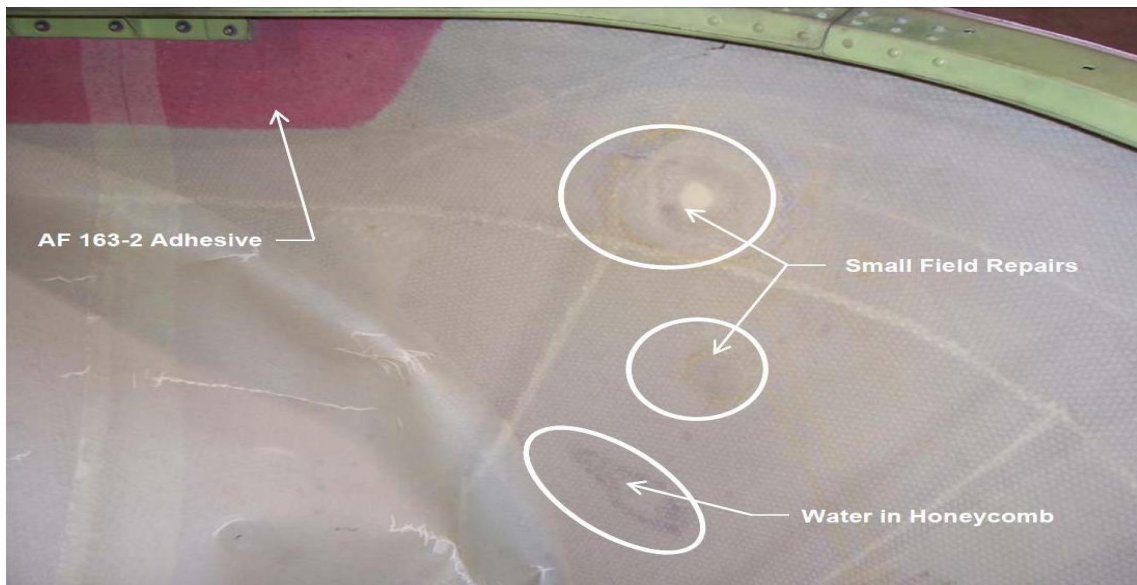
Figure 13
Contact Air Photo of Moisture
Visible through the Inner Skin

Figure 13 shows subsequent repairs post the NORDAM (Texas) repair in 2000. Also there is a third area of concern that shows water in the honeycomb which can be seen through the inner skin. The white area in the middle of the water has delaminated within the skin plies but the area that was wet was still bonded. This section was removed from the radome. During the removal of the inner skin from this area water ran out of the honeycomb cells on to the work surface.

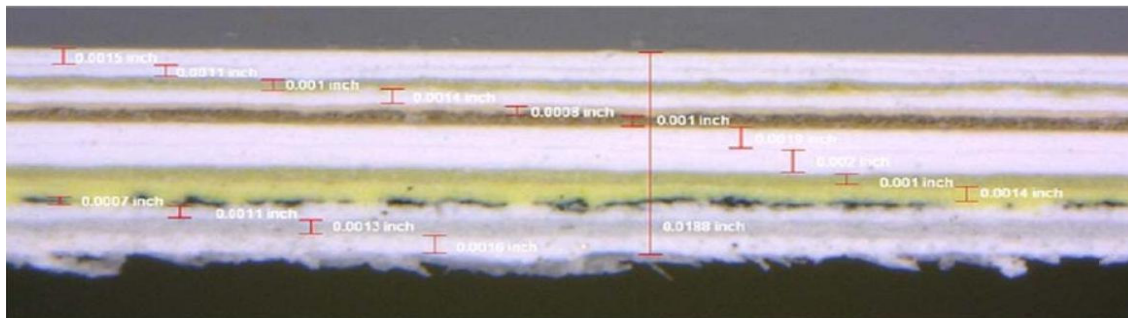
Figure 14

Contact Air Paint Sample
Cross Section of Painted Surface

Coatings over the surface of the Radome appeared to be in good shape; however, we observed multiple layers of what appears to be paint and fillers on this radome. No attempt was made to identify each layer, however, the overall thickness measured about 0,019 inch.

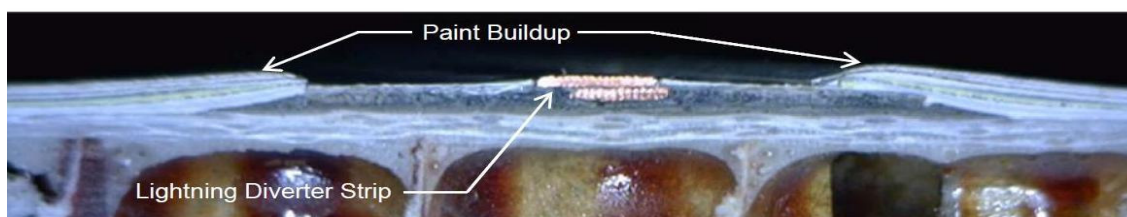
Figure 15

Contact Air Paint Sample
