## Report A-004/2011

Accident occurred on 24th  
February 2011 to aircraft PZL  
W-3AS, registration SP-SYA,  
operated by LPU «Heliseco»  
Sp. z o.o., in Dos Aguas –  
La Caldera de Taburiente  
National Park. Island of La Palma  
(Santa Cruz de Tenerife)

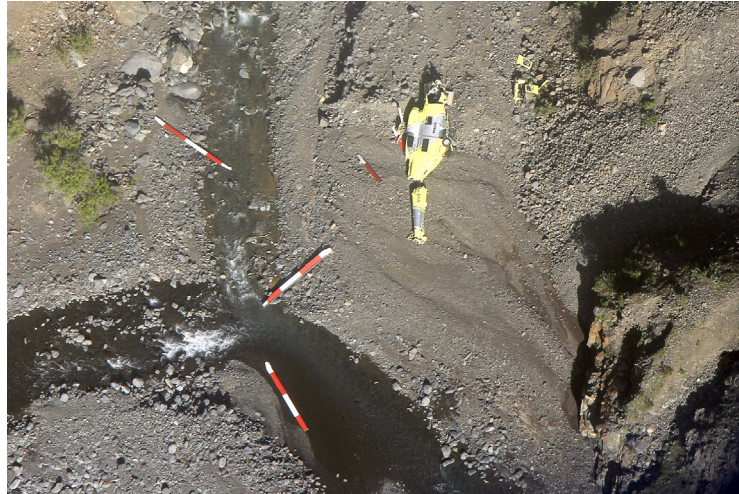
Figure 6. Aerial view of the helicopter wreckage

The terrain where the aircraft crashed is very rocky and features loose, hard rocks of various sizes with very sharp edges. The hillsides are extremely craggy and are also covered in loose rocks at lower elevations. Due to the steep incline of the mountain side these rocks are very unstable, making them susceptible to rock falls.

As a result of these characteristics, the impacts made by the various parts of the helicopter are hard to discern, either because the impacts are not evident on the hard stones or because any rock falls caused by the impact could result in other rocks covering the marks. Some of the wreckage could also have impacted the stream.

This could explain why no clear signs of the aircraft's impact were noticeable on the ground. There was one impact site on the hillside next to the main wreckage was found that uprooted a shrub in the area and caused a landslide of dirt and stones that ended up at the bottom of the valley.

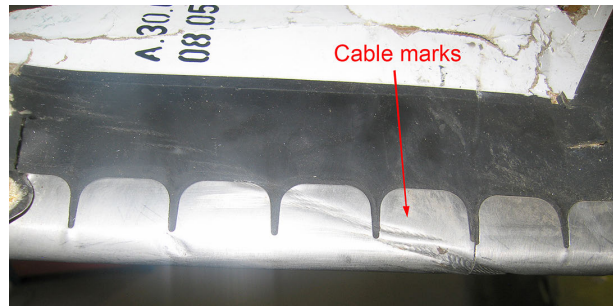
The leading edges of the tail rotor blades exhibited clear signs of having impacted a cable.

Figure 7. Cable marks on the leading edge of the tail rotor blade

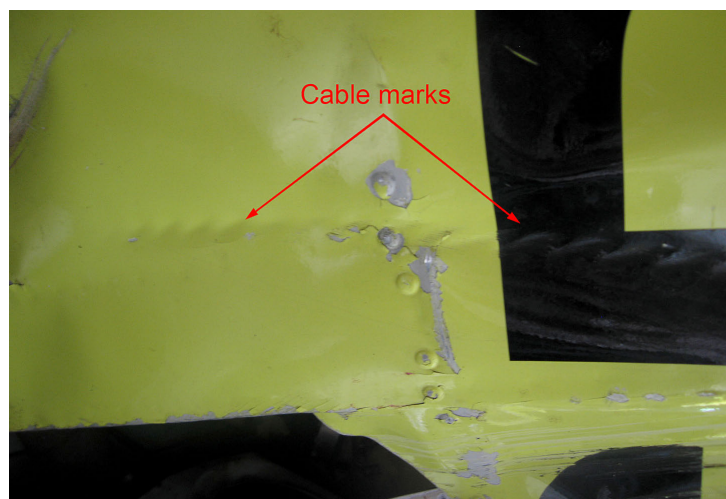
Figure 8. Cable marks on lower aft section of fuselage

Since the rotor continued turning, the cable kept winding around it until all of the available cable was reeled in (the other end of the cable remained attached to the helicopter's barycentric hook). As a result, the cable was once again under tension, leading to the scuff marks found on the underside of the helicopter's fuselage.

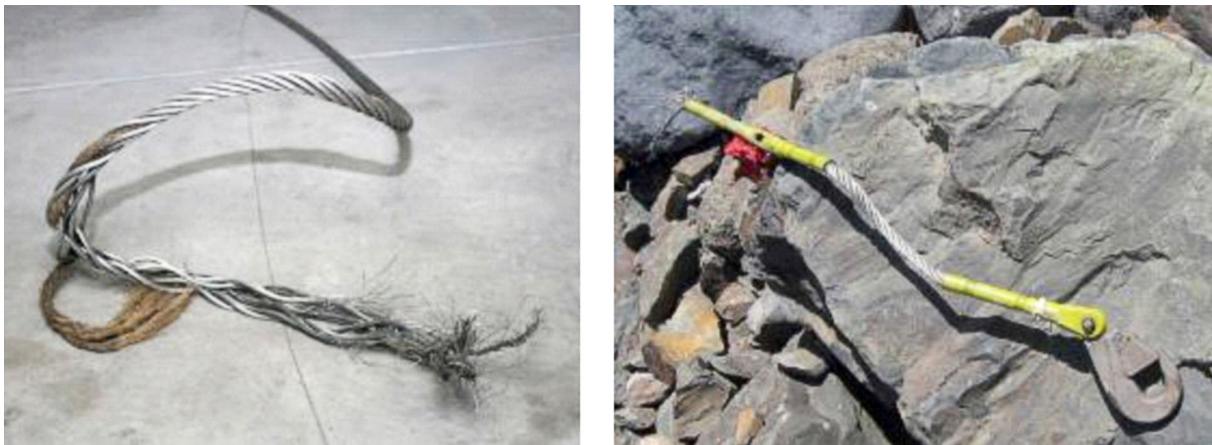
Figure 9. Photographs of the cable break. Top part at left and bottom at right

A visual inspection revealed that the cords were not all broken in the same area.

At the macrofractographic level the fracture surfaces on the wires were observed to be primarily of the cup and cone type, though a small percentage of bevel fractures were also observed.

These characteristics indicate that the fracture was caused by tensile load.

As concerns the breaking of the load sling, it is worth recalling that the break took place at its lower end. An analysis of the fracture surface determined that it broke due to excess tension. A tensile fracture requires the application of two opposing forces, one at each end of the fracture area.

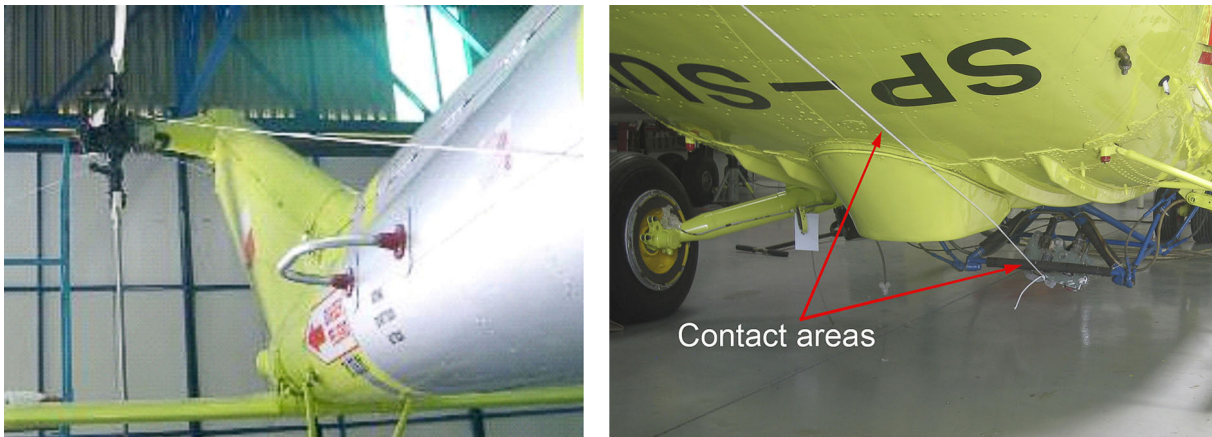
A test was run on a helicopter of the same model as the accident aircraft that consisted of attaching the end of a rope to the barycentric hook and pulling from the other end such that the rope went through the tail rotor (see Figure 10). The rope made contact with the fuselage in the same area where the cable marks were found and the load hook rested against the trapeze bar that detached in the accident.

Figure 10. Photographs of the rope linking the load hook to the tail rotor on a helicopter of the same model as the accident helicopter
