**MINISTRY OF TRANSPORT, CONSTRUCTION AND MARITIME ECONOMY
STATE COMMISSION ON AIRCRAFT ACCIDENT INVESTIGATION**

860/12

FINAL REPORT

**on investigation into air occurrence
to aircraft of a maximum mass equal to or below 2250 kg ***

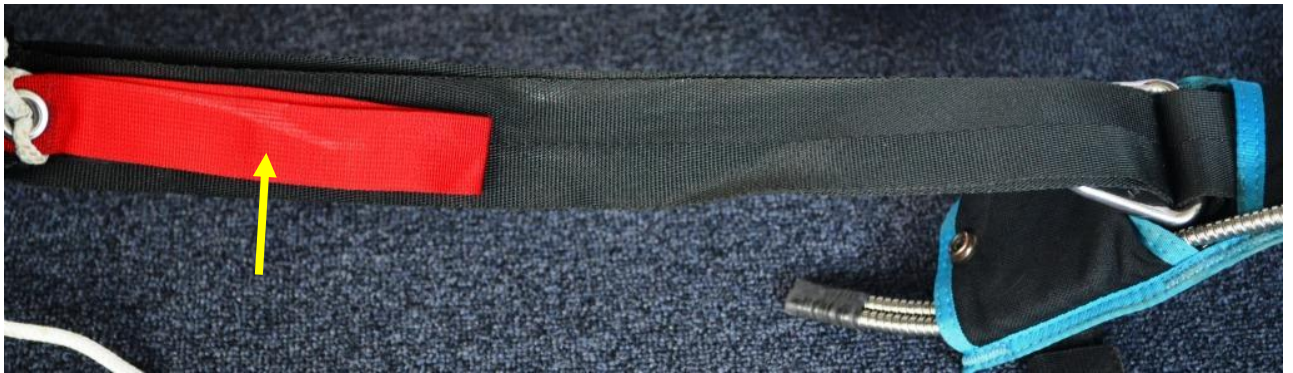
Some marks of molten material were found on the risers and one canopy control handle which indicated a friction, probably during the reserve opening process.

Photo 1. View of the back part of the right riser with a visible mark of melting on the back of the control handle. (Photo SCAA)

The parachute owner informed the Commission that the reserve canopy had never been used before. It follows that the molten material marks on the risers and handle were created during the investigated jump.

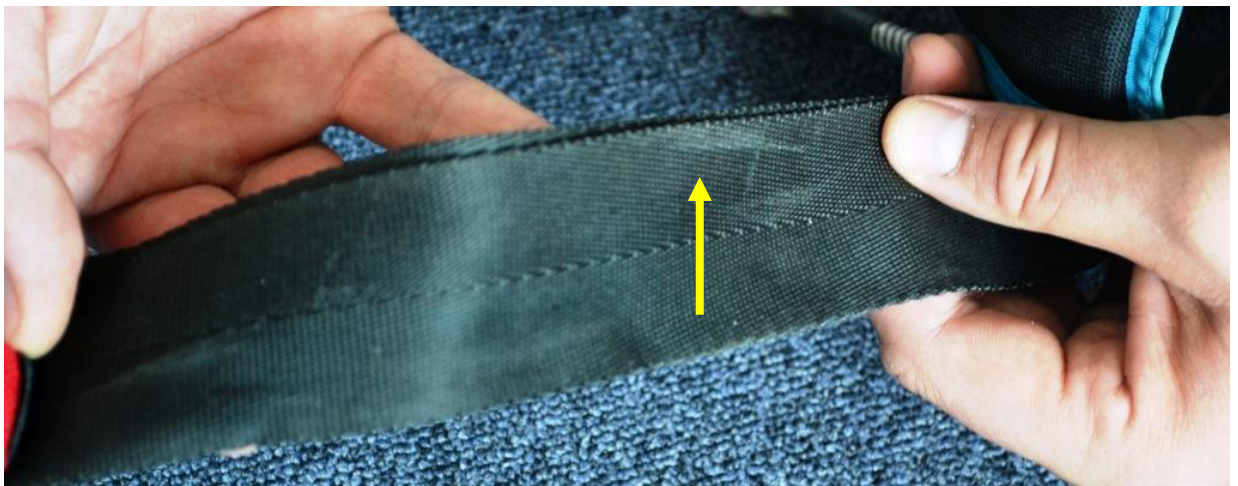
Photo 2. View of the back part of the left riser. Visible mark of melting. (Photo SCAA)

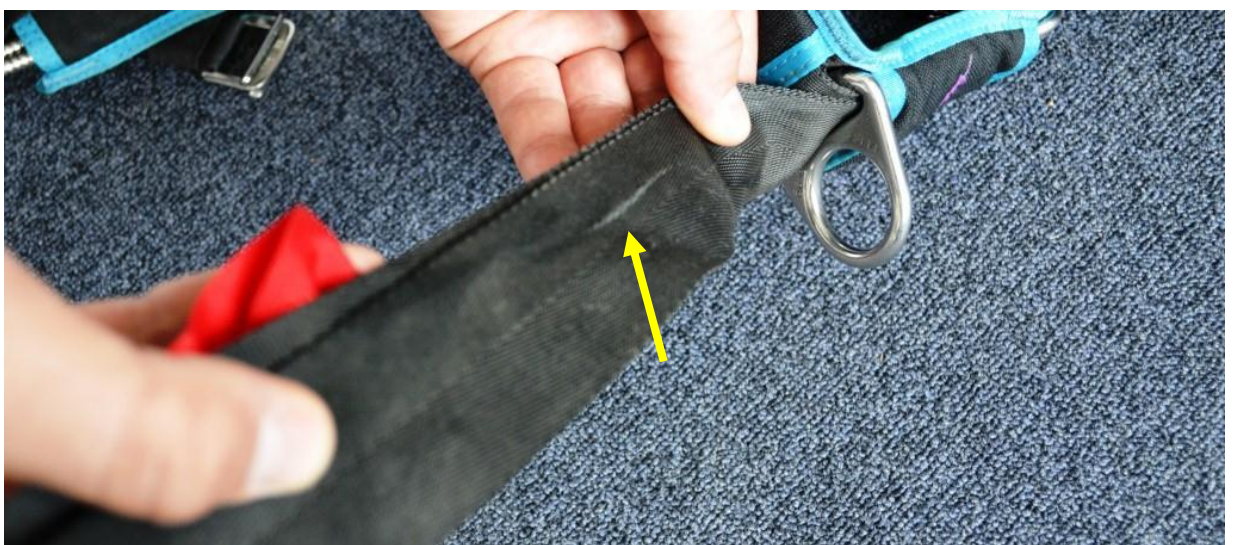
Photo 3. View of the front part of the left riser. Visible mark of melting. (Photo SCAA)

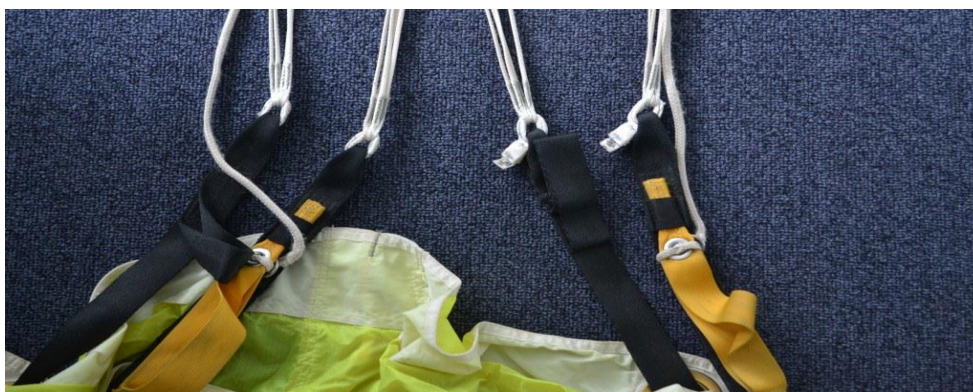
Visual inspection of the main canopy did not show any damage. It was only found that the tips of the soft links connecting the lines with the right risers were not secured by stitching. The cause of incorrect opening of the main canopy was not determined.

Photo 4. View of the main canopy risers. Visible tips of the soft lines which are not stitched to the right risers. (Photo SCAA)

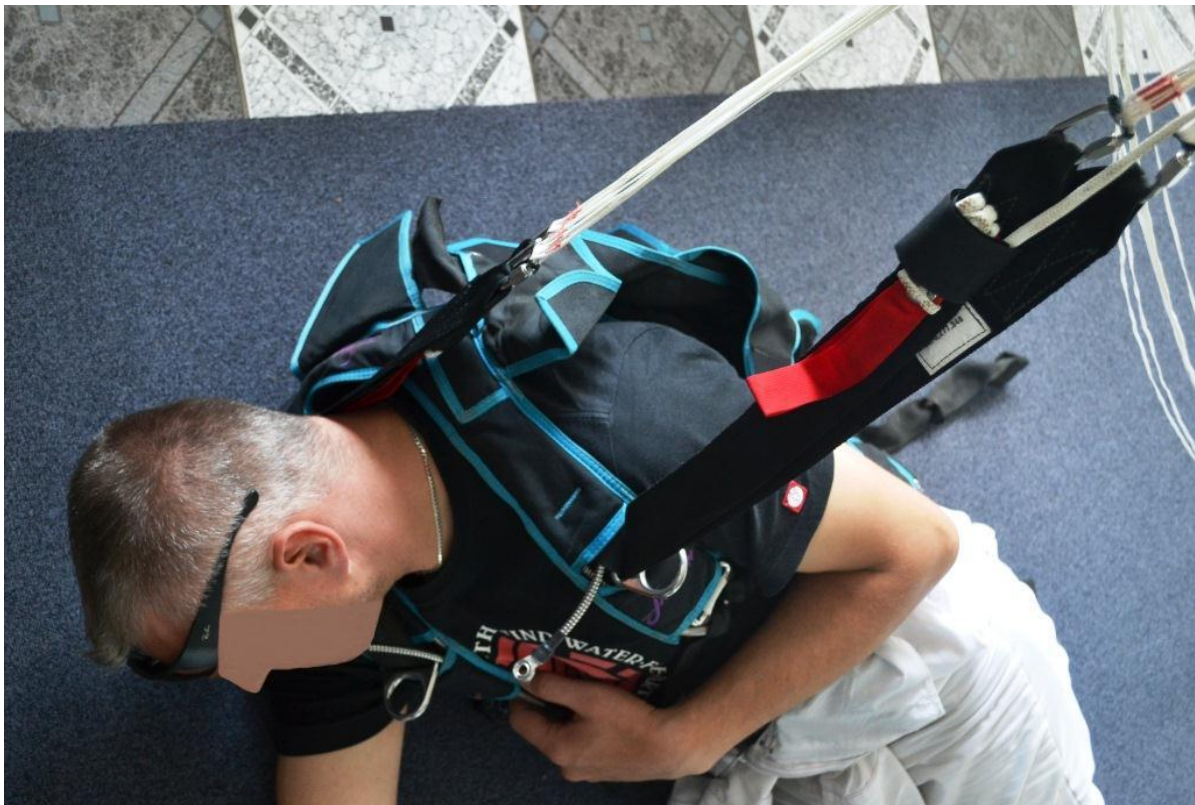
Taking into account unusual marks on the handle and risers of the reserve canopy, the Commission did not exclude that the incorrect opening of the reserve canopy could have been related to the configuration of the jumper. If the opening took place when the jumper was falling in the side position and rotated quickly, at a certain moment the risers and lines would have been unequal.

Photo 5. Likely configuration of the jumper, which could have occurred during opening of the reserve canopy.

Quick rotation could have resulted in tight twisting of the lines improperly positioned over the jumper head, which in turn would lead to the parachute flight in a deep spiral. The flight in a deep spiral could have prevented untwisting of the lines.
