State Commission on Aircraft  
Accidents Investigation

## MESSAGE [Preliminary Report]

on paraglider accident  
(SCAAI reference number: 860/15)

On 31 May, 2015 in Rudniki near Częstochowa a paraglider accident occurred.

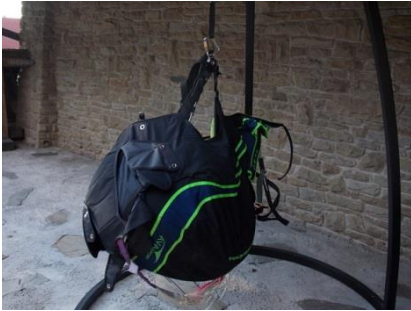
A preliminary functional tests of the CUT AWAY SYSTEM used by the manufacturer in ACRO BASE harness have been carried out. Various types of karabiners have been used. It has been found that some situations have occurred in which the cut away process of paraglider wing risers has been blocked. At this stage of the investigation it has been concluded that blocking the cut away process is due to the shape of the karabiner used to attach paraglider wing [including its thickness and geometry] and its orientation to the tapes of the 3-Ring System. Below are photos showing the way of blocking of the risers cut away system.

Photo 3. During the tests harnesses were suspended. Their own weight was enough to block.

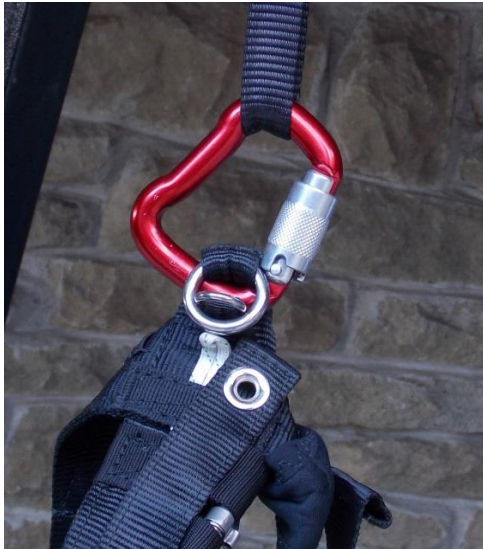
At the scene it found that the cut away handle was fully pulled out - Bowden cables entirely outside the housings, while the right karabiner remained not released in the 3-ring system.

Photo 4. SupAir karabiner (aluminum) used in the accident flight. The blocking of cut away process was due to pressing on the small ring by the karabiner and blocking the movement of the bigger ring on the karabiner gate.

**The Commission reminds** that each device, including each component of a set arranged for paragliding flight, must be operated in accordance with the manufacturer's instructions and limitations provided (described) in user instructions and manuals. Any modification of a system arrangement which is not agreed with manufacturer is burdened with enormous risk of malfunction.

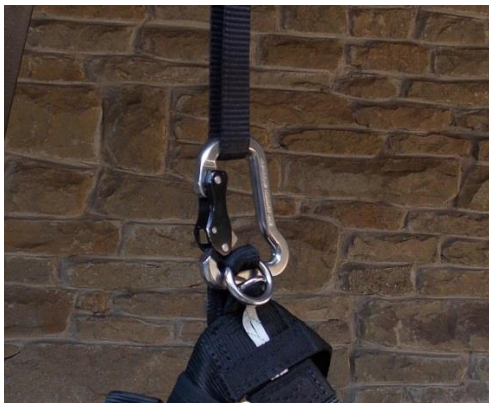
Photo 5. Different shape karabiner (Australpin Parafly). The blocking of cut away process was due to locking the bigger ring tape by the karabiner gate.

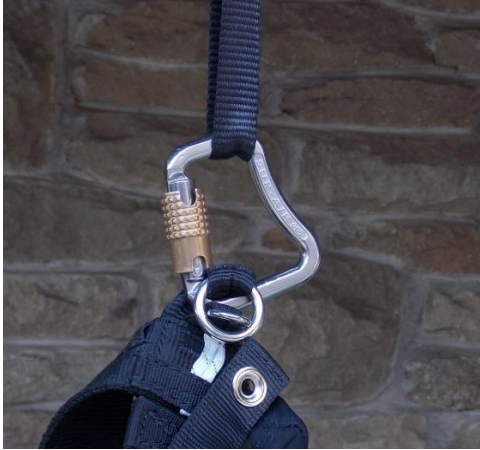
Photo 6. Different shape karabiner (SupAir - steel). The blocking of cut away process shows the same nature as in the case of SupAir aluminum karabiner - see photo 4.
