STATE COMMISSION ON RAILWAY ACCIDENT INVESTIGATION
Ministry of the Interior and Administration

REPORT No. PKBWK 03/2024

**on the investigation of a railway accident
that occurred on 19 May 2023 at 09:51 hrs
on the Komorów – Podkowa Leśna Główna route,
track no. 1, Category D level crossing, at km 18.805
of railway line no. 47 Warszawa Śródmieście WKD – Grodzisk Mazowiecki Radońska
the area of the infrastructure manager Warszawska Kolej Dojazdowa sp. z o. o.**

Warsaw, 1 February 2024

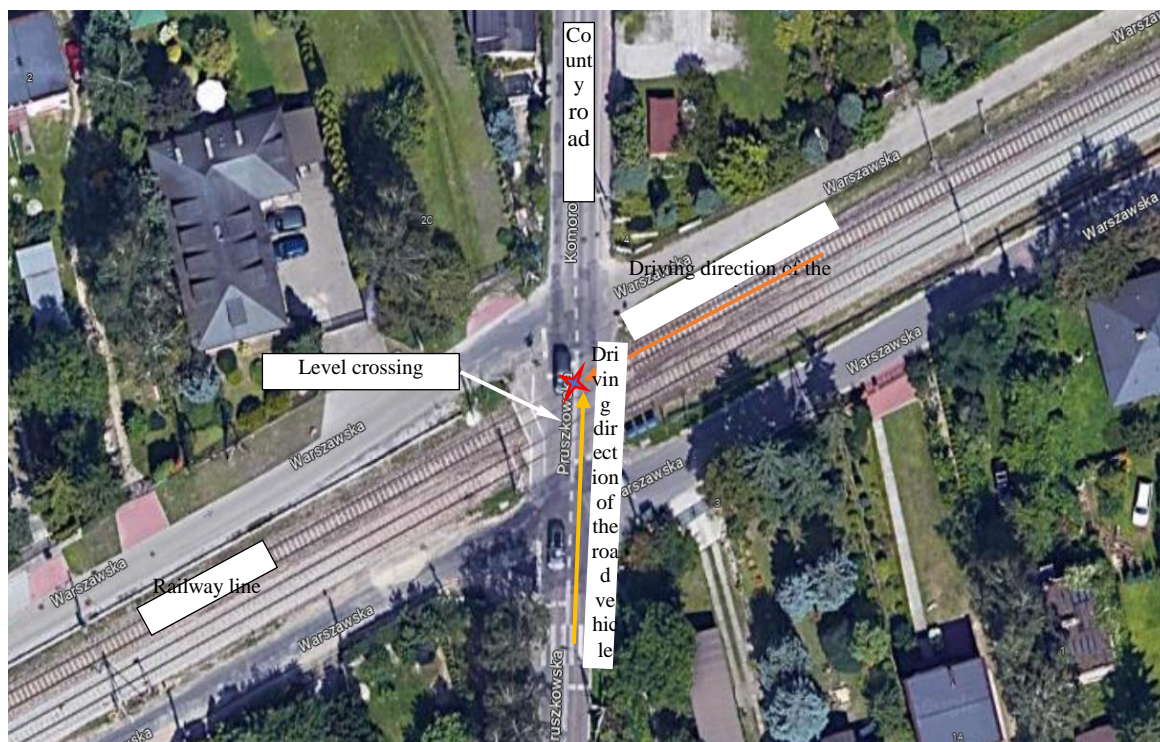
Photograph 3 - A general view of the occurrence site (source: Google Earth)

The Cat. D level crossing on which the occurrence took place is located in the section of county road

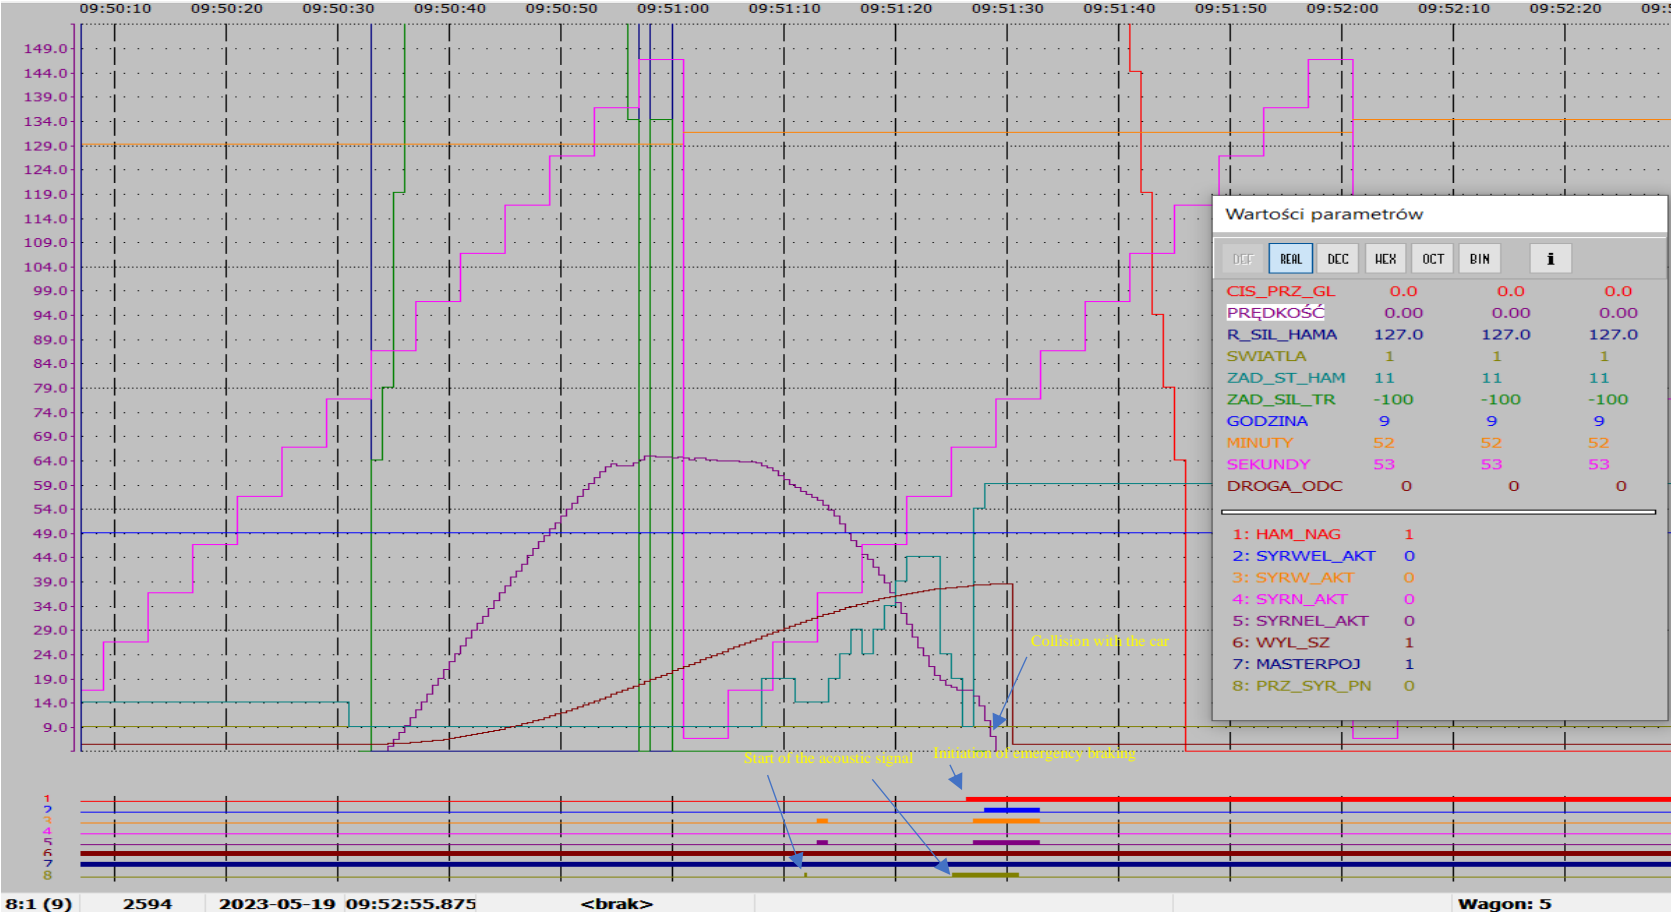
Figure 2 - A chart of driving parameters of train no. 347 (developed by PKBWK)

Fig. 2 shows the driving characteristic of train WKD no. 347 in the time function, and Fig. 3 in the distance function.
