**STATE COMMISSION ON RAILWAY ACCIDENT INVESTIGATION**  
**Ministry of the Interior and Administration**

**REPORT No. PKBWK 4/2024**

**on the investigation of a railway incident**  
**which occurred on 8 May 2023 at 07:26 hrs on the Góra Włodowska – Zawiercie route,**  
**track no. 1, km 212.400 of railway line no. 4 Grodzisk Mazowiecki – Zawiercie,**  
**the area of the infrastructure manager PKP PLK S.A. Railway Line Plant**  
**in Częstochowa**

**Warsaw, 18 March 2024**

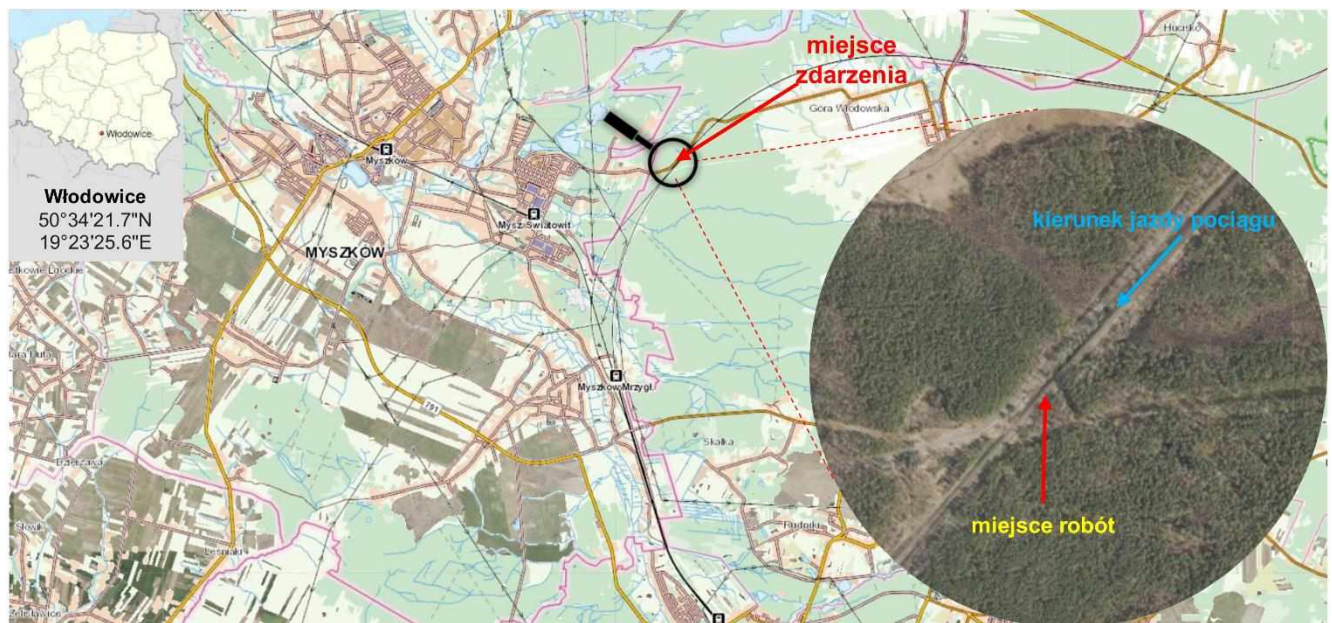
Figure 1 - A general view of the occurrence site (source: Geoportal)

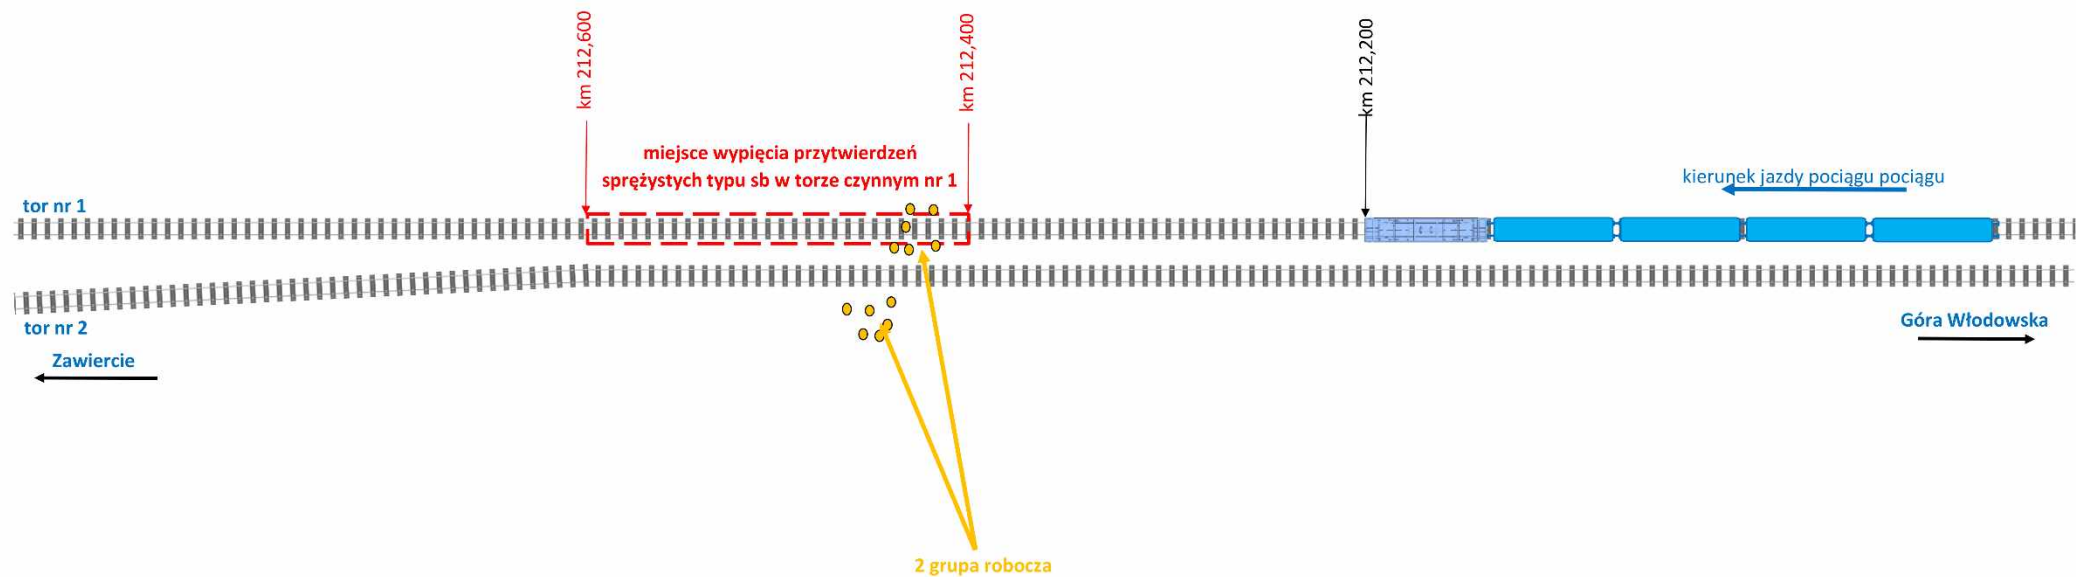
Figure3 - A sketch of the place of the incident

Approaching the work site from the side of track no. 1, group 2 (see Fig. 2) was the first to arrive and immediately, at 07:00 hrs, commenced dismantling (disengaging) the rail attachments in active track no. 1, instead of closed track no. 2. The work progressed in the direction of the line's ascending chainage. That group had managed to disengage ca. 200 m of track no. 1 when the third group arrived on site. Noticing that the second group was disengaging track no. 1, the supervisor of the third group notified the work organisation manager immediately by telephone, and the latter ordered the trackmaster in the second group by mobile phone to start re-engaging the rails in the track. Meanwhile, at 07:24 hrs, train no. 14001 departed the Góra

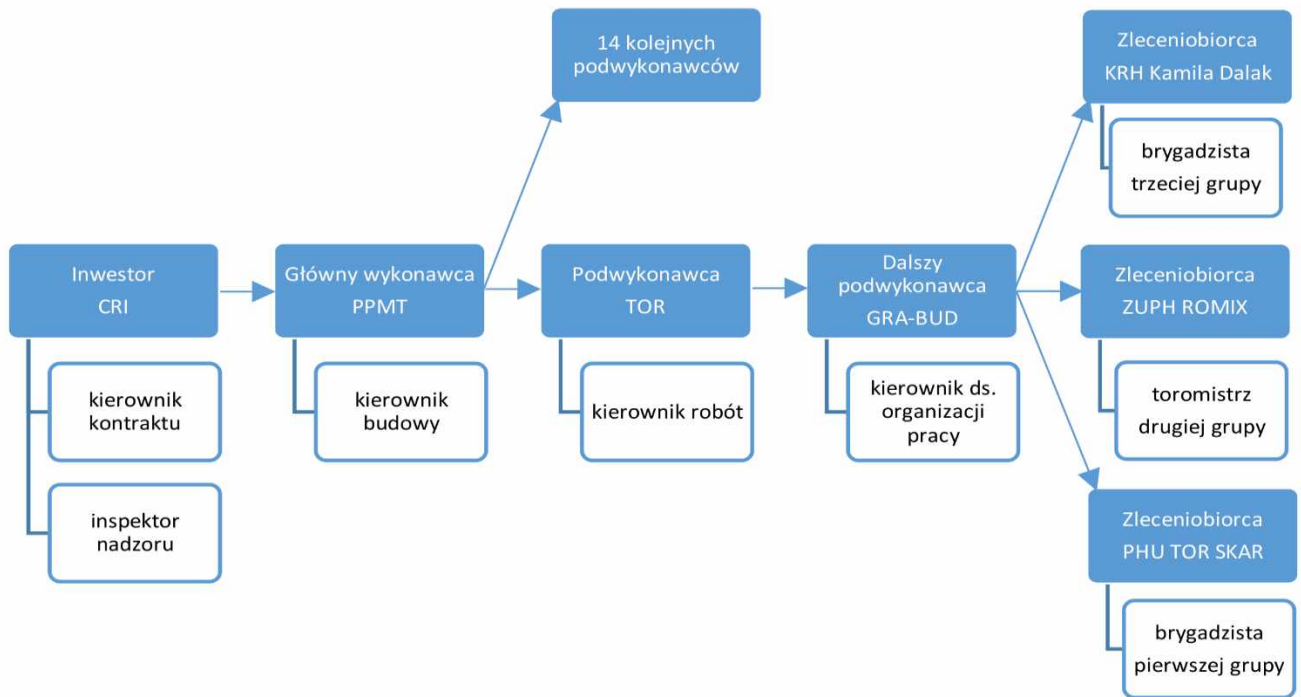
**Figure 5**– Chain of relations: investor, contractor and further subcontractors

GRA-BUD, as a further subcontractor, was tasked to provide construction services including railworks and accompanying works. The agreement for those works concluded with TOR prohibited any further subcontracting. Despite that provision, GRA-BUD subcontracted a part of the works to *inter alia* KRH Kamila Dalak, PHU TOR-SKAR and ZUPH ROMIX without the knowledge or approval of the investor and main contractor. The Investigation Team found, as a contributing factor, non-compliance by a further subcontractor with the provisions of agreement as regards the prohibition of commissioning work to further subcontractors, and admission of the company workers, without any knowledge or approval of the contracting entity and the main contractor, which had contributed to the lack of immediate supervision over them on the part of the investment supervision inspector.
