**STATE COMMISSION ON RAILWAY ACCIDENT INVESTIGATION**  
**Ministry of the Interior and Administration**

**REPORT No. PKBWK 5/2024**

**on the investigation of a railway accident  
that occurred on 12 April 2022 at 09:22 hrs at Poznań Główny station  
at turnout no. 140 in track 51, at km -0.181 of railway line no. 351  
Poznań Główny - Szczecin Główny,  
the area the infrastructure manager PKP PLK S.A. Railway Line Plant in Poznań**

**WARSAW, 10 June 2024**

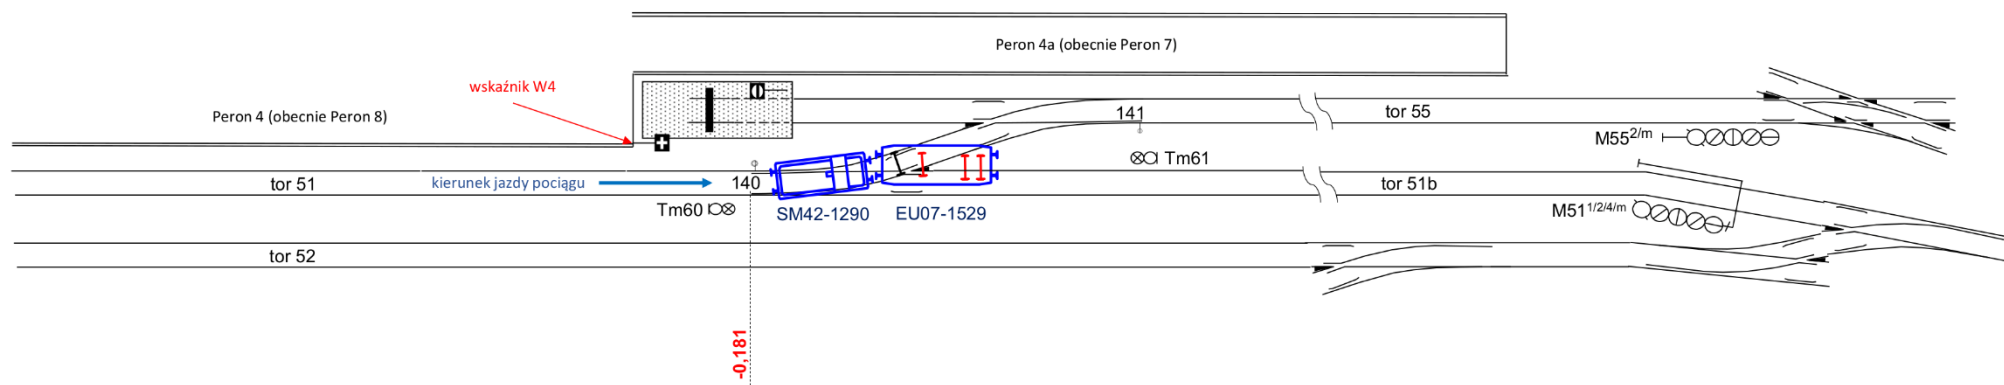
Figure 2 - A sketch of the accident scene

As a result of the derailment of locomotive EU07-1529 leading train THE 575001, the rolling surfaces of three wheelsets were damaged. The locomotive was sent for wheelset reprofiling. There was no other damage to the train set.

The half switch of turnout no. 140, the wheel detector and 35 alloy bolts were damaged.

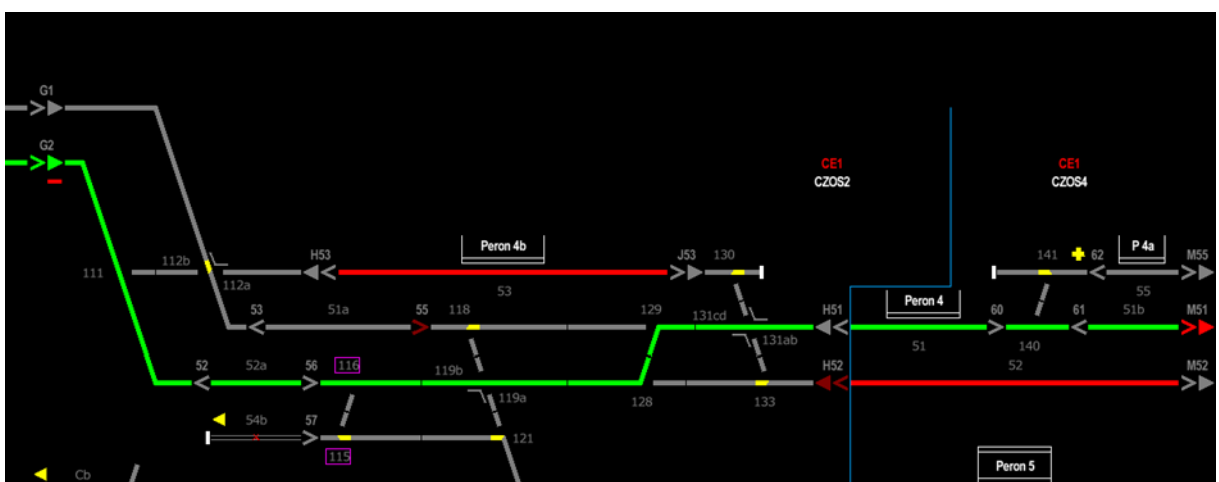
Figure 3 - Computer mapping of train route from the G2 signal to the M51 signal, 09:18:37 hrs (source: Thales)

At 09:18:37 hrs, route  $G2_{51b}^2$  was fixed on intermediate signal  $G2^{1/2/m}$  of Poznań Główny station with the aspect S13 "Proceed at a speed not exceeding 40 km/h, and Stop at the next signal" (track 55 free, see Figure 3).

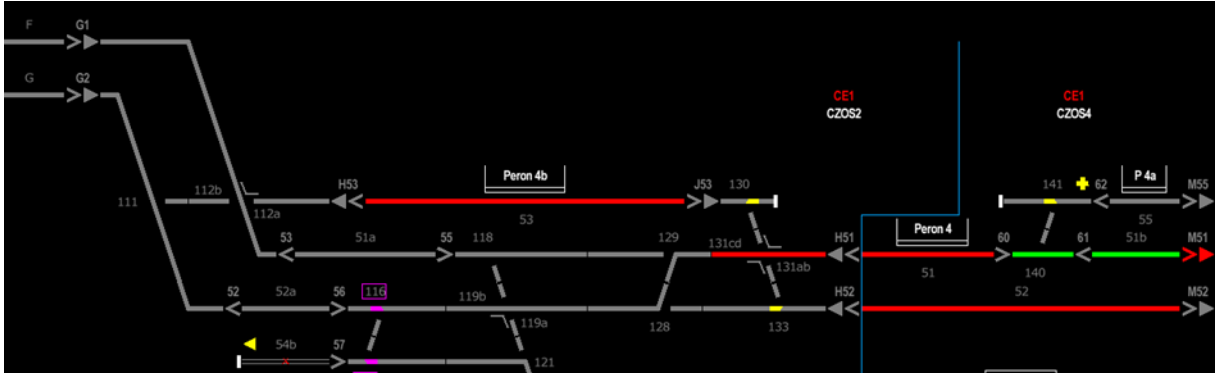
Figure 4 - The train's entry on track 51, 09:21:32 hrs (source: Thales)

At 09:21:32 hrs, the train entered track 51 at the speed of approximately 26 km/h.

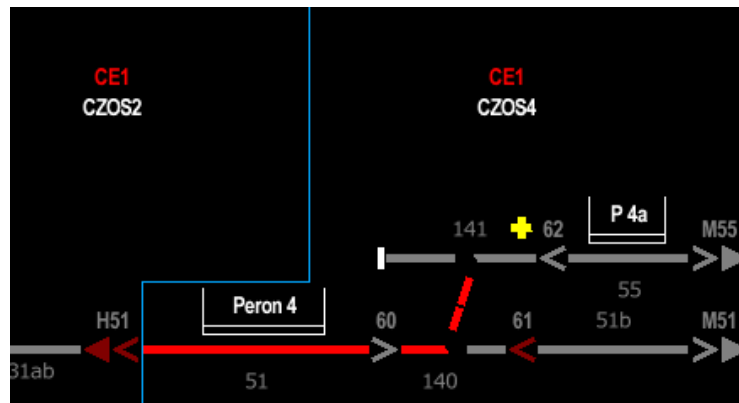
Figure 6 - The train's entry to switch isolation Iz140, 09:22:22 hrs (source: Thales)

At 09:22:22 hrs, the "station D" signaller gave the order to set the shunting route from shunting disc Tm60 to exit signal M55.

At 09:22:25 hrs, the train occupied switch isolation Iz140, i.e. it drove two axles of the first bogie onto the switch of turnout no. 140 directing straight ahead (plus (+) position) at the speed of 19 km/h.

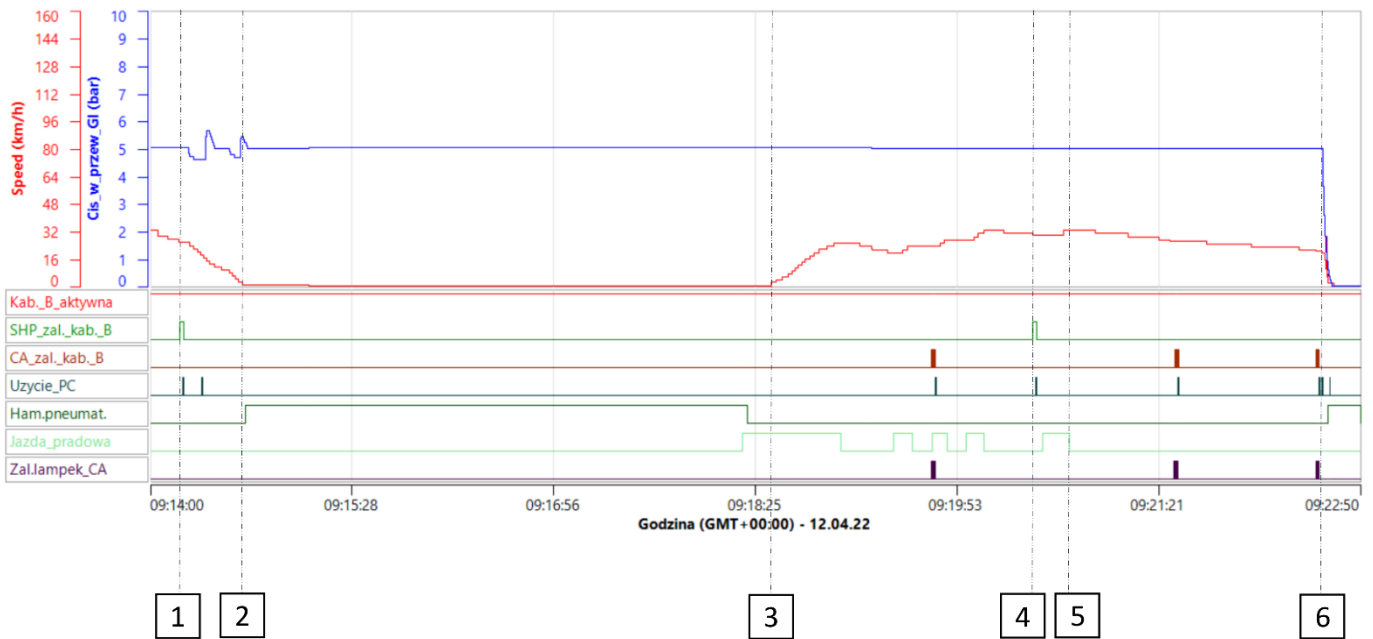
**Figure 8 - A chart of the locomotive's driving parameters**

1. 09:14:12 hrs - passage over the SHP of home signal B<sup>1/2/4</sup> at the speed of 25.67 km/h
2. 09:15:09 hrs - stop at signal B<sup>1/2/4</sup>
3. 09:18:31 hrs - start from home signal B<sup>1/2/4</sup>
4. 09:20:26 hrs - passage over the SHP of intermediate signal G2<sup>1/2/4</sup> at the speed of 29.82 km/h
5. 09:20:42 hrs - non-electric driving until the derailment
6. 09:22:33 hrs - entry of the locomotive to turnout no. 140

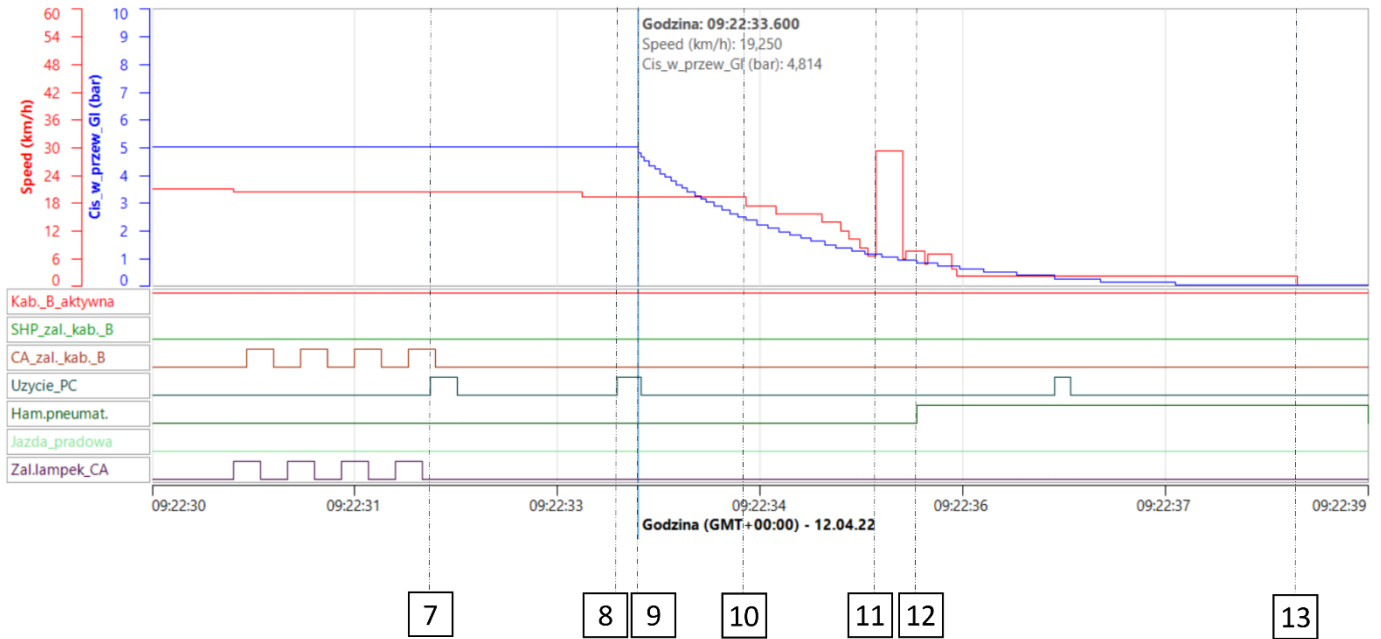
**Figure 9 - The locomotive's driving parameters during the occurrence**

7. 09:22:32 hrs - use of the passive vigilance button (PC) at the speed of 20.48 km/h
8. 09:22:33 hrs - use of the PC button at the speed of 19.25 km/h
9. 09:22:33 hrs - the locomotive enters turnout no. 140 at the speed of 19.25 km/h; pressure drop in brake main line from 5.032 [bar]
10. 09:22:34 hrs - the speed drops to 6.5 km/h
11. 09:22:35 hrs - a sudden increase in the speed to 29.39 km/h (the moment the axle of the set was rolled over due to loss of contact between the wheel and the rail)
12. 09:22:35 hrs - implementation of braking from the speed of 7.56 km/h
13. 09:22:38 hrs - the locomotive stops

The speed values given in Points 11 and 12 are derived from the parameters recorded at the time of free-rolling and are not actual speeds. It is therefore not possible to establish, on the basis of the driving parameter readouts, a reliable distance travelled from the time of the derailment until the time the locomotive stopped.
