STATE COMMISSION ON RAILWAY ACCIDENT INVESTIGATION
Ministry of the Interior and Administration

REPORT No. PKBWK 06/2024

**on the investigation of a railway accident that occurred on 24 August 2023 at 12:05 hrs
at Skierniewice station, at turnout no. 13, at km 64.282
of railway line no. 1 Warszawa Zachodnia - Katowice
the area of the infrastructure manager PKP Polskie Linie Kolejowe S. A.
Railway Line Plant in Łódź**

WARSAW, 1 August 2024

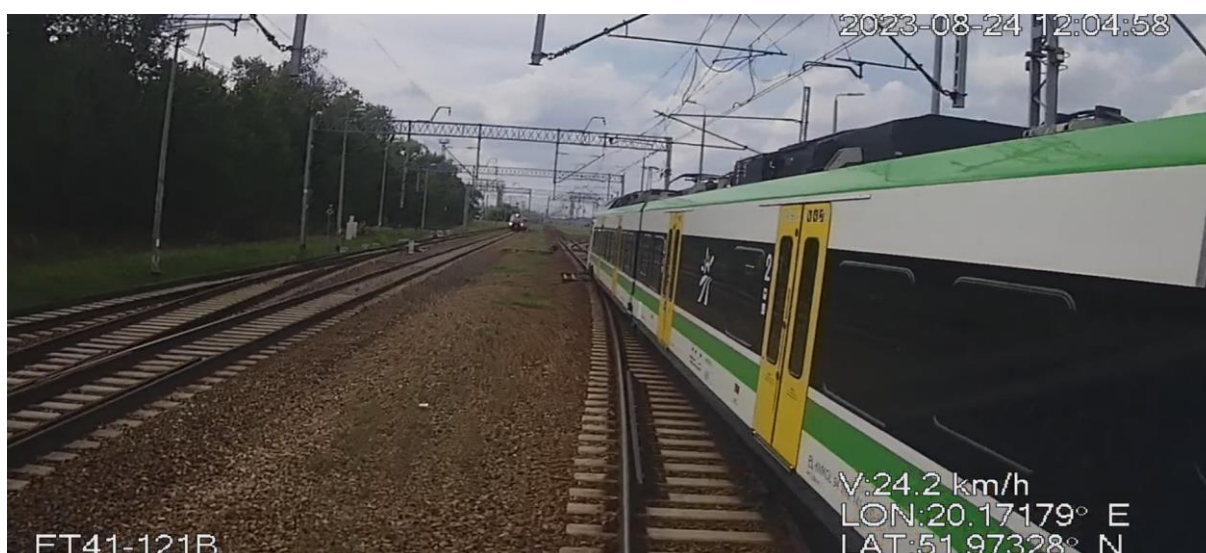
Photograph 3 - A view from the front view camera of train no. 524009 at the time of the collision

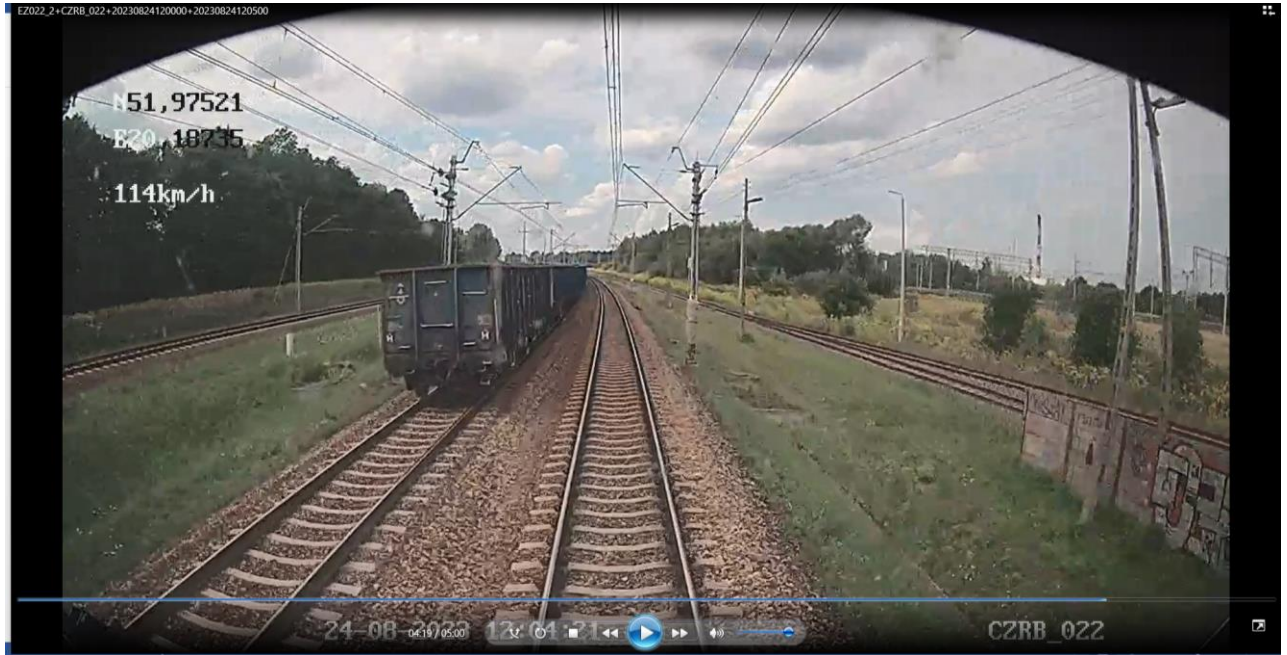
Photograph 7 - Driving foreground - the moment when the passenger train was approaching train no. 524009, a view from the camera of the EMU ER160-22

Driving at the speed of 111 km/h, the driver of the passenger train terminated the call at 12:04:39 hrs when the head of the train was 166 m ahead of the signal J1^{1/2/3/m} showing the aspect S1 "Stop", and implemented braking.
