STATE COMMISSION ON RAILWAY ACCIDENTS INVESTIGATION
Ministry of Interior and Administration

REPORT No PKBWK 05/ 2021

**on the investigation of a serious train accident that occurred on
26 January 2021 at 07:39
on route between Zbąszynek and Lutol Suchy, track no 1,
level crossing category D
at km 10.196 of railway line no 367 Zbąszynek - Gorzów Wielkopolski**

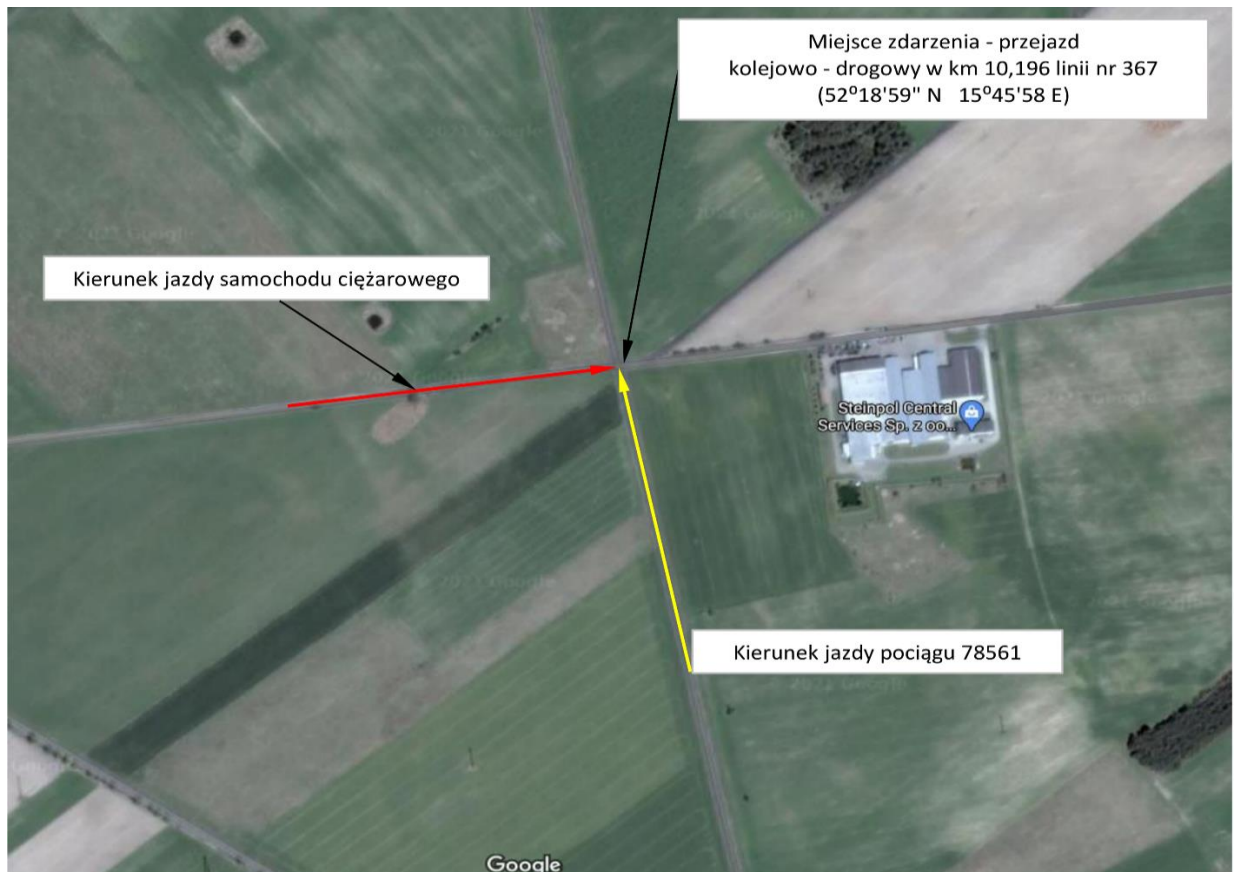
Photo 4- General view of the incident site (source: Google maps)

The D-category crossing where the accident happened is located on a communal dirt road No. 006323F Chociszewo - Mago, made partly of 3 m wide concrete road plates with dirt roadside. The crossing location coordinates are 52°18'59 "N 15°45'58 "E. The maximum speed of road vehicles on the road in the area of the crossing is 30 km/h, according to the road sign. The road is crossing the railway track at an angle of 90 °. The area of the railway line and road crossing is flat, undeveloped, and in fields area. Visibility of the crossing measured along the road axis is normal (higher than the required 60m). Visibility of train head from the road for the required triangles of 5 m, 10 m and 20 m preserved. In the field of visibility triangles there are no bushes and trees and no other obstacles limiting the field of vision. On the day of the incident, that is on 26 January, no works were carried out in the area of the crossing. On that day the weather conditions were good, there was no rain or fog. It was morning, before sunrise, the sky was slightly cloudy, the temperature was approx. 1° C. Moreover, in the area of the crossing at the time of the incident there were no other road users who could absorb the attention of the driver of the road vehicle.
