STATE COMMISSION ON RAILWAY ACCIDENTS INVESTIGATION
Ministry of Interior and Administration

REPORT No. PKBWK 01/2023

**on the investigation of the railway incident
that occurred on October 16, 2019 at 13:51
at Leszczyny station, at km 31.738
railway line no. 140 Katowice Ligota - Nędza**

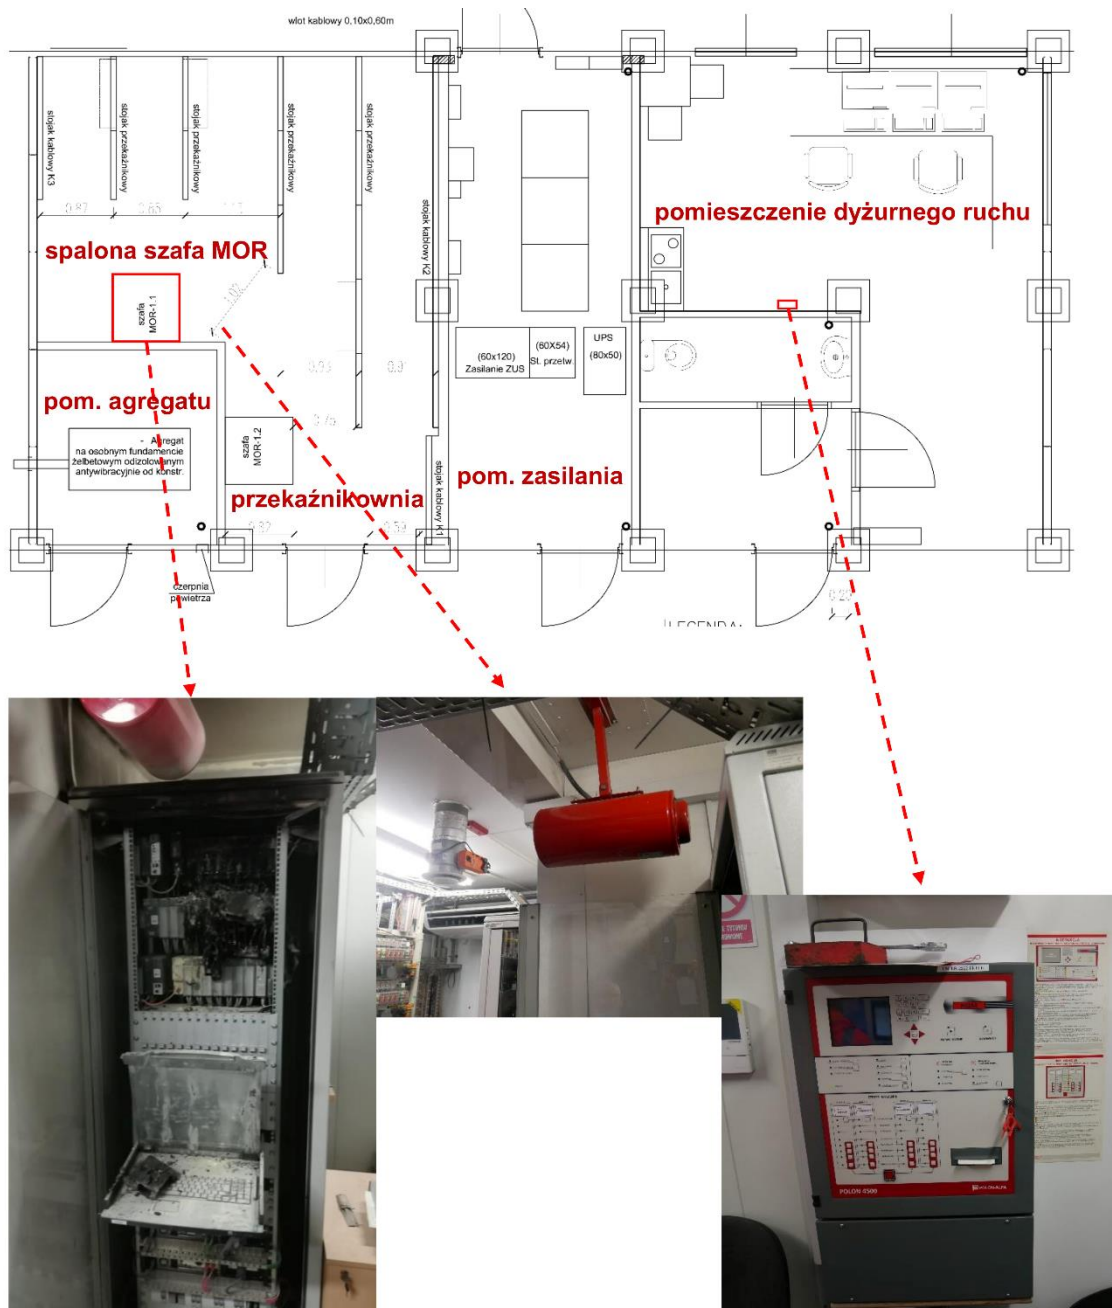
Figure 1 - Sketch of the layout of the rooms and some equipment of the Lsz control room

The container yard is located at 31.738 km of railway line No. 140 at a distance of 5.5 m from the outermost rail of switch No. 17. The layout of the yard is shown in Figure 1 below.

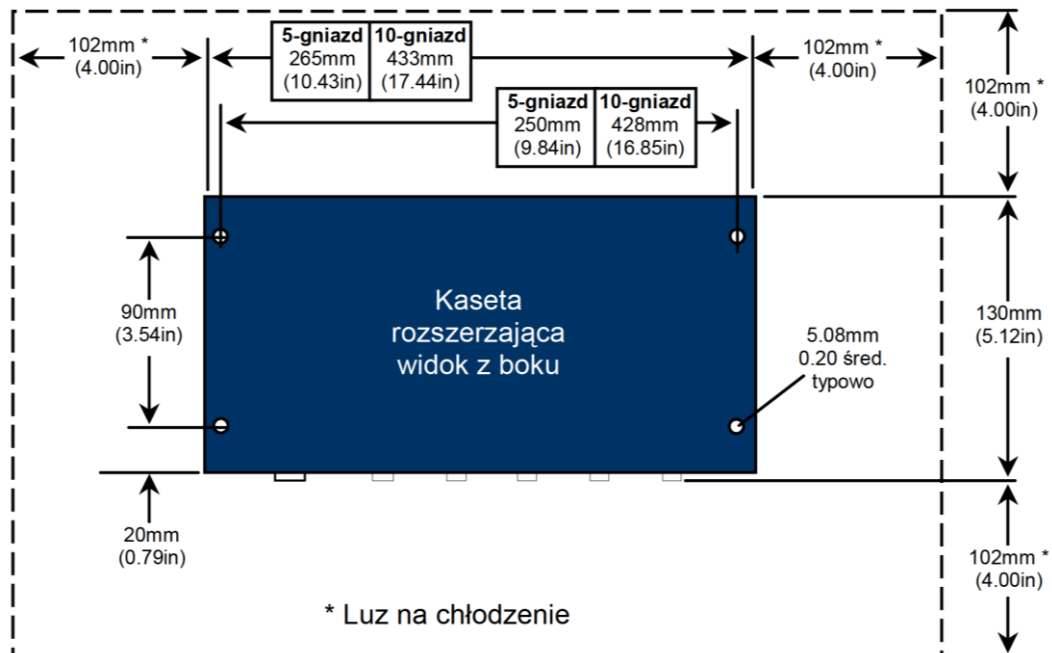
Figure 3 - Dimensions of the RX3i serial expansion cassette and layout in the enclosure

"The enclosure must be able to properly distribute the heat generated by the components inside so that none of them overheat. The amount of heat dissipated is also a factor in determining the need for cooling systems such as fans or air conditioners in the enclosure. The minimum clearance around the RX3i base cartridge for cooling purposes should be 102 mm. Additional clearance may be required depending on the amount of heat generated by the equipment during operation. Appendix C describes how to calculate power dissipation through RX3i modules and field devices mounted in the enclosure."
