STATE COMMISSION ON RAILWAY ACCIDENTS INVESTIGATION
Ministry of Interior and Administration

REPORT No. PKBWK 07/2022

on the investigation of a railway accident
that occurred on February 03, 2022, at 06:14 on the route Warlubie - Laskowice Pomorskie,
on track no. 2, category B level crossing at km 437.386
railway line No. 131 Chorzów Batory - Tczew
area of the Infrastructure Manager PKP PLK S.A. Railway Line Department in Bydgoszcz

WARSAW, December 14, 2022.

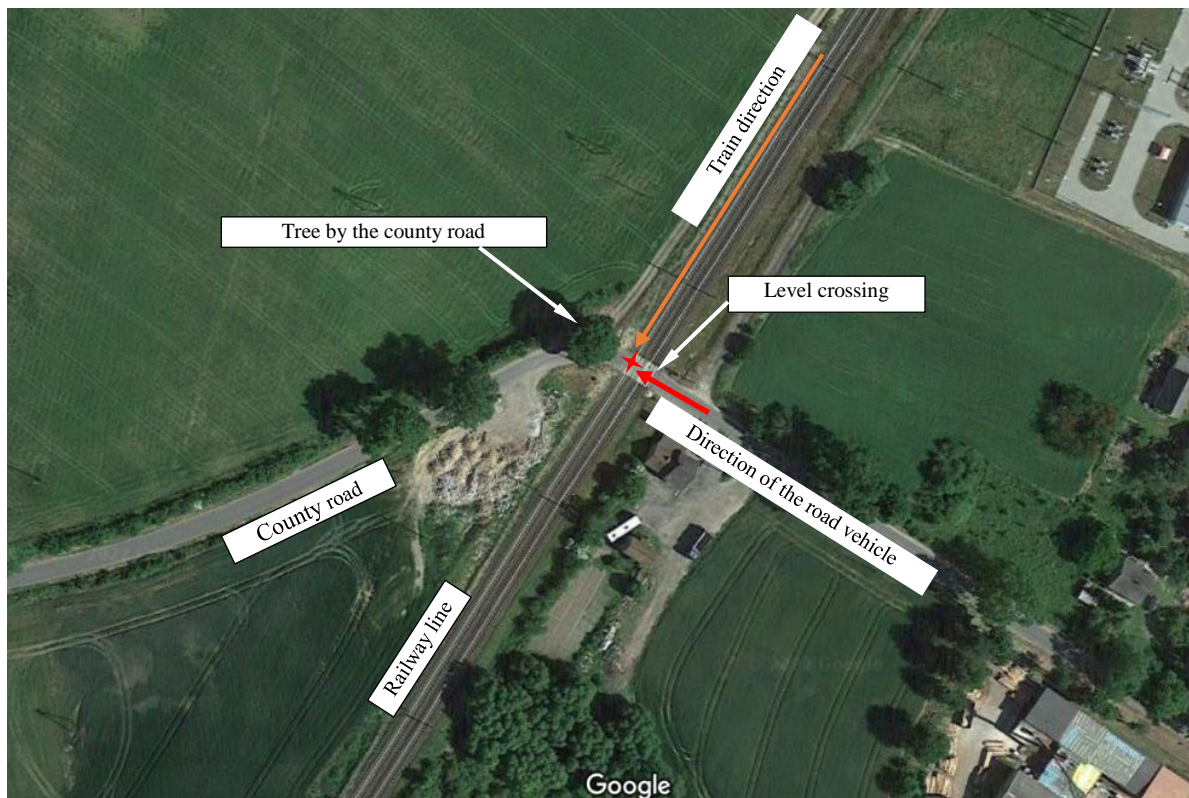
Fig. 3 - General view of the site (source: Google Earth)

The crossing where the accident occurred, is located on district road No. 1222C Bąkowski Młyn - Bąkowo, made of bituminous pavement with a dirt shoulder. The width of the roadway between traffic signals S1 and S3 is 5.10 m, while between traffic signals S2 and S4 is 4.70 m (Figure 1). The permissible speed of road vehicles on the road in the area of the level crossing according to the crossing metric is 50 km/h. The district road is intersected with the railway track at an angle of 85°. The area of the level crossing with the road is in an undeveloped area. County road No. 1222C from the village of Bąkowo on both sides is marked with warning signs A-9 and indicator posts on the right side G-1a, G-1b, G-1c. In front of the crossing, on both sides of the access road there are traffic signals of the

automatic crossing system. The distances of the traffic signals from the outermost rail of track 1 are: S1 - 6.5 m, S3 - 6.7 m, while from the outermost rail of track No. 2 they are: S2 - 6.5 m, S4 - 6.1 m. The crossing is equipped with semi-control barriers that close the entrance to the crossing from both directions of travel on county road No. 1222C. Visibility of signals given by traffic signals correct. At the S4 traffic signal at 5.50 meters from the outermost rail of track No. 2, parallel to the track axis, a concrete fence is built, preventing safe exit from the crossing. In the direction of the village of Bąkowski Młyn (the direction of the bus), there is a tree behind the crossing at 11 meters from the extreme rail of track No. 2, in front of which the road turns sharply to the left (Figure 1). The tree made it difficult for the bus to turn gently to the left to avoid damaging the turnpike devices and for the bus to stay in its lane while turning without occupying the opposite lane. The geographical coordinates of the crossing are 53°34'44 "N 18°36'54 "E. The occurrence occurred during dark season without precipitation or fog, with an ambient temperature of -2°C. No work was carried out in the area of the crossing affecting the occurrence.
