# FINAL REPORT

## ACCIDENT

**Occurrence No.: 466/07**

**Aircraft: B737-800, EC-HBM**

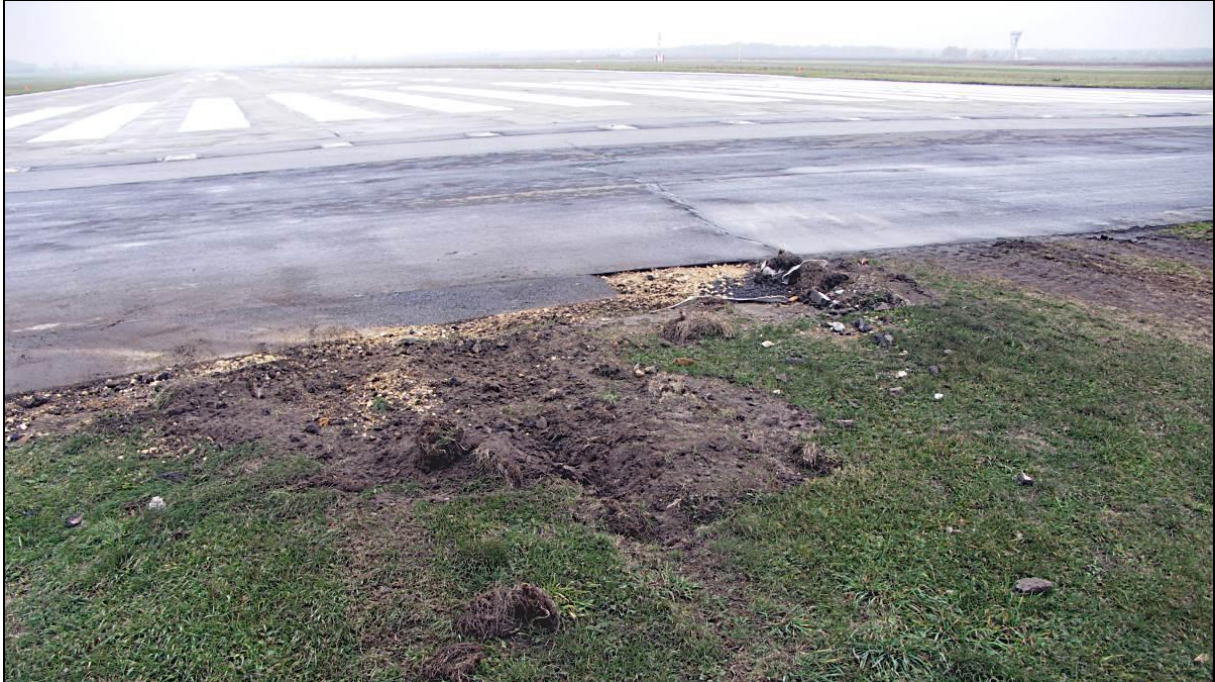
**27 – Crossing point of the RWY27 threshold by the airplane left main landing gear wheels**

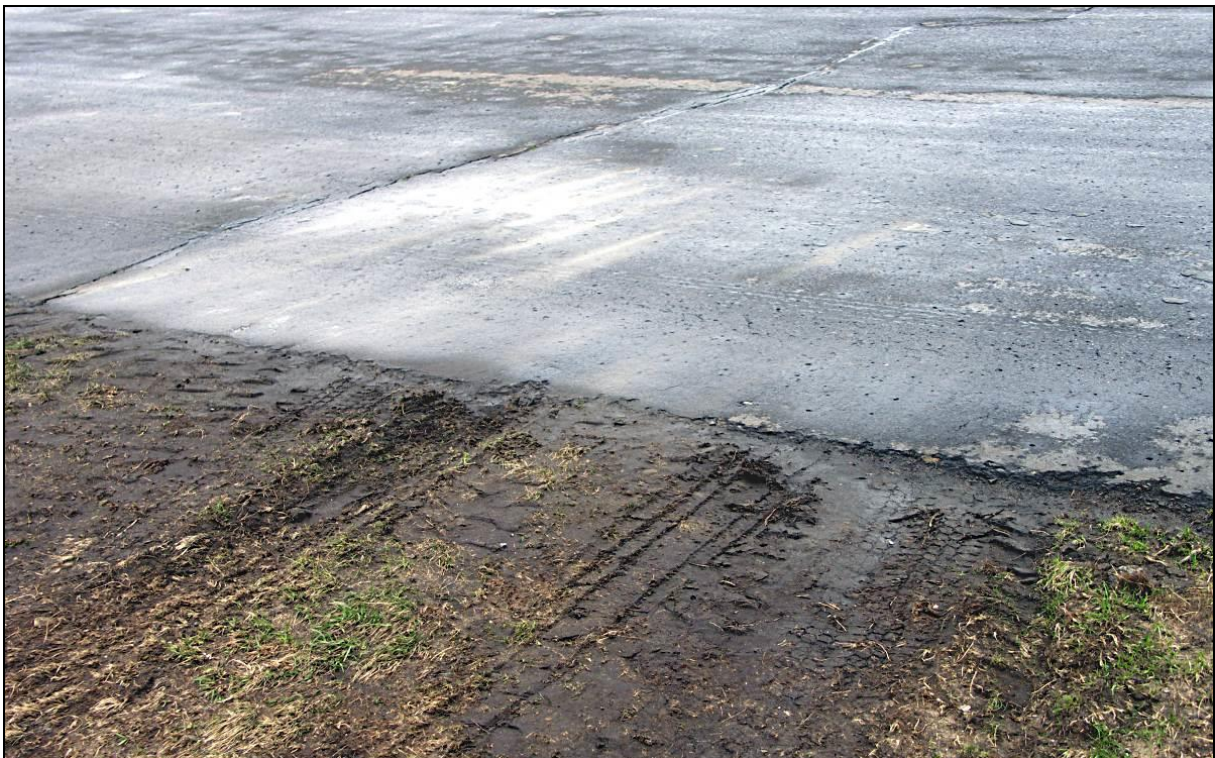
**28 – Crossing point of the RWY27 threshold by the airplane right main landing gear wheels**

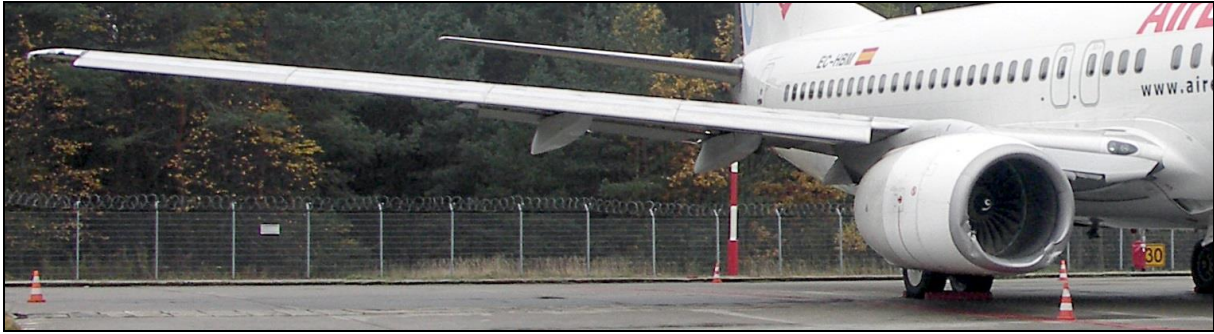
65 – Right wing – general front view

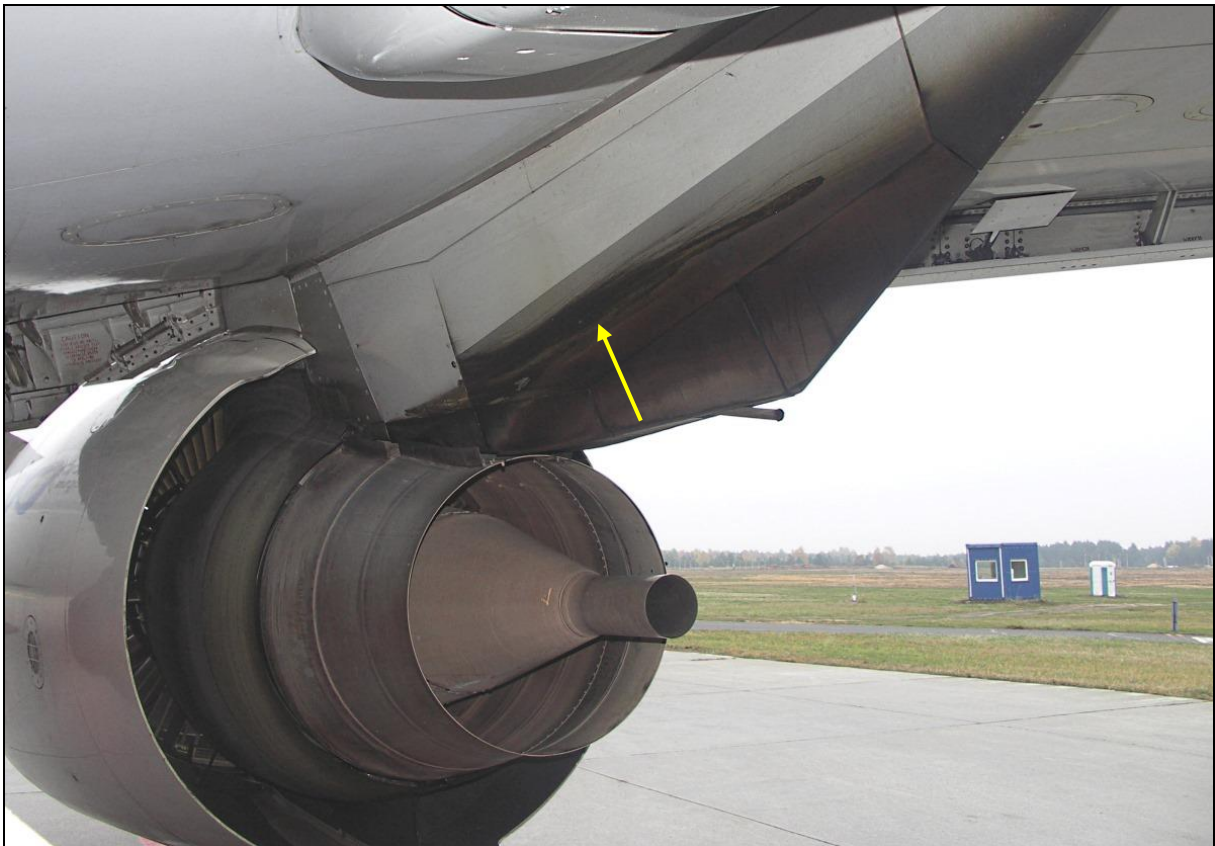
**75 – Abnormal signs on the right engine pylon**

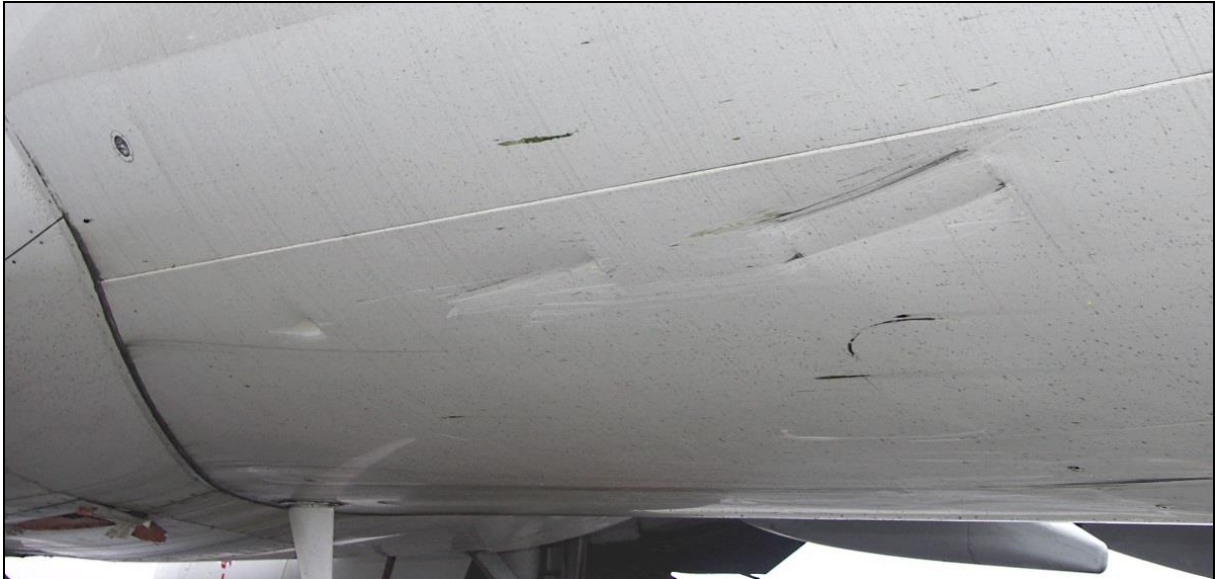
**82 – Scratches and abrasions of the left rear part of the fuselage skin – close-up**
