MINISTRY OF INFRASTRUCTURE
STATE COMMISSION ON AIRCRAFT ACCIDENT INVESTIGATION

FINAL REPORT

Occurrence No: 619/10

Aircraft: F-100, D-AGPH

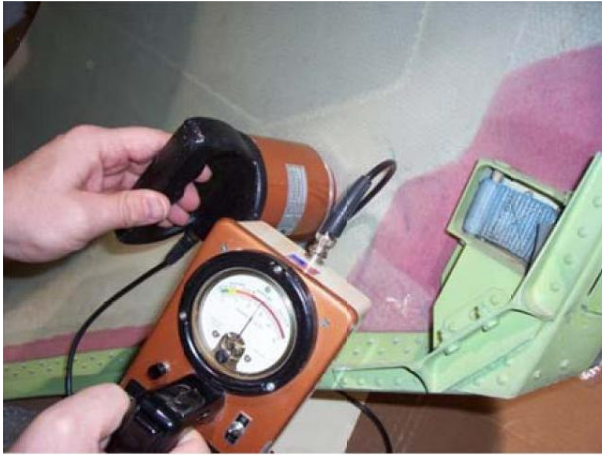
During examination of Radome S/N 172 and prior to removing the samples the radome was checked for moisture using equipment manufactured by Moisture Register Products, Mod.: A8-AF, SN: 5D0387 (see Figures 7 and 8). Several areas were found with extensive moisture (H₂O) ingress. Evidence of water was also observed in and around the area of failure. This can be seen by the staining of the inner skin (see Figures 9 through 12).

Figure 7
Moisture Meter used to determine location of moisture in Radome

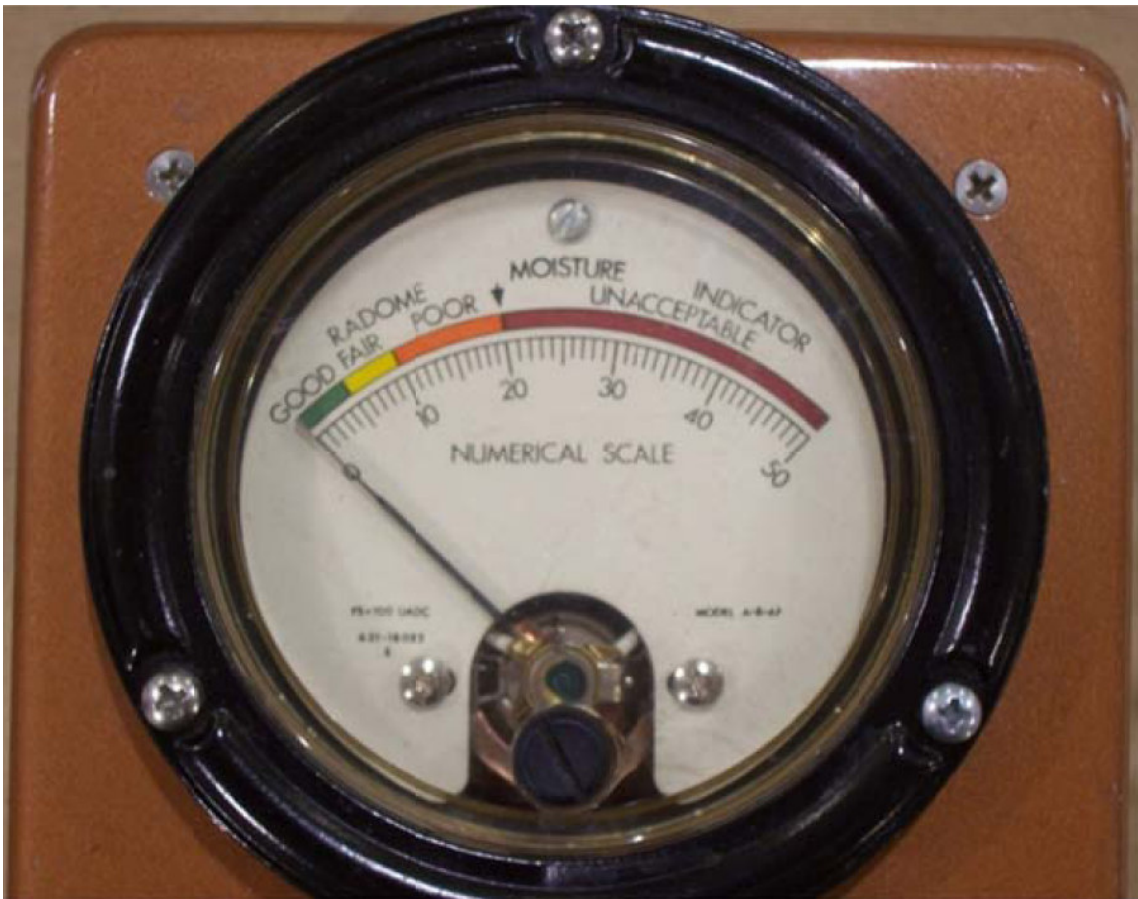
Close up of face of moisture meter with moisture reading ranges
