## Report A-004/2011

Accident occurred on 24th  
February 2011 to aircraft PZL  
W-3AS, registration SP-SYA,  
operated by LPU «Heliseco»  
Sp. z o.o., in Dos Aguas –  
La Caldera de Taburiente  
National Park. Island of La Palma  
(Santa Cruz de Tenerife)

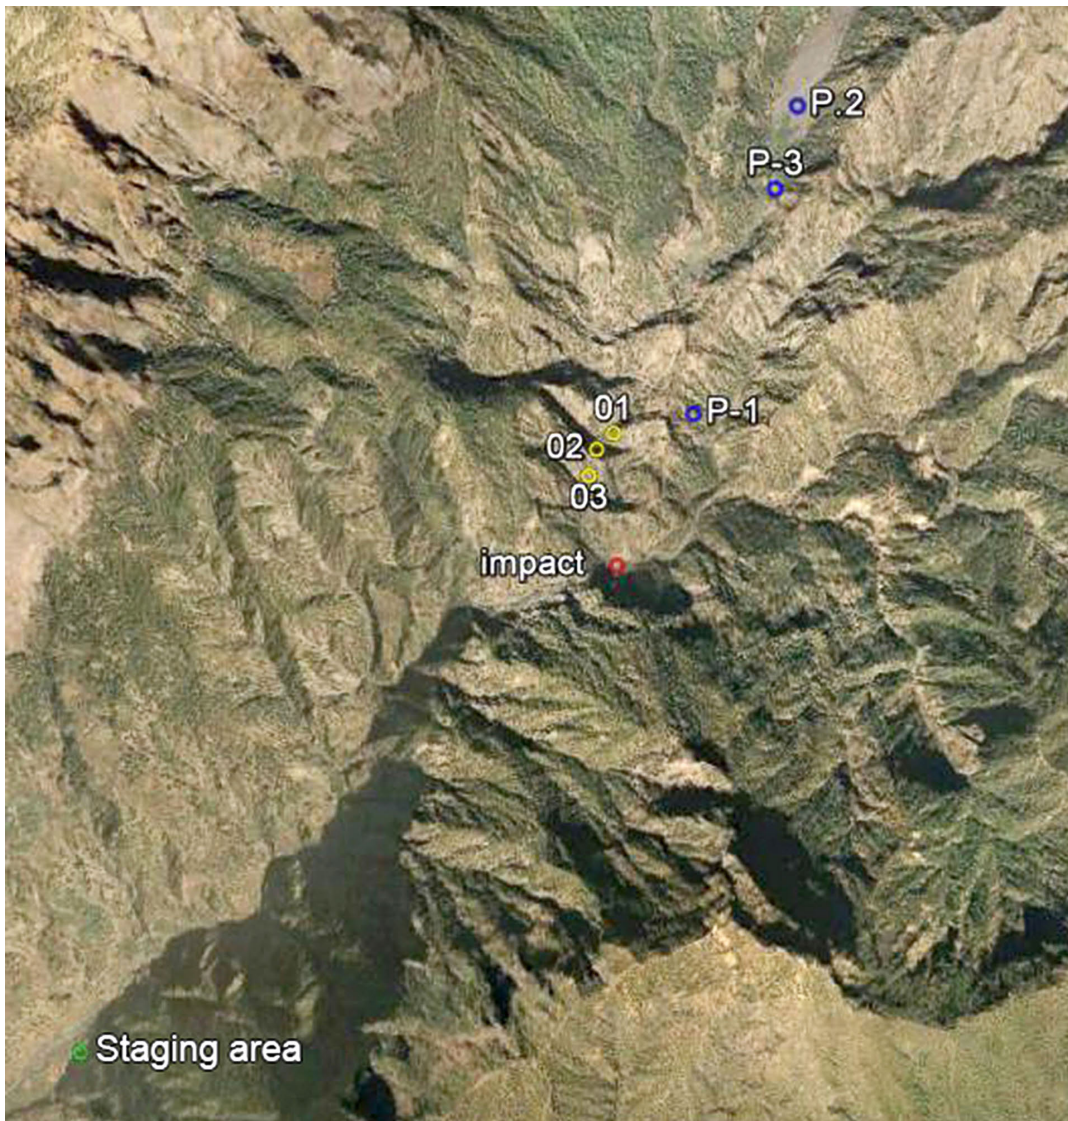
Figure 1. Location of the staging area and unloading points (P1, P2 and P3), as well as of main wreckage and other aircraft components

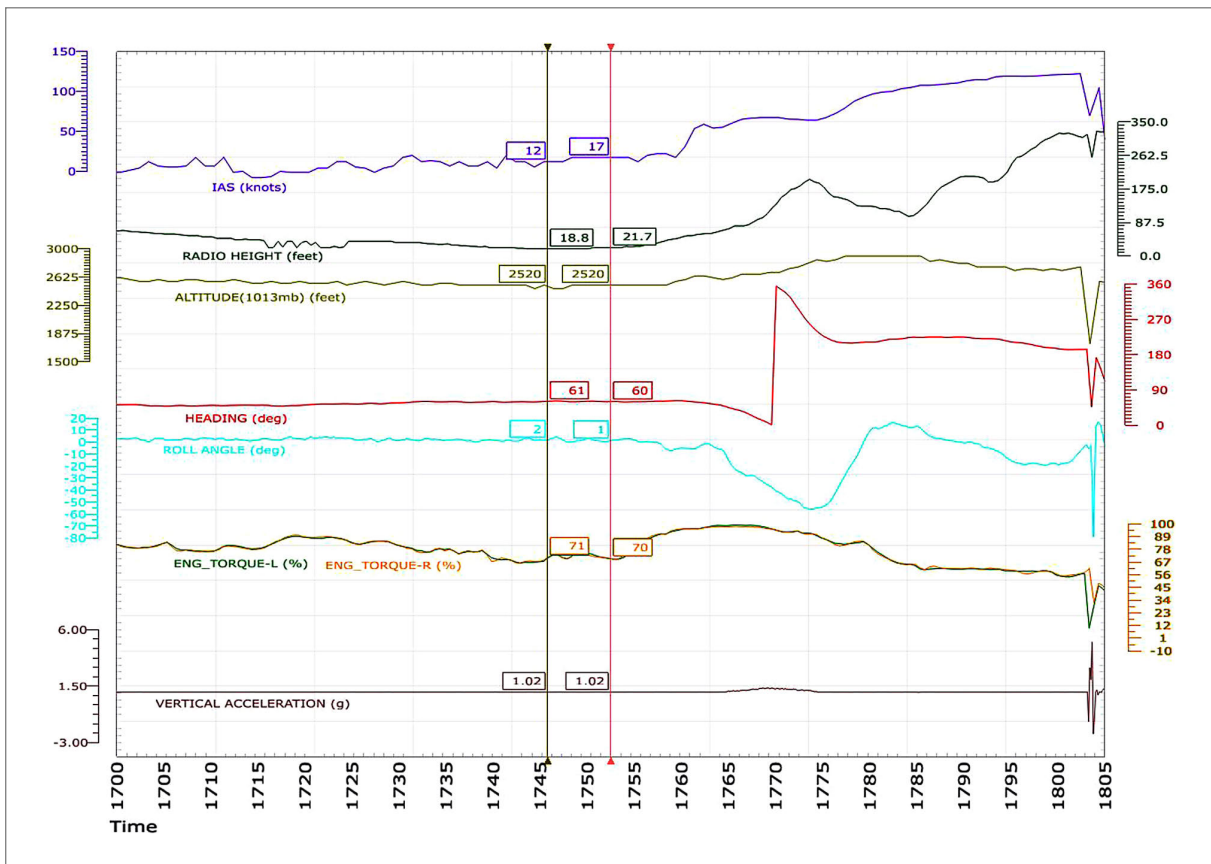
As the graph in Figure 2 shows, at time t = 1,756 s the helicopter stopped hovering once ground personnel unhooked the tank and reported this to the crew. The helicopter's speed and altitude increased and it proceeded on an approximate course of 60° for 9 seconds, after which it started a turn to the left, reaching a heading of 210° 14 s later. This means that the helicopter went further into the valley until it reached a wider area, where the crew made a turn of almost 180° to head down the valley toward the staging area. While it hovered the altitude value recorded on the FDR was 2,520 ft. By the end of the turn the helicopter had climbed to an altitude of 2,904 ft, a difference of 384 ft. Its indicated airspeed (IAS) at that point was 79 kt.

Figure 2. Indicated airspeed, radioaltitude, altitude, heading, bank angle, engine torque and vertical acceleration over 105 s

During the hover the engine torque supplied by each engine was practically identical, their values ranging between 65 and 75%. Once the helicopter stopped hovering and started to gain speed and altitude, the torque supplied by the engines increased to a maximum value of 99% during the 180° turn. From then on the torque values decreased to around 60% as the IAS increased.

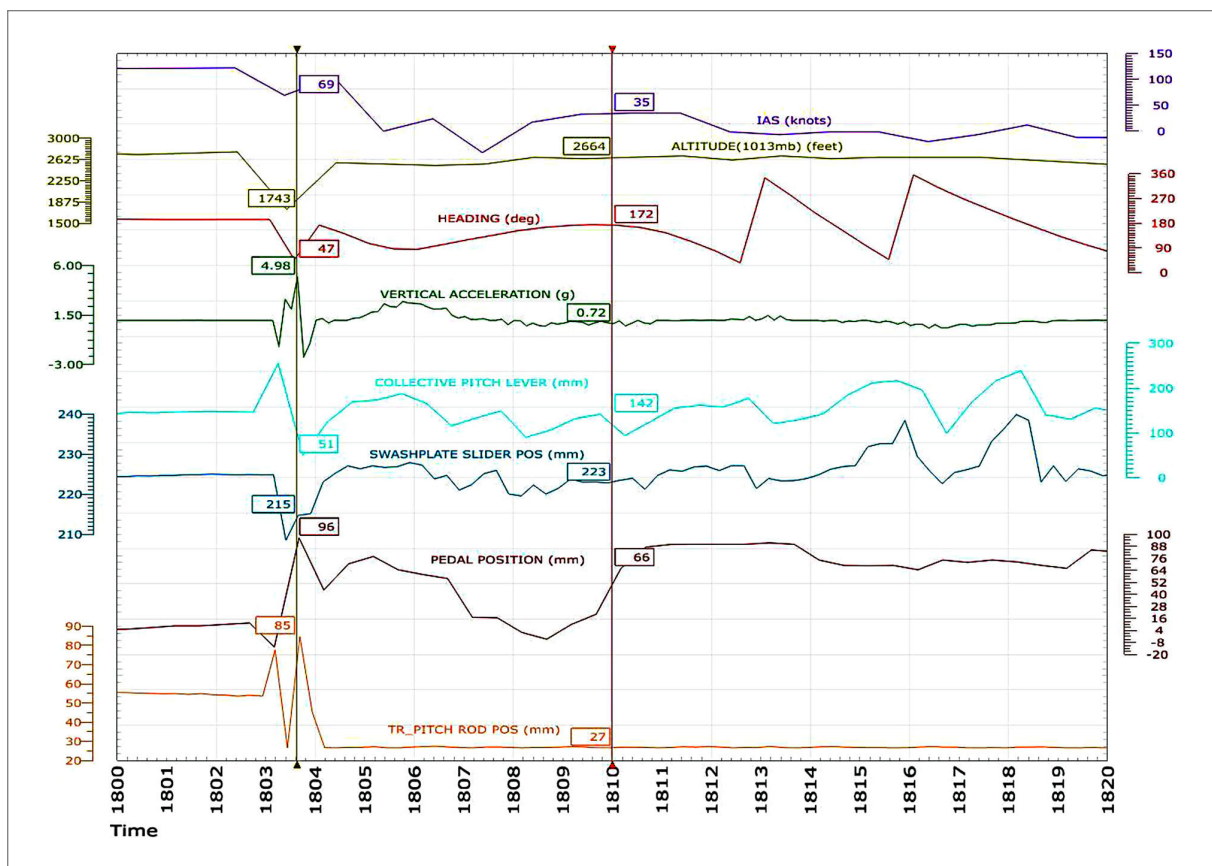
Figure 3. Indicated airspeed, altitude, heading, vertical acceleration, collective lever position, swash plate displacement (collective), right pedal position and displacement of the pitch control actuating lever for the tail rotors blades between  $t = 1,800$  s and  $t = 1,820$  s

According to these data, in the second immediately prior to  $t=1803$  s, the aircraft was flying on a heading of  $193^\circ$  at an IAS of 122 kt, an altitude of 2,760 ft (1,820 ft corrected), the main rotor RPMs were 105%, the bank angle was  $6^\circ$  left, the pitch angle  $-4^\circ$  and the engine torque for both engines was 56%.

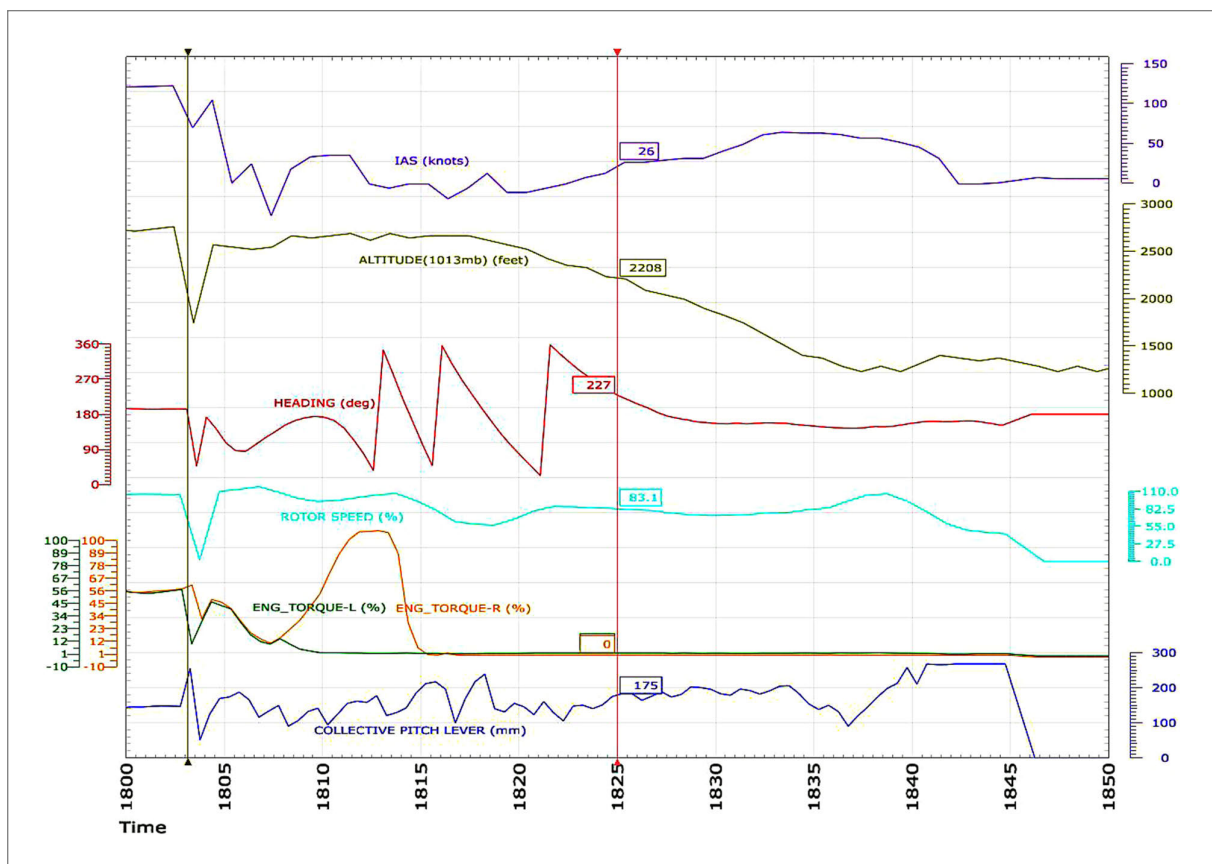
Figure 4. Indicated airspeed, altitude, heading, rotor speed, engine torques and position of collective lever during the final phase of the flight

- Engine 2 torque: at  $t = 1,810$  s it was 22.84% and increasing. At  $t = 1,815$  it reached its maximum value, 107.46%, after which it started to decrease such that 3 s later it was below 5%.

- Collective: between  $t = 1,815$  s and  $t = 1,833$  s the lever was moved upward and downward from its middle position. From this last period on, there was a noticeable move downward for two seconds, followed by an increase toward the upper part of the range of motion, where it stayed until the end of the recording.

- Altitude: at  $t = 1,810$  s it was 2,664 ft. It remained stable for the 7 subsequent seconds. From then on until  $t = 1,839$  s, it dropped to a value of 1,228.6 ft at an average descent rate of 3,900 ft/m. From there until the end of the recording, there are five more readings ranging in value from 1,400 to 1,342.9 ft, this being the last recorded value.

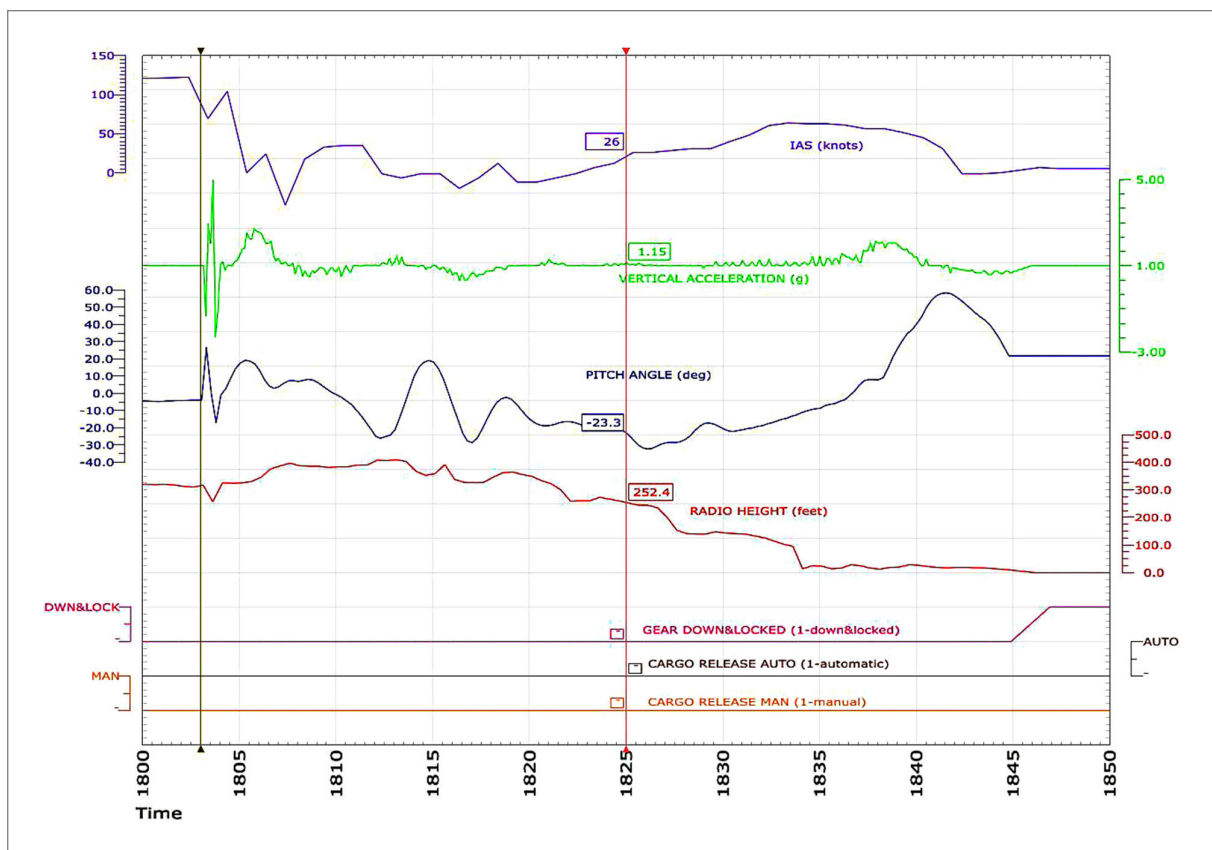
Figure 5. Indicated airspeed, vertical acceleration, pitch angle, radioaltitude, gear down and locked and automatic and manual openings of the load hook during the final phase of the flight

- IAS: at  $t = 1,810$  s, the value recorded for this parameter was 34.80 kt. Until  $t = 1,822$  s, negative values were recorded for IAS. Starting with  $t = 1,823$  s, the values were positive and increasing such that at  $t = 1,832$  s, IAS was above 60 kt, remaining around that value for the next 6 s. Then, until the end of the recording there were six readings indicating a drop in speed to virtually zero.
