State Commission on Railway Accidents Investigation
MINISTRY OF INTERNAL AFFAIRS AND ADMINISTRATION

ANNUAL REPORT 2020

ON ACTIVITIES OF THE
STATE COMMISSION ON RAILWAY ACCIDENTS
INVESTIGATION (PKBWK)

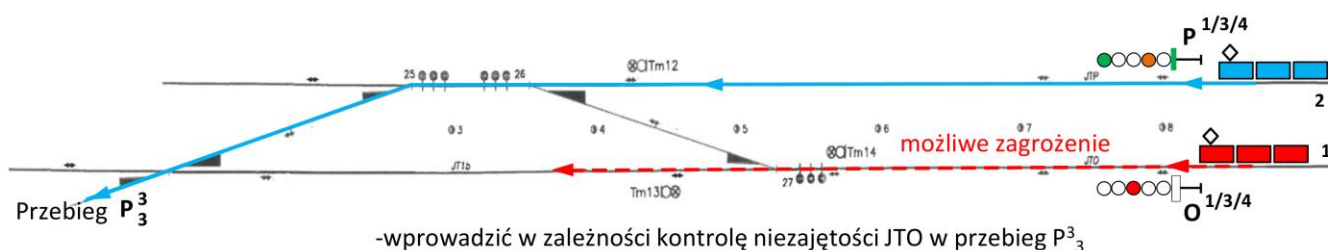
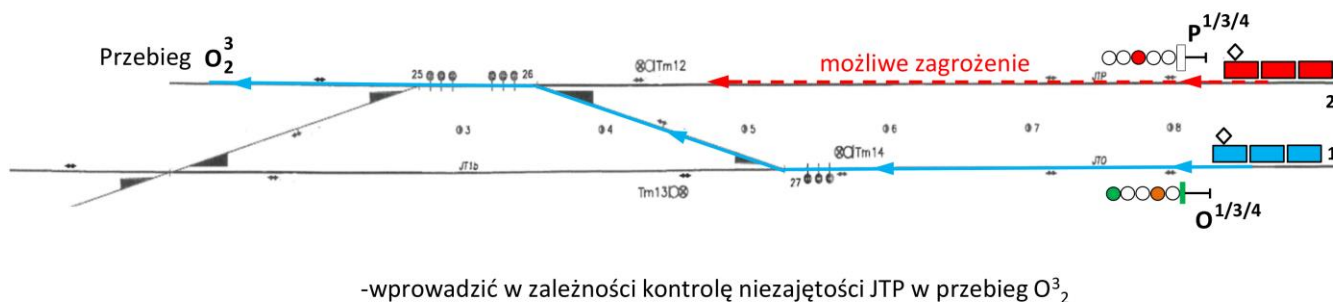
- 6) To increase traffic safety in a signalling circle in case of simultaneous train movement on tracks in the same direction - of the same station and when a train (red) with "stop" signal given on the entry semaphore does not stop to cause earlier change of authorising picture to the "stop" signal, for the train (blue) approaching the entry semaphore on the adjacent track with "free passage" signal it is necessary

In control-command and signalling systems with unoccupied track sections following semaphores on the entry and exit sides of multiple-track routes as part of their mutually conflicting routes, introduce their relation as shown in the examples in the following figures.

This recommendation is addressed to infrastructure managers to eliminate of events such as those which occurred (or similar) at Szymankowo station on 9 March 2020 at 04:15, and the circumstances presented in Report No. PKBWK 01/2021.

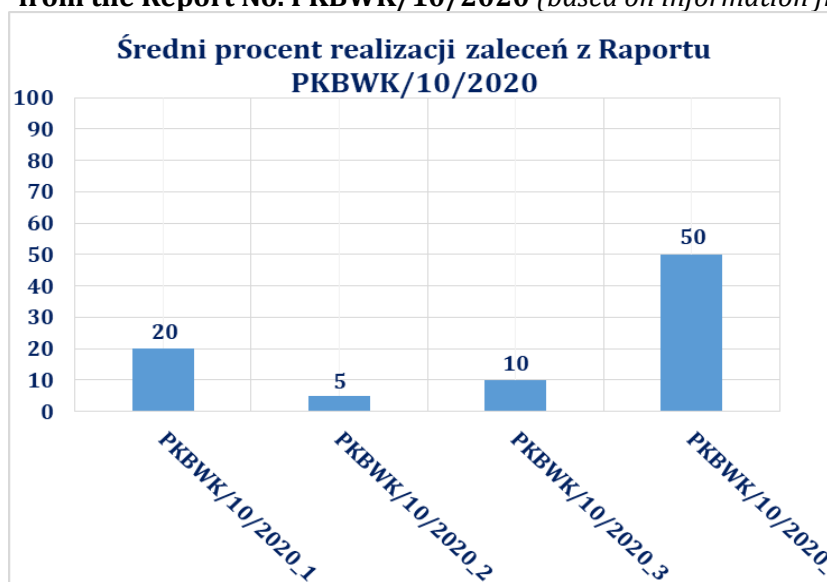
Figure 21: **Average percentage of implementation of recommendations forwarded by the President in Report No. PKBWK/10/2020 (based on information from UTK)**

The average percentage of implementation of recommendations was determined by UTK based on declarations of addressees of a given recommendation. Lack of 100% of recommendation results from the schedule of activities undertaken by the entity to fully implement the recommendations of PKBWK.

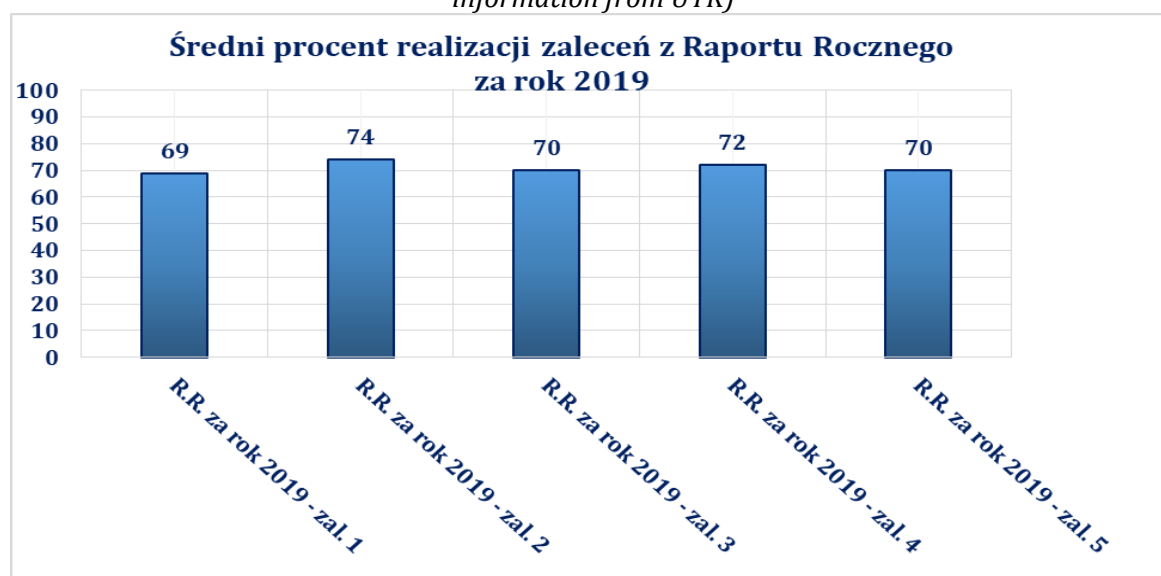
Chart 22: **Average percentage of implementation of individual recommendations from the Annual Report for 2019 provided by the President of UTK to railway market entities** (based on information from UTK)

The average percentage of implementation of recommendations was determined by UTK based on declarations of addressees of a given recommendation. Lack of 100% of recommendation results from the schedule of activities undertaken by the entity to fully implement the recommendations of PKBWK.

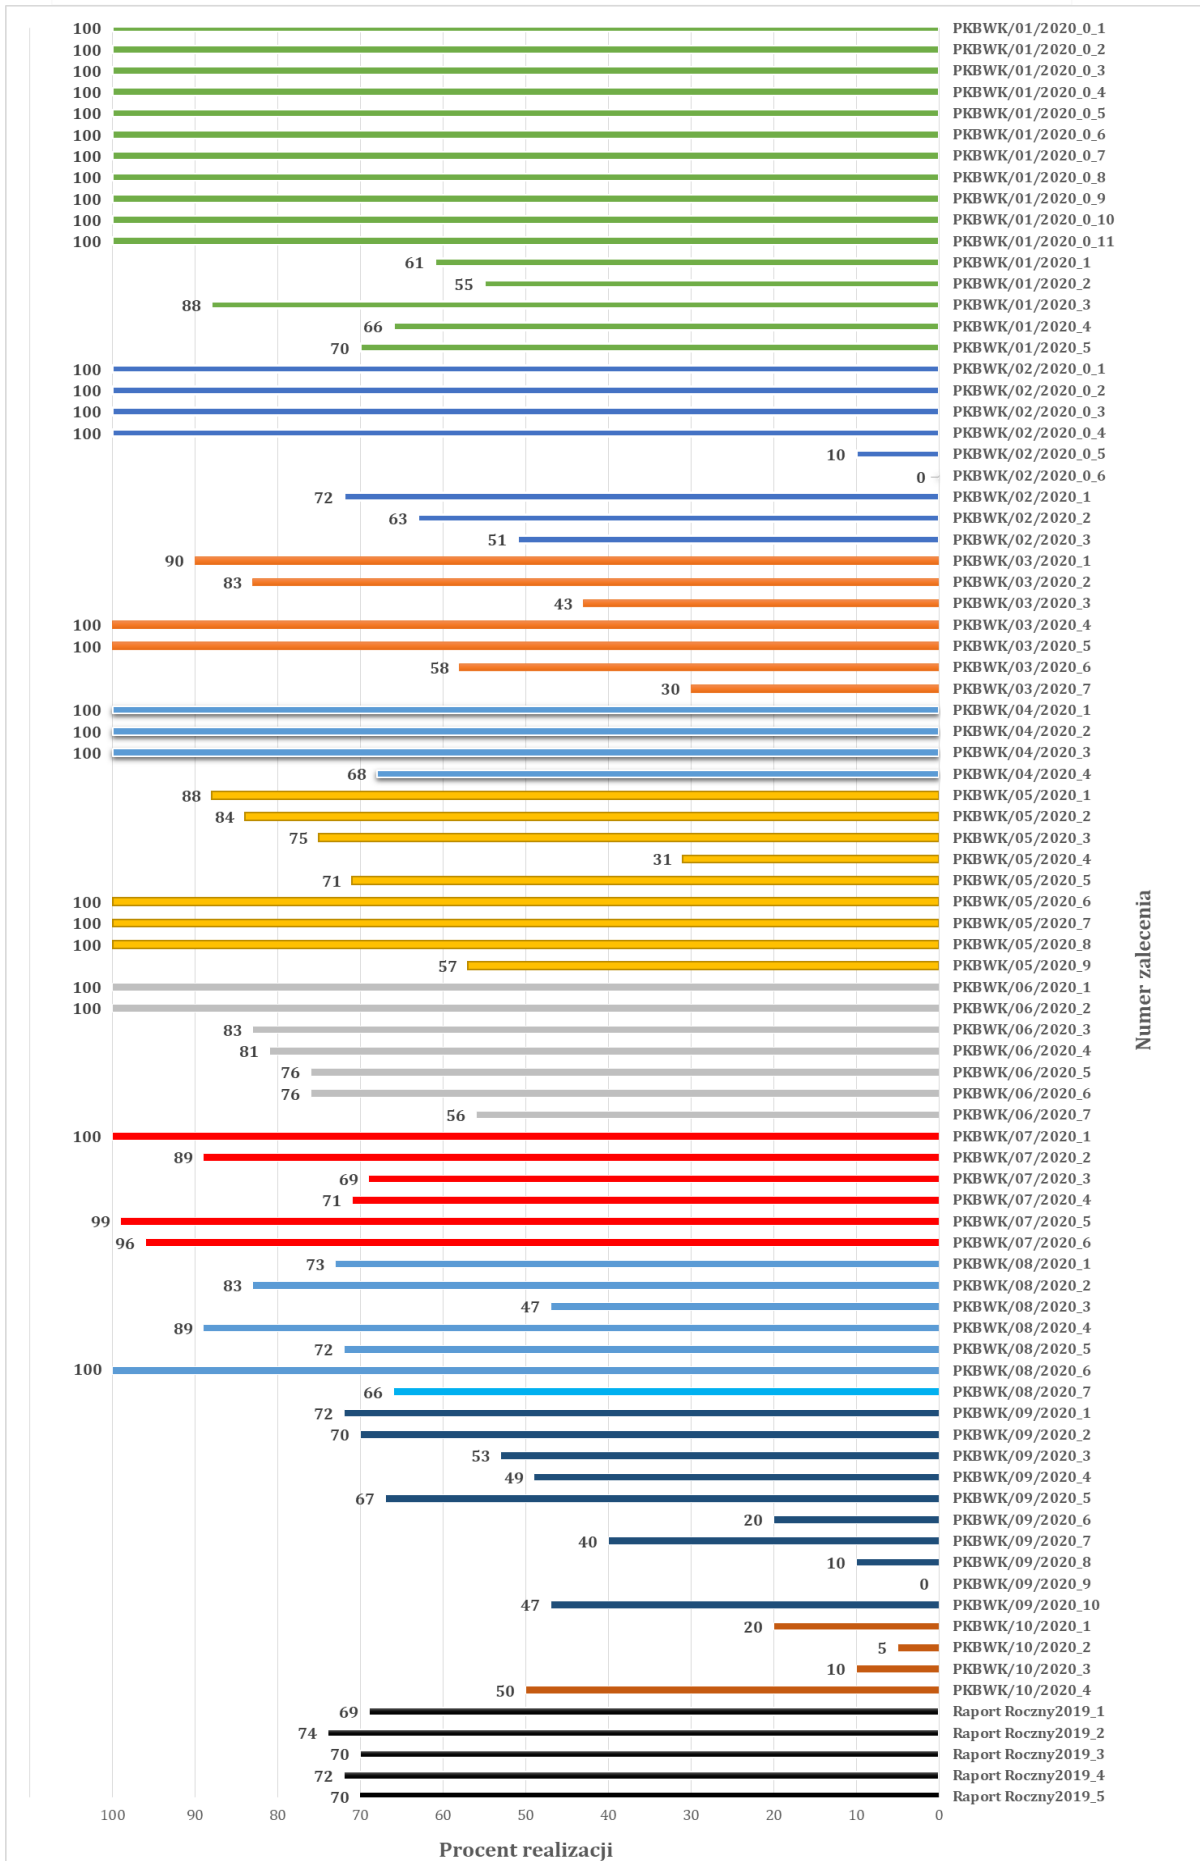
Figure 24: Average percentage of implementation of PKBWK recommendations for 2020 according to Appendix A

The cards include the average percentage of recommendation fulfilment, which was determined based on declarations of addressees of a given recommendation. Lack of 100% implementation of the recommendation results from the schedule of actions taken by the entities to fully implement the recommendations provided to market entities by the President of UTK.

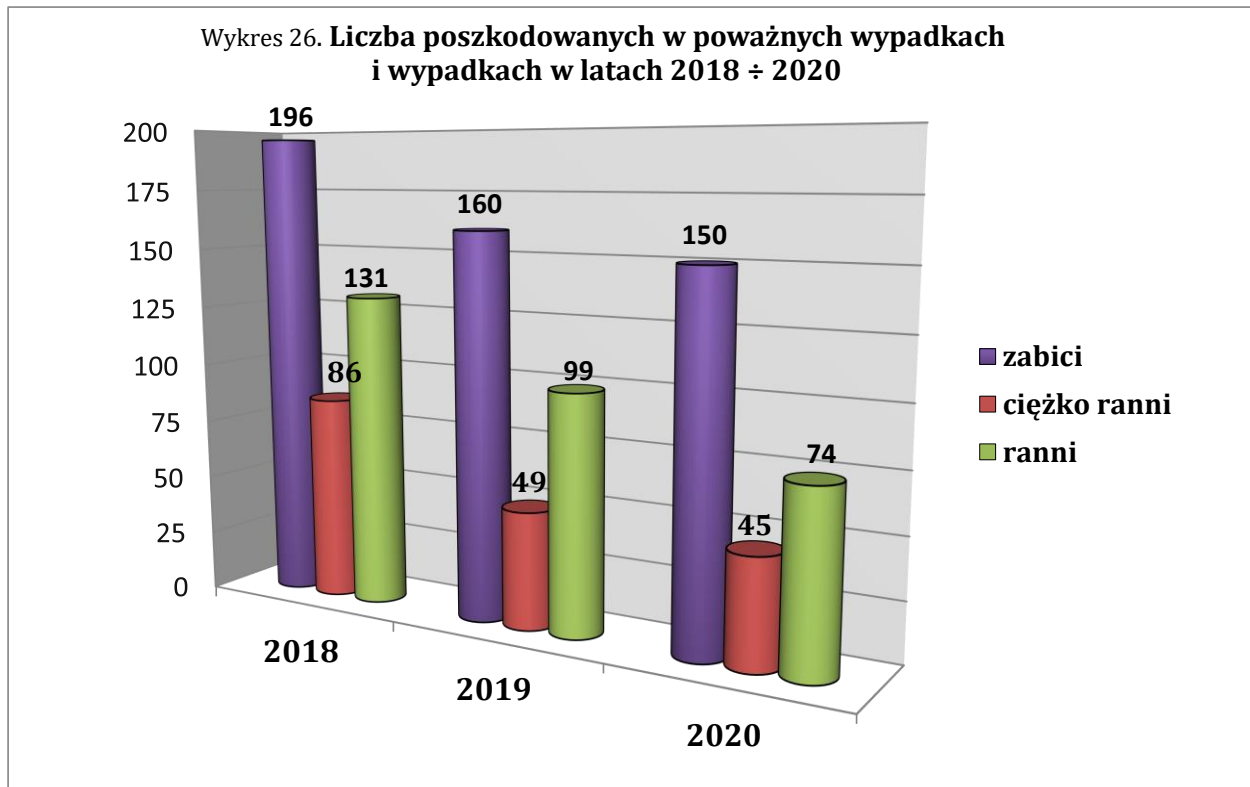
Below the chart illustrates the basic data on the injured (killed, seriously injured and wounded) in 2018 ÷ 2020.

In 2020, compared to 2019, the number of people killed in rail incidents decreased by 6.3%, while the number of seriously injured people decreased by 8.2% (Table 2). In the group of injured persons (killed and seriously injured), the overwhelming majority are persons crossing the tracks in prohibited places or at level crossings, persons hit by railway vehicles, persons jumping in and out of railway vehicles in motion, and users of railway-road crossings.

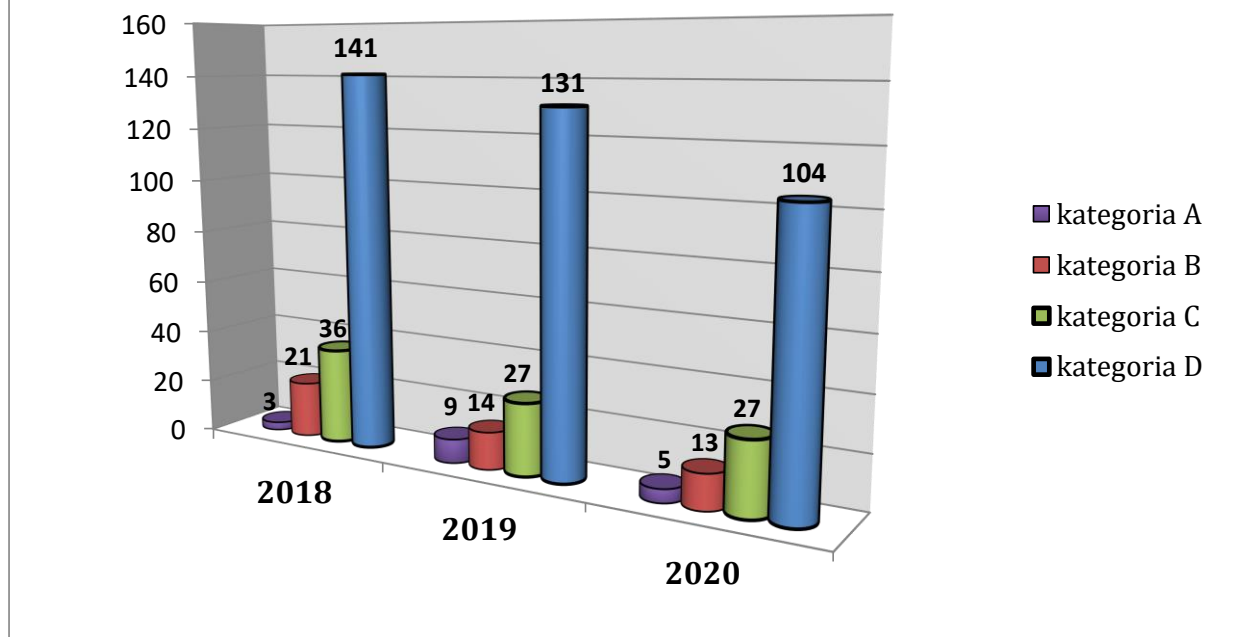
Wykres 27. Poważne wypadki i wypadki na przejazdach kolejowo-drogowych poszczególnych kategorii z udziałem pojazdów drogowych i kolejowych w latach 2018 ÷ 2020

In 2020, compared to 2019, there was a **17.7% decrease** in the total number of accidents at Category A, B, C, D railroad crossings, including:

- at A category railway-road crossings - decrease by 4 accidents,
- at category B railway-road crossings, a decrease of 1 accident,
- At level crossings of category C, the number of incidents (accidents and serious accidents) did not change with respect to the previous year,
- at D category railway-road crossings - decrease by 27 accidents (including users of railway sidings).
