# FINAL REPORT

## ACCIDENT

**Occurrence No.: 466/07**

**Aircraft: B737-800, EC-HBM**

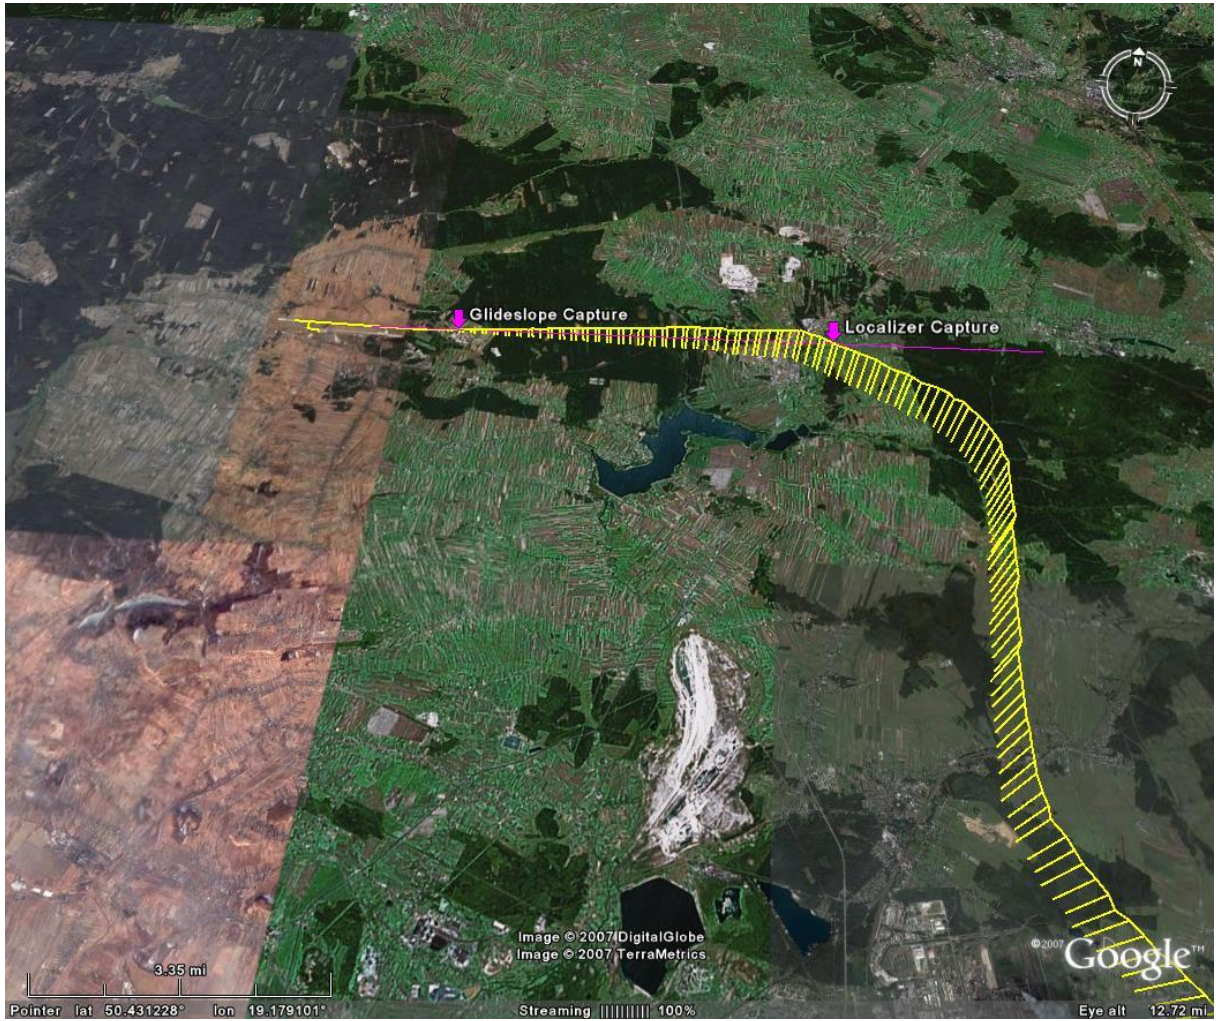
Fig.1. EC-HBM approach trajectory

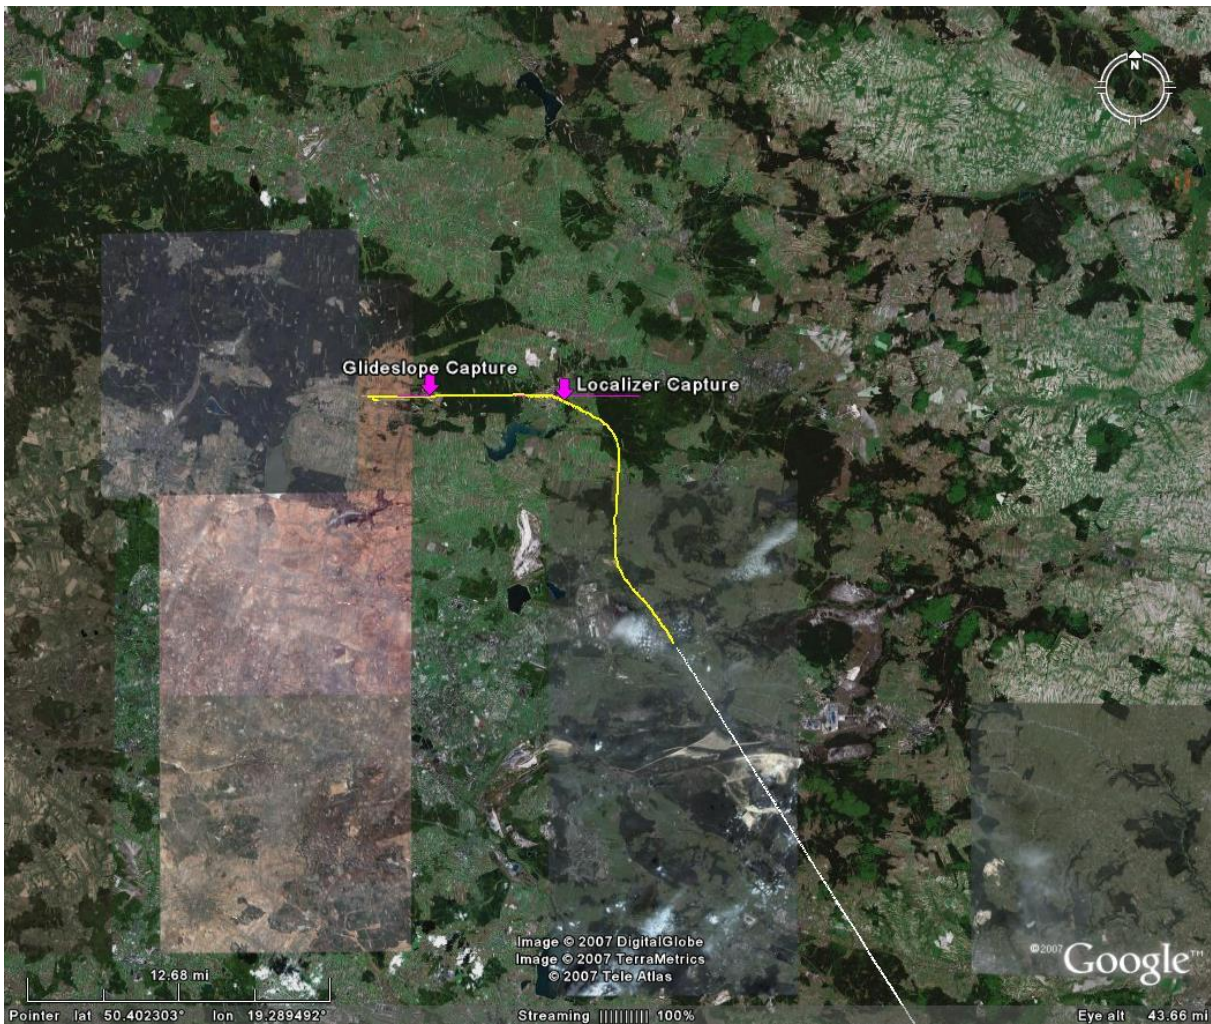
2 – End phase of the flight – approach to EPKT [M. Smith, NTSB]

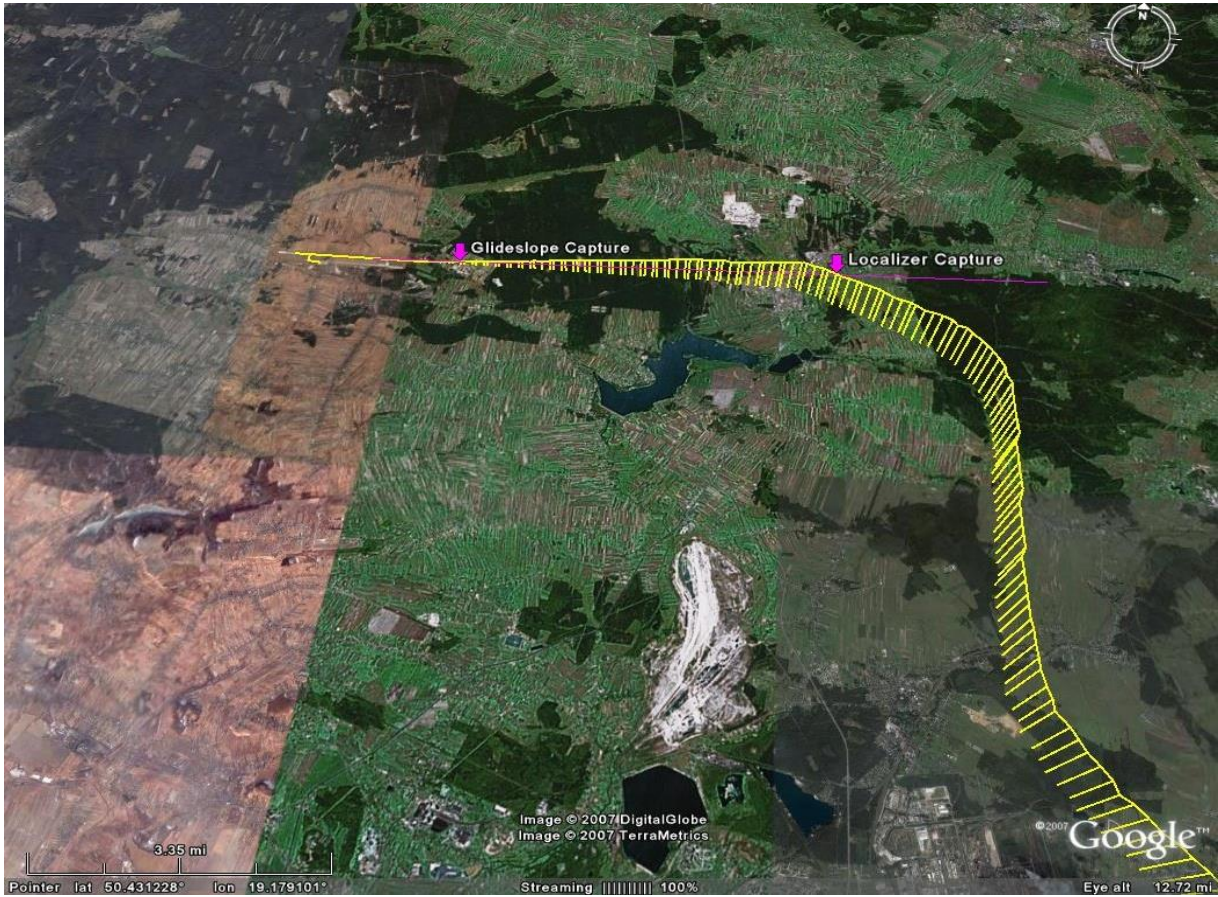
3 – End phase of the flight – G/S capture [M. Smith, NTSB]

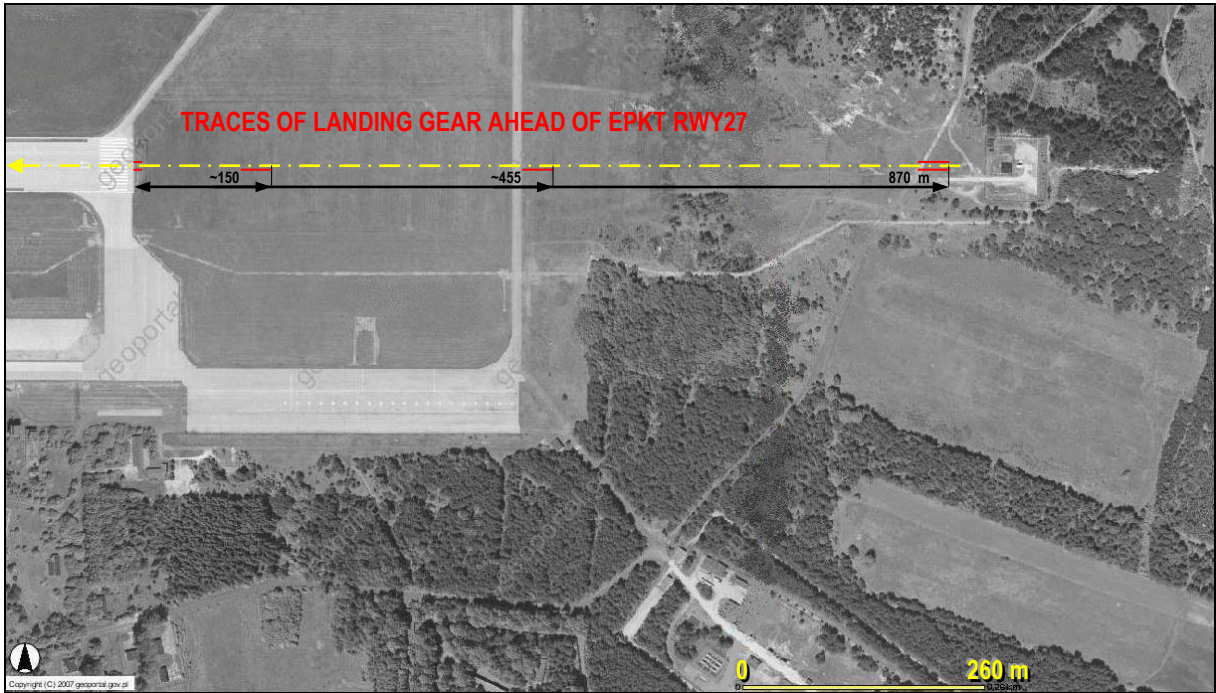
5 – Traces of landing ahead of EPKT RWY27 [geoportall, 2007]

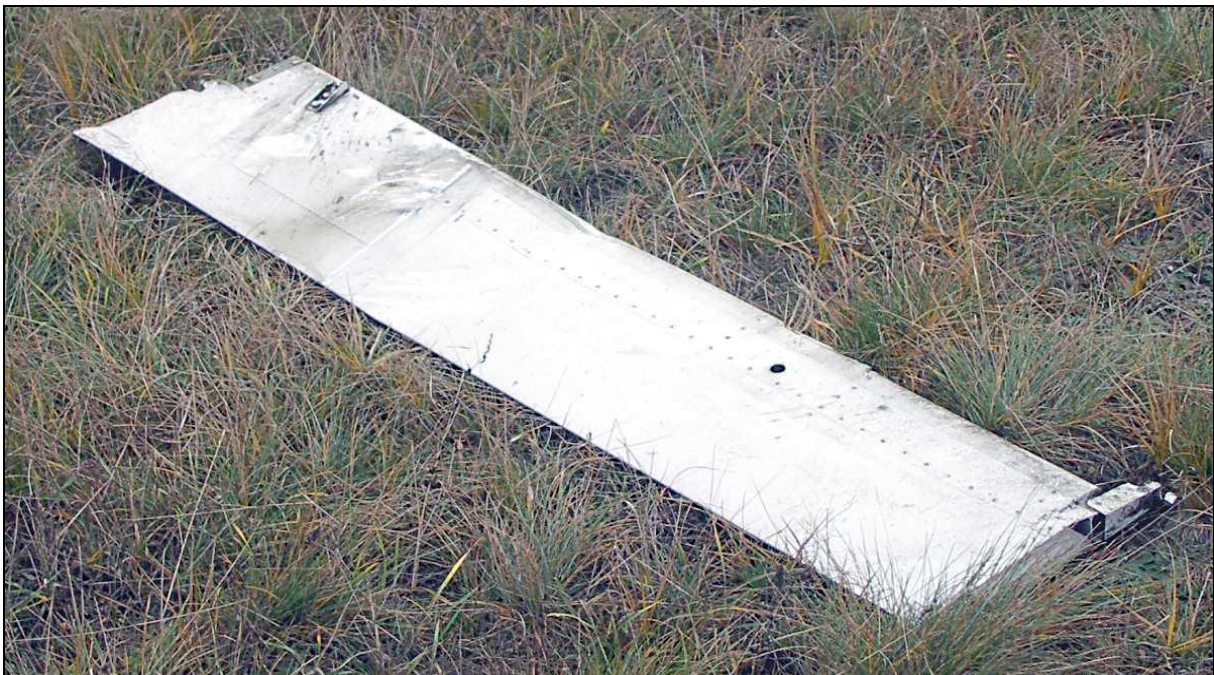
**14 – Trailing part of the right outboard flap separated from the airplane**

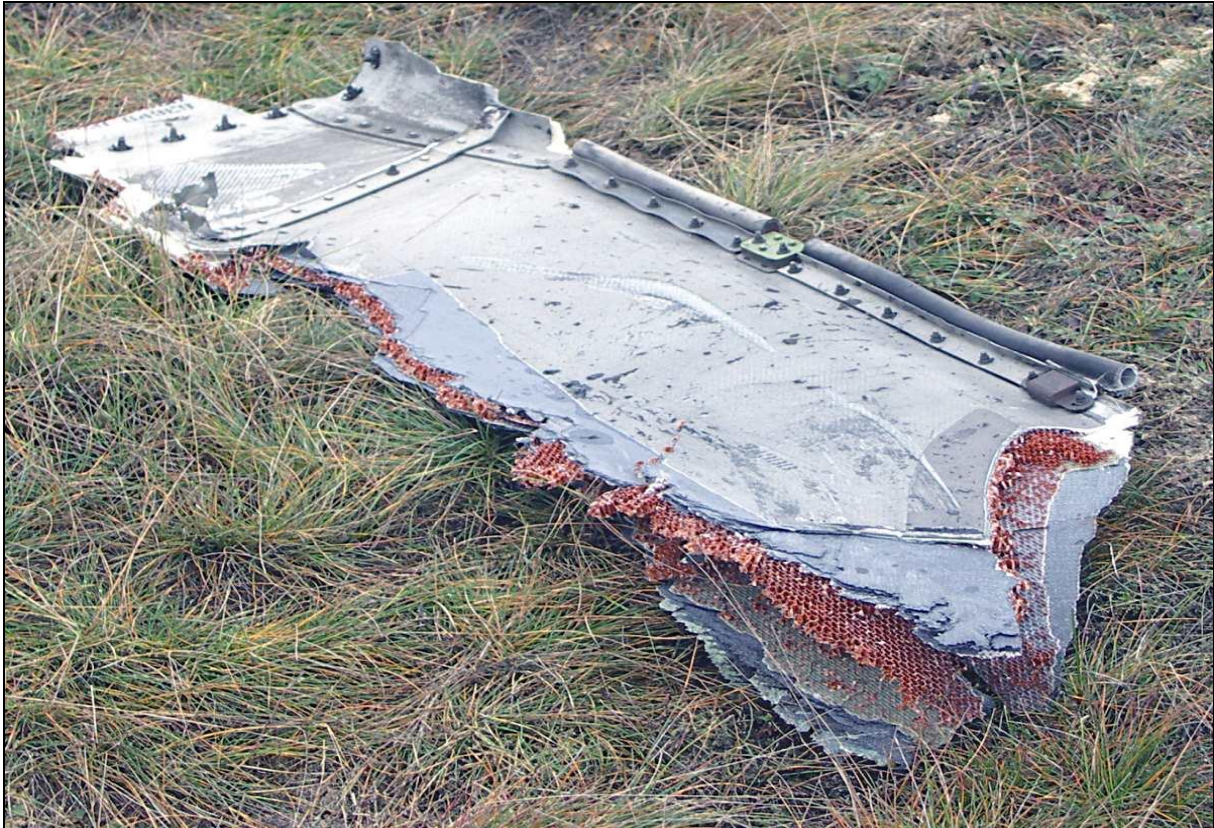
15 – Part of the right Krüger flap

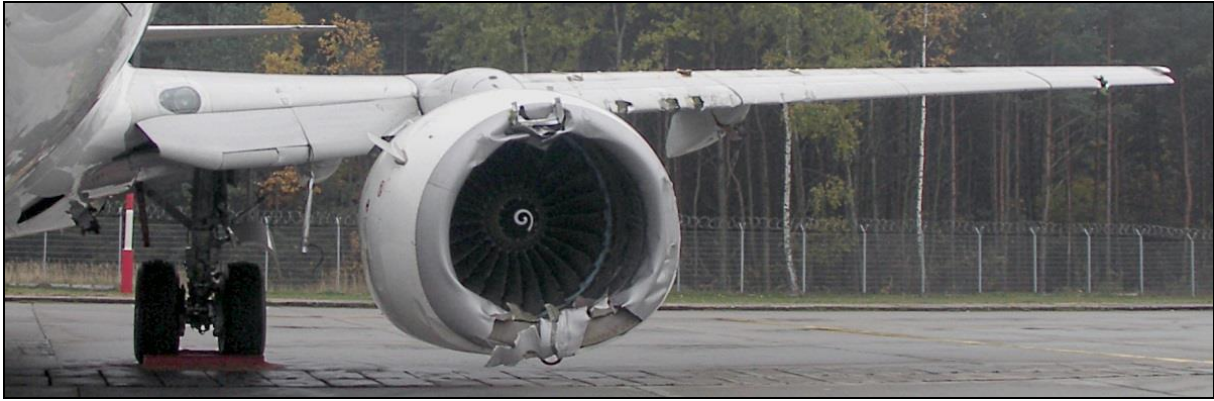
**44 – Left wing – general front view**

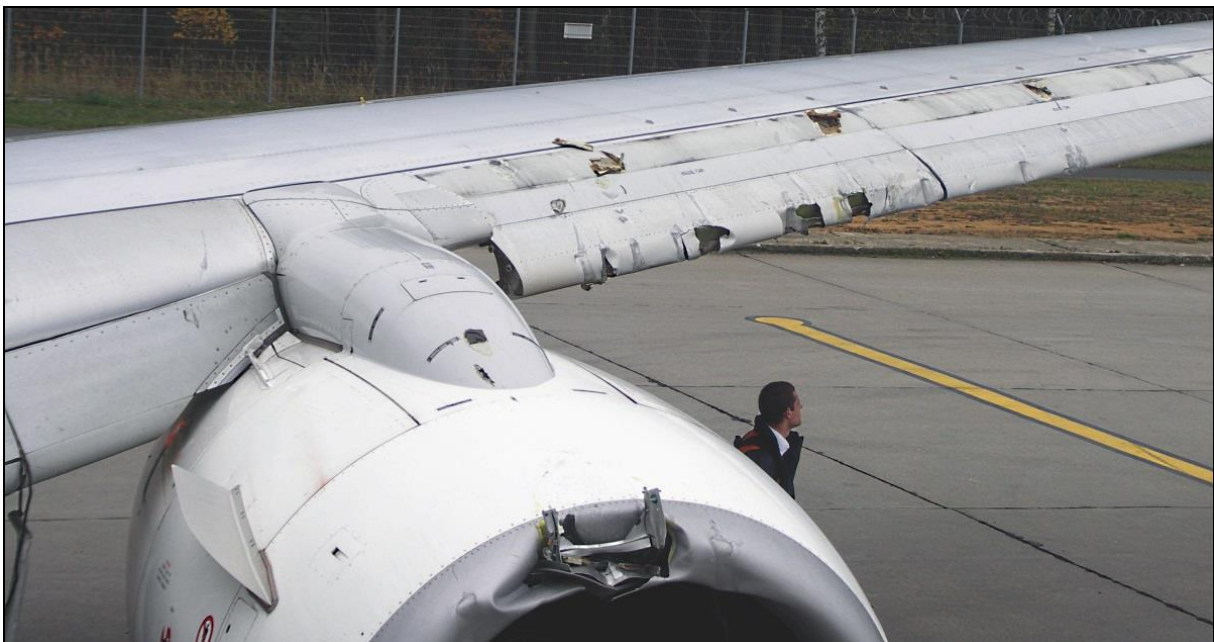
**45 – Left wing front view – inboard and middle parts**

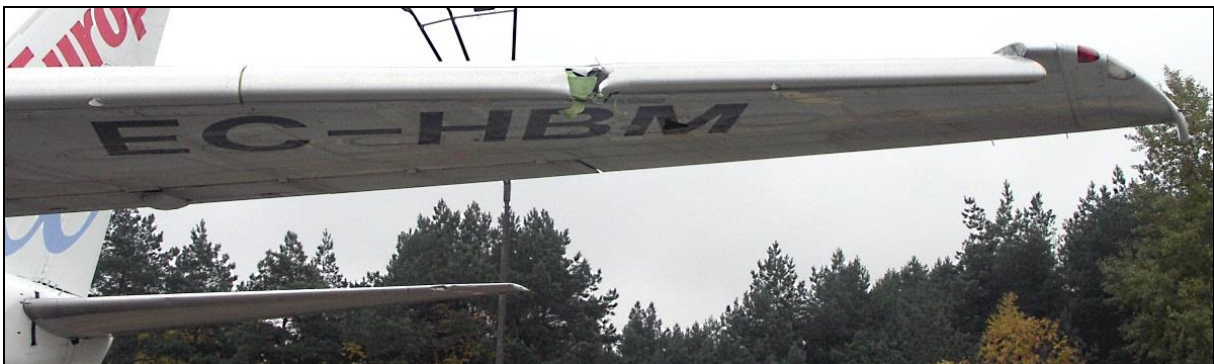
**46 – Front view of the left wing tip**

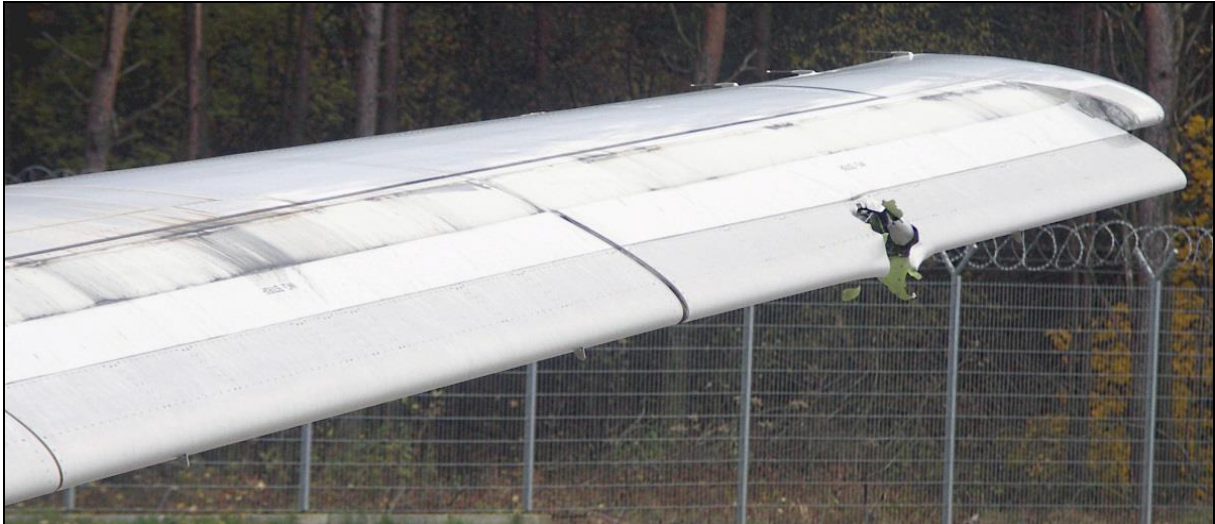
47 – Front view of the left wing tip – close-up
